Captain Robert Falcon Scott Statue

Repair Project Update

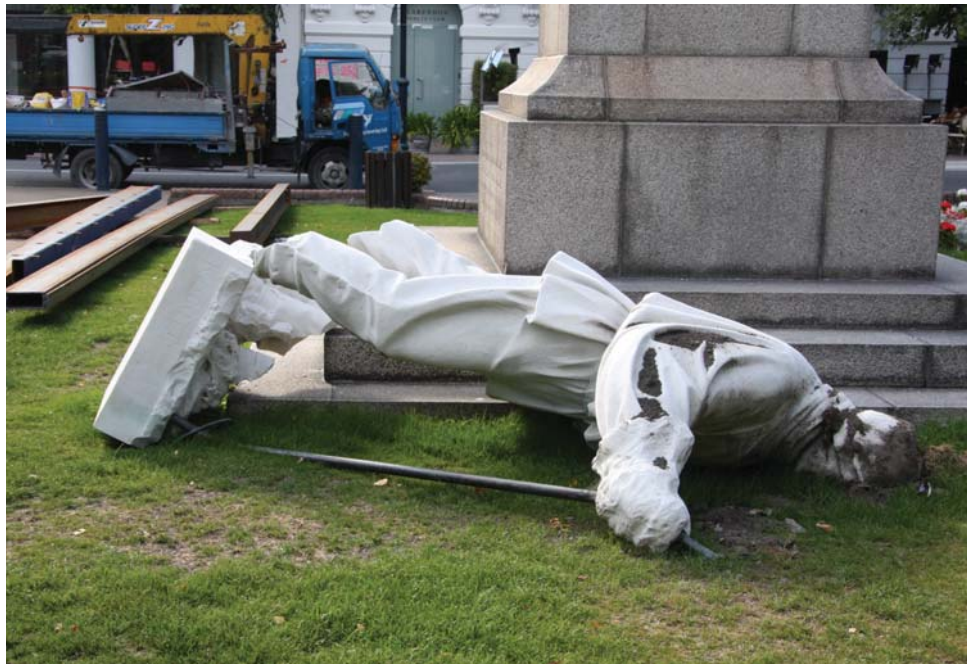
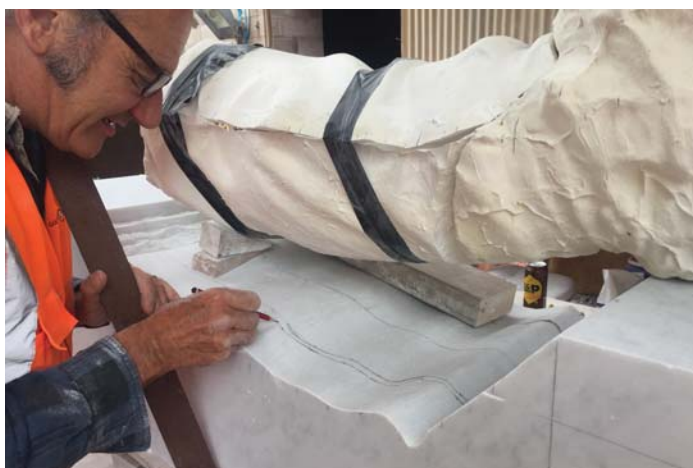
Sculptor Mark Whyte uses a plaster cast he made of one of the statue's legs and carefully copies the exact angles of the break to carve a marble replica to test the repair method on.

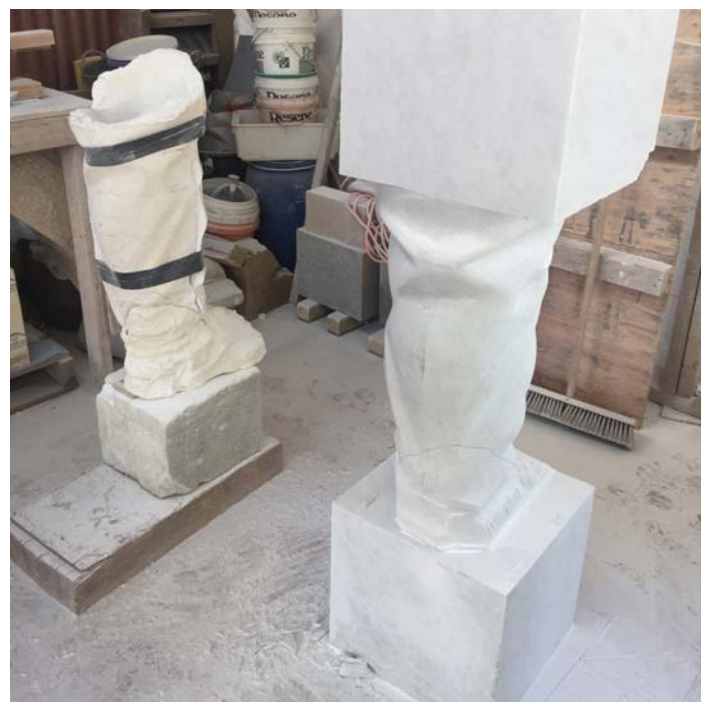
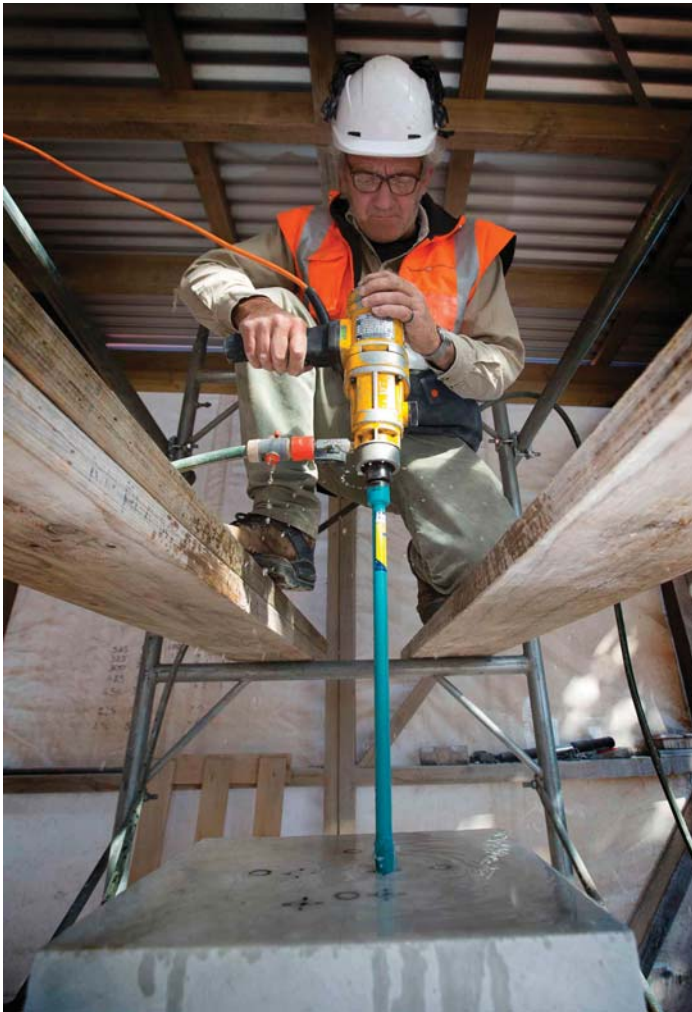
Sculptor Mark Whyte drills holes down into the replica marble leg for the carbon fibre rods that will strengthen the structure.

The two replica pieces were then joined together, using the carbon fibre rods and a special epoxy glue.

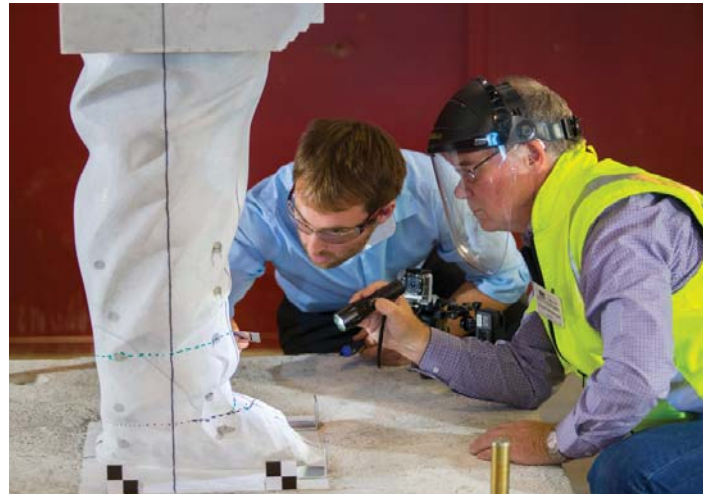
The replica leg was rocked back and forth on its base under an incrementally increasing loading. The design target was to withstand a 1.5-tonne load and this was achieved with only minor cracking in the structure.

Engineers check the replica leg for cracking during the load testing process.
