Christchurch Fish Barriers Update

September 2022

Prepared for:
Christchurch City Council

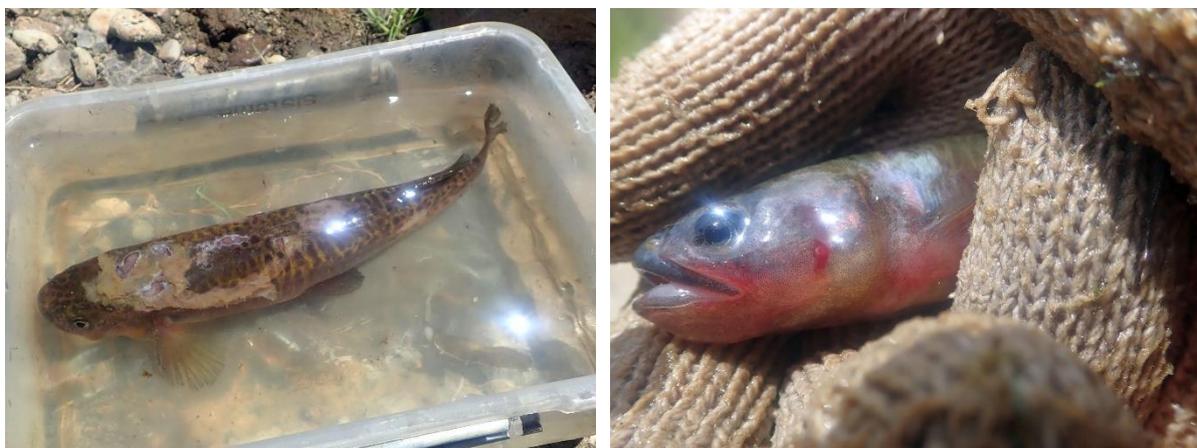
Stormflows may be an opportunity for upstream migration for some individuals, but they also represent a disturbance event. A particularly large storm event occurred around Banks Peninsula during December 2021, about a month prior to the fish survey, resulting in severe flooding of streams in the Le Bons Bay area. A small number of the larger banded kōkopu caught during the survey in Le Bons Stream Branch No 13 had signs of damage and infection, which may have been caused by the storm event (Figure 4).

Figure 4: Two large banded kōkopu with signs of injury and infection.

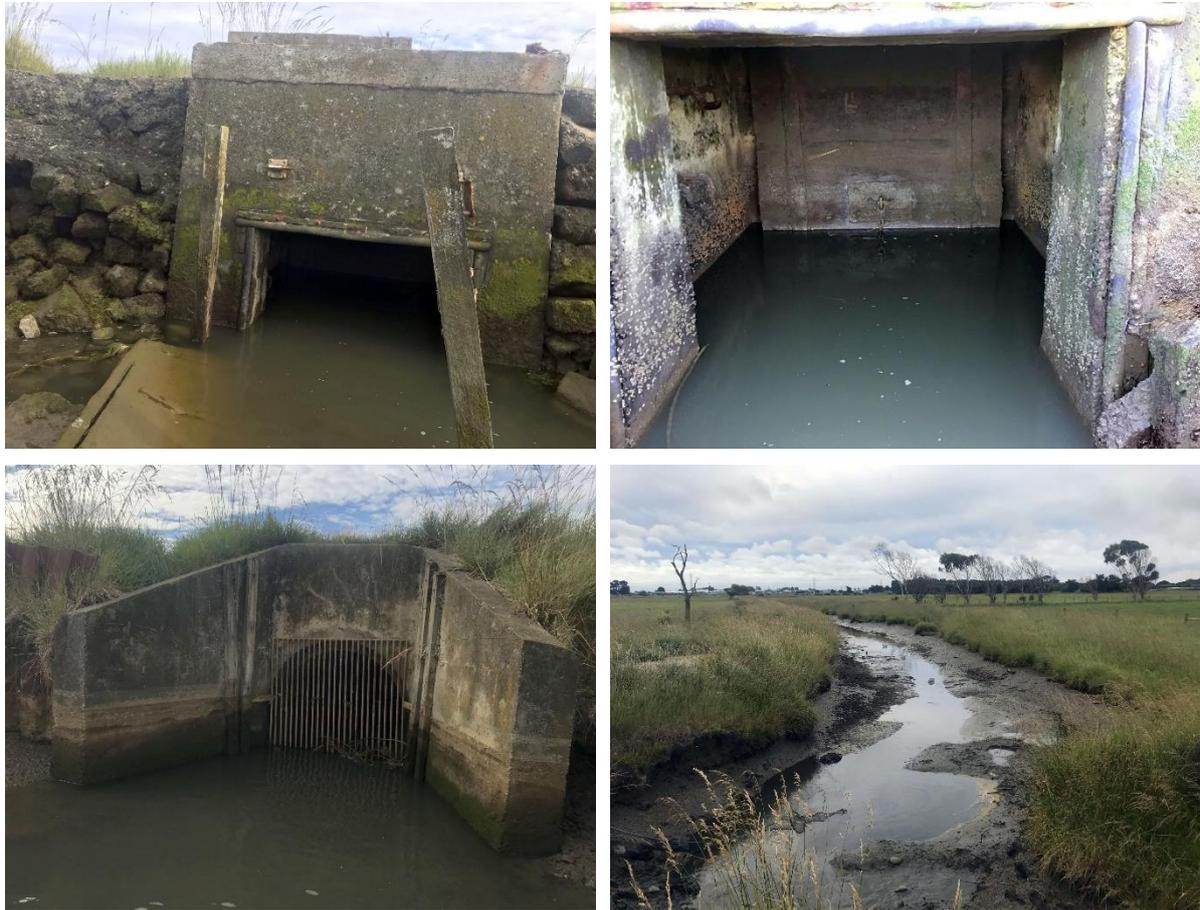
Figure 6: Charlesworth Reserve Drain downstream view of culvert and flap gate externally (top left) and internally (top right). Upstream end of structure (bottom left) and upstream sampling reach (bottom right).

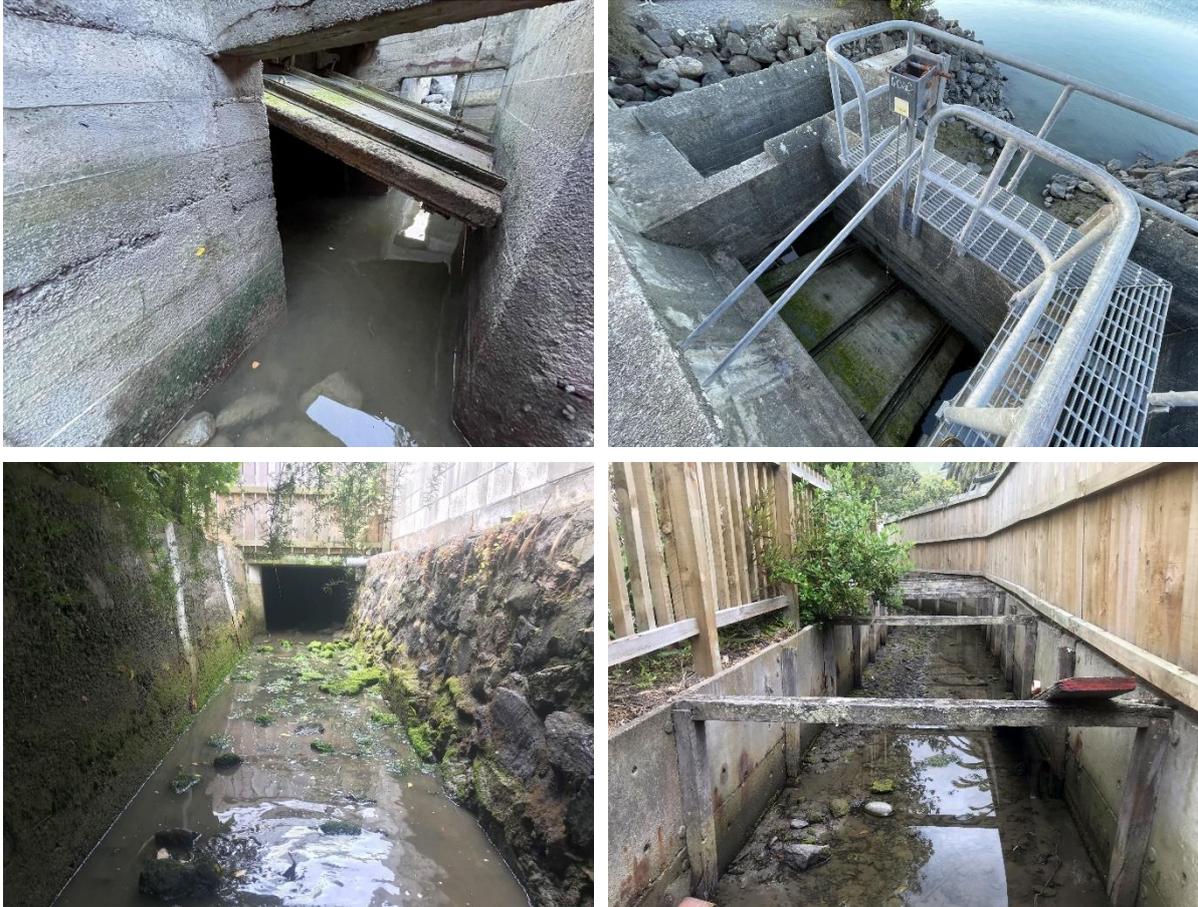
Rifle Range Waterway

Figure 7: Rifle Range Waterway, including the flap gate outlet (fixed in an open position; top) and the habitat immediately upstream (bottom).

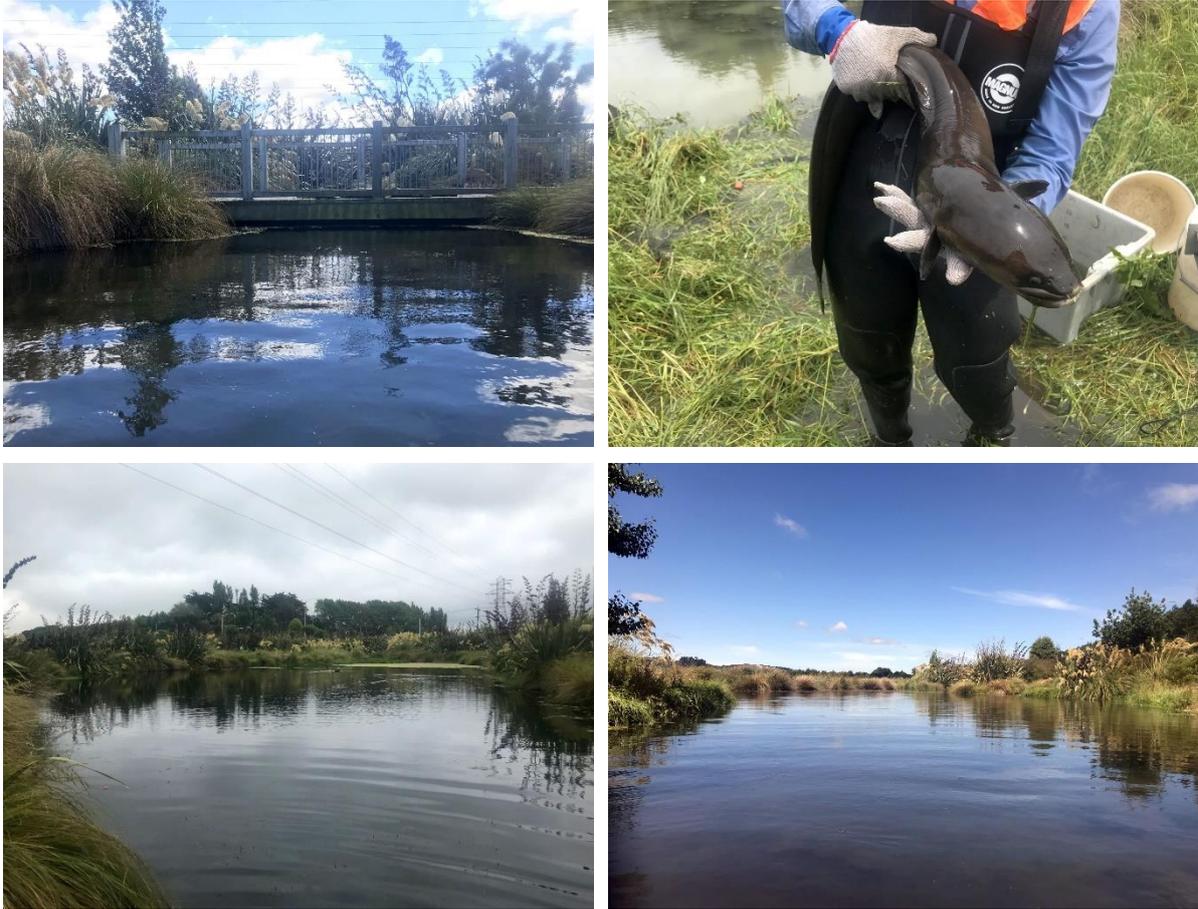
Structure 3, Miln Drain: Shortfin eel numbers were reduced upstream (50 individuals) when compared with downstream (103 individuals). Five inanga were recorded downstream of the structure but none were recorded upstream. These results confirm that the structure is a high risk to fish passage and is impacting the distribution of native fish in the catchment.

Miln Drain (Cashmere Stream)	130166	Other	SwPipe 87535	R4	Fish surveys upstream and downstream of the structure indicated that this structure is substantial barrier to shortfin eels and inanga, as per the barrier fishing results discussed above.

Figure 8: The upstream end of the structure in Miln Drain (top left), a large longfin eel caught upstream of the structure (top right), and the downstream (bottom left) and upstream (bottom right) sampling reaches.

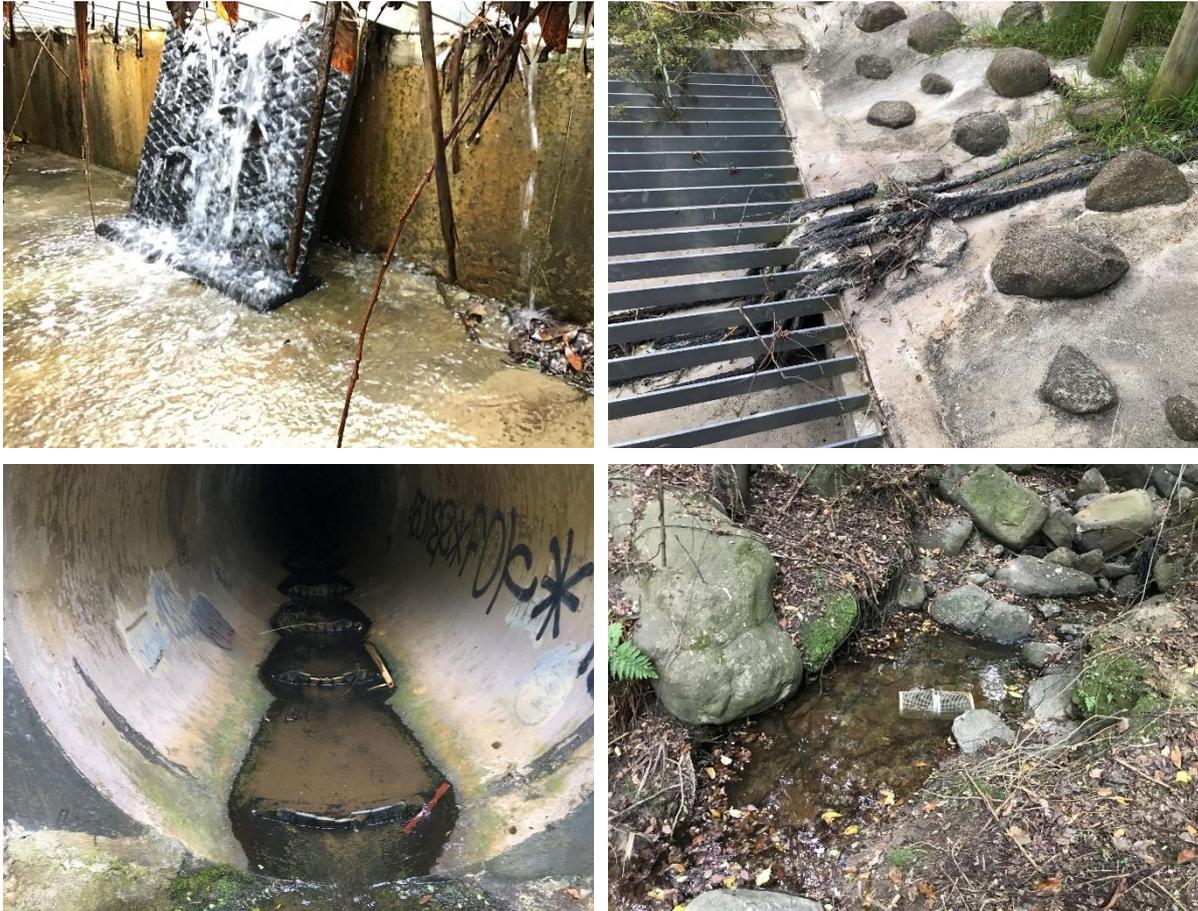
Cass Bay Drain

Figure 9: The weir structure and steep fish ramp during the associated FPAT assessment (top left), the structure during the fish survey (note the addition of mussel spat rope; top right), the culvert downstream under Harbour View Tce which includes baffles increasing water depth (bottom left), and an example of the habitat in the Upstream 1 sampling reach.

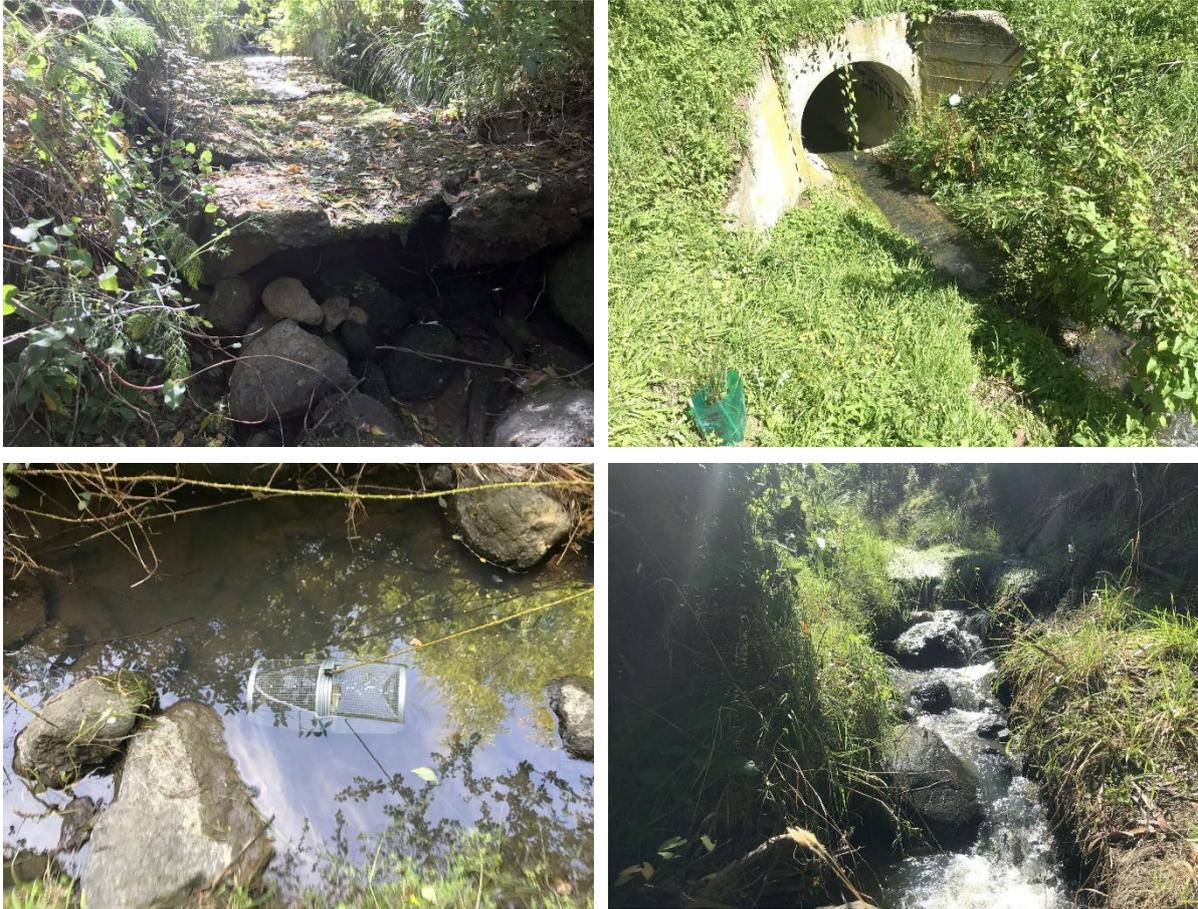
Figure 10: The perched apron at the downstream end of the Omaru Stream culvert (top left), the upstream end of the culvert (top right), a pool typical of the reaches sampled downstream near the Rāpaki Marae (bottom left), and the Upstream 1 sampling reach.

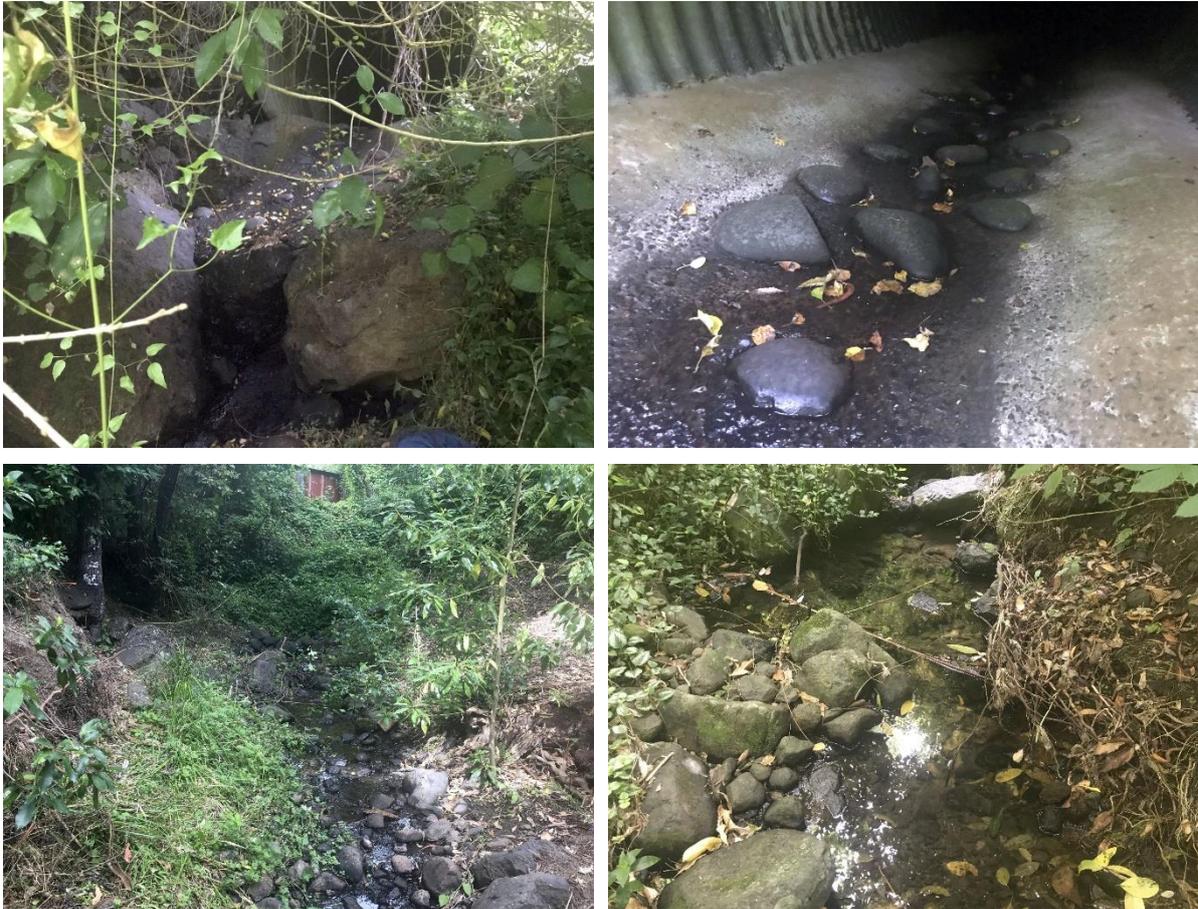
Structure 6, Stream Reserve Drain: Banded kōkopu were recorded in reduced numbers upstream of the culvert (eight individuals) when compared with downstream (21 individuals). A slight reduction in shortfin eel abundance was also recorded, with six individuals caught downstream of the culvert compared to the three individuals upstream. A single redfin bully was also caught downstream end of the culvert, with no redfin bully caught upstream. These results confirm that the structure is a high risk to fish passage and is impacting the distribution of native fish in the catchment.

Stream Reserve Drain (Lyttelton Harbour / Whakaraupō)	134866	Culvert	SwPipe 76048	R4	Fish surveys upstream and downstream of the culvert indicated that the structure is impacting fish passage, with reduced numbers of banded kokopu and shortfin eel caught upstream, as per the barrier fishing results discussed above.

Figure 11: The perched apron at the downstream end of the culvert (top left), rocks imbedded through the culvert to enhance fish passage (top right), the Downstream 1 sampling reach, and one of the sampled pools upstream of the culvert (bottom right).

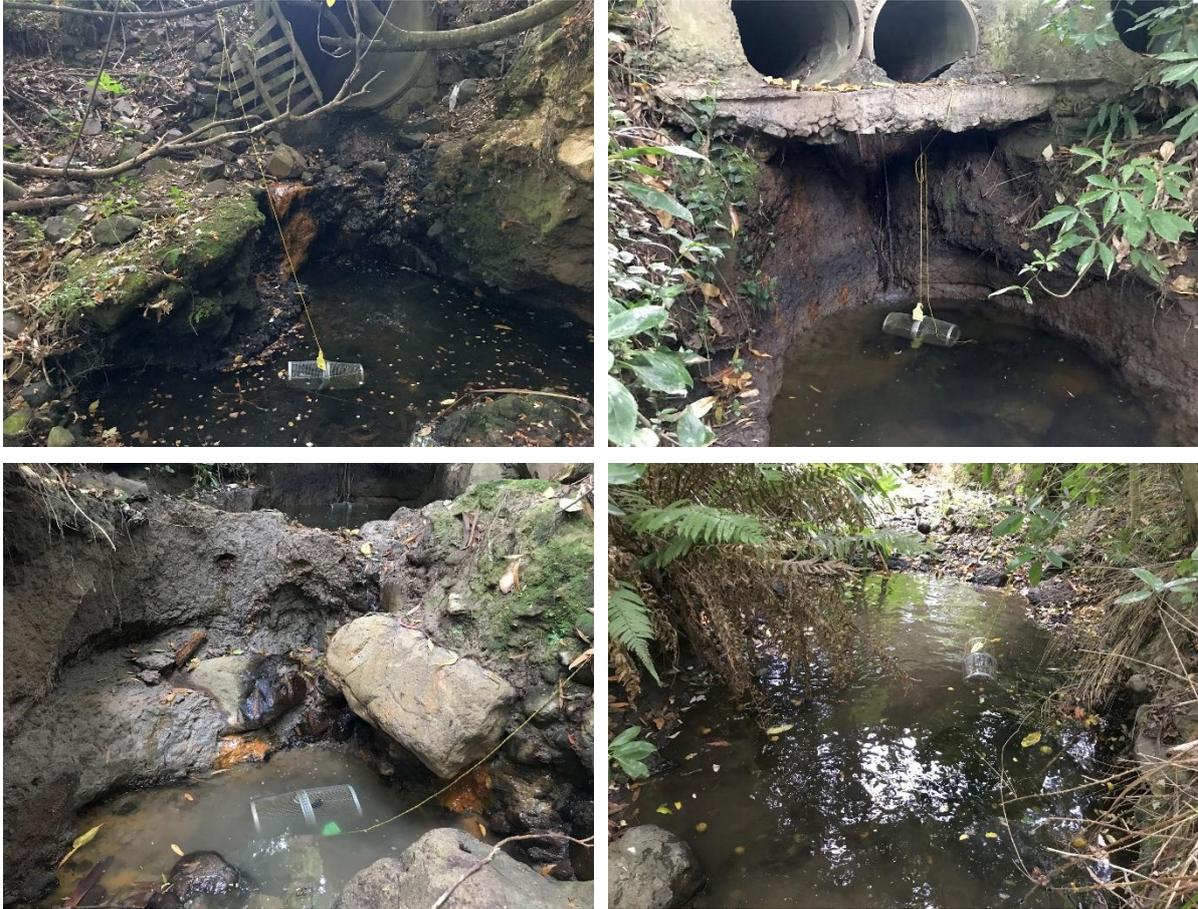
Figure 12: The perched culvert in Church Lane Drain immediately under Main Road (top left), a perched private culvert under a driveway downstream (top right), a natural barrier immediately downstream of the private culvert (bottom left), and the habitat sampled at site Upstream 1 (bottom right).

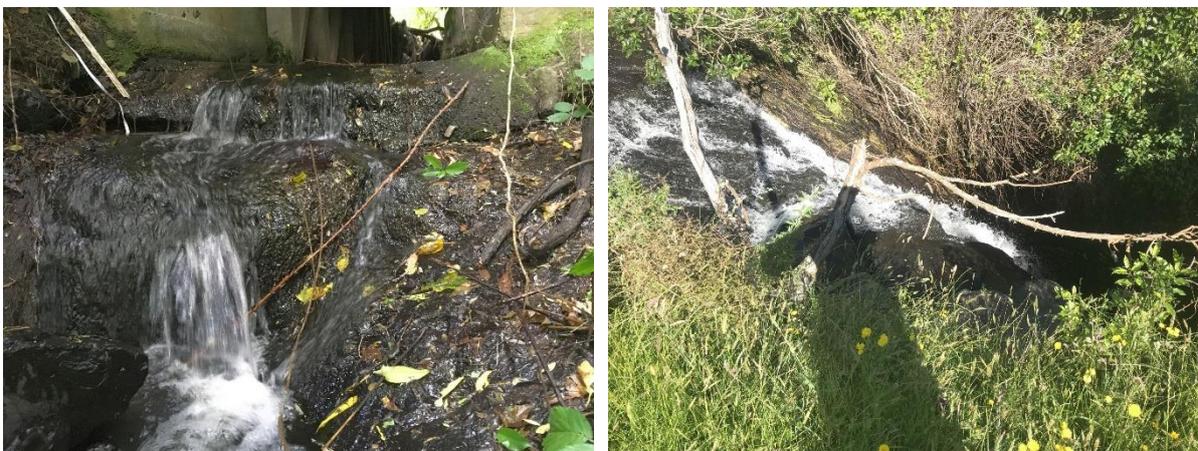
Following the discovery of a 6 m vertical waterfall 40 m downstream of the Raupō Stream culvert in Raupō Bay, the fish survey at this site was abandoned. The justification for this was that any species capable of ascending the waterfall would have no problem passing the culvert. Therefore, fish surveys were completed at 13 structures.

Figure 13: The perched culvert outlet (left) and the 6 m high vertical waterfall located 40 m downstream from the culvert (right). Note that this photograph only captures the entry to the waterfall, not the vertical face, as this could not be photographed safely.

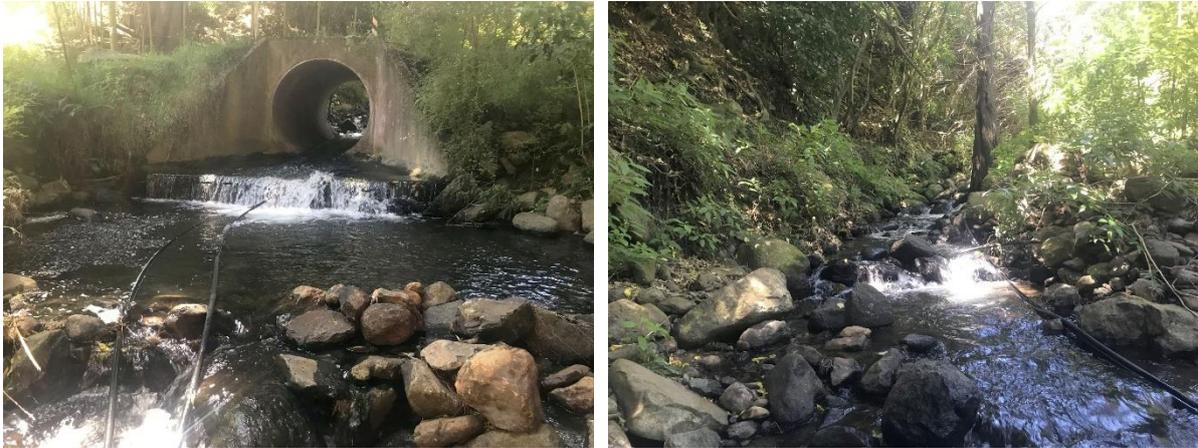
Figure 14: Owhetoro Stream Branch No. 4 culvert with perched apron (left) and the upstream sampling site (right).

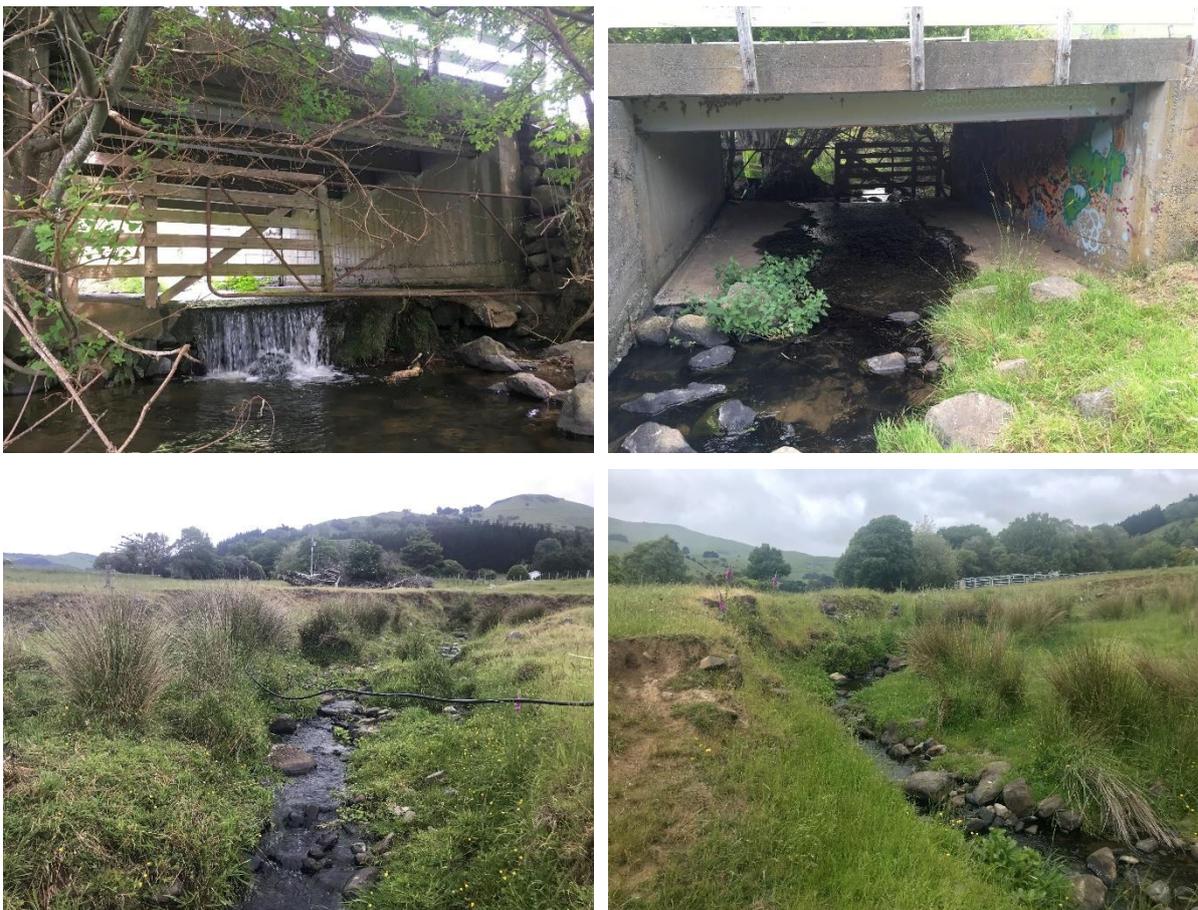
Structure 10, Totara Stream: The surveyed fish population around the culvert in Totara Stream had high species diversity, with five species recorded. While the structure appeared to be passable by shortfin and longfin eel, the remaining three species were only caught at the downstream site. These species included common bully, upland bully, and inanga (At Risk – Declining; Dunn *et al.* 2018), all of which were recorded in low densities (1–3 individuals per species). These results confirm that the structure is a high risk to fish that are weak climbers and that it is impacting the distribution of native fish in the catchment.

Figure 15: Totara Stream culvert with perched apron (top left), upstream view showing shallow water depth through the culvert (top right), downstream sampling site (bottom left), and upstream sampling site (bottom right).

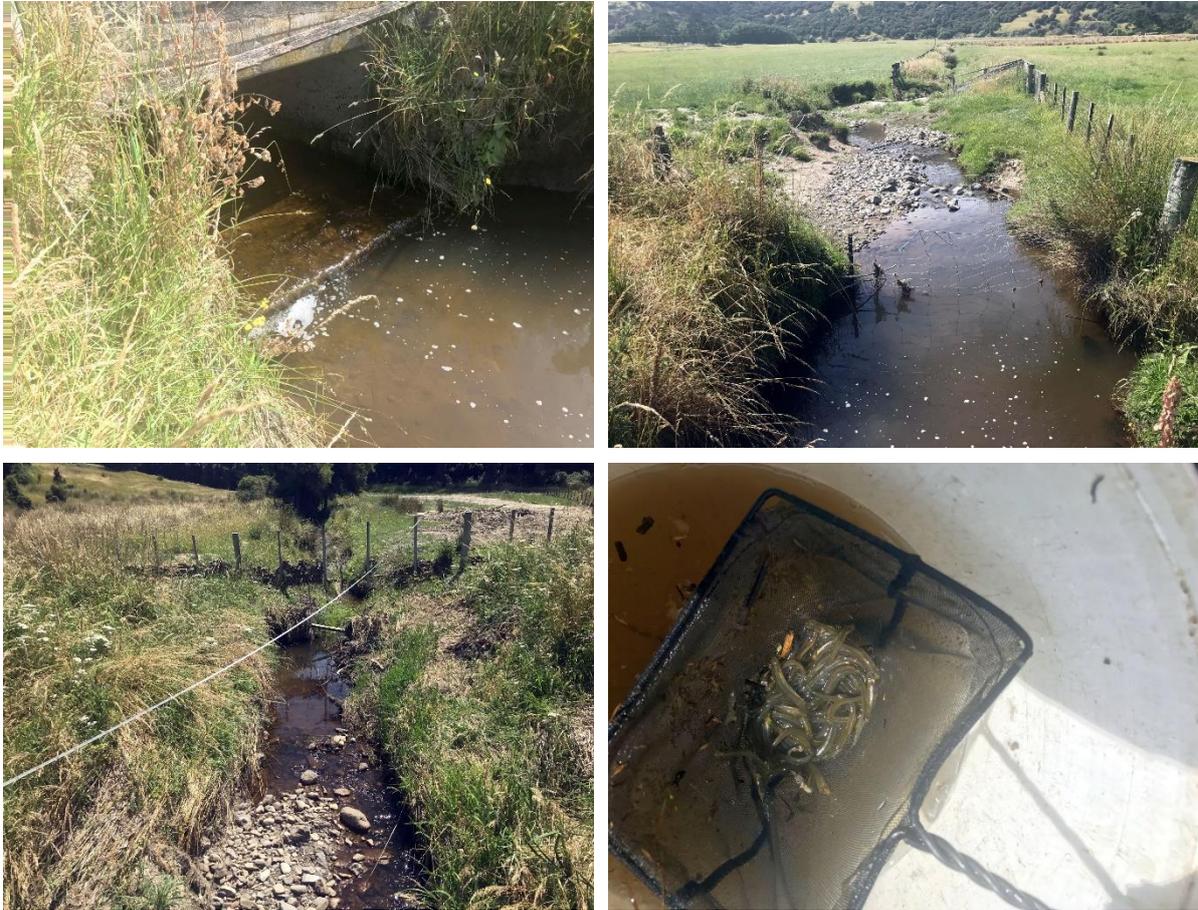
Le Bons Bay Stream Branch No.13

Structure 11, Le Bons Stream Branch No 13: The sampled fish community around the culvert in Le Bons Stream Branch No 13 was the most abundant and diverse of any of the sampled waterways (Table 3). Of the six species caught, three have a conservation status of At Risk – Declining, including: longfin eel, bluegill bully, and inanga (Dunn *et al.* 2018). The culvert was perched at the time of sampling and has the potential to affect fish distributions. Of the six species recorded downstream, all but two were found upstream. The two species not recorded upstream were shortfin eel and banded kōkopu. The juveniles of these two species are exceptional climbers and it is very unlikely that the structure was responsible for their absence upstream. Species recorded both upstream and downstream of the structure included inanga, which are poor climbers, and several bully species, which are not strong climbers. Therefore, despite the observed potential barrier to fish passage, it does not appear to be significantly affecting fish distributions. Thus, we do not consider the structure a high priority for remediation.

Figure 16: The slightly perched culvert in Le Bons Bay Stream Branch No. 13 (top left), the downstream sampling reach (top right), the upstream sampling reach (top left), and a photo of some juvenile galaxias (bottom right), which were caught both upstream and downstream of the culvert.

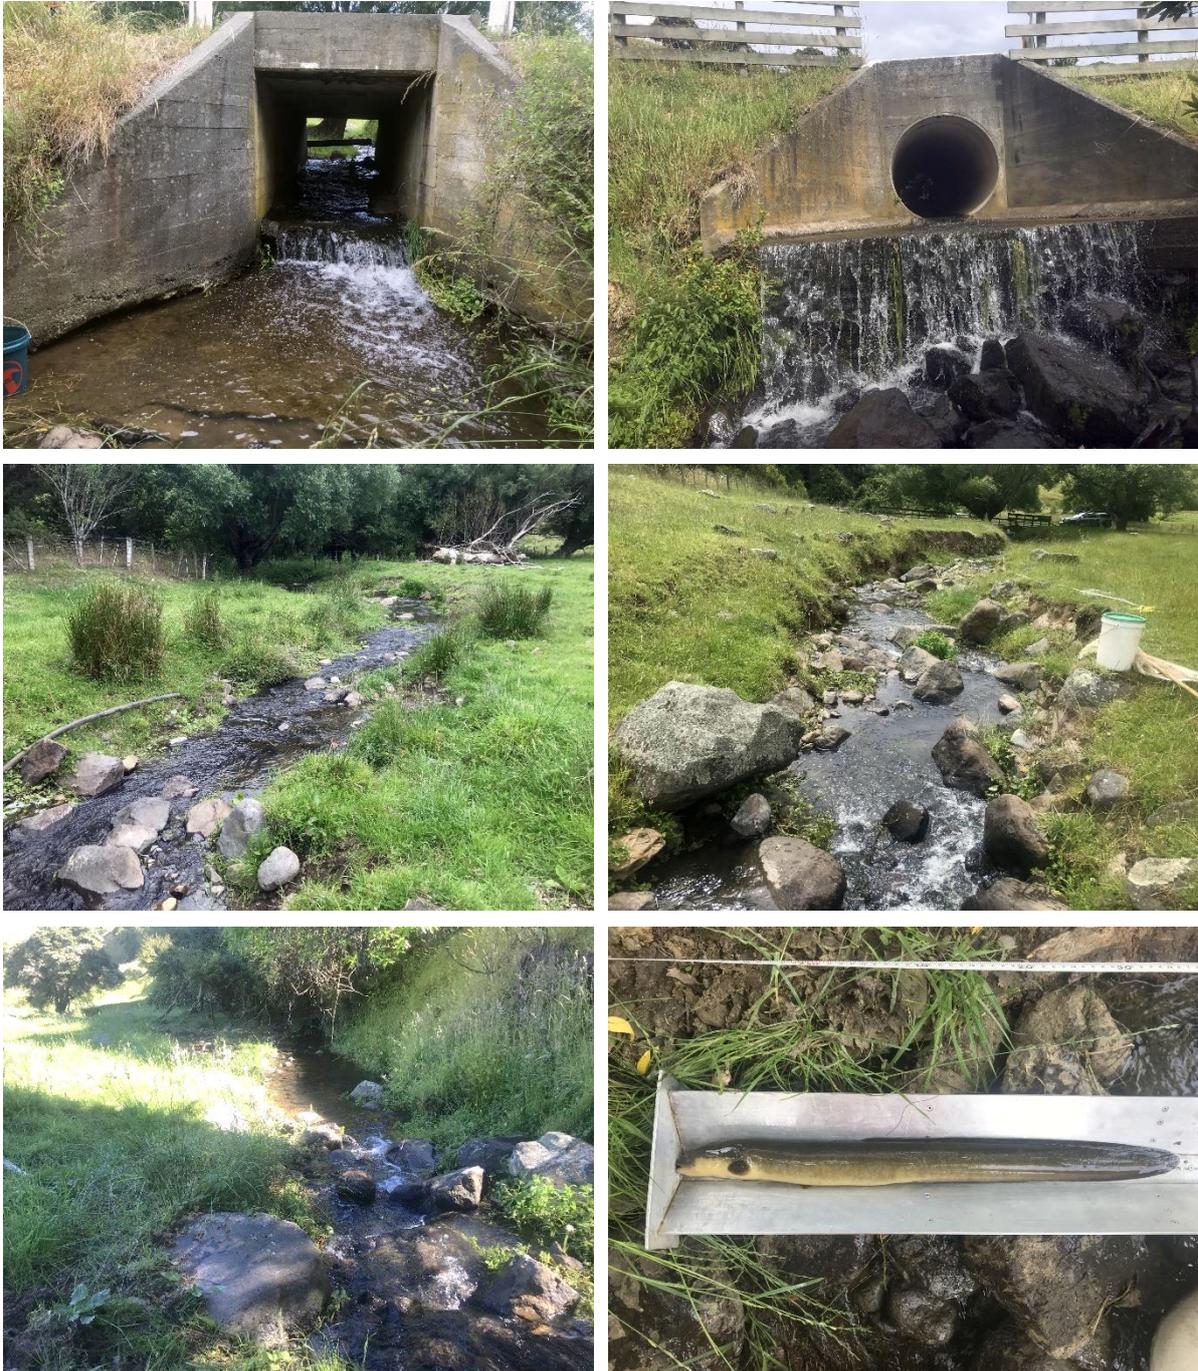
Figure 17: Opuahou Stream Branch No. 14 downstream perched culvert under Puaha Road (top left), upstream perched culvert under SH75 (top right), and Downstream 1 (mid left), Upstream 1 (mid right), and Upstream 2 (bottom left) sampling reaches. Longfin eel caught at Upstream 1 site (bottom right).

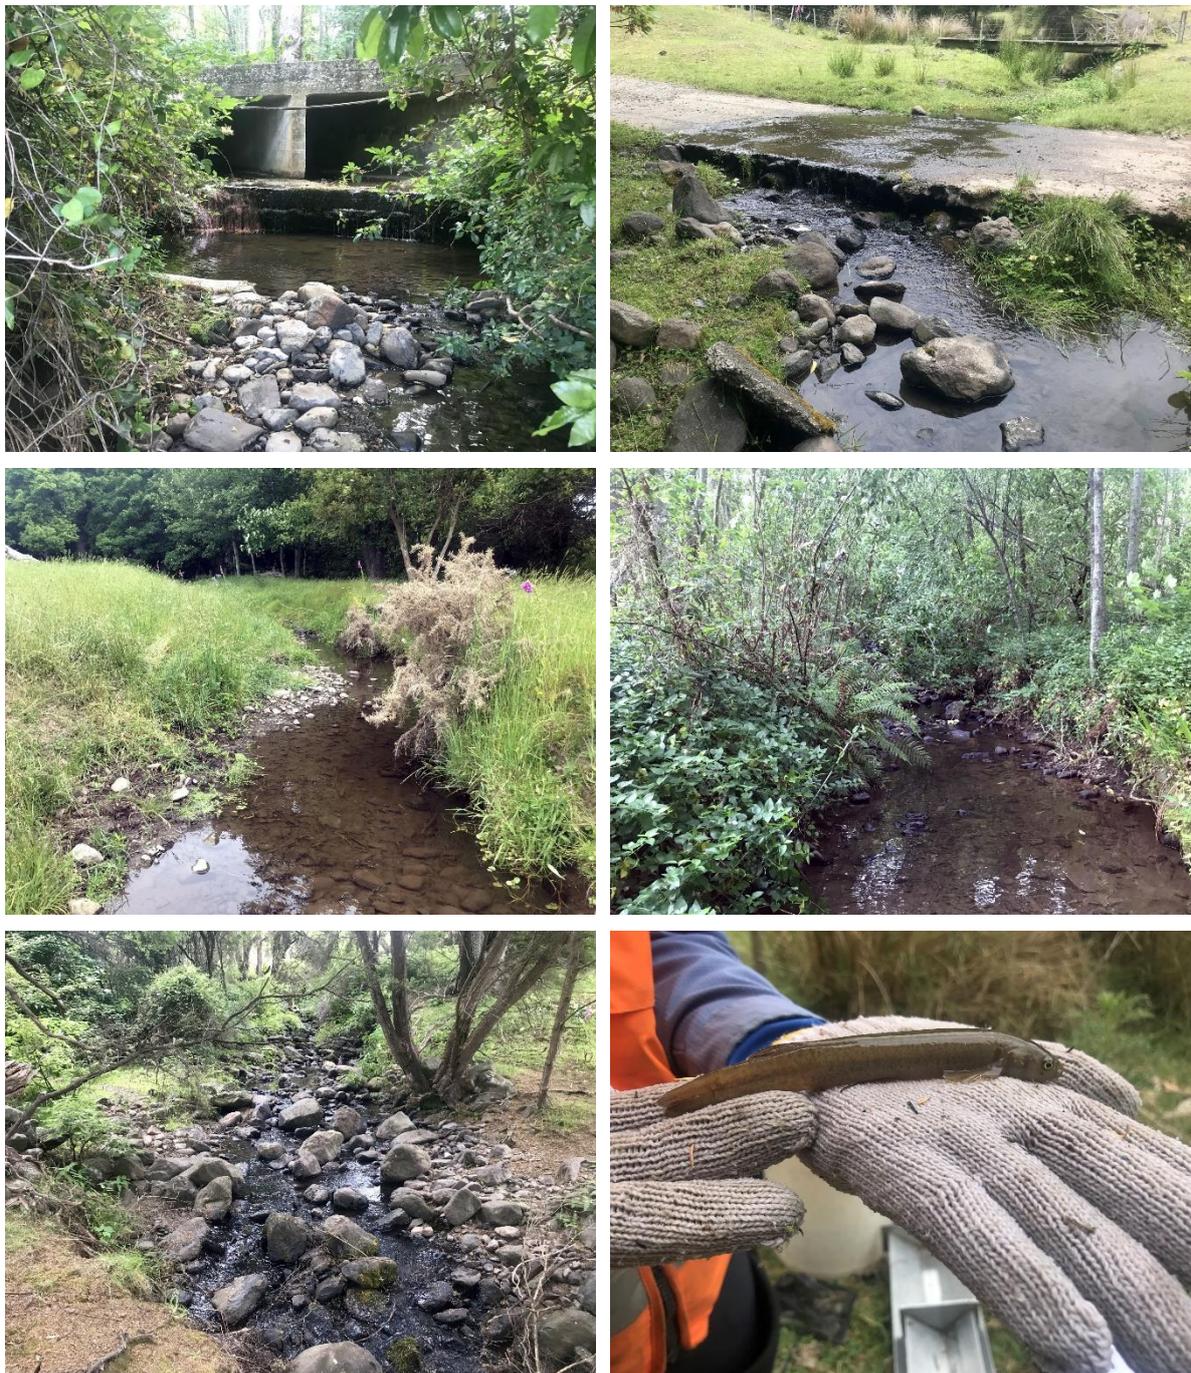
Structure 13, Kinloch Stream: The culvert in Kinloch Stream appeared to be unpassable by common bullies, with 11 individuals recorded downstream and none recorded upstream. Brown trout numbers were reduced upstream, with 15 individuals recorded downstream of the culvert and 10 upstream. Juvenile lamprey (ammocoetes) were abundant above the culvert, totalling 67 individuals, with only two individuals caught downstream. The difference in lamprey density was attributed to a greater proportion of soft sediments upstream of the culvert, which is the preferred habitat of ammocoetes. Lamprey have a Threatened – Nationally vulnerable conservation status (Dunn *et al.* 2018), and Kinloch Stream is one of the few locations where lamprey spawning has been observed in New Zealand (Baker *et al.* 2017). We do not recommend altering fish passage at the structure, given the presence of threatened lamprey upstream, and given that the structure may be providing some protection from predation and competition with other species.

Figure 18: Culvert with perched apron in Kinloch Stream (top left), upstream ford with culvert (top right), and Downstream 1 (mid left), Upstream 1 (mid right), and Upstream 2 sampling sites (bottom left). Kōaro caught at Upstream 2 site (bottom right).

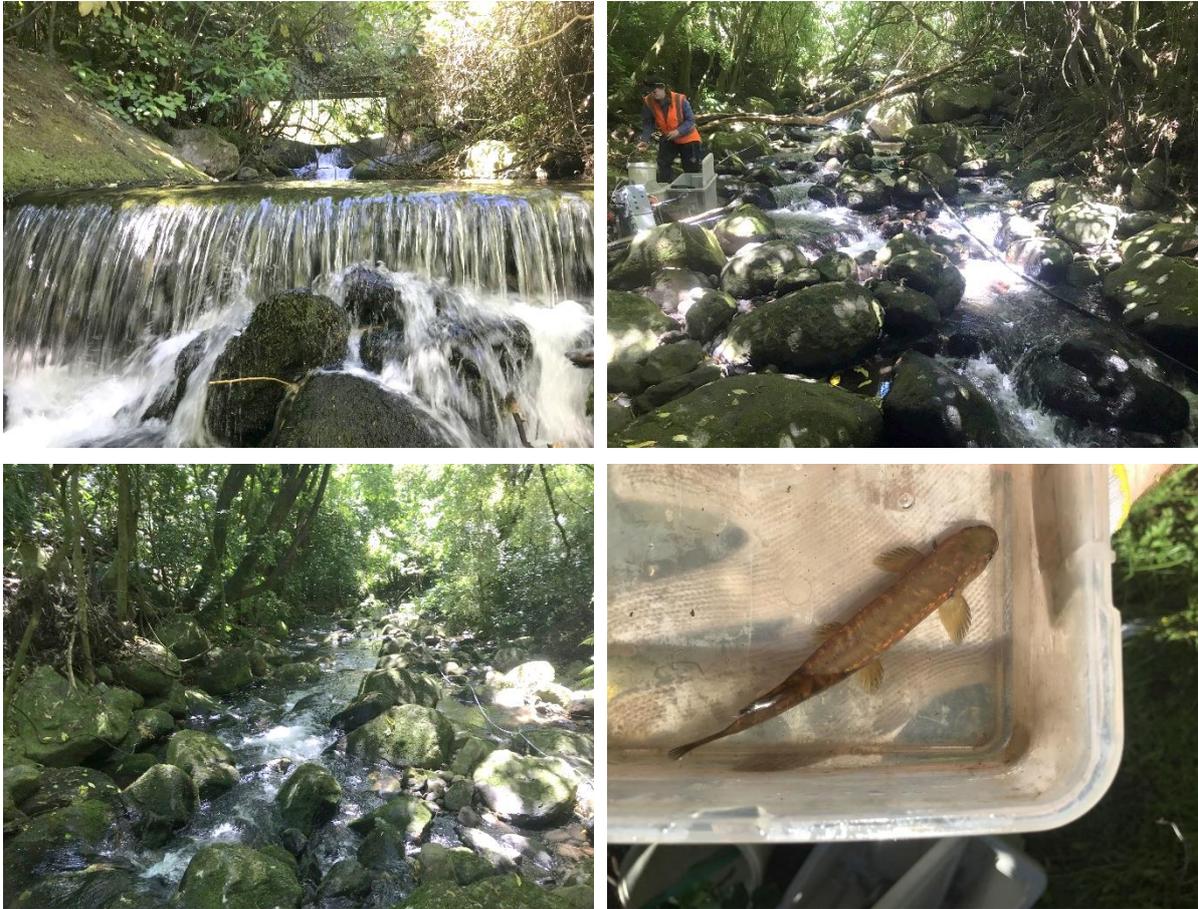
Okuti River Branch No 9 (Lake Forsyth (Wairewa))	278	Weir	RAMM W11	R4	Weir situated under bridge W11, but not listed in CCC weir database. Likely owned by CCC. Would need to remediate at the same time as another (presumably private) weir immediately downstream. Fish surveys upstream and downstream of the weirs indicate that the structures are substantial barriers for longfin eel and kōaro.

Figure 19: Two weirs in Okuti River Branch No. 9 (top right), downstream sampling site (top right), upstream sampling site (bottom left) and a kōaro caught downstream (bottom right).
