# Prioritisation of Fish Barriers for Remediation in Christchurch

August 2021

Prepared for:  
Christchurch City Council

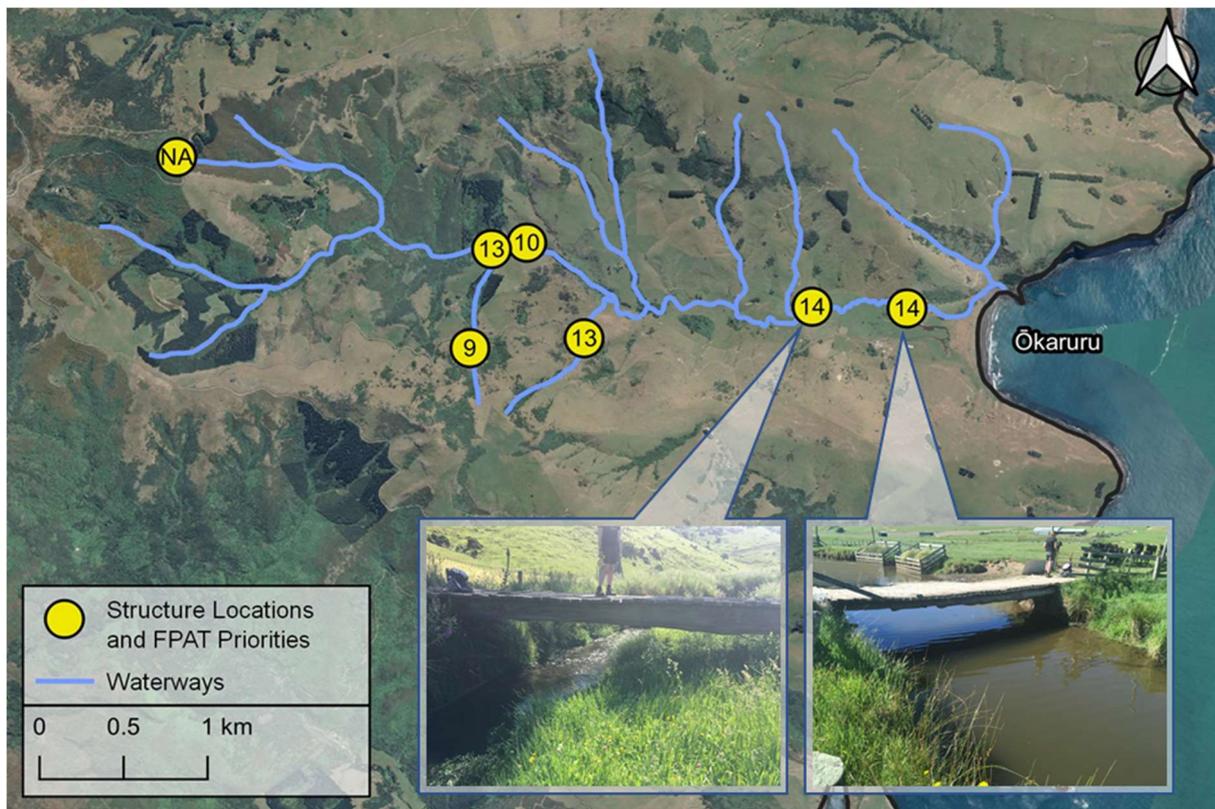
By far the most common reason for adjusting a priority score was due to the structure presenting a low risk to fish passage yet having a high FPAT priority score, which accounted for 65% of adjustments. This was a common adjustment due to the way in which the FPAT model calculates its priority scores. The FPAT priority score is the sum of four scores, with each of these scores representing a different attribute of the structure or its position in the catchment. Franklin (2018) terms the four scores the ‘downstream connectivity score’, ‘catchment position score’, ‘accessible upstream habitat score’, and the ‘barrier score’. Briefly, these scores are affected, respectively, by a) the number of barriers downstream, b) the relative proportion of catchment upstream of the barrier (irrespective of upstream barriers), and c) the length of upstream habitat, and d) the degree of risk to fish passage the barrier poses. Every structure is scored on a scale of 1–5 for each of these attributes, with the sum of these attributes being the final FPAT priority score (i.e., 5–20). Structures that have a low barrier score (i.e., very low risk to fish passage), may still have a priority of up to 16 (out of a maximum of 20) if they receive maximum scores for the other three attributes. For example, two bridges in Ōkaruru (Goughs Bay) were determined to be very low risk to fish passage, however, due to their catchment position, both received relatively high FPAT priorities of 14 (Figure 3). As Ōkaruru is a priority catchment and there are NZFFD records of inanga in the area, the current automatic model produces priorities of R5 for both structures, the maximum score for remediation (Figure 2). The manual adjustment process allowed for these structures to be reduced to R1 priority, on the basis that the structures present a ‘Low Risk’ to fish passage.

Figure 3: Two structures that required manual priority adjustments due to having high FPAT priority scores, despite presenting no risk to fish passage.

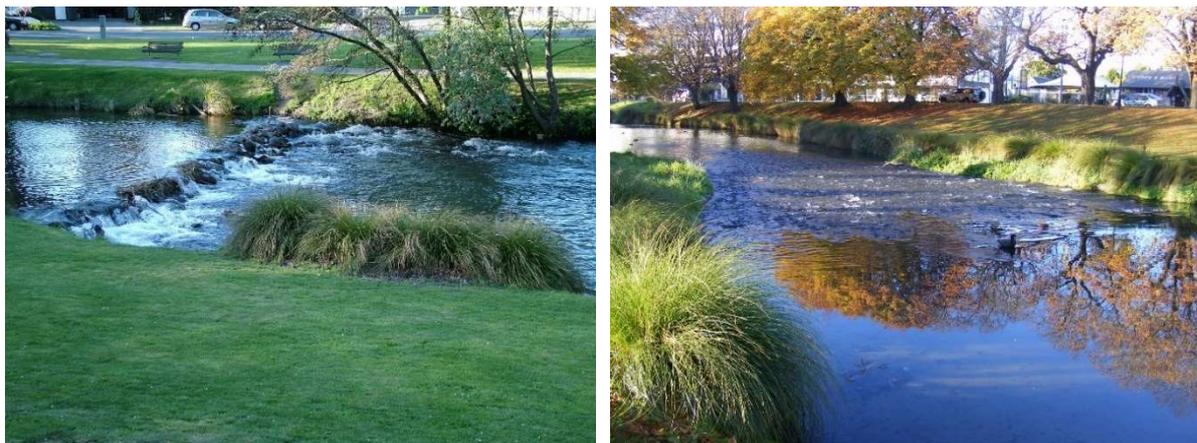
Figure 9: The unstable rock weir (left) and the replacement rock riffle weir (right).

**Solution:** Proposed solutions included upgrading the current weir by adding more rocks, a formal concrete weir, and a rock riffle, with the latter ultimately being selected (Figure 9). Construction of the rock riffle was completed in 2008.

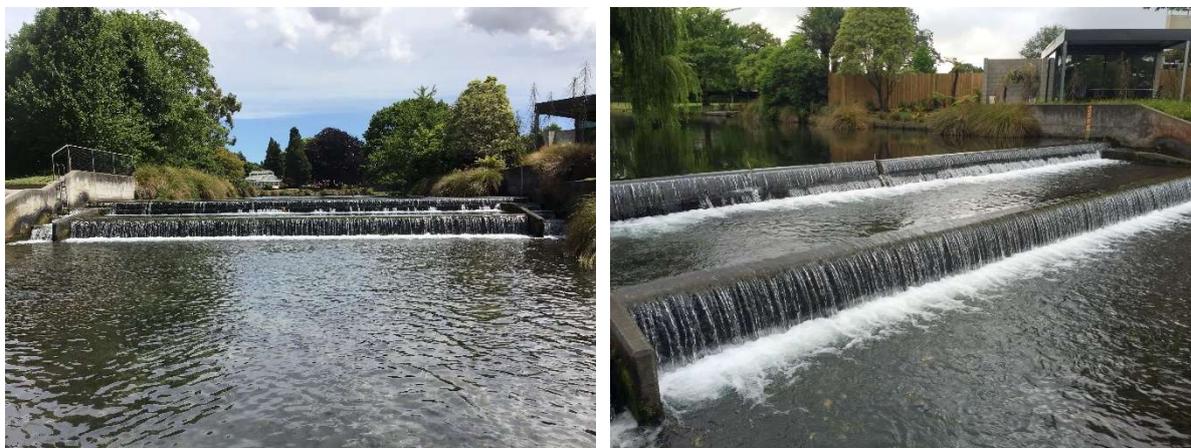
*Figure 10: Photographs of the weir in the Avon River at Mona Vale.*

**Fish passage issue:** A large, stepped weir with drop heights of up to 0.6 m (Figure 10). Fish ladders are present, but they do not provide passage for smaller non-jumping native fish and they do not appear to be used by the original target species, brown trout, which have been seen trying to jump over the weir (personal observation).

**Potential remediation and cost:** Discussions are currently underway regarding remediation of this structure with the addition of a rock riffle downstream. Construction of a rock riffle at Mona Vale is estimated to cost in the order of \$750,000 (Mark Mullaney, 2021, Pers. Comm.). From a fish passage perspective, the design should focus on achieving low marginal velocities and rest zones. Slopes of 1:30 are recommended to achieve passage of weakly swimming species such as inanga (Franklin *et al.* 2018).

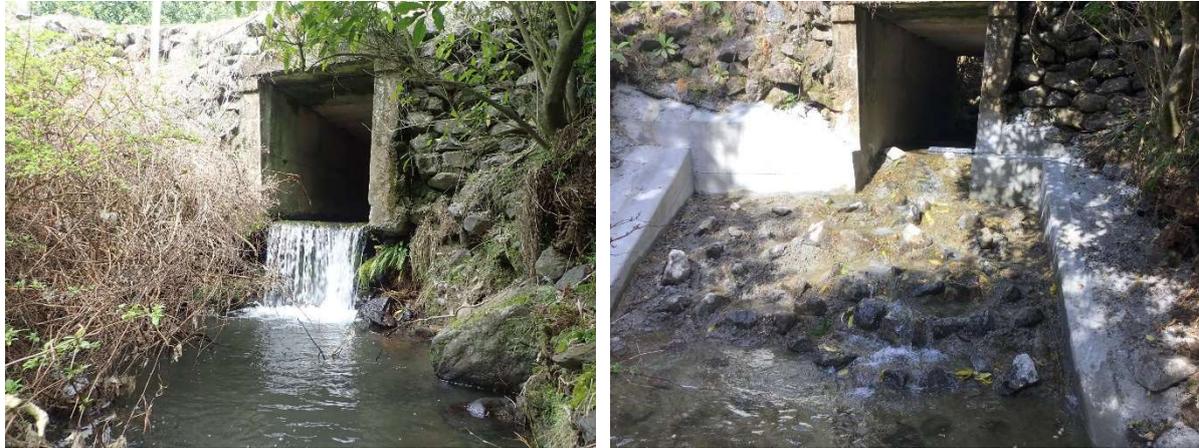
Figure 11: The perched culvert in Kaituna Valley before (left) and after (right) remediation.

included in the repairs. This entailed the addition of a fish ramp (slope: 1:2.8) constructed of rocks embedded in concrete, and the addition of baffles through the culvert (Figure 11). Construction was completed in 2020.

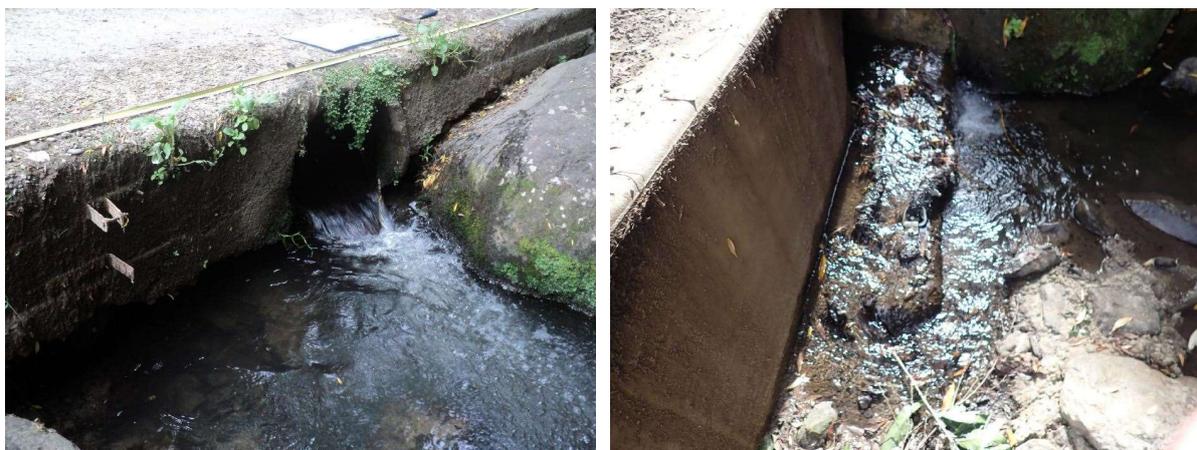
Figure 12: The perched culvert in Hukahuka Turoa Stream before (left) and after remediation (right).

**Solution:** Due to the absence of weak swimmers, and the only migratory species in the vicinity being longfin eel, the solution was tailored towards providing passage for this species. This included the installation of a rock ramp and mussel spat rope running through the culvert.

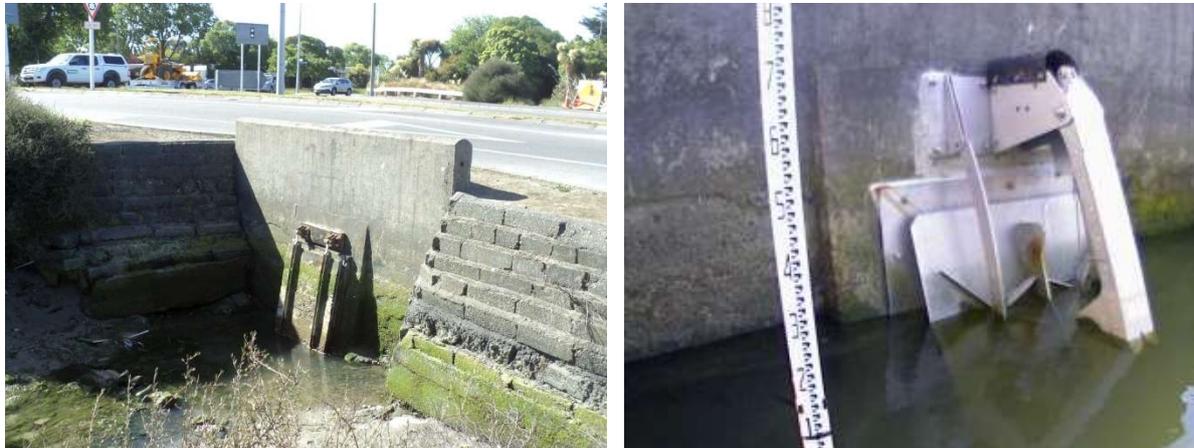
**Fish passage issue:** Tide gate that was a high risk for upstream migrating fish. It had previously been manually propped open to enhance fish passage, but the tide gate was in a poor state of repair and needed replacement.

*Figure 13: Steamwharf Stream tide gate before (left) and after (right) remediation. The right-side photograph shows the structure on an incoming tide, with the counterweight delaying gate closure.*

**Solution:** Fish-friendly tide gate installed. This type of tide gate includes a counterbalance to delay gate closure on the incoming tide (Figure 13).

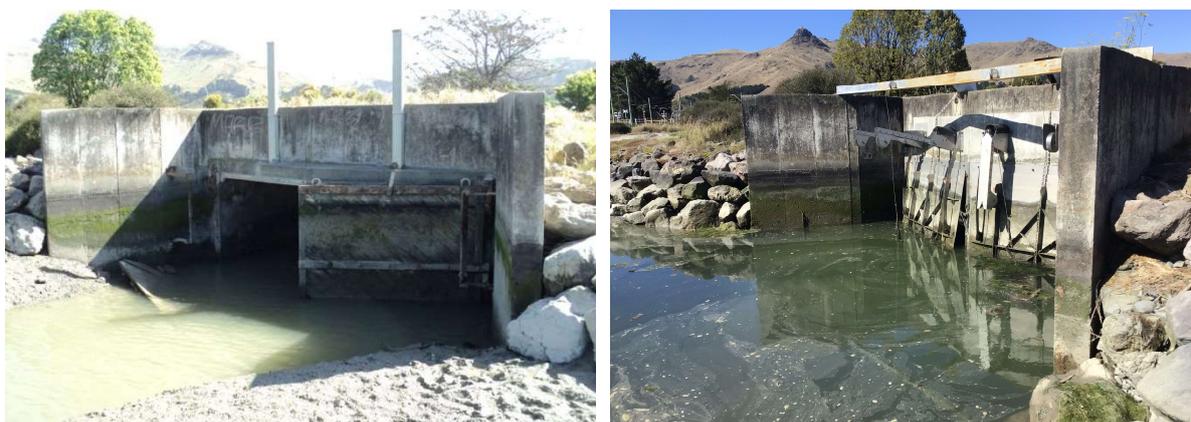
**Fish passage issue:** Tide gates that were in a poor state of repair needed replacing. Standard tide gates would present a high risk to passage for upstream migrating fish.

Figure 14: The old tide gates (left) and new fish friendly tide gates (right) in Avoca Valley Stream near the Ferrymead golf course.

**Solution:** The old tide gates were replaced with two fish-friendly gates (Figure 14). These gates were much larger than the standard fish-friendly design, requiring two counterbalance arms on each gate.

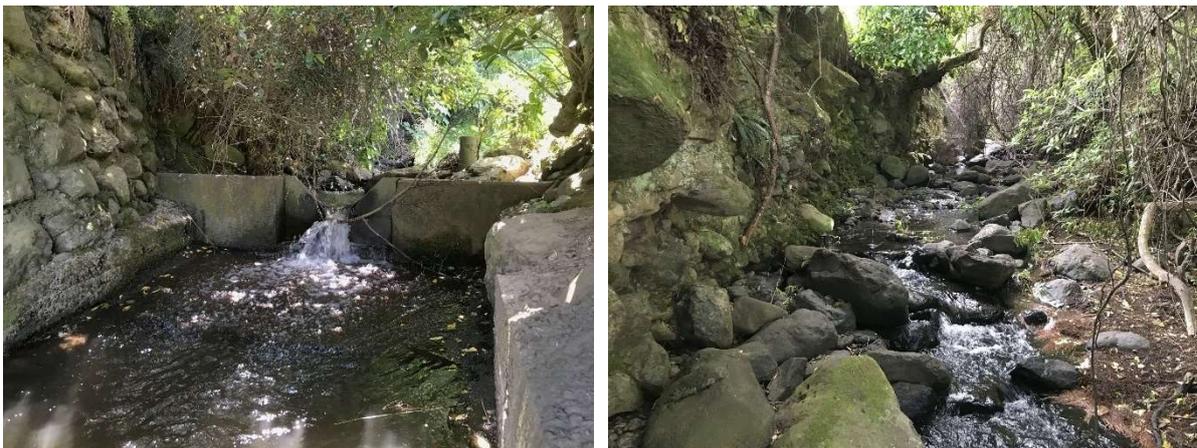
**Priority and values:** This structure was considered a high priority (R5) for remediation in the current study. It fulfils many of the suggested ecological prioritisation criteria (Table 1). It is proximate to the coast (1.4 km), with a relatively large upstream catchment (6.5 km), that includes divers flow habitats and native riparian vegetation (Figure 15). There are no known barriers upstream of the weir. Numerous species downstream are likely to benefit from the remediation of this structure, including two At Risk species.

Figure 15: The Takamātua v-notch weir (left) and upstream habitat (right).

1. Removal: If the flow gauging at this location is no longer required, complete removal would provide the greatest ecological benefits.
2. Addition of a downstream rock ramp: If flow gauging at this location is still required, a downstream ramp could be installed to assist fish passage. Given the high-energy stream environment, the best ramp option would likely be a concrete ramp embedded with numerous angular rocks. In a study on redfin bully passage, successful passage was found to significantly reduce from 15–30 degree slope, however, wetted margins allowed this species to climb on greater slopes (Baker and Boubée 2006). Therefore, important design features to incorporate in this rock ramp would be a low gradient slope, wetted margins, and resting pools.

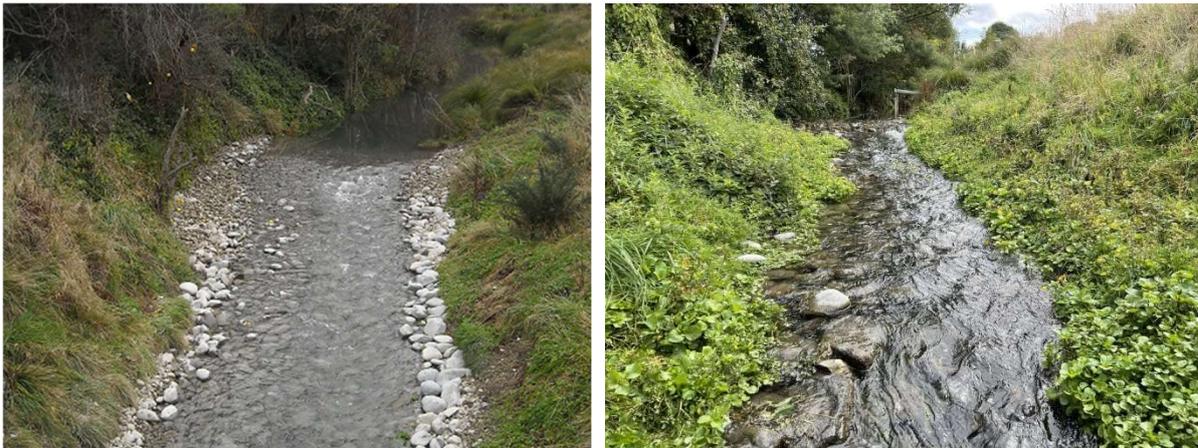
Figure 16: The weir just after construction in 2015 (left) and in 2021 (right).

**Effect on fish passage:** With regards to fish passage, the selected rock riffle weir design is superior to other alternative flow gauging designs, such as v-notch or crump style. Consideration of fish passage was given during the design of this structure. This included design criteria of c.  $<0.3$  m/s velocity, with a riffle gradient of 1:20. This is steeper than the 1:30 slope required on all new weir structures by the NESF (Parliamentary Counsel Office 2020), but the structure pre-dates the guidance in the NESF. Velocity measurements made by Instream in March 2021 revealed that velocities  $<0.3$  m/s were generally achieved on the margins of the riffle, with marginal velocities being comparable to downstream run habitat (Figure 17). While the low marginal velocities and abundant rest areas among cobbles and marginal vegetation is likely to allow passage for many species, the high velocities through most of the channel may deter a proportion of inanga swimming upstream, especially smaller individuals. Stronger swimming species are unlikely to be deterred by these velocities. The presence of eels upstream, including a juvenile that must have passed this location since construction of the riffle, indicates that it is indeed passible by these species.

**Solution:** A rock riffle was installed in 2015 to provide the necessary hydraulic requirements for the water level recorder station, while allowing for fish passage.
