Appendix 2

Condition Notes and Specific Recommendations for Selected Notable Graves

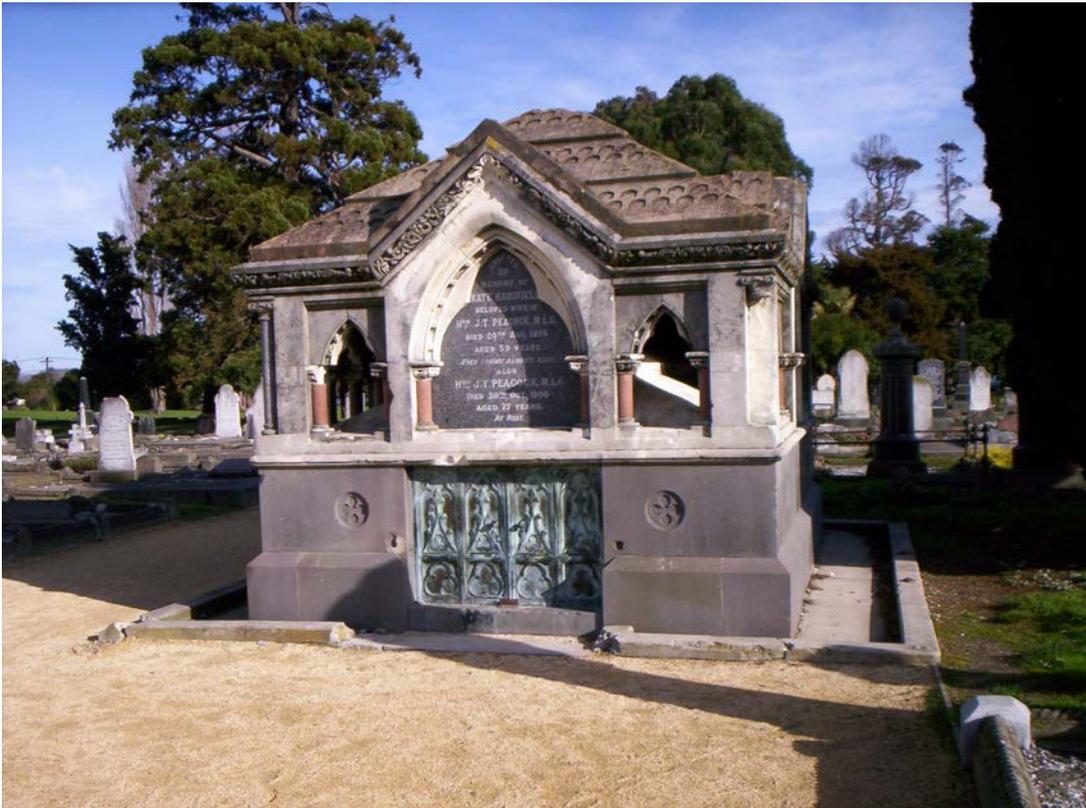
Peacock Mausoleum

Painted and scratched-on graffiti;
Limestone has black scab, skin damage, exfoliation;
Missing column to the north east corner;
Chipped edges;
Moss and lichen growth;
Missing cast iron fittings;
Rusting steel supports to ceiling;
Missing Gothic ornaments to arches;
Unsympathetic repairs near the bronze doors;
Mortar is missing between stone joints;
Chipped basalt;
Cracked and dislocated concrete and cement rendered base surround;
Exfoliation of tuff roof.

Remove painted graffiti - necessary/desirable;
Poultice to remove salts from tuff and to remove black scab, consolidate skin damage and

exfoliation – necessary;
Reinstate missing column to match the existing – necessary;
Investigate reason for chipping – urgent;
Apply biocide to remove biological growth;
Reinstate cast iron railings following research to determine design – desirable;
Clean down and treat cast iron elements for rust, paint with appropriate coating – necessary;
Reinstate missing Gothic ornaments to match the original– desirable
Cut out all pointing and repoint whole monument with lime mortar– necessary;
Repair damage to base, replacing cracked and missing concrete - necessary

Instigate maintenance regime, with cleaning of limestone every twenty years, repointing every hundred years, painting cast iron every 10 years, oil all door hardware and furniture to ensure in good working order, apply biocide when necessary.

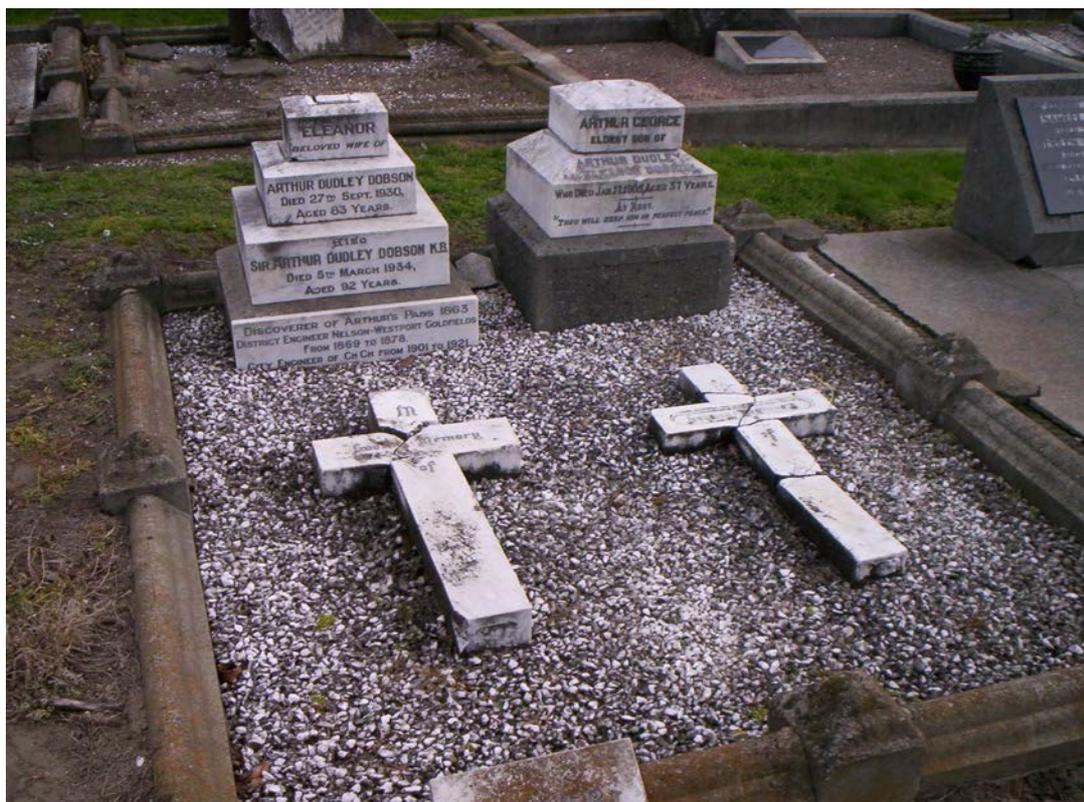
Arthur Dudley Dobson

Crosses broken and on ground, having been displaced from marble stepped bases;
Stepped bases have been dislocated;
Micro-biological growth over all elements of the memorial;
Stone base is disaggregating;
Concrete edging is eroding with cracking between units;
Missing and worn lead lettering;

Pin elements of crosses together and reinstate on bases - necessary;
Refix bases to correct orientation - necessary;
Treat whole memorial with biocide;
Poultice stone base to remove salts, cover over winter - necessary;
Remortar units together and ensure foundations are secure – necessary;
Repair damaged and renew missing lettering – desirable.

Instigate maintenance regime, with cleaning of marble every twenty years, apply biocide when necessary. All work should be specified and supervised by a stone conservator with stone repairs carried out by an experienced mason.

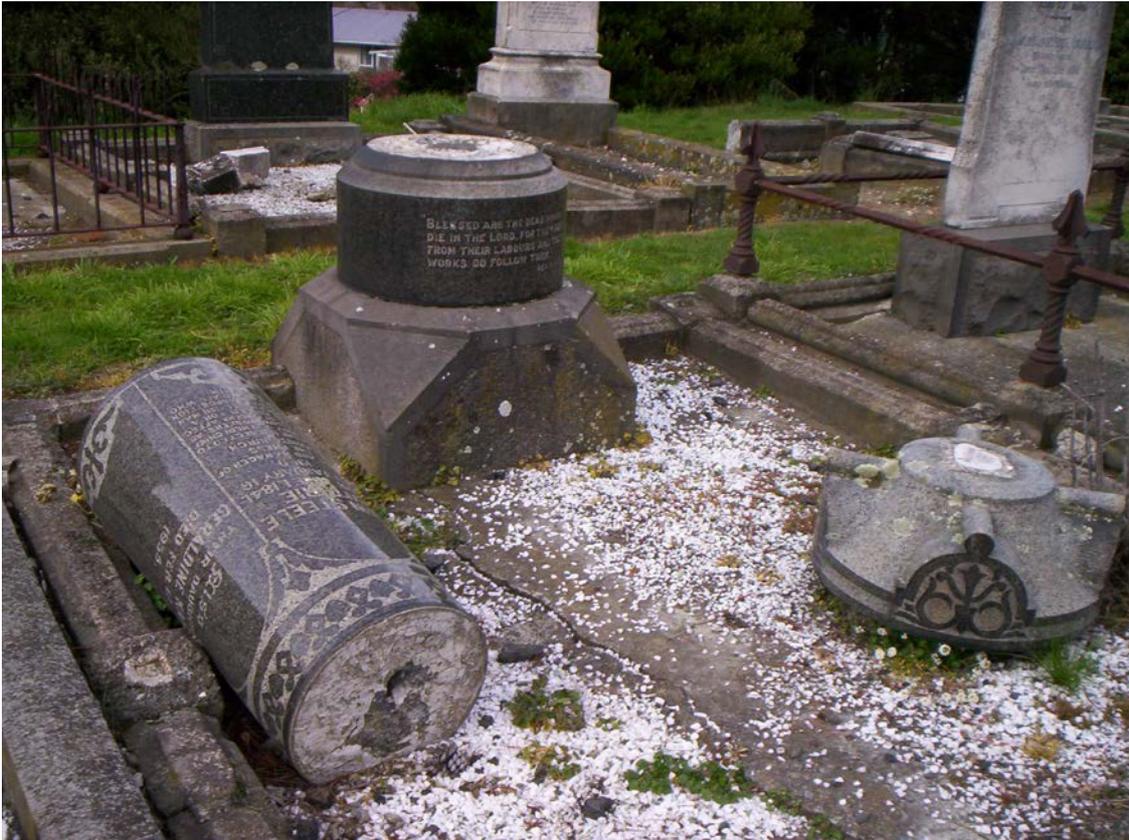
John Steele Guthrie

Cross broken and on ground in adjacent grave;
Cracked and slumped base slab;
Granite memorial shaft and bases have been dislocated and separated, all of which are lying on the ground;
Pointing has micro cracking;
Micro-biological growth especially on concrete and basalt elements;
Missing cast iron railings;
Concrete edging is eroding with cracking between units;

Pin elements of cross together and reinstate on base - necessary;
Reinstate granite elements on basalt base - necessary;
Treat whole memorial with biocide;
Repoint pointing using lime mortar – necessary;
Repair or replace base slab, ensuring no further slumping – necessary;
Reinstate cast iron railings based on documentary evidence - desirable

Instigate maintenance regime, with cleaning of granite every twenty years, apply biocide when

necessary.

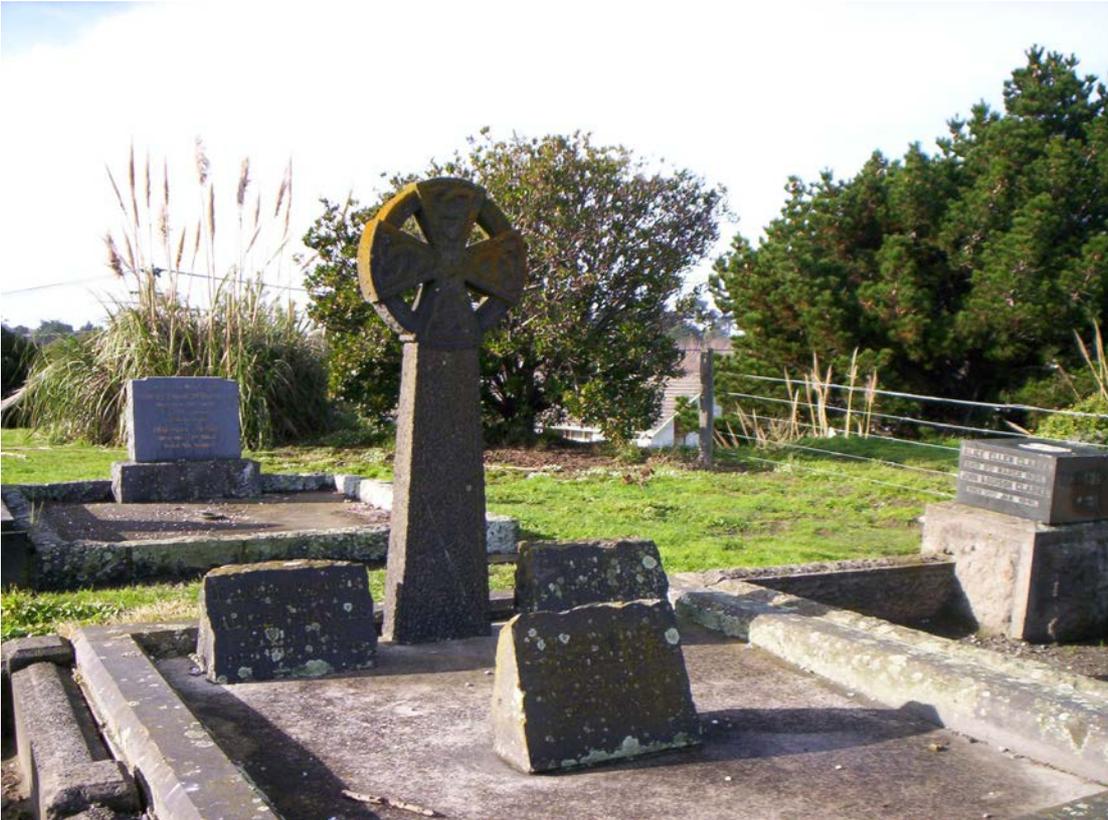
Bishop Julius

Cracked base slab and concrete foundation;
Extensive micro-biological growth over all elements;
Edging is dislocated;

Ensure stability of base and foundation – necessary;
Treat whole memorial with biocide;
Repair base slab, ensuring no further slumping – necessary;

Instigate maintenance regime, with cleaning of granite every twenty years, apply biocide when necessary

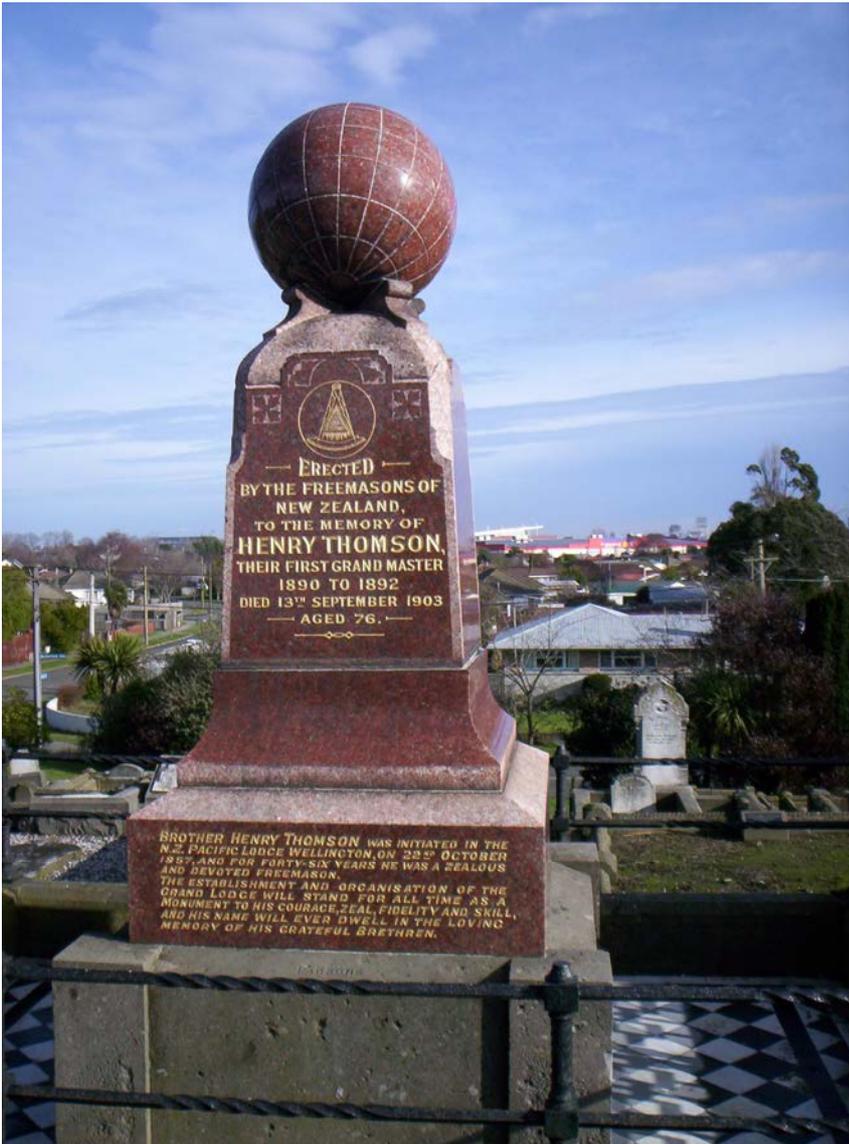
Henry Thomson

Mortar cracking and damp with micro-biological growth in joint;
Vegetation growth between tiles;
Base and perimeter are exfoliating/disaggregating;
Micro-biological growth especially on concrete and perimeter edging;
Cracked, bent, loose, rusting and broken cast iron railings;
Concrete foundation is cracked at has slumped;

Repoint pointing using lime mortar – necessary;

Treat whole memorial with biocide;

Poultice base and perimeter edging, protect in winter - necessary

Repair concrete foundation to ensure no further slumping – necessary;

Repair cast iron railings, clean down, treat for rust and repaint - necessary

Instigate maintenance regime, with cleaning of granite every twenty years, apply biocide when necessary, repoint every hundred years, repaint cast iron every 10 years

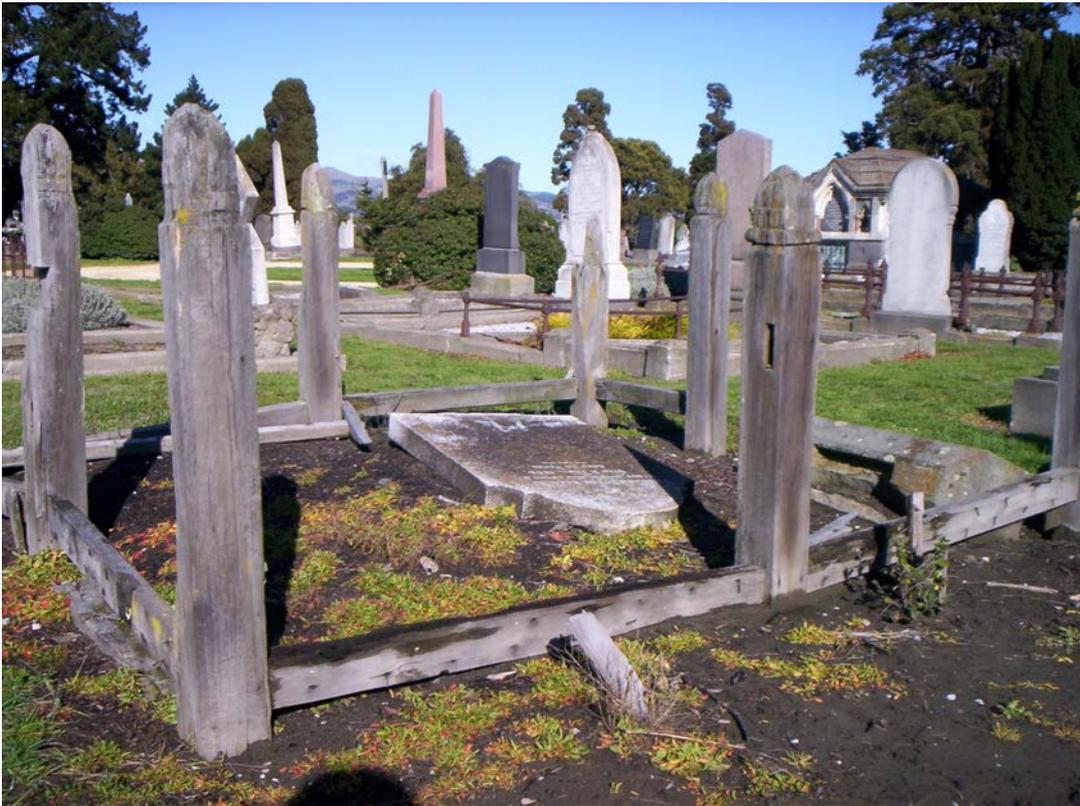
Walter Powell Beauchamp

Memorial and base are disconnected and lying on ground;
Memorial and base have micro-biological growth;
Timber elements are missing, broken or rotten;
Timber elements are eroding and splitting;
Nails heads are rusting.

Reinstate memorial and base ensuring base is well founded –necessary;
Cut out rotten timber elements and splice in new, treating area with zinc naphthenate - urgent;
Treat all timber elements with zinc naphthenate and tung oil urgent;
Treat stone elements with biocide –necessary;
Treat nails heads with fisholene – necessary.

Instigate maintenance regime, with applying zinc naphthenate and tung oil every five years, apply biocide when necessary.
