From: Official Information
Sent: Friday, 9 March 2018 4:54 p.m.
To: '██████████@fairfaxmedia.co.nz'
Subject: LGOIMA 18/029 response - wellheads material

- o Correspondence between the engineers who carried out the assessments of the wellheads, and Council staff members.
- **CityCare report** dated 22 December, concerning the assessment of the below ground wellheads, and the works undertaken as part of the project to repair the wellheads.

Christchurch City Council (CCC) commissioned CH2M Beca Ltd (CH2M Beca) to carry out a review of 25 water supply wells at 9 primary water supply pump stations against *Bore Water Security Criterion 2 (bore head must provide satisfactory protection)* of the Drinking Water Standards New Zealand 2005 (revised 2008) (DWSNZ). The scope of works included inspecting the bores and determining their compliance with Criterion 2, recommending upgrades to improve bore head protection and DWSNZ compliance, and summarising the findings with one report per water scheme. This report summarises the findings for the wells supplying Dunbars Pumping Station.

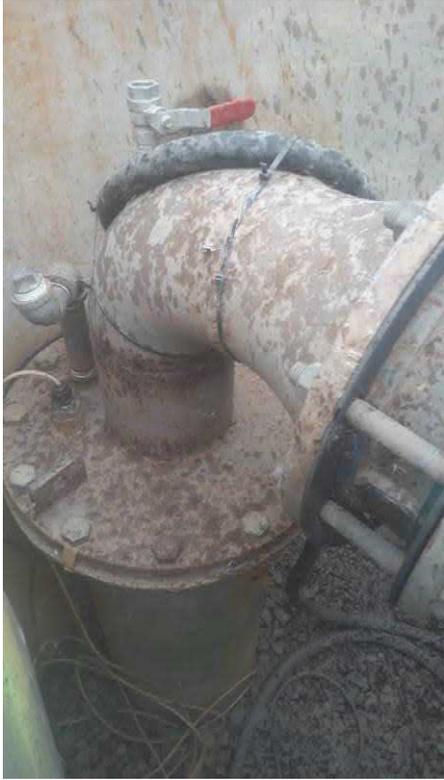
Well is adjacent to sidewalk and road. A creek is on the other side of the well.

<p>Pipework in reasonable condition with some rust.</p> <p>Bottom of chamber is gravel.</p> <p>Sample tap not installed but connection point is present.</p>

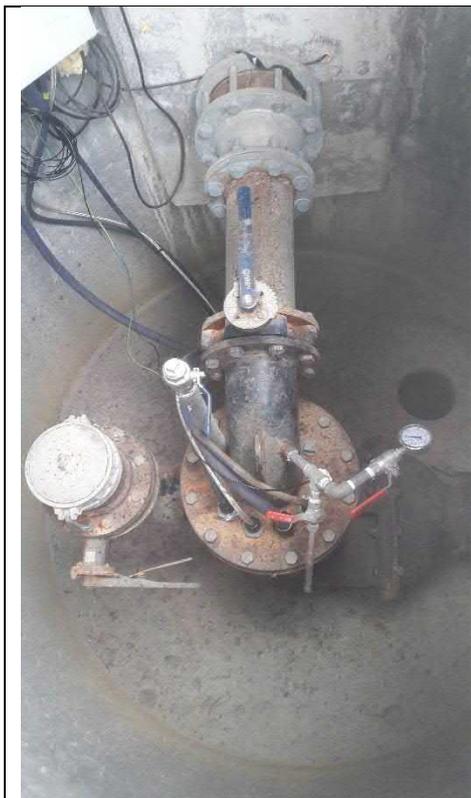
Ground surrounding chamber is slightly lower

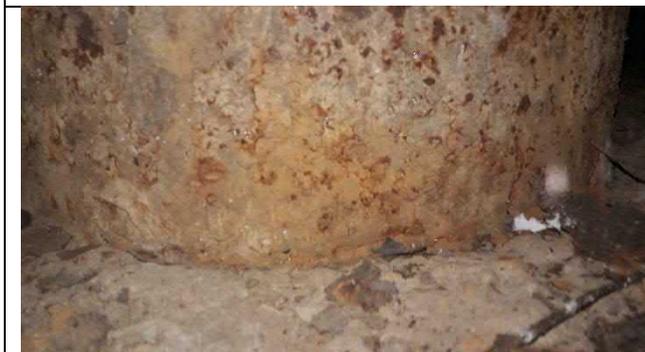
Chamber has a sump but no pump
Some pipe rust

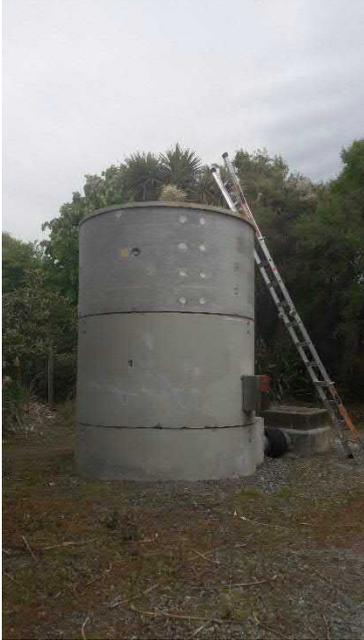
Brookland Well 2 could not be accessed due to safety concerns. The chamber has recently been increase to ~3m above ground level and there is no railing or a permanent ladder

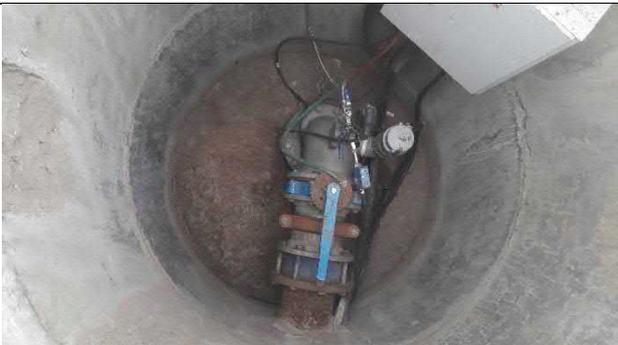
Well chamber is within a fenced area

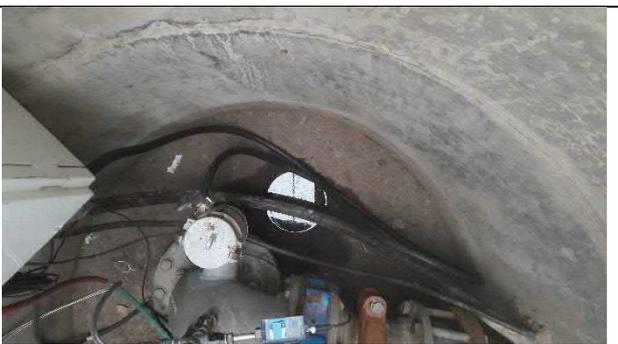
Pipework is in reasonable condition. Chamber was reasonably dry at the time of inspection.

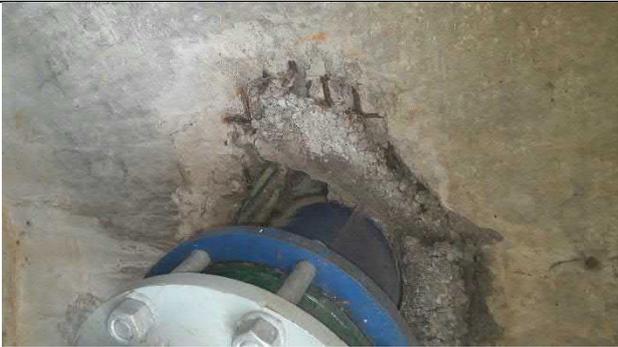
Pipework in reasonable condition

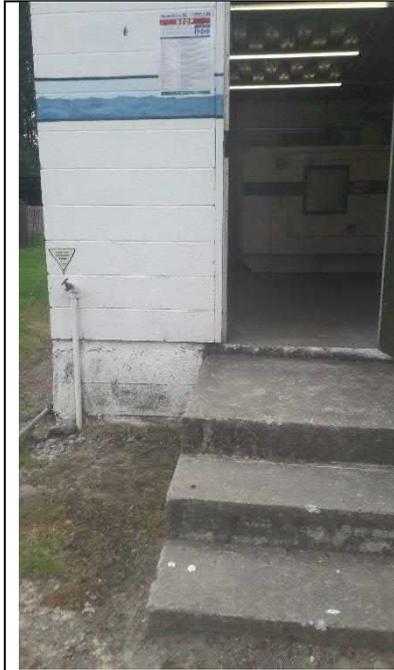
Step up into the pump station for flood protection

Note that the site is above the 100 year flood level and so flooding potential is low

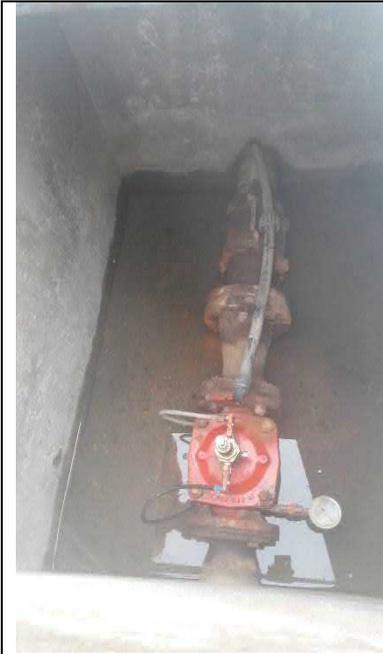
Chamber does not have cable seals.

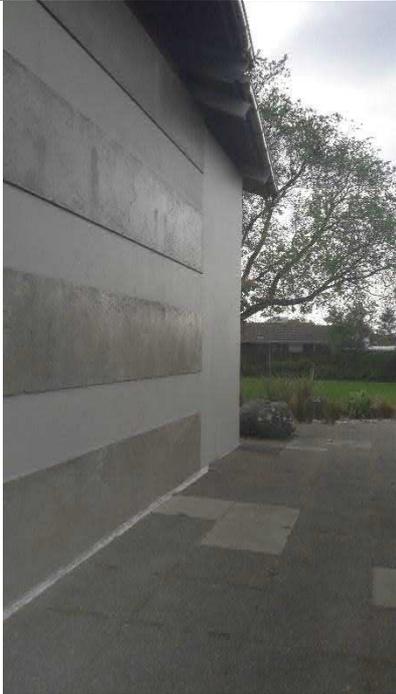
Pump station is located within a park

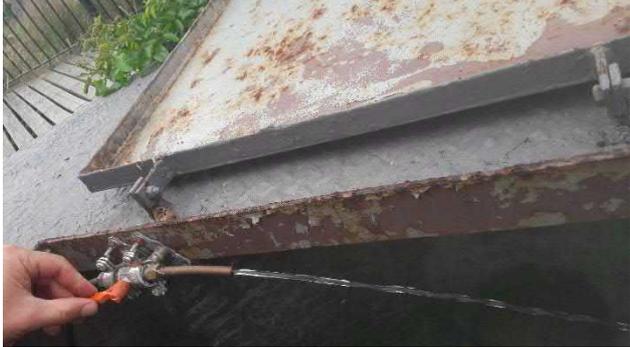
<p>Pipework has surface rust.</p> <p>Approximately 60mm of water in bottom of chamber.</p>

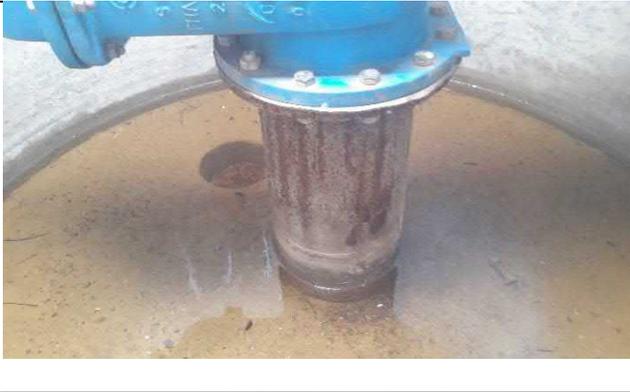
<p>Sample tap discharges into chamber. This may be the source of the water in the bottom</p>

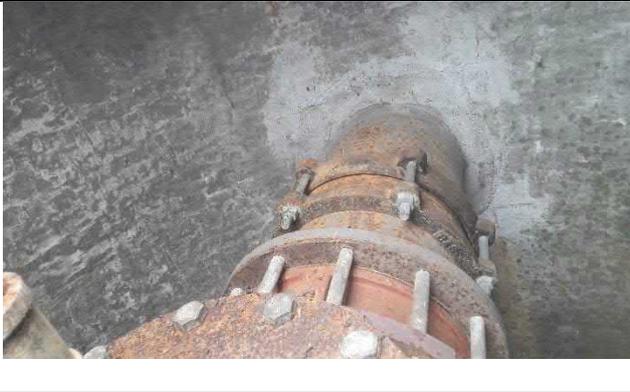
<p>Surface rust on casing. Sump installed but no sump pump.</p>

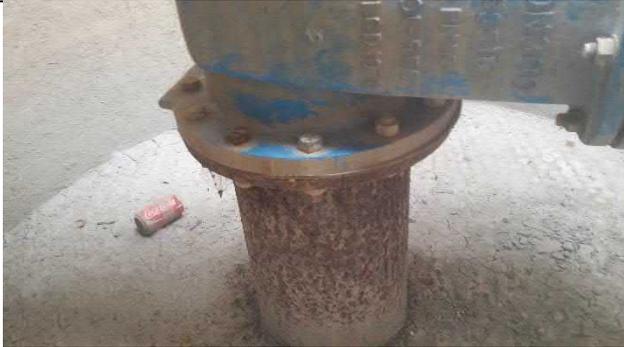
<p>Pipe work has some surface rust. Chamber is dry.</p>

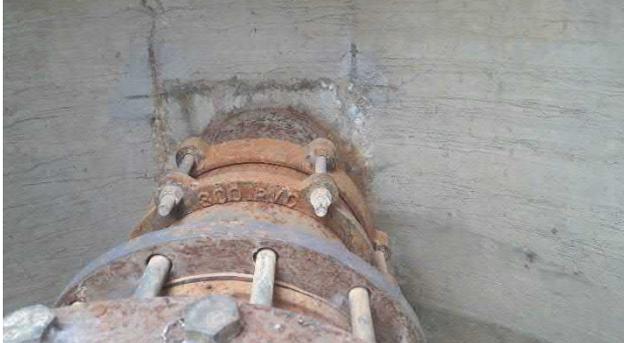
<p>Bore casing has some surface rust. Casing appears to be sealed with chamber floor.</p>

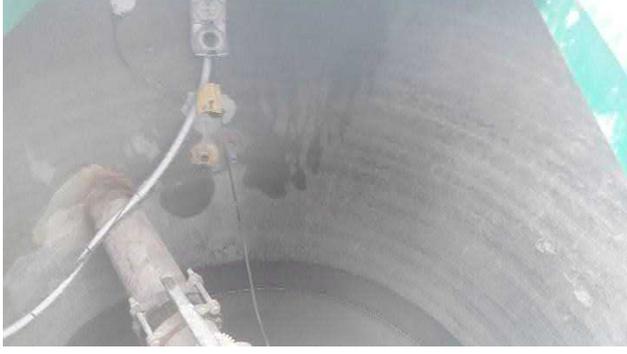
Water in the bottom of the chamber (~170mm) which may be from the sample tap, the ducts, from a hole behind the electrical cable, lid or chamber floor. It is possible that the nearby construction work has had an effect on this.

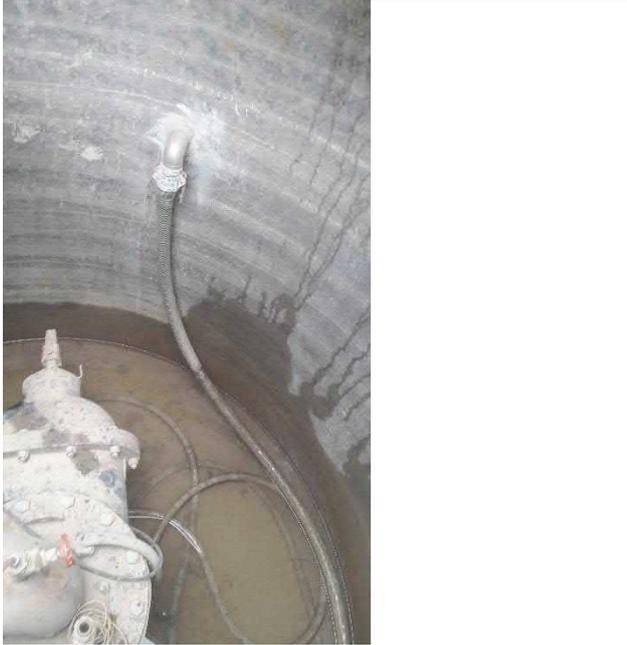
<p>Pipe penetration through chamber wall is sealed.</p> <p>Leaking down from the top of the chamber</p>

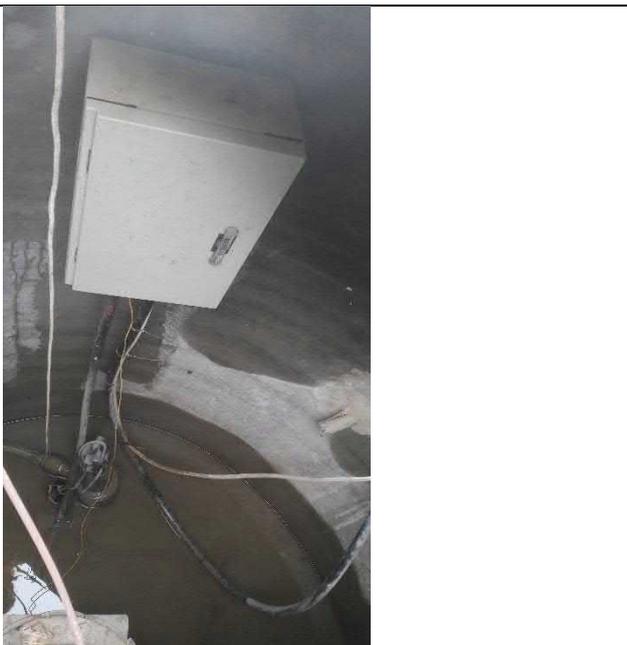
<p>Chamber wall penetration sealed</p>

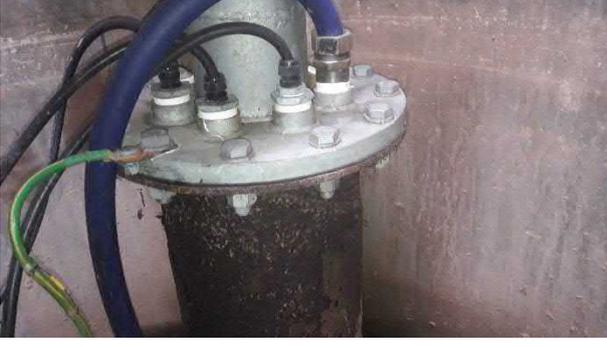
<p>Chamber penetrations appear to be sealed</p>

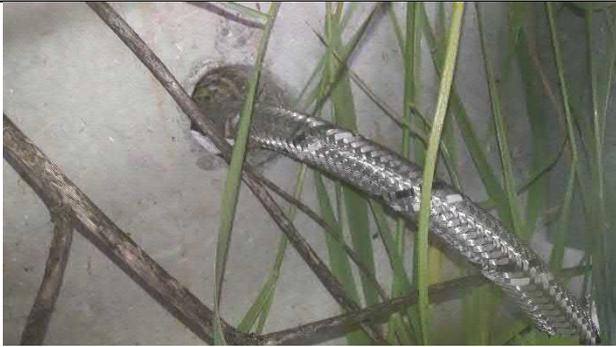
<p>Cable entries have minor leaks and need sealing</p>

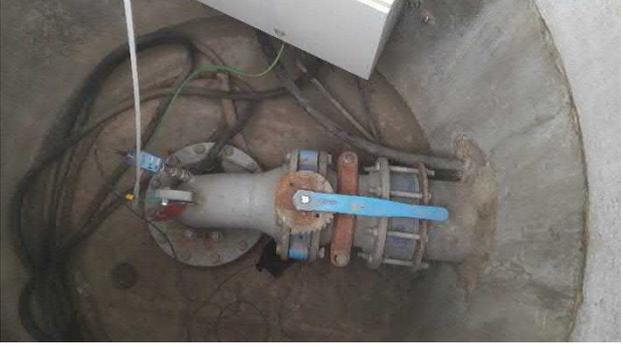
<p>Well chamber location</p>

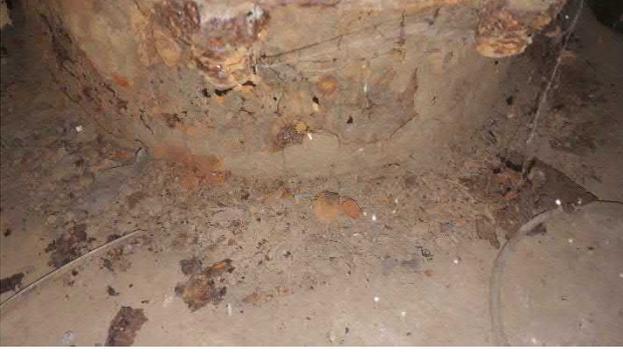
<p>Casing to chamber floor connection. Some debris build-up but appears to be sealed</p>

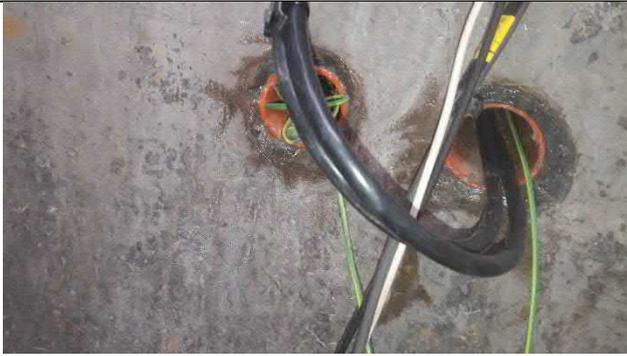
<p>Rust and casing flaking</p>
