# **Kids First Aranui Creche BU 2112-001 EQ2**

Detailed Engineering Evaluation  
Quantitative Report  
Version FINAL

284 Breezes Road, Aranui

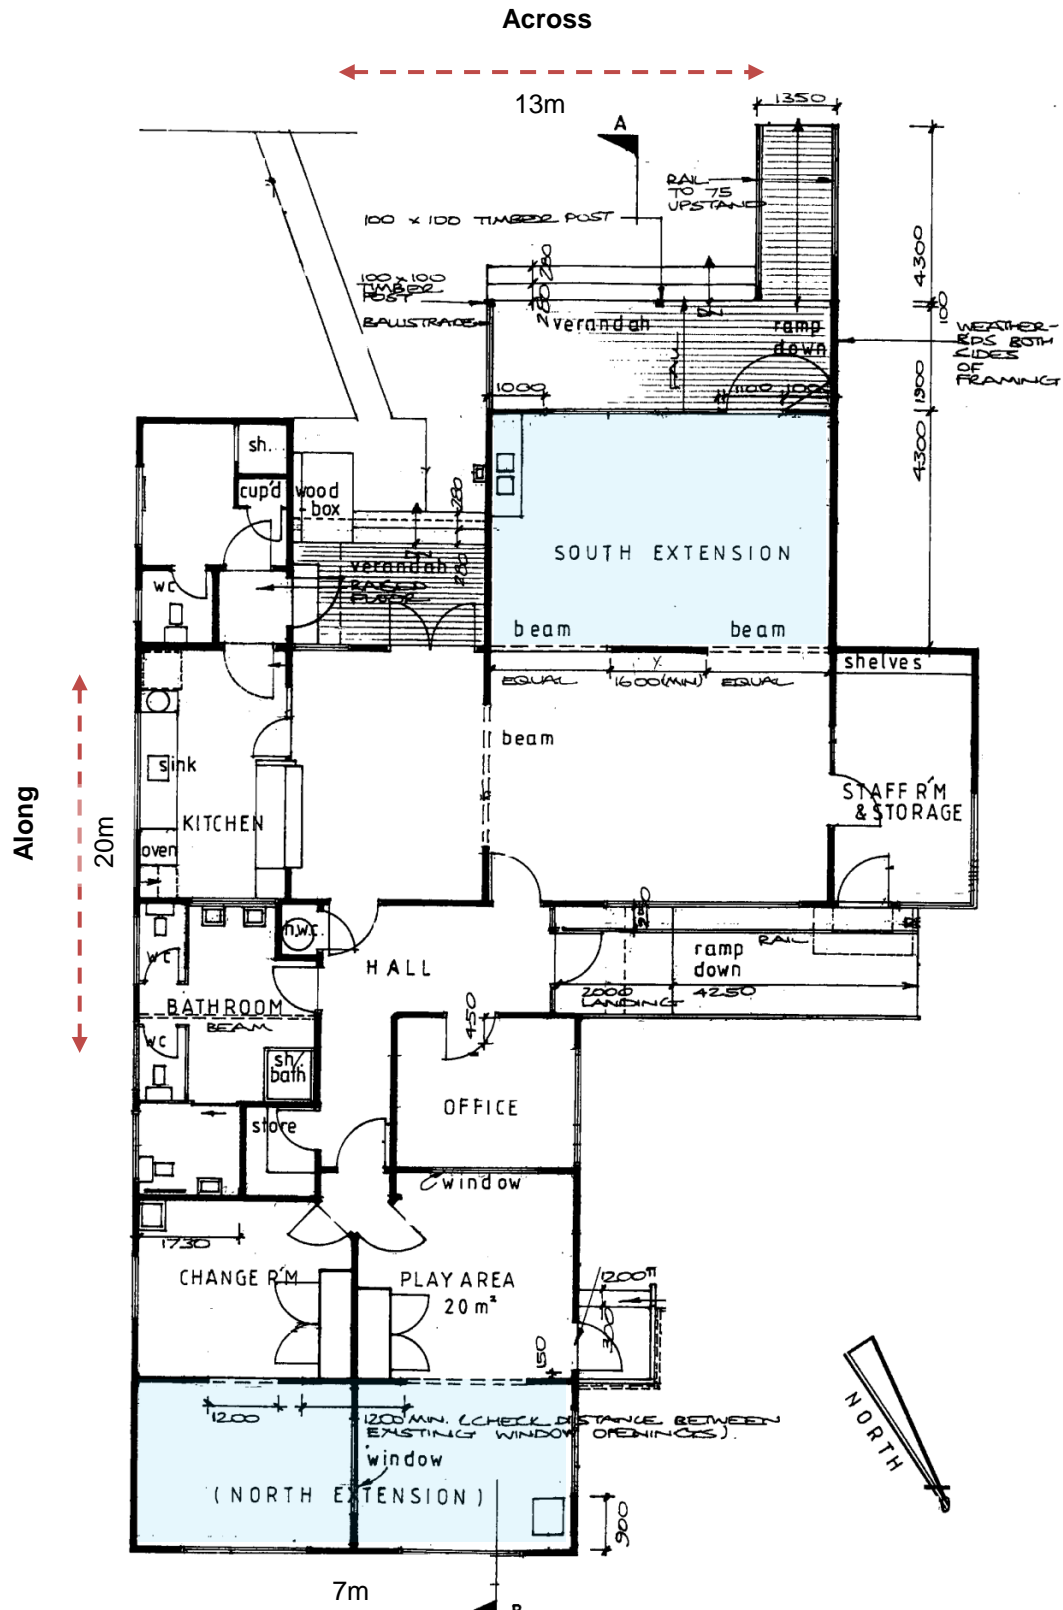
Lateral loads acting on the structure in both the long and short directions of the building are resisted by timber framed, braced, plasterboard walls. Seismic forces acting on the roof structure during an earthquake are distributed to the braced walls through diaphragm action of the plasterboard lined ceiling. The braced walls are distributed throughout the building in both the long and short directions. The braced walls then transfer the lateral loads to the subfloor structure. The lateral loads to the sub-floor structure are then distributed by diaphragm action provided by the floor into the concrete perimeter foundation walls. The concrete perimeter foundation walls are expected to provide bracing for the subfloor structure.

**Figure 2 Plan Sketch of building showing bracing walls and openings**

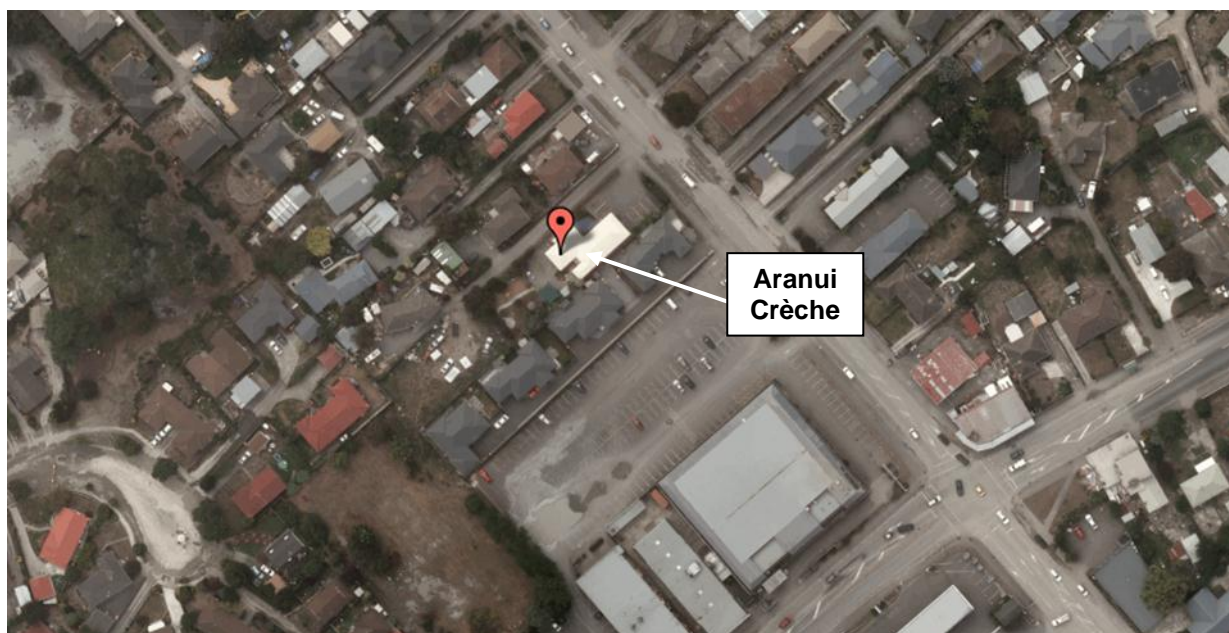
There was no evidence of ground damage on the property. No liquefaction or ground movement was evident in the sub-floor space, as viewed from the access hatch location (See Photograph 9). Significant areas of the sub-floor space could not be inspected due to lack of access. Signs of liquefaction outside the building footprint and adjacent to the site can be seen on aerial photographs following the 22 February 2011 earthquake.

**Figure 3 Post February 2011 Earthquake Aerial Photography**

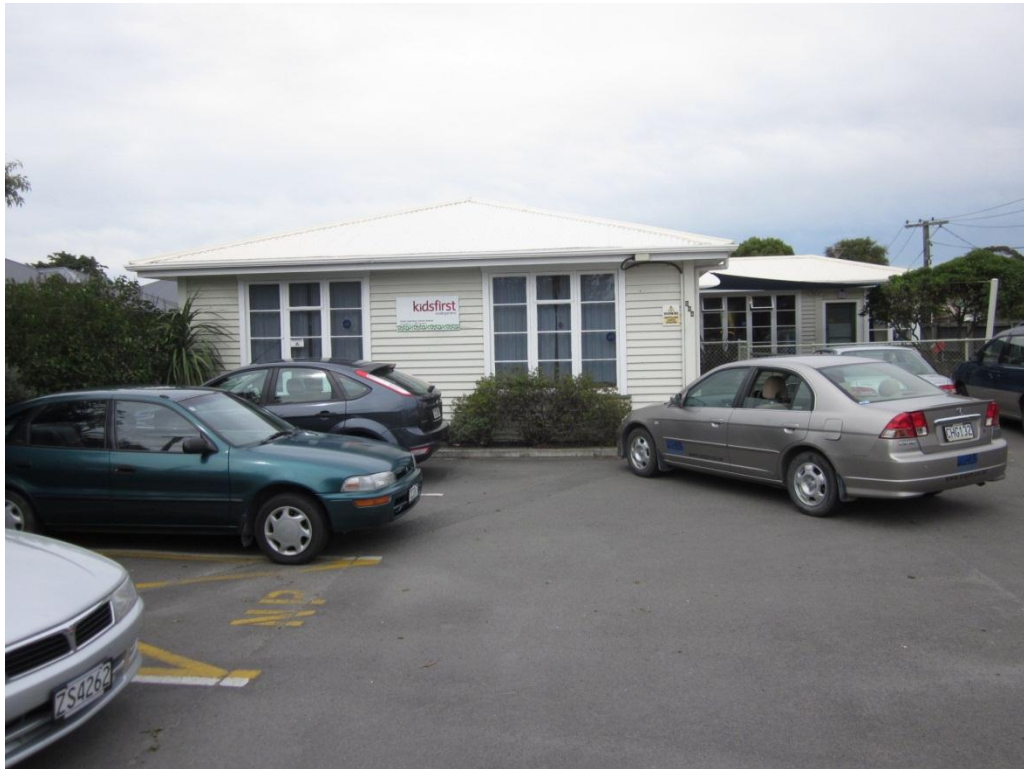
**Photograph 1 North (front) elevation.**

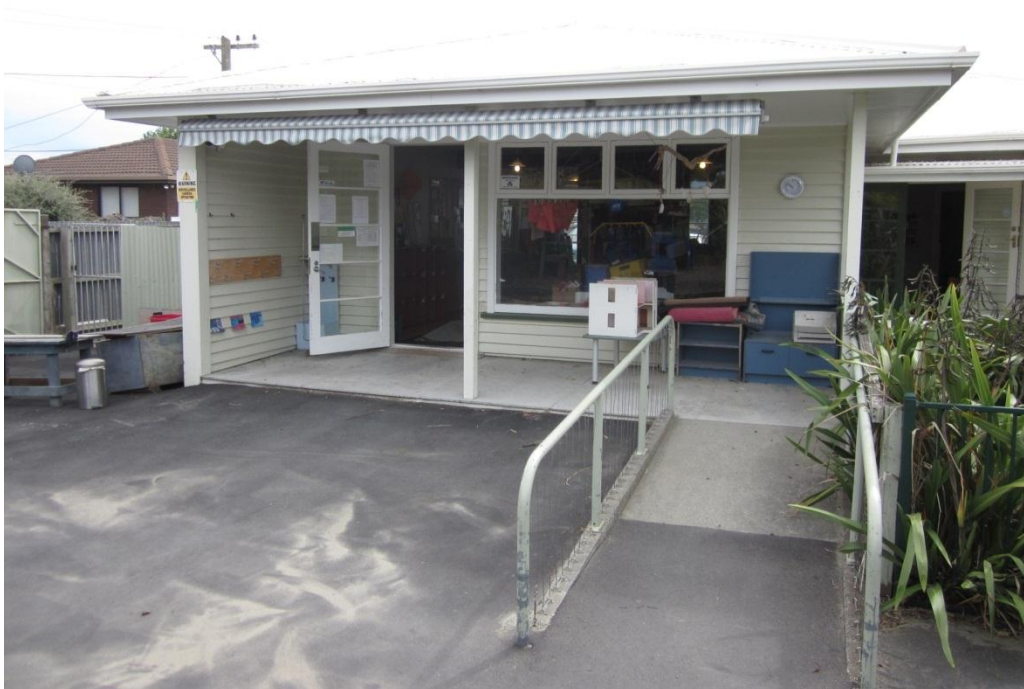
**Photograph 2 View of the crèche from the south (rear).**

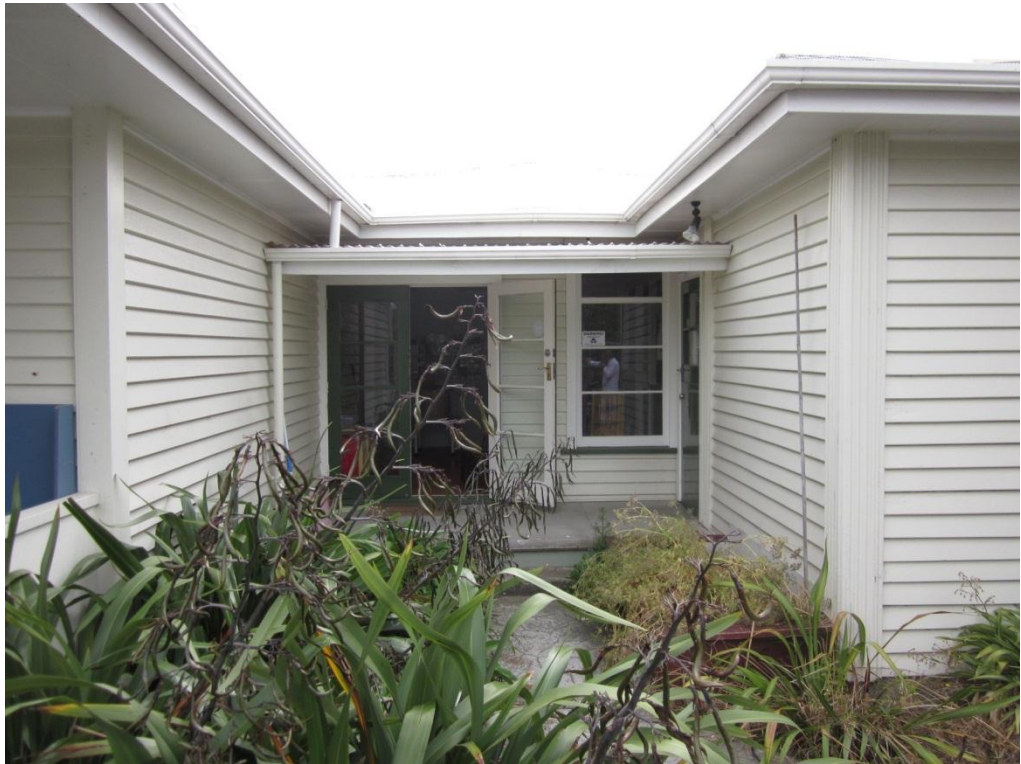
**Photograph 3 View of the crèche from the south.**

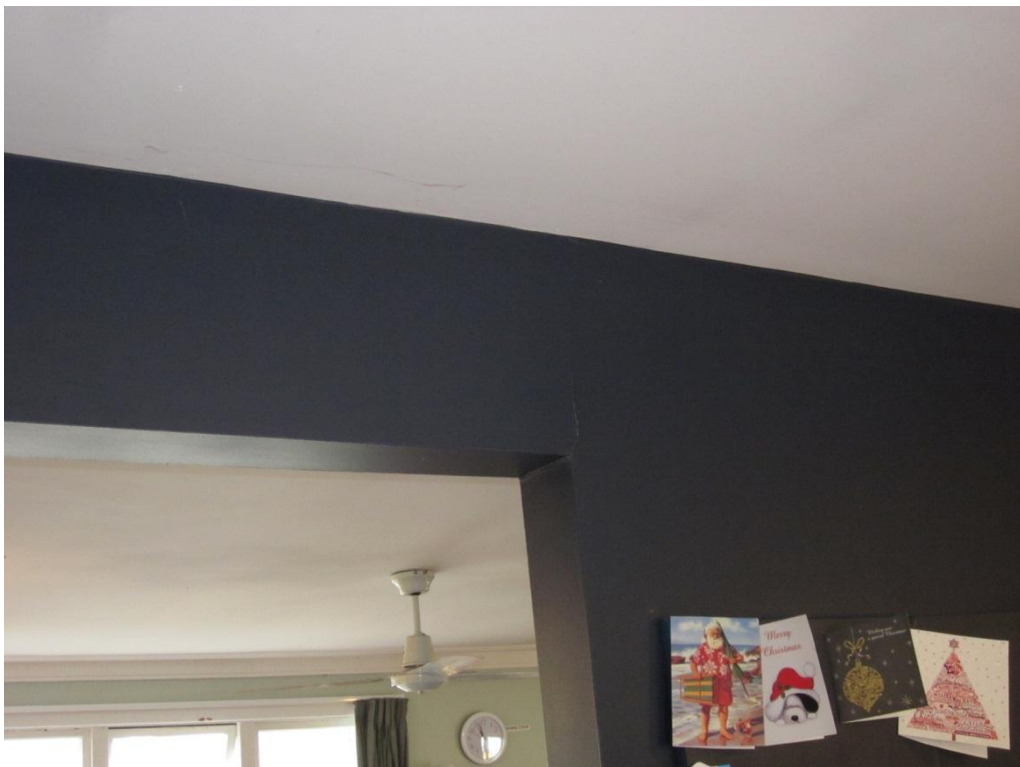
Cracking was noted to the internal plasterboard linings in several locations throughout the building, primarily above window and door openings (See Photograph 4, Photograph 5, Photograph 6 and Photograph 10). The damage to the plasterboard linings are due to movement of the structure during an earthquake. The ductile timber wall frames are able to accommodate movement during an earthquake; however the plasterboard linings have behaved in a more brittle manner and have cracked as a result of the movement. These lining cracks are not considered to be compromise the structural integrity of the building.

**Photograph 4 Vertical cracking in plasterboard lining of timber beam where original exterior wall was removed.**

Repair work should be carried out on all cracking to plasterboard linings. Moderate ground liquefaction can be expected under significant earthquakes; however there is no evidence of any foundation damage or settlement at the time of this report. Therefore foundation strengthening or repairs are presently not contemplated. Future ground damage from earthquakes may lead to minor foundation settlement or damage which can be rectified by re-levelling and localised repairs as necessary.

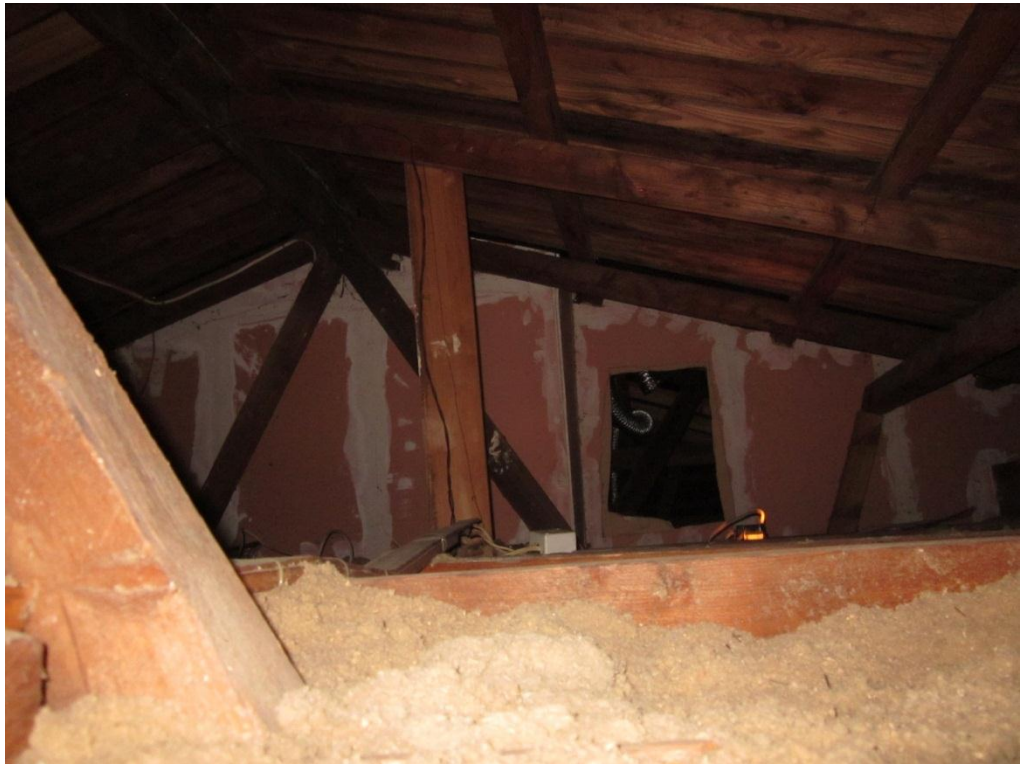
**Photograph 7 Roof rafters of the original structure as seen from access hatch.**

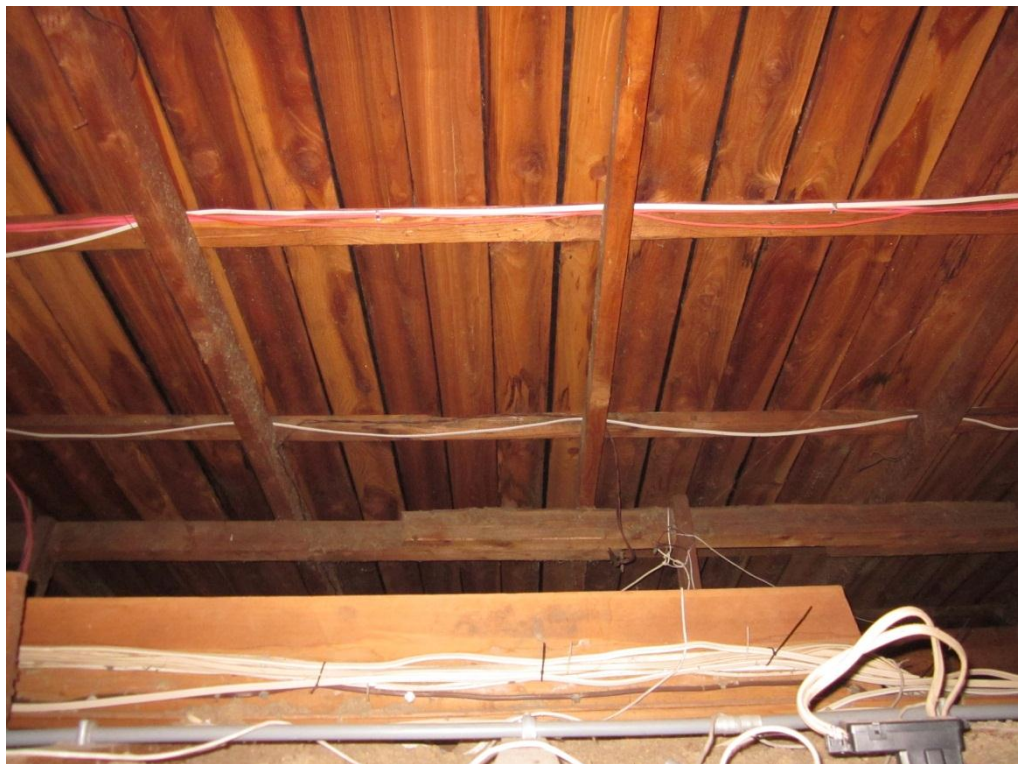
**Photograph 8 Roof sarking elements acting as a bracing diaphragm.**

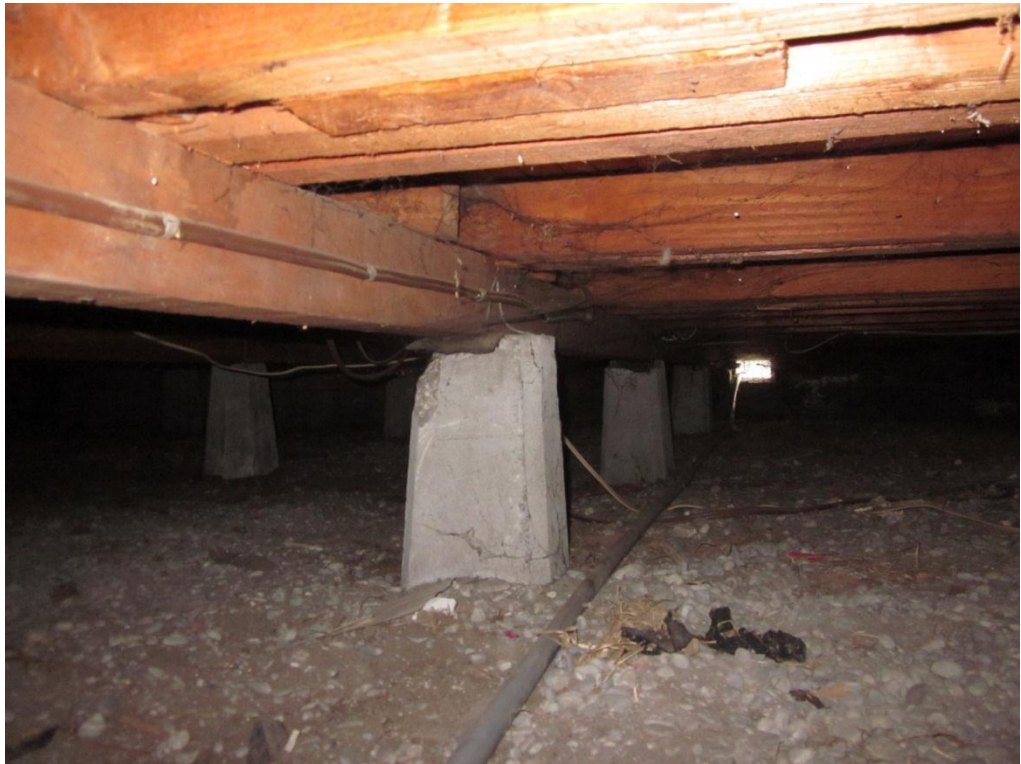
**Photograph 9 Suspended timber floor support system of the original structure as seen from the access manhole.**

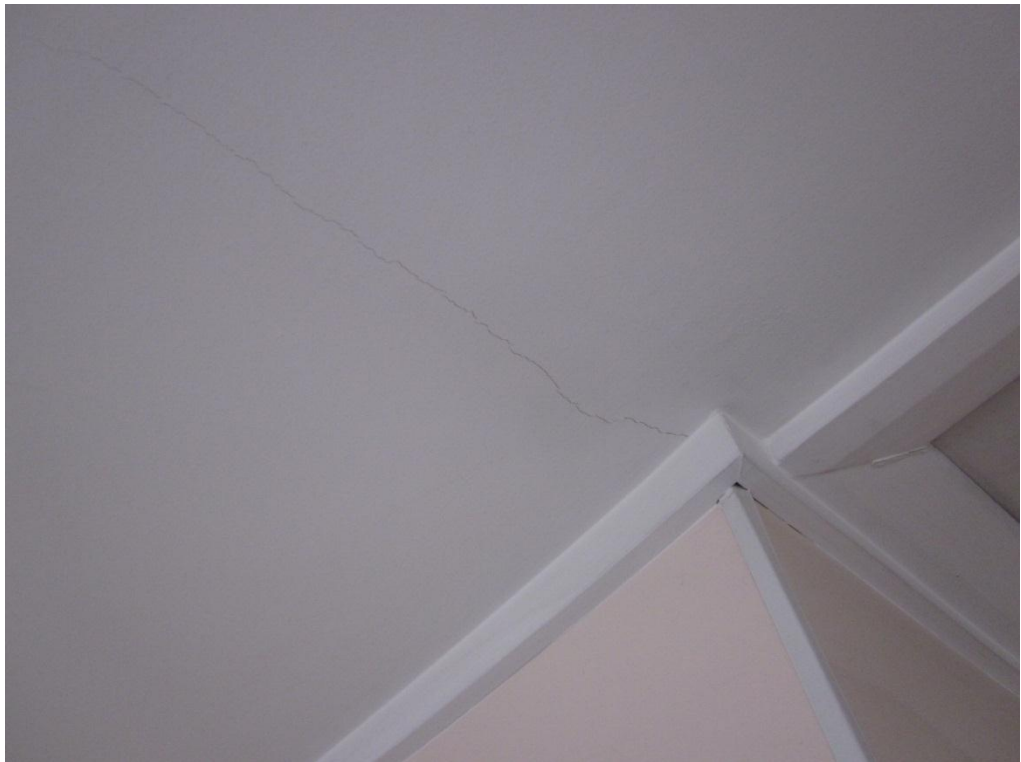
**Photograph 10 Minor cracking to the ceiling plasterboard in the bathroom.**
