REPORT TO CANTERBURY EARTHQUAKE RECOVERY AUTHORITY

Argent Building
82 Peterborough Street, Christchurch

Detailed Engineering Evaluation and Initial Evaluation Procedure Assessment

Project Argent Building, 82 Peterborough Street

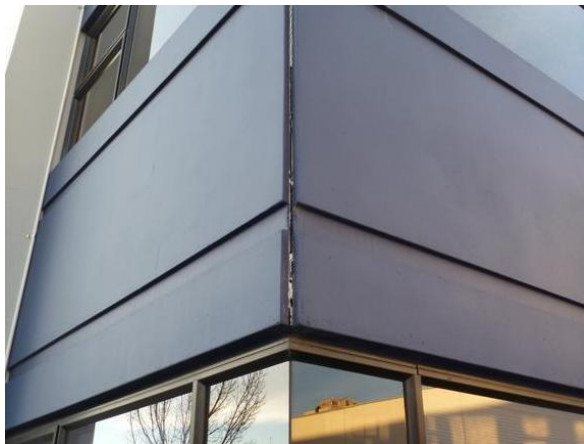
- Hairline cracks in both wing-wall extensions of the eastern shear wall
- Loss of flexible sealant on corner joints between precast concrete panel walls (Figure 3)
- Fracture of bottom edge concrete of precast panels on the south side wall (Figure 4)
- Crack, and in one instance fracture, of internal wall partition lining (Figure 5)
- Racked door frames

Figure 3: Corner joints, external walls

2. Loss of flexible sealant on exterior walls	Remove damaged sealant. Replace with flexible sealant (Ramset Hi-Seal, Bostik Seal-N-Flex 1, or Roadware Flexible Cement II). Paint over.

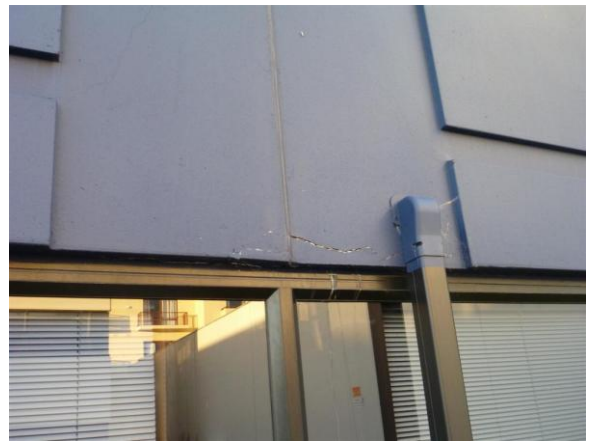
Figure 4: Precast panels, external south side wall

- Further loss of flexible sealant on corner joints between precast concrete panel walls.
- Further fracture of bottom edge concrete of precast panels on the south side wall (Figure 4).
- Cracks and fracture of internal wall partition linings slightly worse.

Minor			
Damage description	Location	Investigations	Reason for damage
6. Fracture of precast panels	External south side wall	Visual inspection	Stress cracking from building flexure
7. Differential settlement in floor levels	Ground and first floors	Floor level survey	Likely settlement of foundations.

5. Superficial inverse pitting of bitumen pavement surface	None required.
6. Fracture of precast panels	Break out loose concrete. Completely abrade surface to produce sound concrete with good mechanical key. Fill with suitable non-shrink cementitious grout (Ramset Premier Grout MP, Sika Mono Top Structural Mortar, or Roadware Concrete Mender). Paint over.

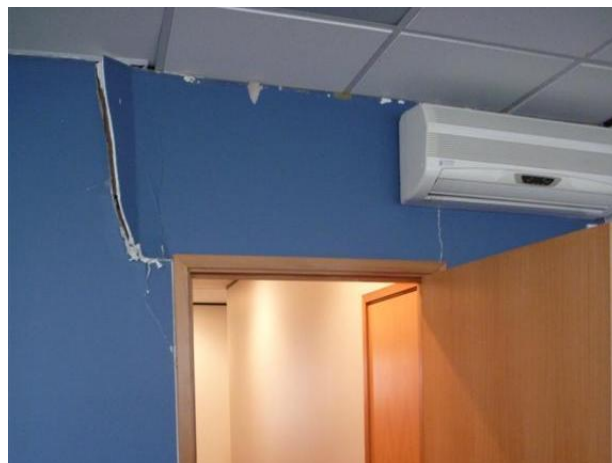
Figure 5: Internal wall partition

It was noted from this inspection that the observed aftershock damage was unchanged from damage after the February earthquake, although the non-structural cracks in the GIB lining may have increased slightly.

3. Cracks to internal wall partitions	Repair internal linings per the GIB Information Bulletin dated November 2011, and re-paint.
4. Hairline cracking to exterior panels	To protect reinforcing steel apply a high-build flexible paint system in accordance with manufacturer's specifications.

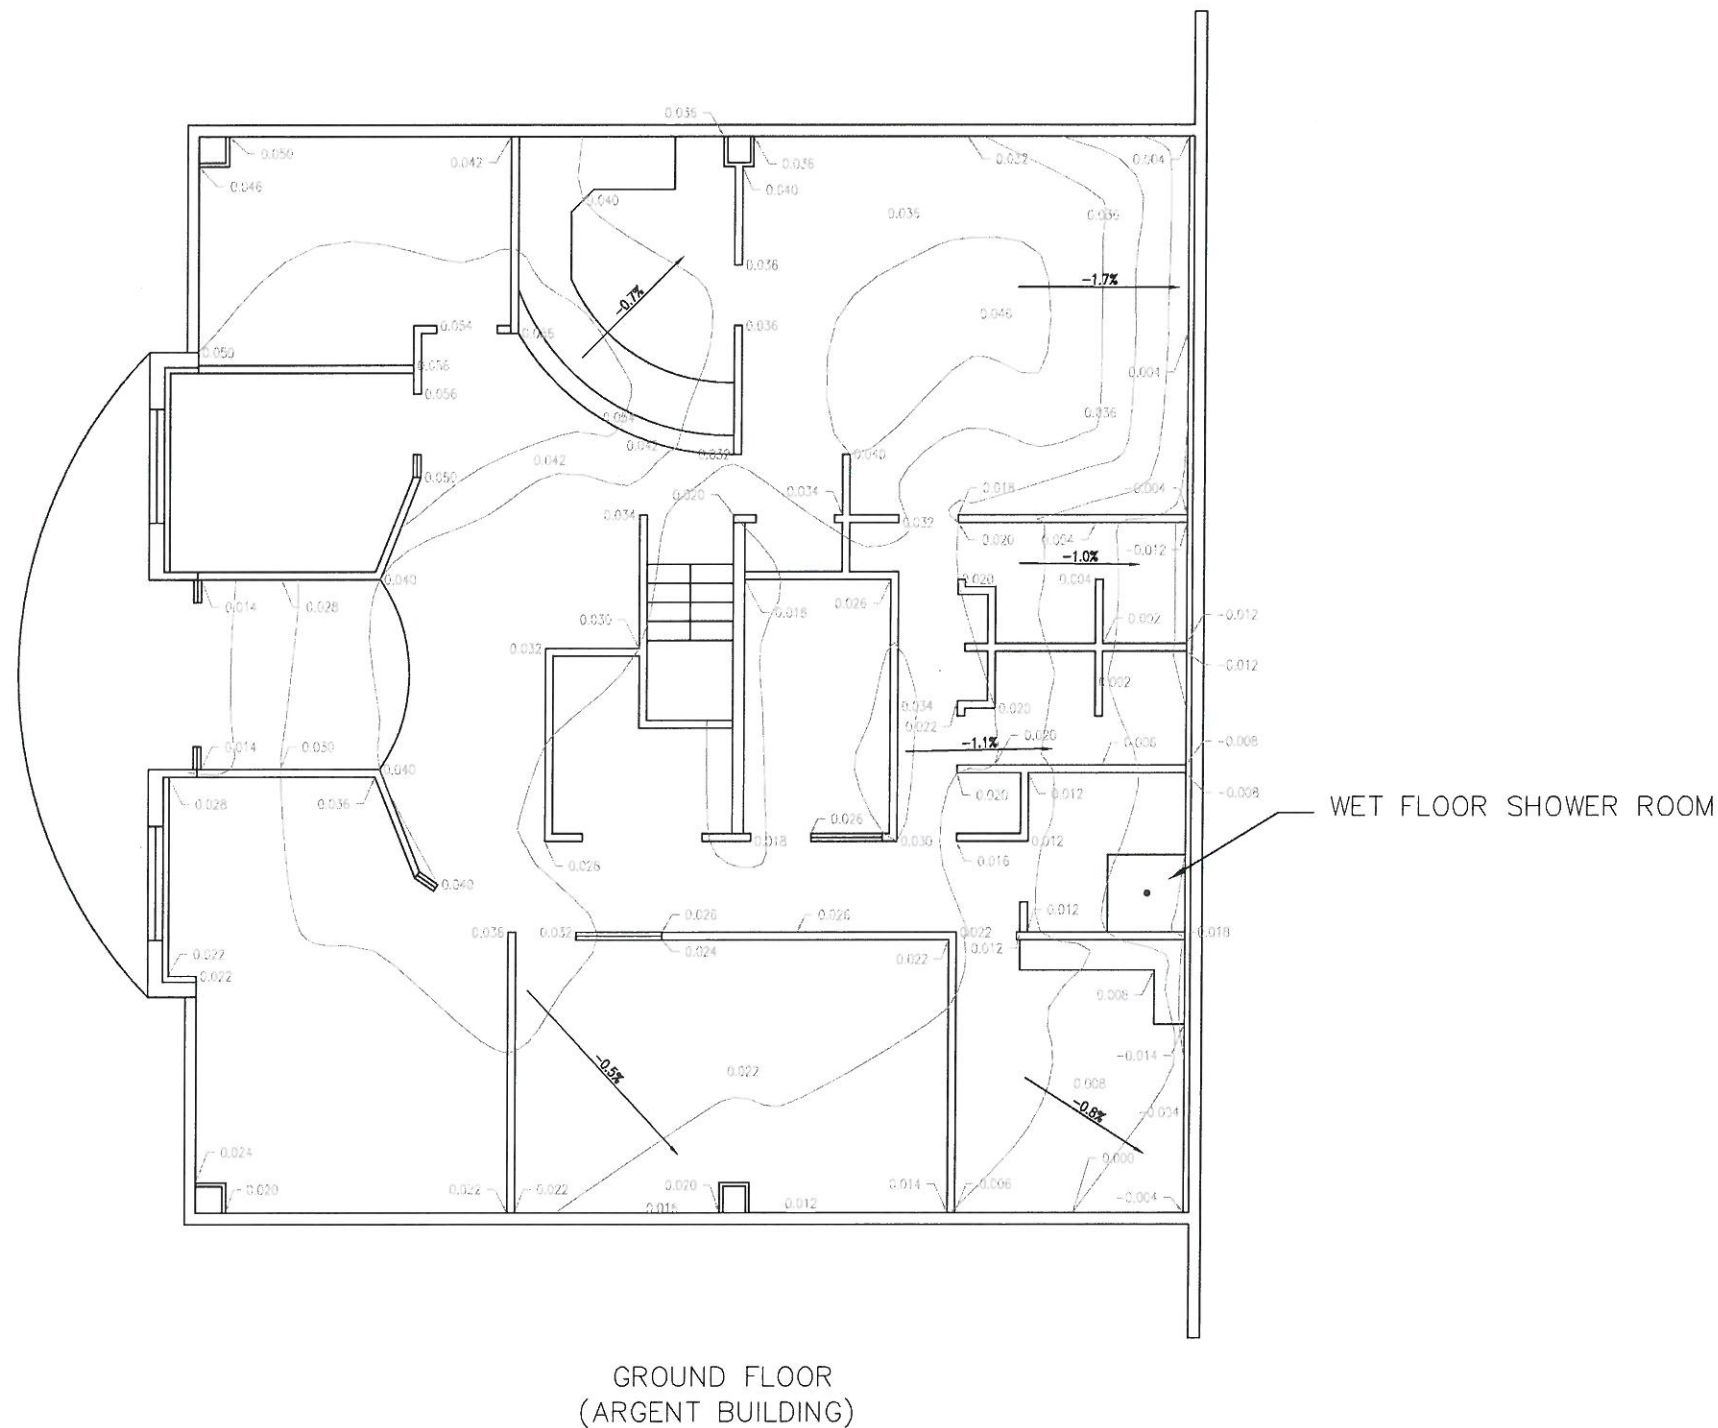
TITLE:
**FLOOR LEVEL SURVEY
ARGENT BUILDING
GROUND FLOOR**

From an arbitrary datum of 0.00 the variation of level is -18 to +60mm giving an overall difference in level of 78mm. This is in excess of the DBH guidance.

The average floor slope is greater than 0.5%. The area of greatest concern is adjacent the east boundary wall in the northern office area where the last 2.5m of floor dives down at a grade of 1.7%. This is clearly noticeable once pointed out by the current occupants.

This indicates that there has been settlement of the exterior foundation ground beam in this location. Due to the floor coverings we were unable to check whether the floor has cracked but the location of the change of grade is consistent with the saw-cut line shown on the structural drawings. The floor is reinforced with 665 Mesh but it is possible that this could have been cut by the saw when the shrinkage control cuts were made.

The current tenants are due to move out around the 9th September 2012. Following their departure the carpet should be lifted to fully inspect the continuity of both the ground floor slab and the first floor Hi-bond slab.

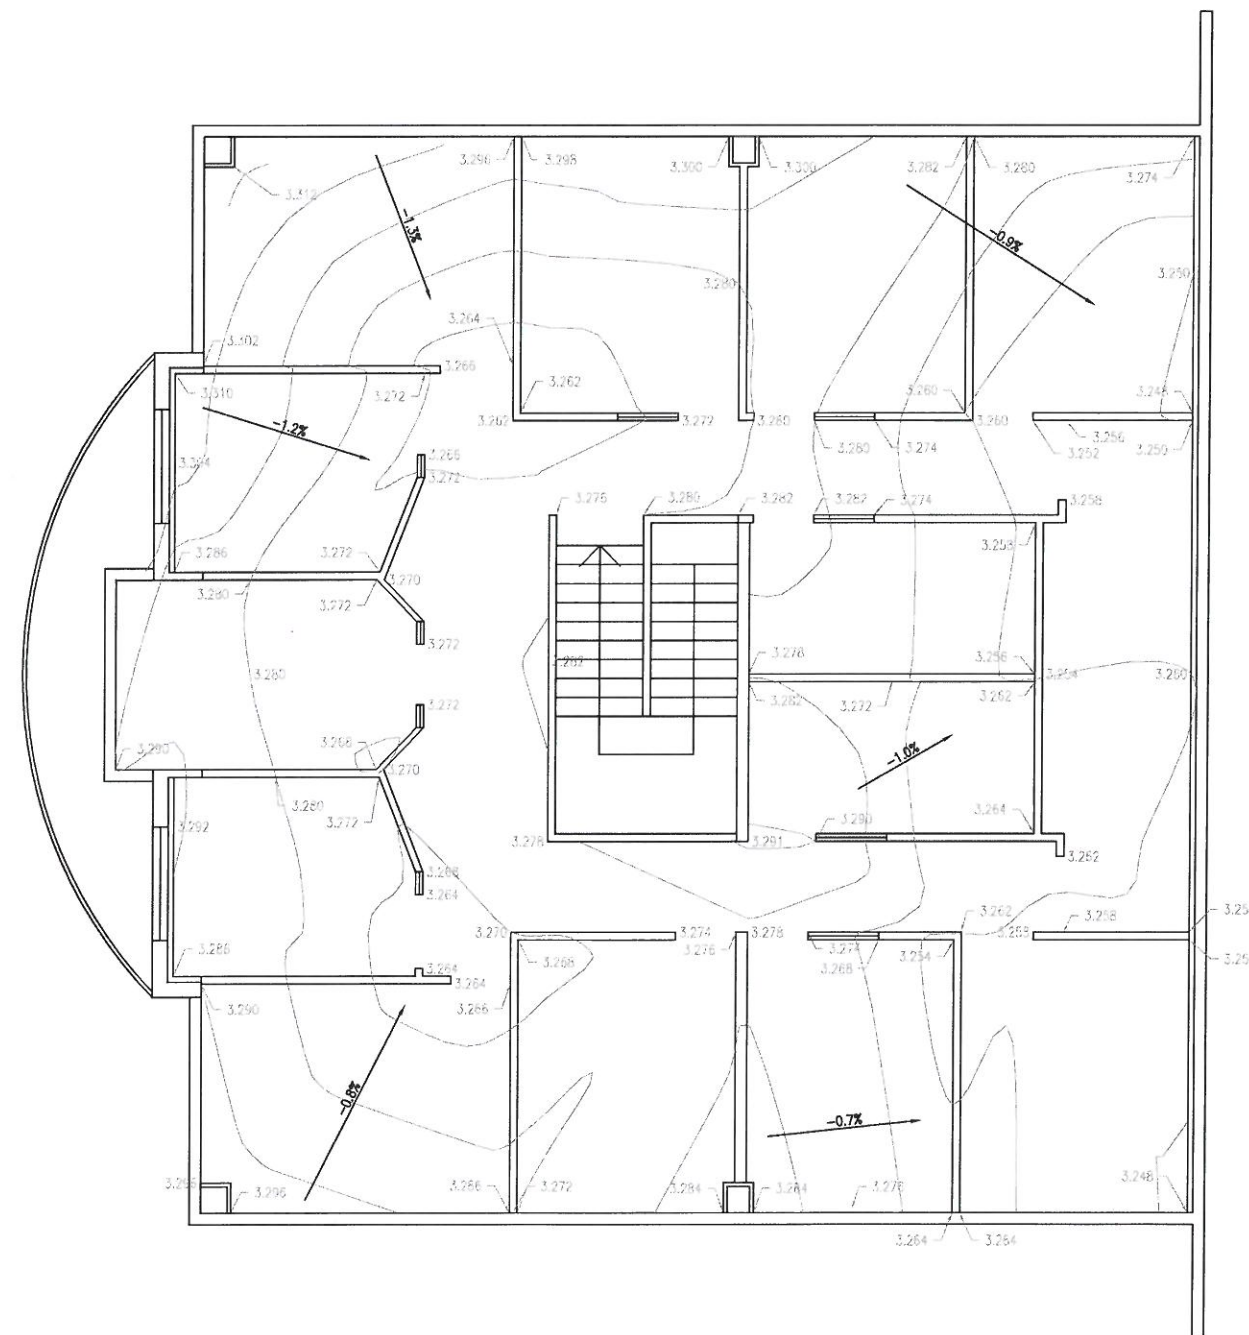
TITLE:
**FLOOR LEVEL SURVEY
ARGENT BUILDING
FIRST FLOOR**

The variation of level on the first floor is 3.312 – 3.248m giving an overall difference in level of 64mm. This is in excess of the DBH guidance.

The average floor slope is also greater than 0.5%. The area of greatest concern is the North West office floor where the floor slope is 1.3%. Interestingly this does not correspond with the critical ground floor location. It appears that the foundation settlement mentioned above has not dragged the first floor down with it.
