# Ascot Community Centre Detailed Engineering Evaluation BU 1306-003 EQ2 Qualitative Report

**Prepared for Christchurch City Council (CCC)**

**By Beca Carter Hollings & Ferner Ltd (Beca)**

14 June 2013

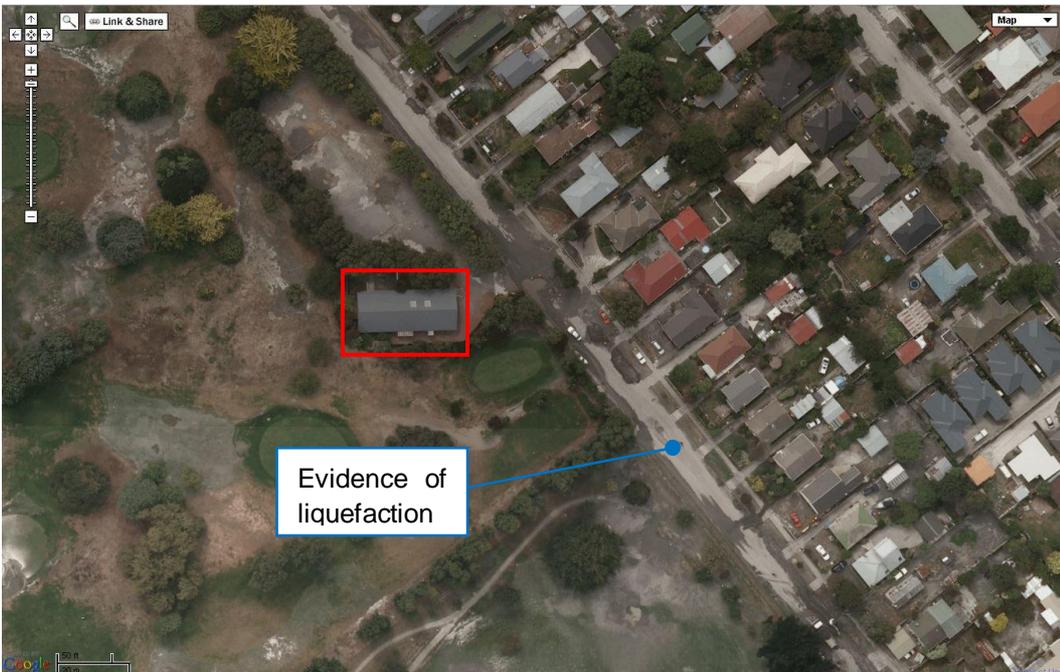
- n Site characteristics: significant liquefaction potential due to widespread liquefaction observed in the surrounding area.

**Photo 2:** Liquefaction of areas surrounding site (aerial photo taken 24 February 2011)

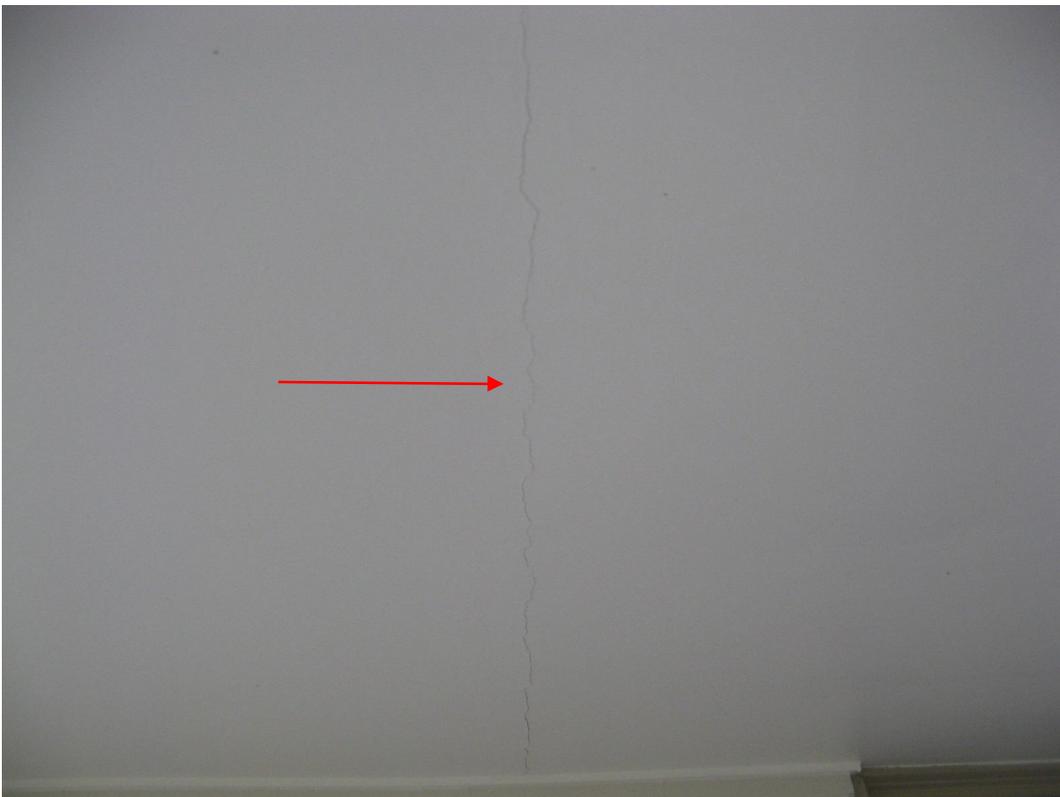
**Photo 4:** Damage to plasterboard ceiling

Other than minor localised cracking in the plasterboard ceiling no superstructure damage was observed during our visual inspection and therefore we believe the structural capacity has not been materially affected.

**Damage:** Minor cracking (<1mm) to plasterboard ceiling panels.

<b>Recommendations</b>	Level of repair/strengthening required: <input type="text" value="minor structural"/>	Describe: <input type="text" value="Repair cracking to plasterboard"/>
Building Consent required: <input type="text" value="no"/>	Describe: <input type="text"/>	
Interim occupancy recommendations: <input type="text" value="full occupancy"/>	Describe: <input type="text"/>	
Along	Assessed %NBS before e'quakes: <input type="text" value="36%"/>	36% %NBS from IEP below
	Assessed %NBS after e'quakes: <input type="text" value="36%"/>	
Across	Assessed %NBS before e'quakes: <input type="text" value="36%"/>	36% %NBS from IEP below
	Assessed %NBS after e'quakes: <input type="text" value="36%"/>

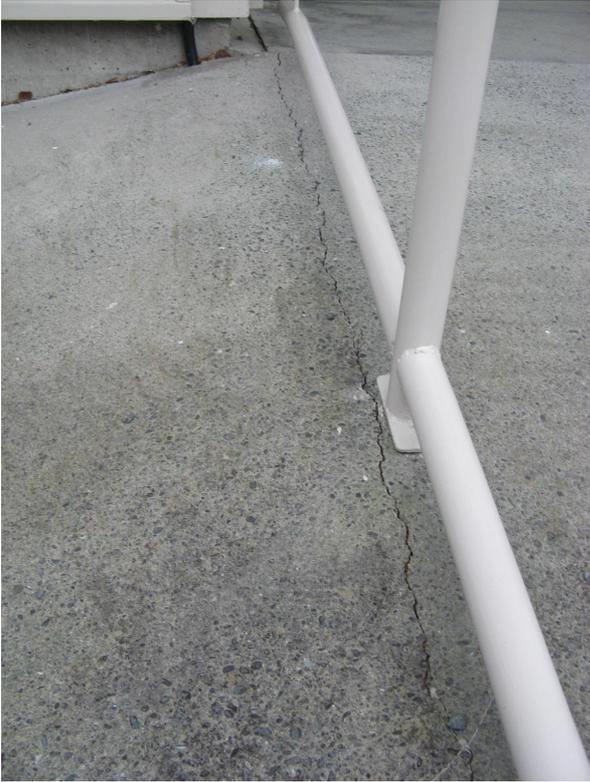
**Photo 5:** External concrete pavement

**Damage:** Minor cracking to concrete slab.
