Our Ref: 1587

12 September 2011

Re: Avebury Park Residence – POST-EARTHQUAKE INSPECTION

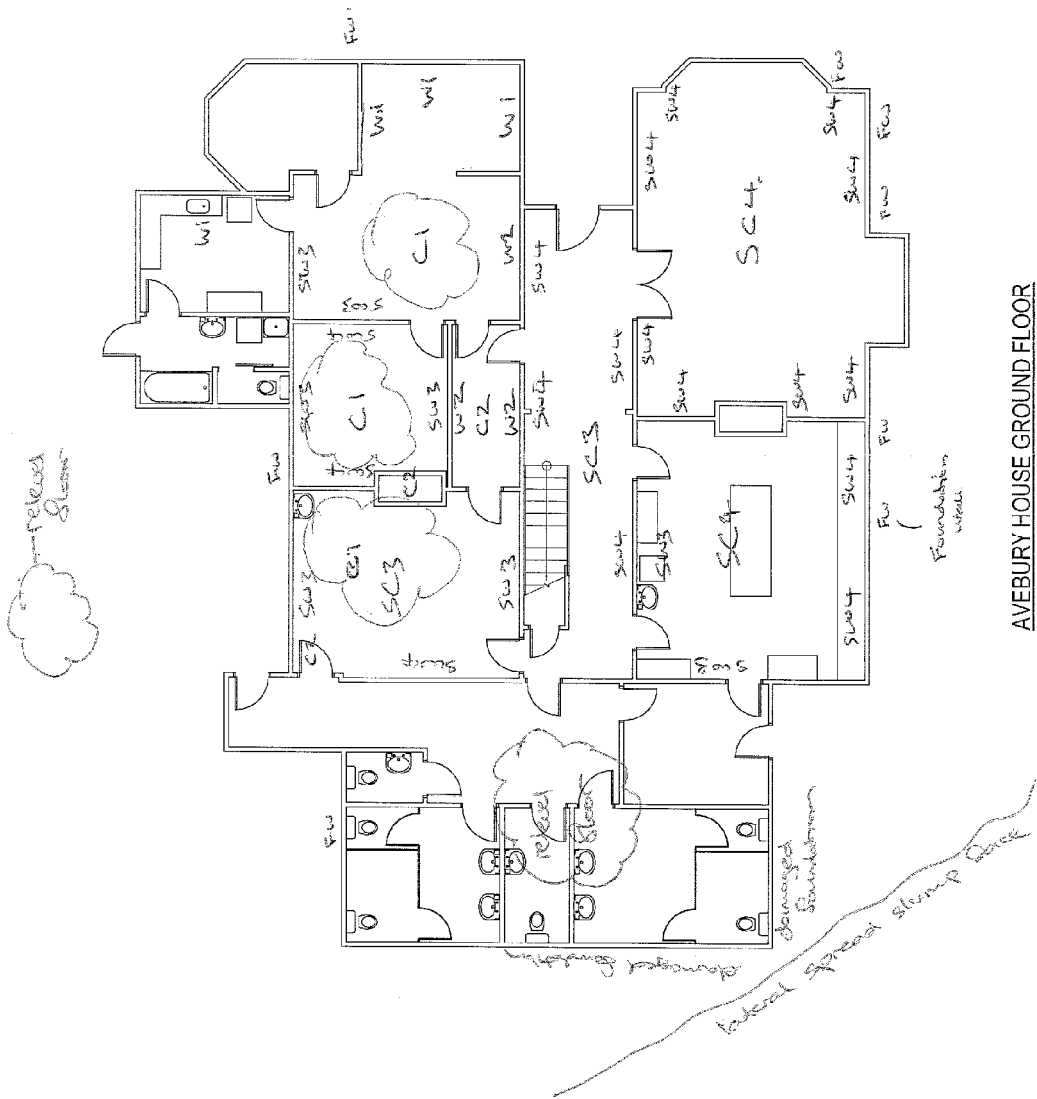
AVEBURY HOUSE GROUND FLOOR
11:00 at A3

- C1 ceiling cracks
- C2 major cracking in ceiling
- W1 walls cracking
- W2 major wall cracking
- SW3 replace lining or re-plaster lining

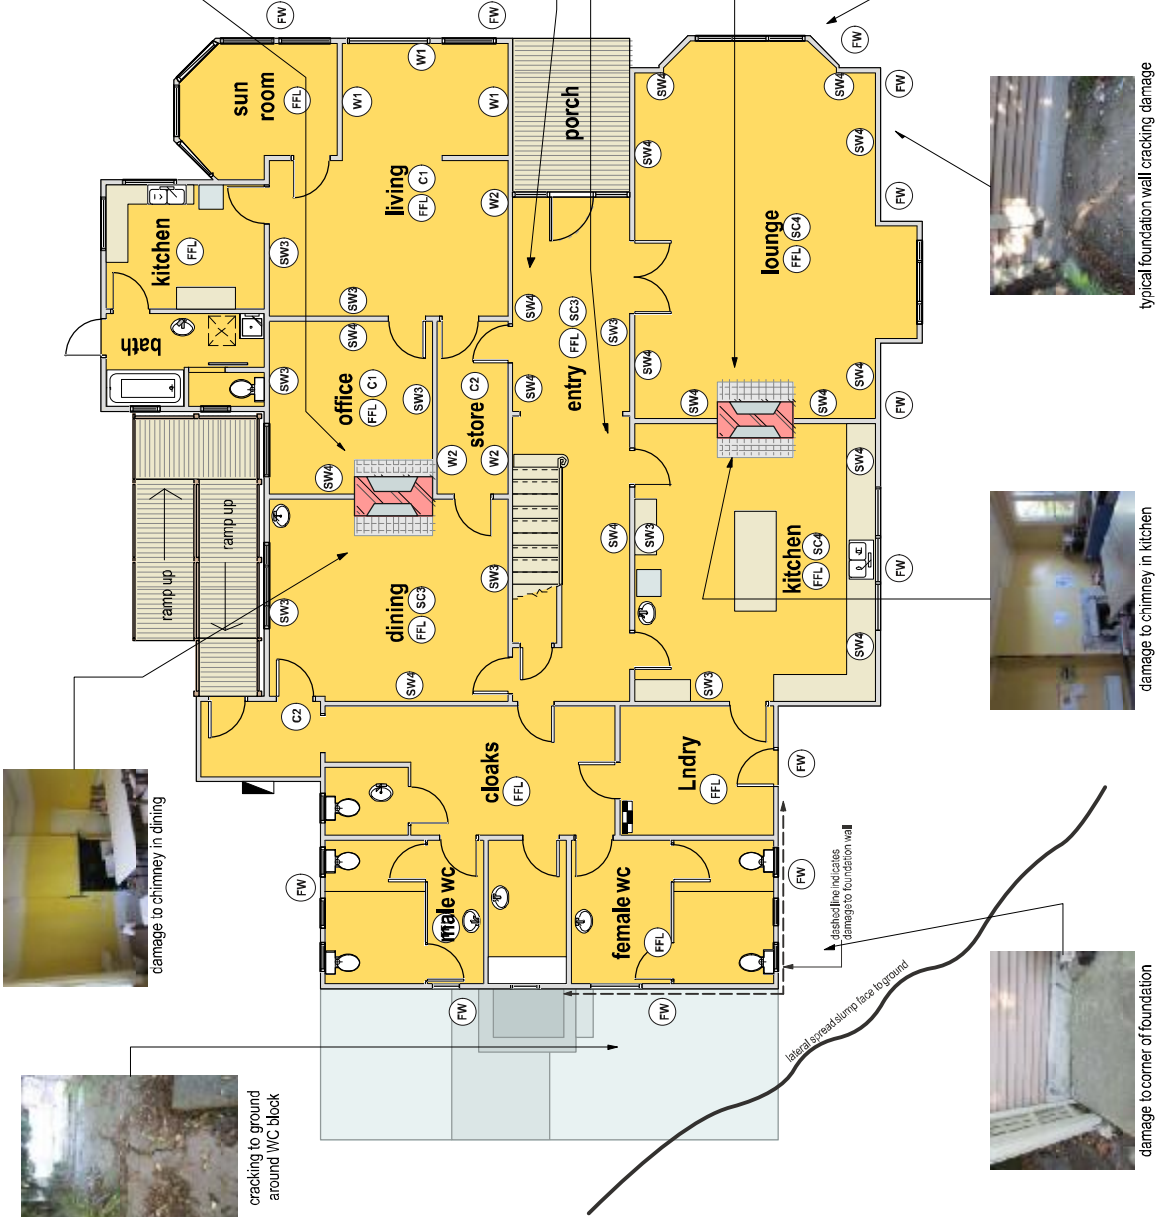
dashed line indicates damage to foundation wall

lateral spread-slip base to ground

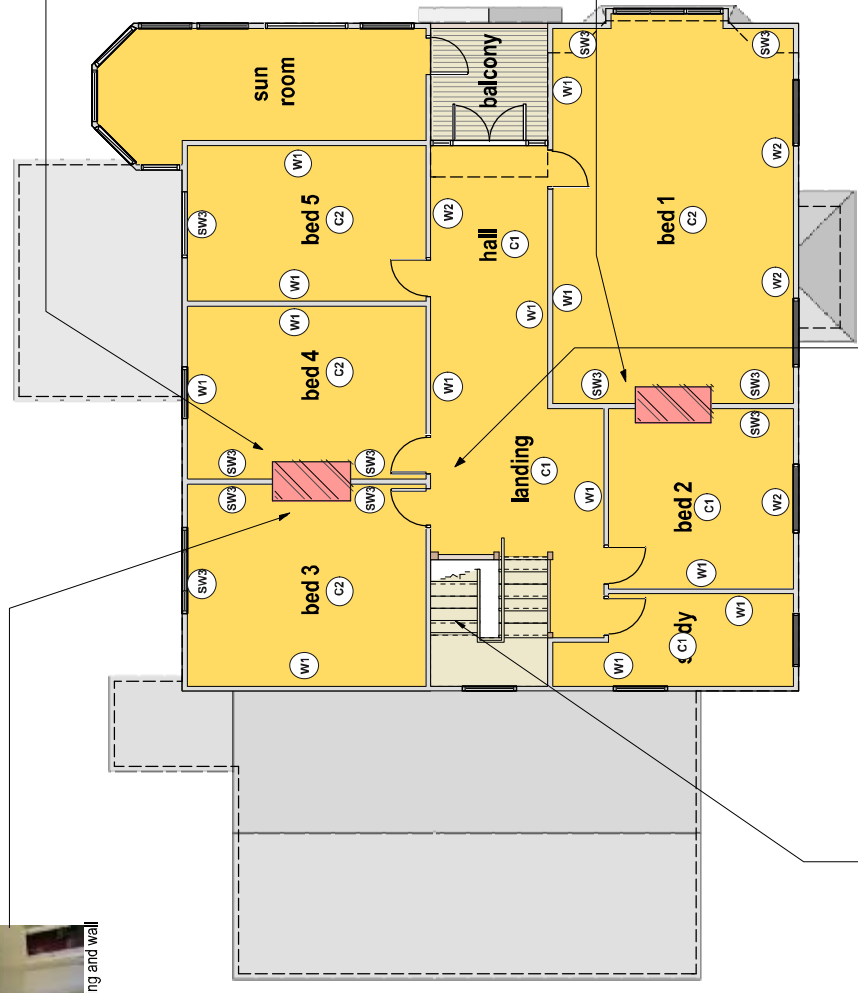
damage to walls in hallway

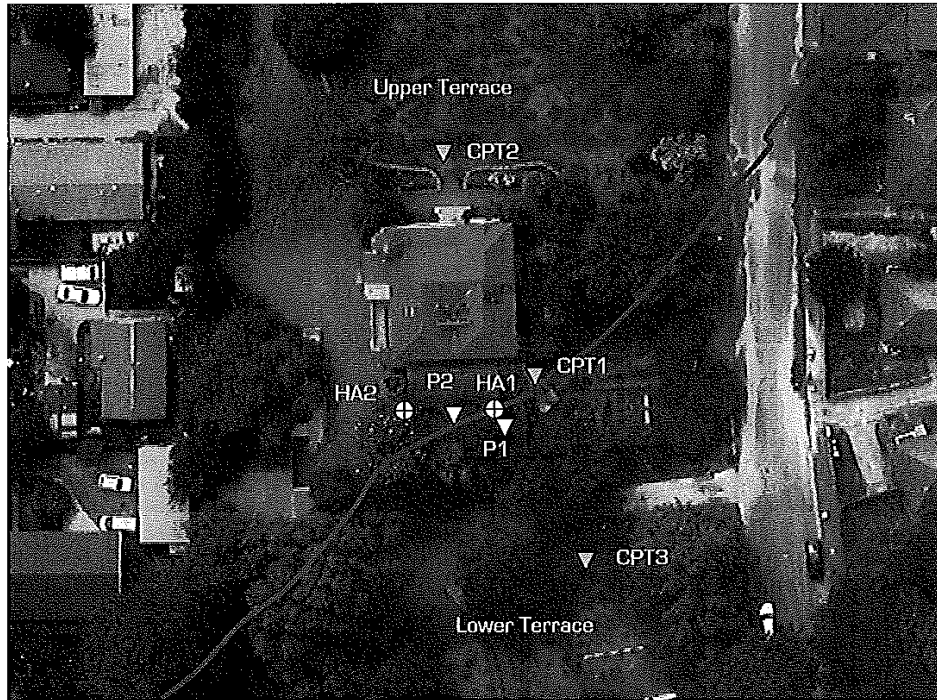
Figure 1: Aerial view of site showing location of major lateral spreading tension zone passing through the property.

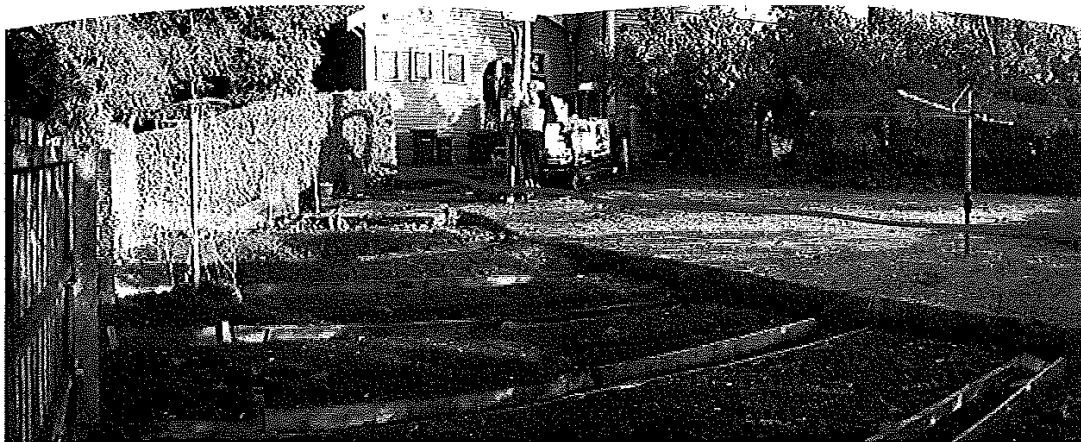
Figure 2: View of southeastern corner of building affected, main tension crack location and position of CPT1.

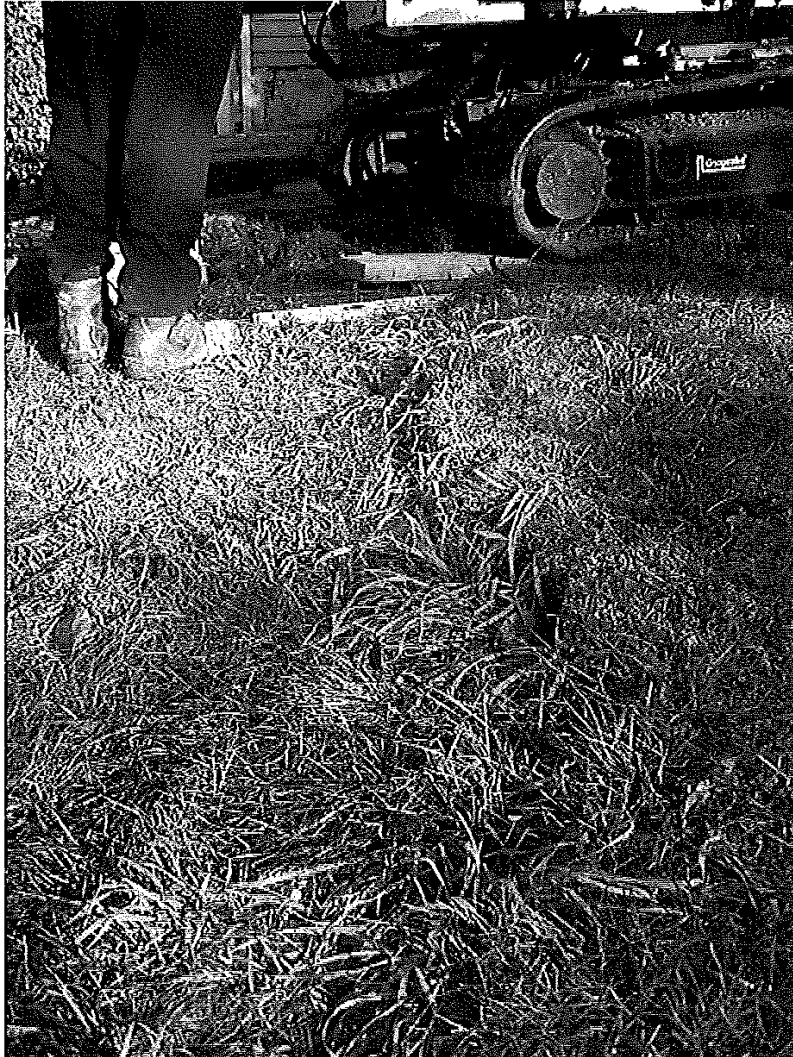
In addition to minor to moderate liquefaction, the property has been affected by lateral spreading. This is indicated by the presence of the headscarp of a reasonably significant zone of lateral spreading that passes along the boundary between the lower and upper alluvial terrace immediately around the southern end of the building (Figures 1, 2 and 3). The headscarp comprises tension cracks up to 100mm wide, and a noticeable drop of up to 50mm to the southeast along its alignment. The ground immediately behind the upper side of the headscarp has slightly subsided resulting in the slight tilting of the southern wing of the building towards the southeast, and the separation of the wing from the main building by up to some 20mm. The strip footing for the wing has also separated by up to 20mm near the wing corner and approximately half way along the eastern wall strip footing as a result of land extension associated with lateral spreading. A hairline crack in the strip footing along the northern side of the main building has also occurred. Furthermore, an alignment of sand ejecta some 20m to the north of the property exists indicating the presence of a small hairline crack paralleling the main headscarp has also formed as a result of lateral spreading.

Figure 3: View of tension crack passing through southeastern corner of property and building.

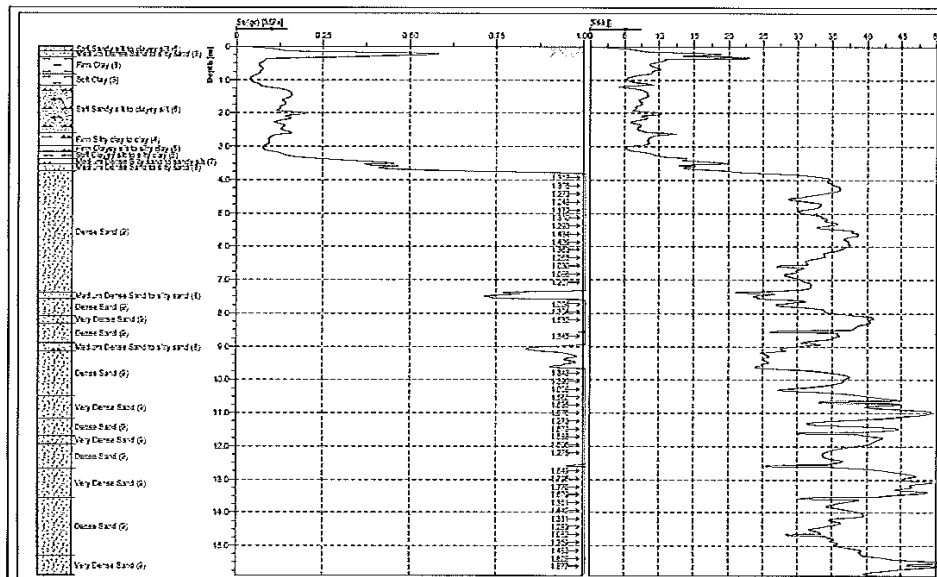
Figure 4: CPT 1 estimated profile, SPT N and S_u values beneath the southeastern corner of building.

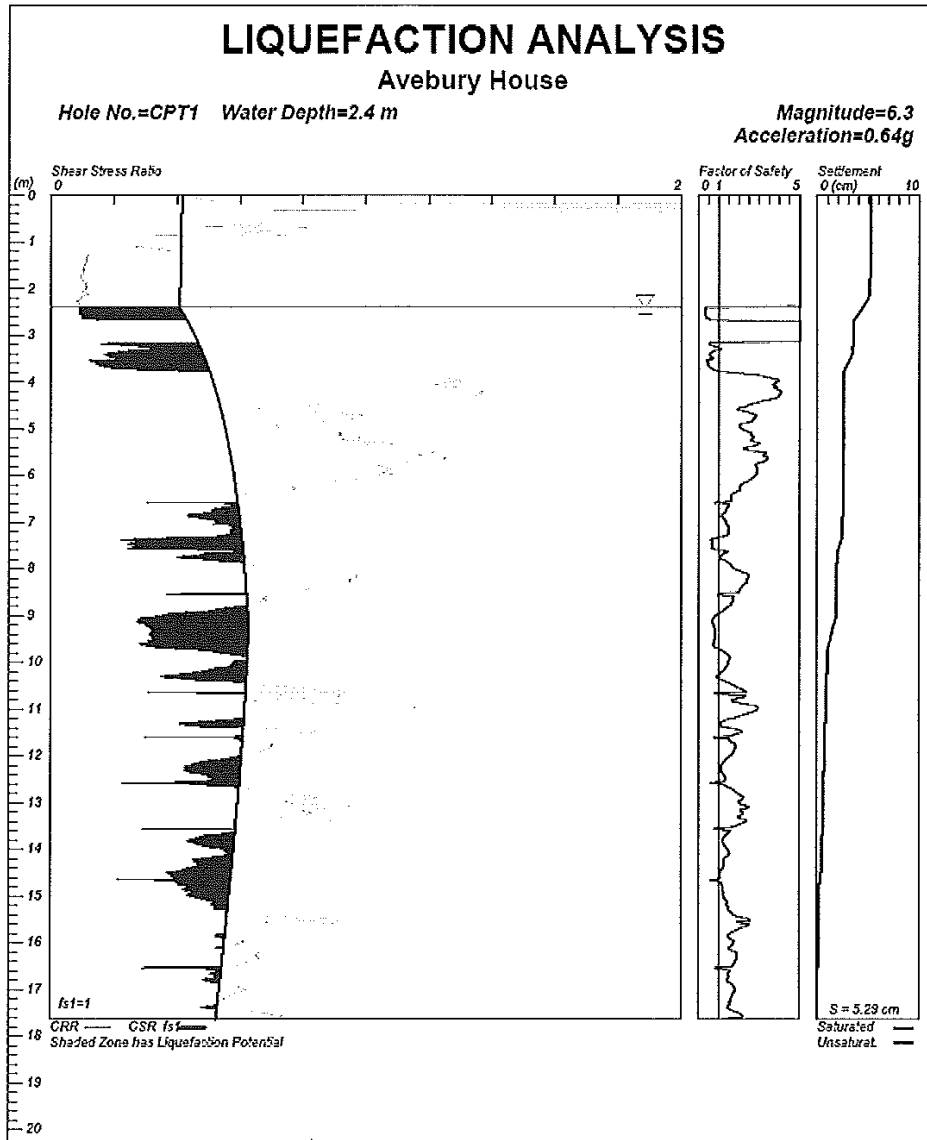
Figure 6: Layers which are likely to have liquefied in the February 22 M6.3 earthquake event.

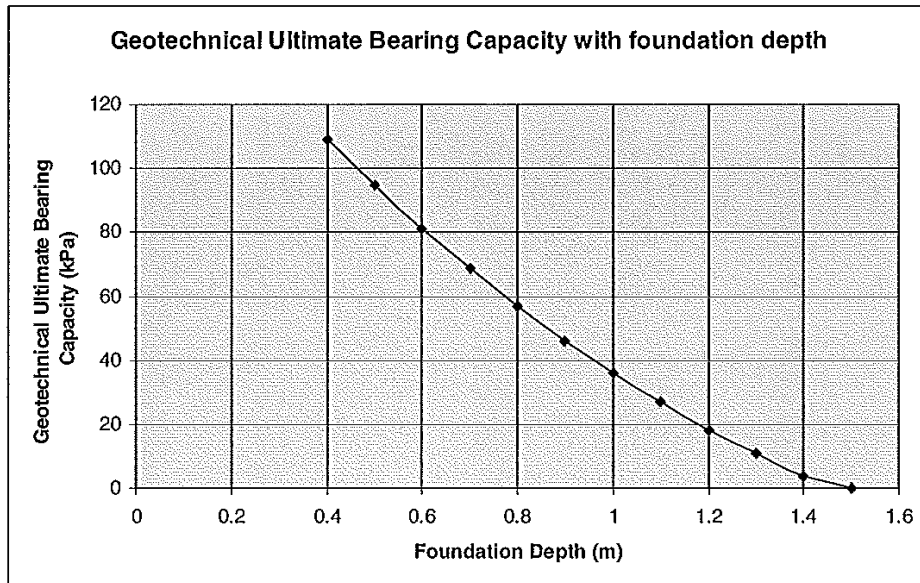
The analyses indicate that the bearing capacity of the near surface soils is likely to be reduced under ULS seismic conditions due to the loss of strength of the materials below the groundwater table. Figure 7 shows the estimated geotechnical ultimate bearing capacity available for various footing depths (assuming a 0.4m wide footing) for this situation. In essence, greater bearing capacity is calculated to be available for shallow footings, although this is still approximately 33% of the geotechnical ultimate bearing capacity of 300kPa for footings taken to 0.45m depth. Given that much of the building is likely to be supported on shallow foundations, some settlement of the building foundations could occur under ULS seismic loads (est up to 75mm), which is consistent with the observed foundation settlement of the building following the 22 February 2011 earthquake event.

Figure 7: Geotechnical ultimate bearing capacity of footing with depth.

Accordingly, to avoid adverse settlements following a future ULS seismic event we recommend that the replacement strip footings be limited to depths less than 0.5m, unless supported on piled foundations taken to the dense sand from 3.8m depth.
