Avonhead Park Pavilion
PRK 0206 BLDG 001 EQ2
Detailed Engineering Evaluation
Quantitative Report

Christchurch City Council

Date: November 2012
Reference: 6-QUCC1.19
Status: Final

146 Hawthornden Road, Christchurch

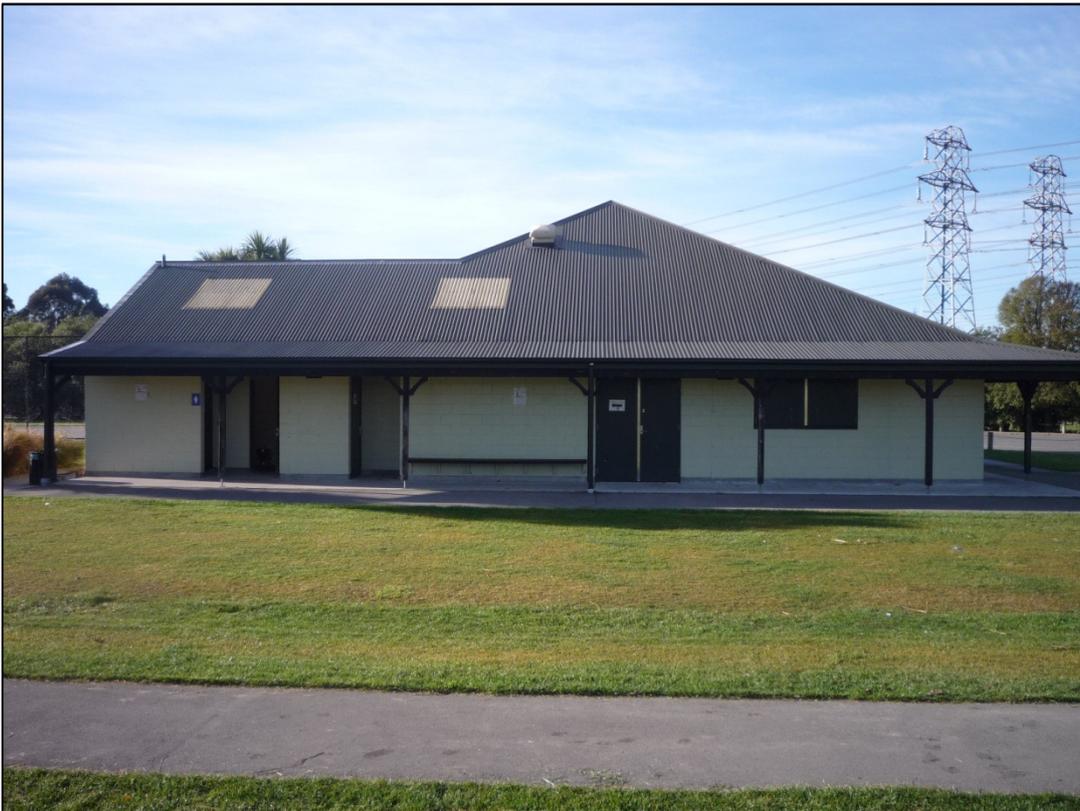
We observed minor cracks on the bottom northern wall and minor cracking of a lintel beam.

Photo 1: Northern wall.

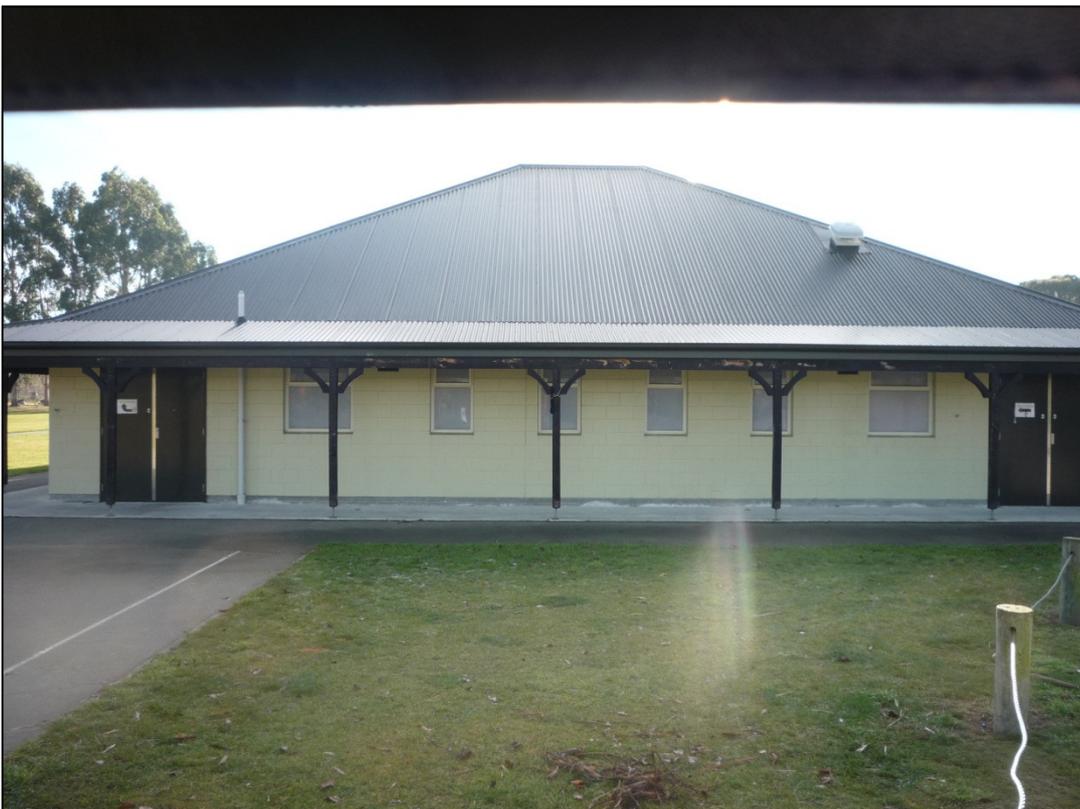
Photo 2: Western wall.

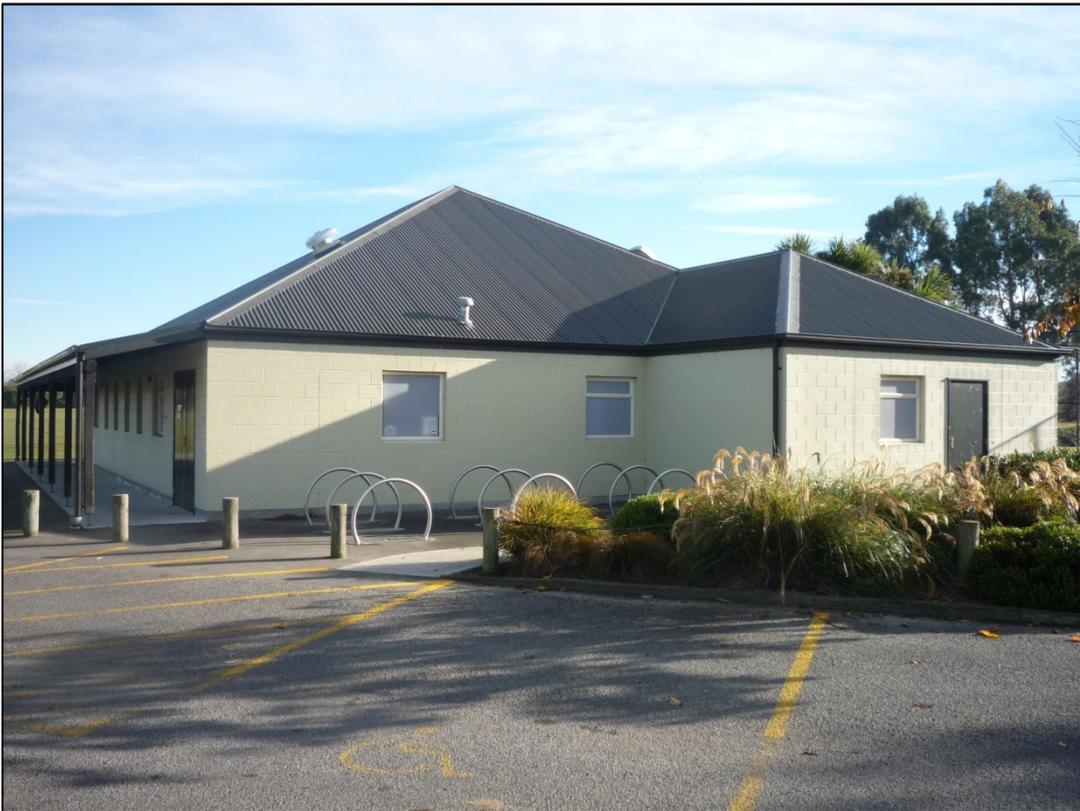
Photo 3: Southern wall.

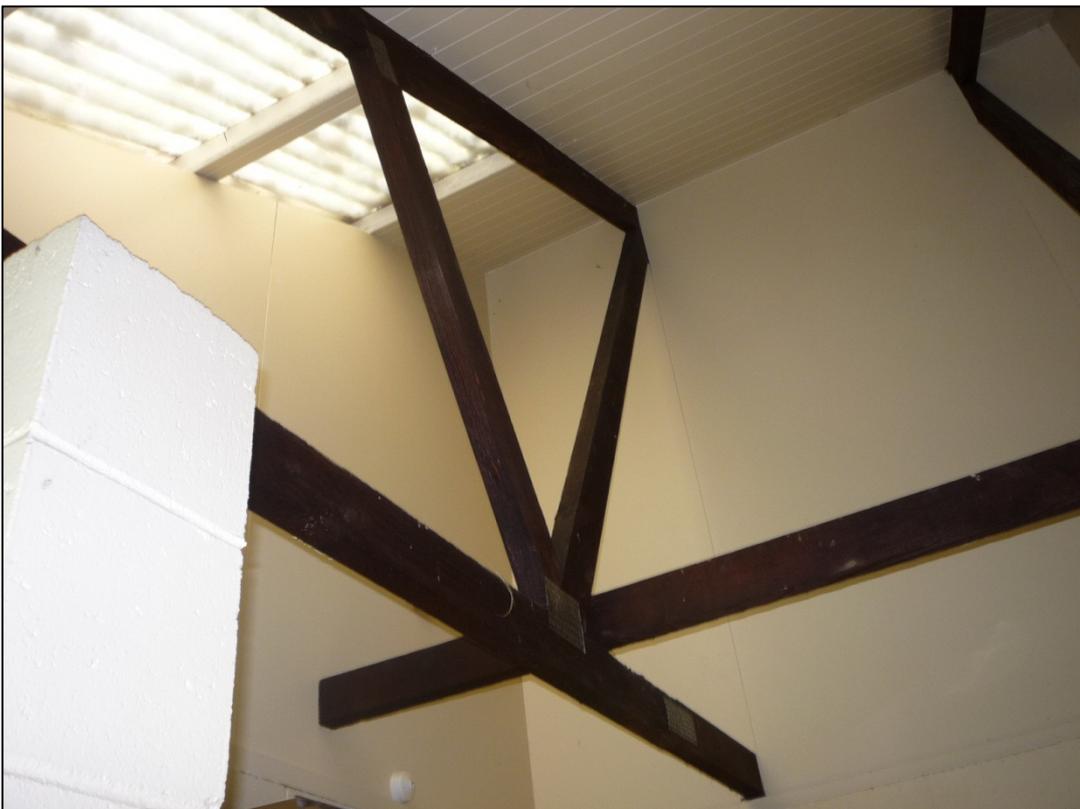
Based on the information available, and from undertaking a quantitative assessment, the building's original capacity has been assessed to be 20%NBS across the building and 20%NBS along the building, limited by the out-of-plane bending capacity of the masonry wall, due to the absence of a ceiling diaphragm.

Photo 4: Typical view of roof truss. Note no ceiling diaphragm.

Recommendations	Level of repair/strengthening required: minor structural	Describe: Install ceiling diaphragm or other restraint to top of wall
Building Consent required: yes	Interim occupancy recommendations: partial occupancy	Describe:
Along	Assessed %NBS before: 20%	Assessed %NBS after: ##### %NBS from IEP below
Assessed %NBS after:		If IEP not used, please detail assessment methodology: Quantitative
Across	Assessed %NBS before: 20%	Assessed %NBS after: ##### %NBS from IEP below

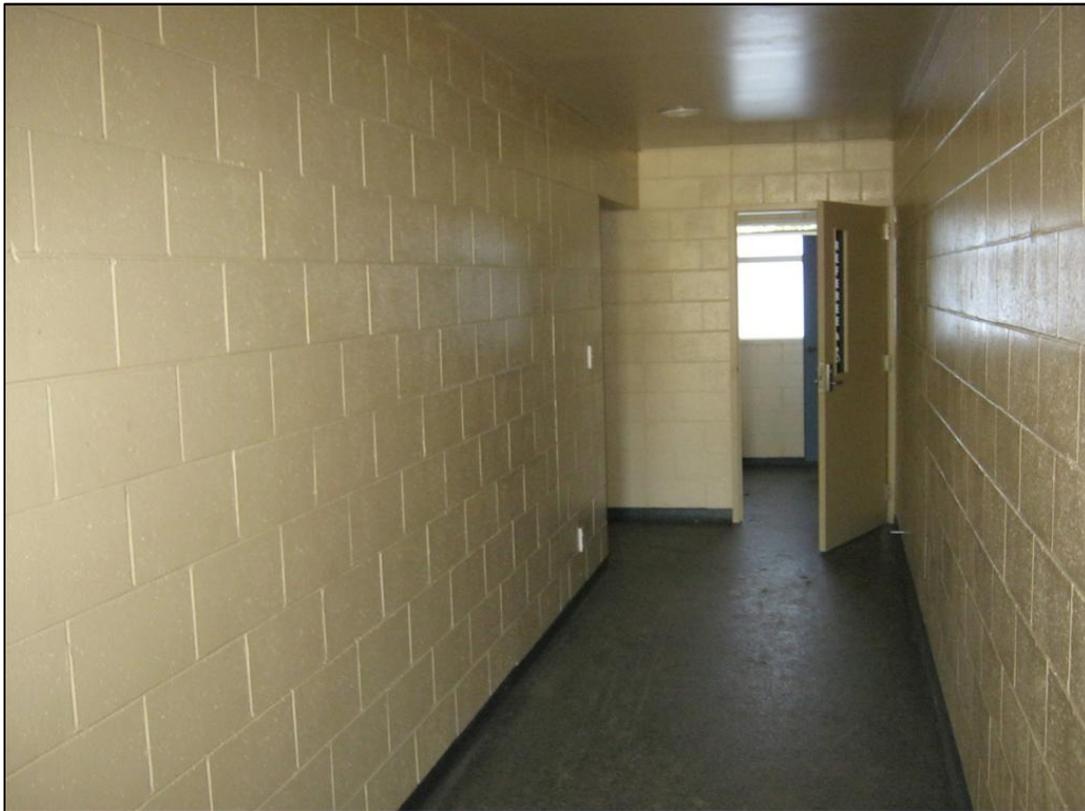
Photo 5: Typical view of internal walls.

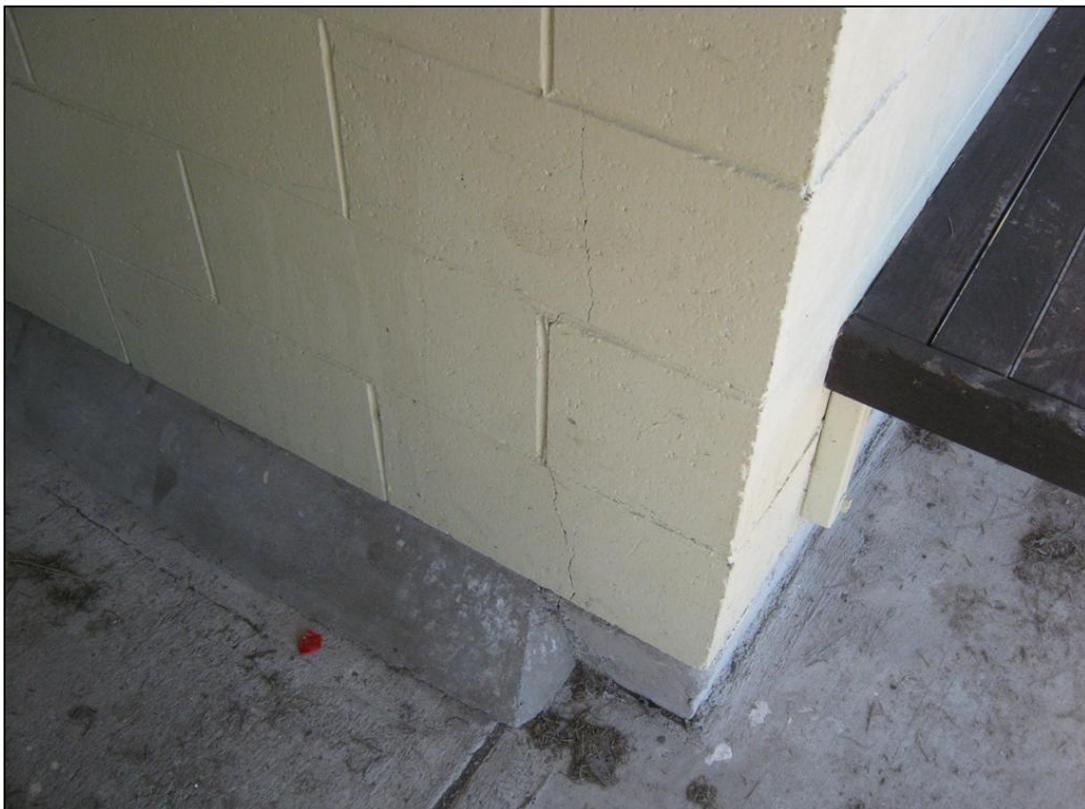
Photo 6: Crack on masonry wall.

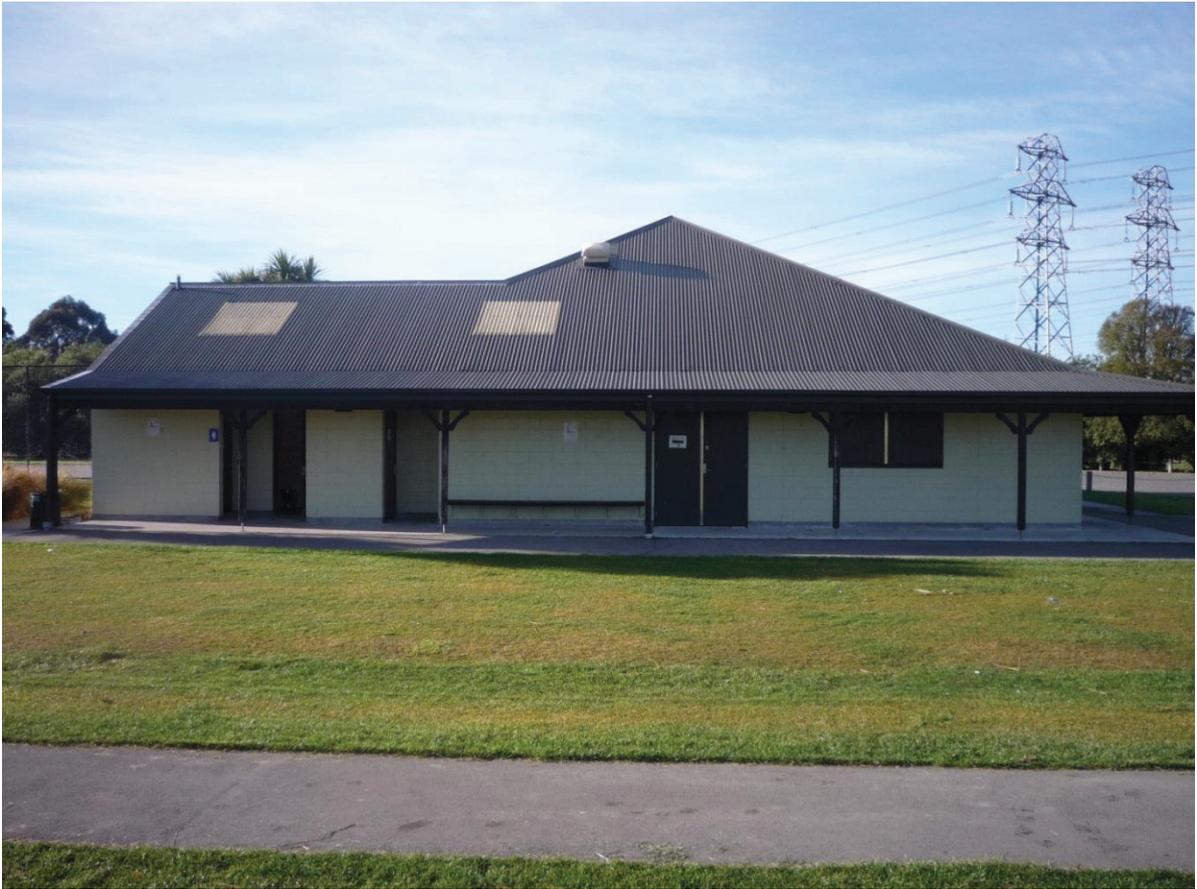
Figure 1: West elevation of the Avonhead Park Pavilion.

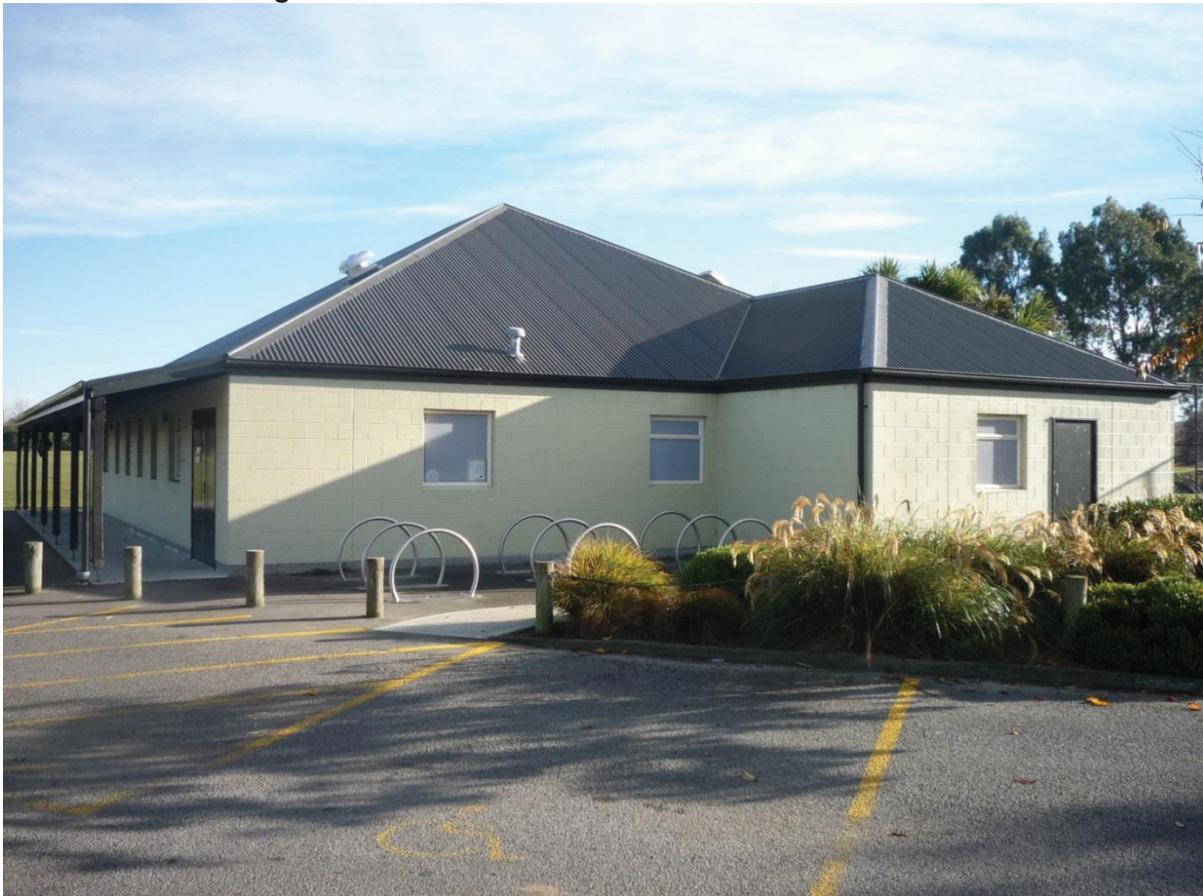
Figure 2: East elevation of the Avonhead Park Pavilion.
