Awa-iti Domain Garage 007
PRK 3746 BLDG 007
Detailed Engineering Evaluation
Quantitative Report
Version FINAL

4313 Christchurch Akaroa Road,
Little River.

Christchurch City Council

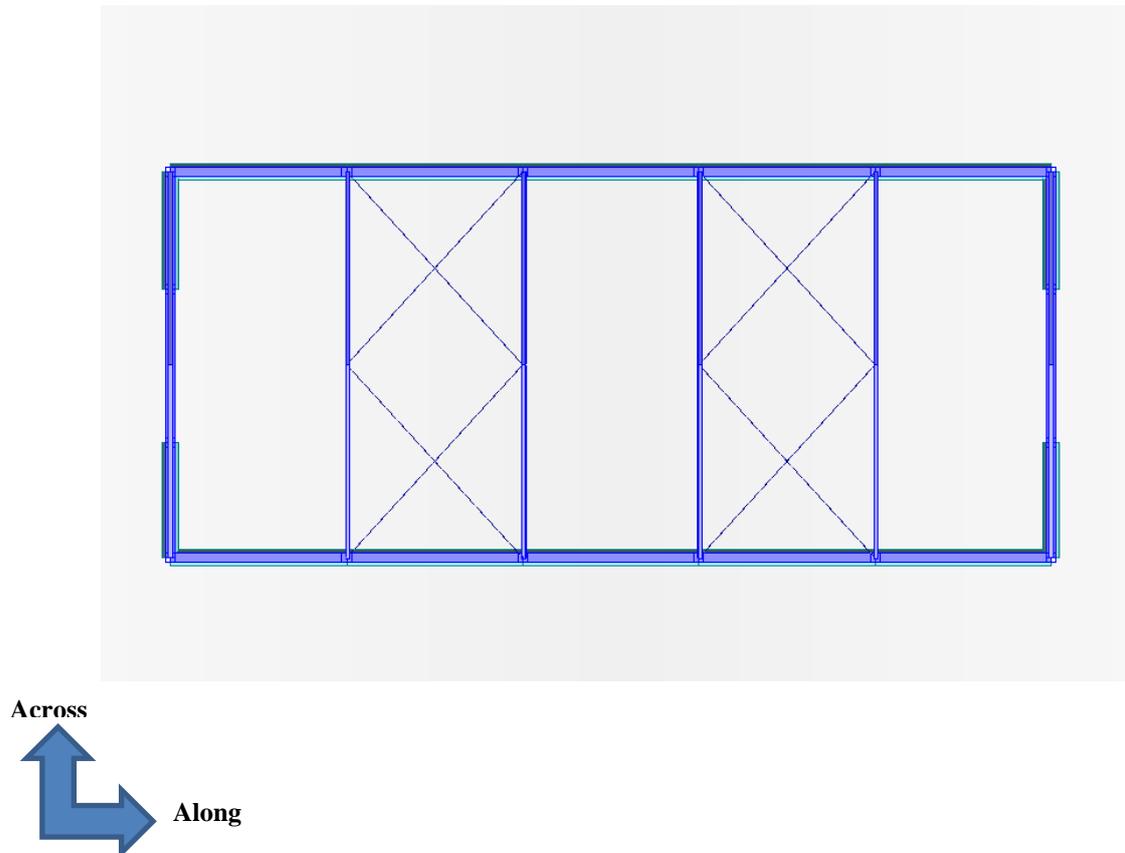
Figure 2 Plan sketch showing key structural elements

The building is a single storey concrete framed structure on a concrete slab with perimeter thickening. The roof is pitched up to a central longitudinal ridge and consists of lightweight metal cladding fixed to timber purlins. The purlins are fixed to the equal angle steel trusses which are supported by load bearing reinforced concrete columns. There is unreinforced concrete masonry infill panels between the reinforced concrete framing elements.

The building dimensions are approximately 18.2 m long by 8.4 m wide with an approximate total floor area of 153 m². The overall height of the building is 4 m with masonry wall heights of 2.4 m.

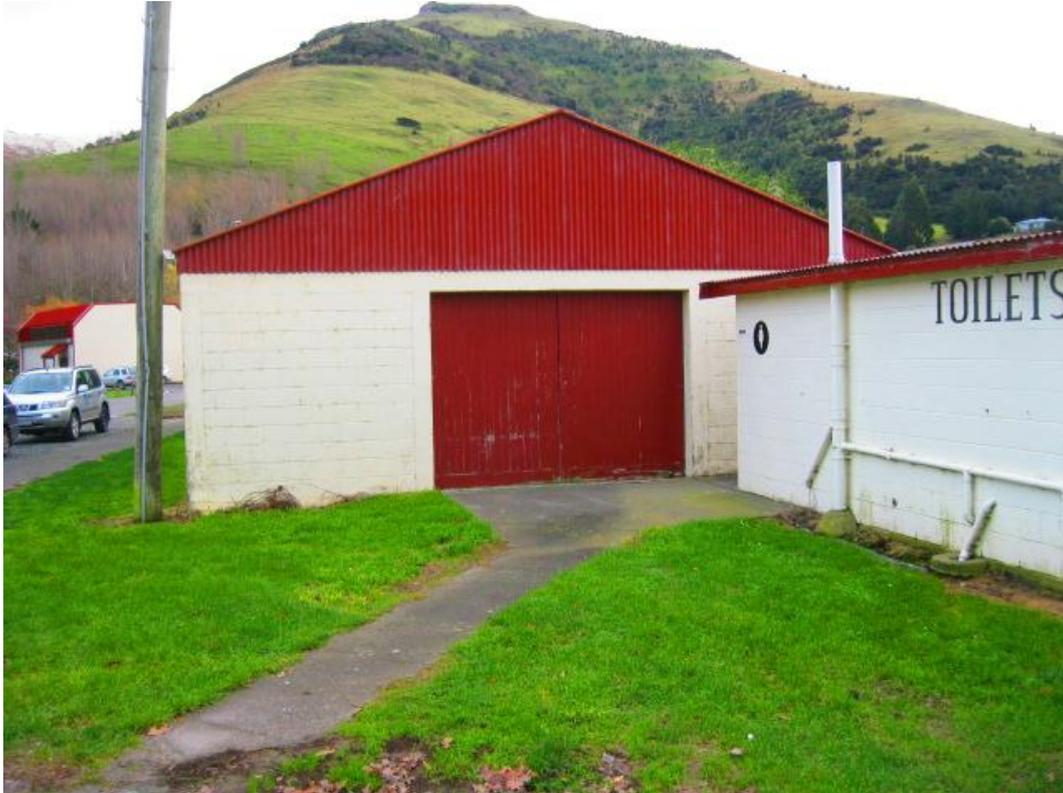
Photograph 1 Transverse gable wall

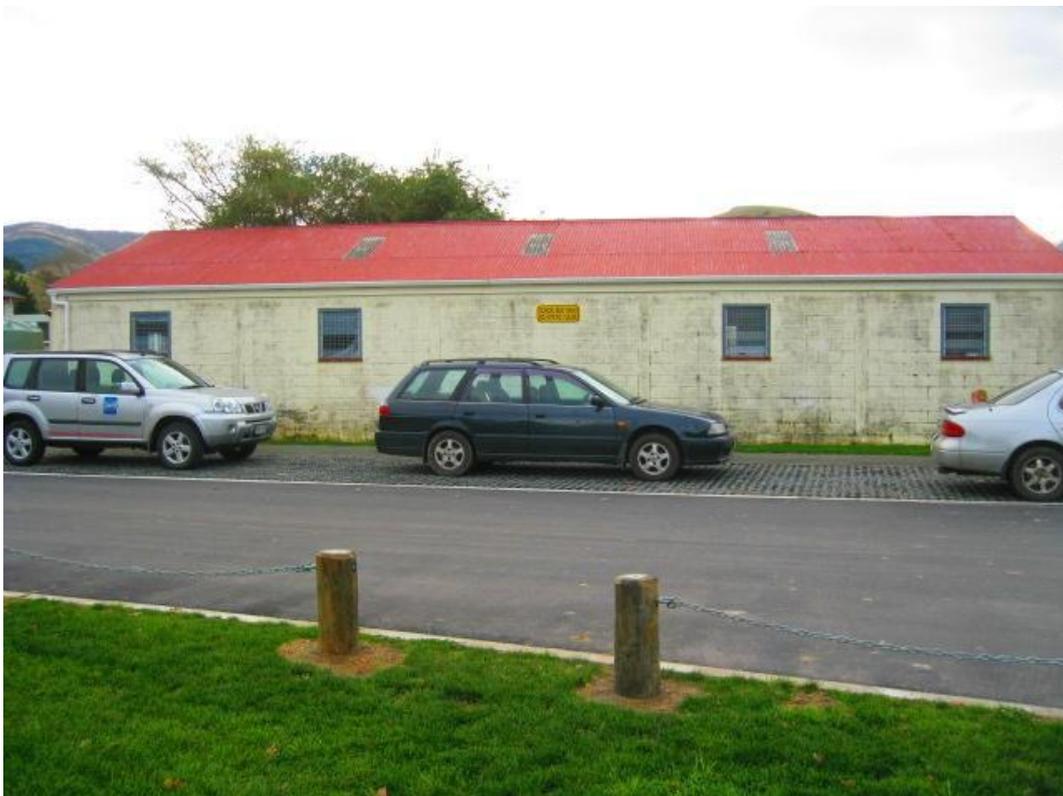
Photograph 2 Longitudinal wall

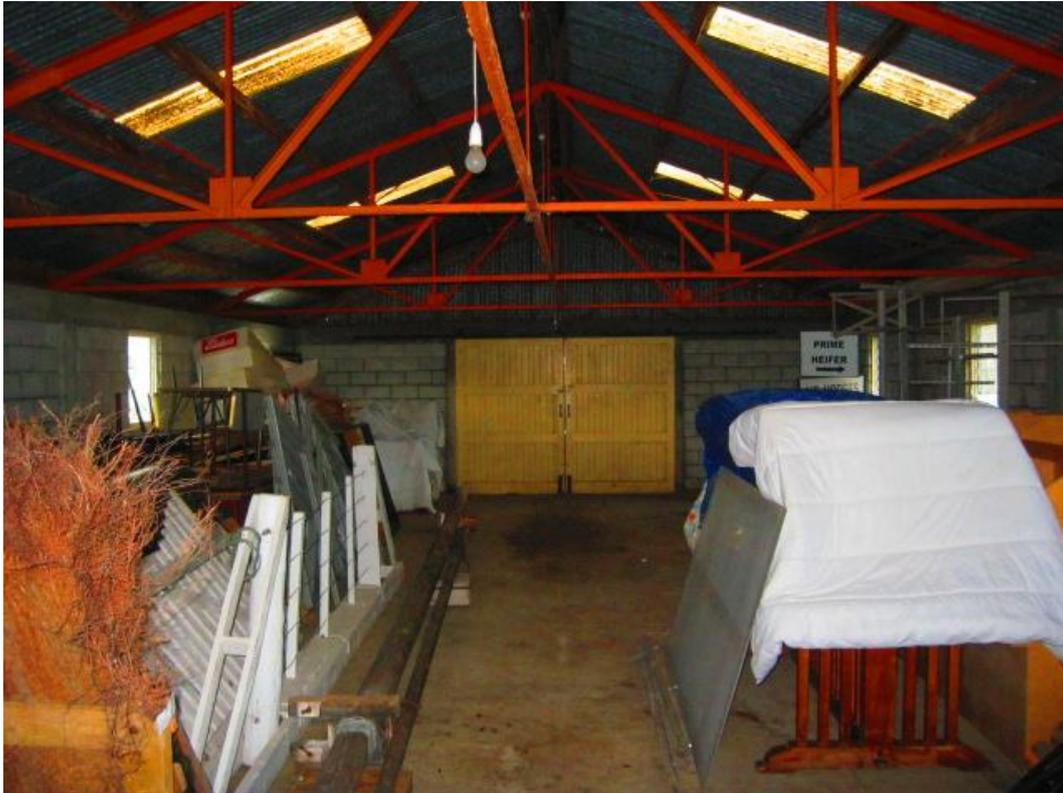
Photograph 3 Internal view showing eastern gable

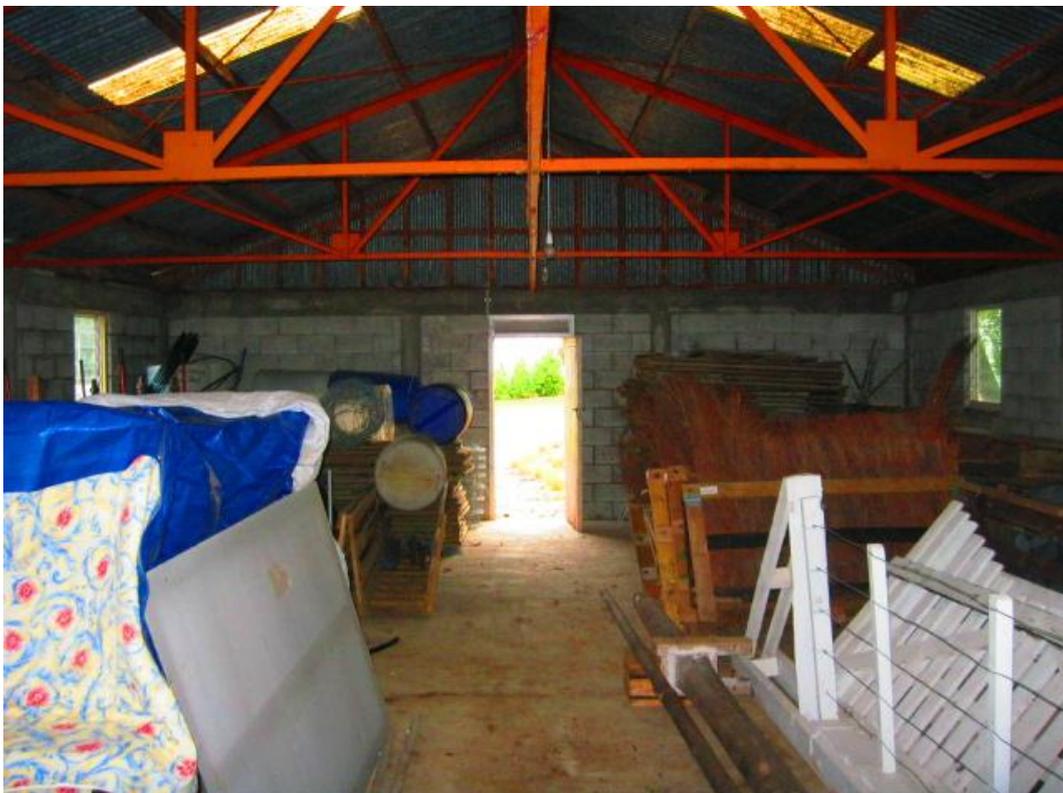
Photograph 4 Internal view showing western gable

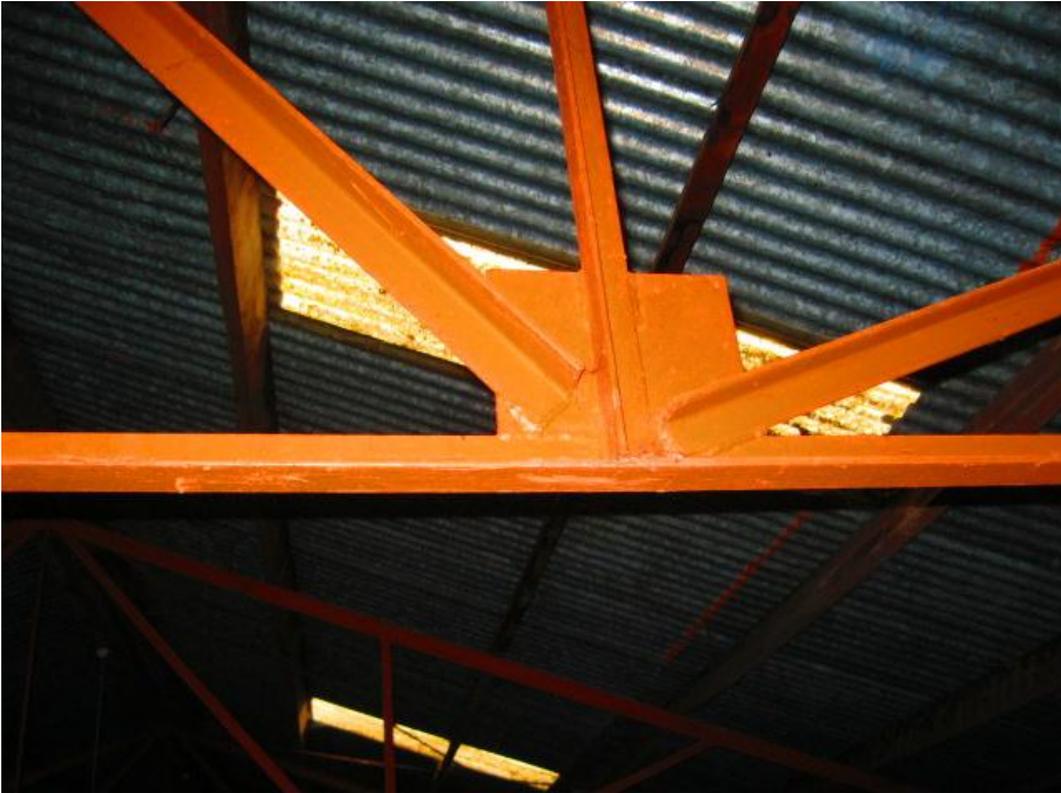
Photograph 5 Typical of roof truss connections

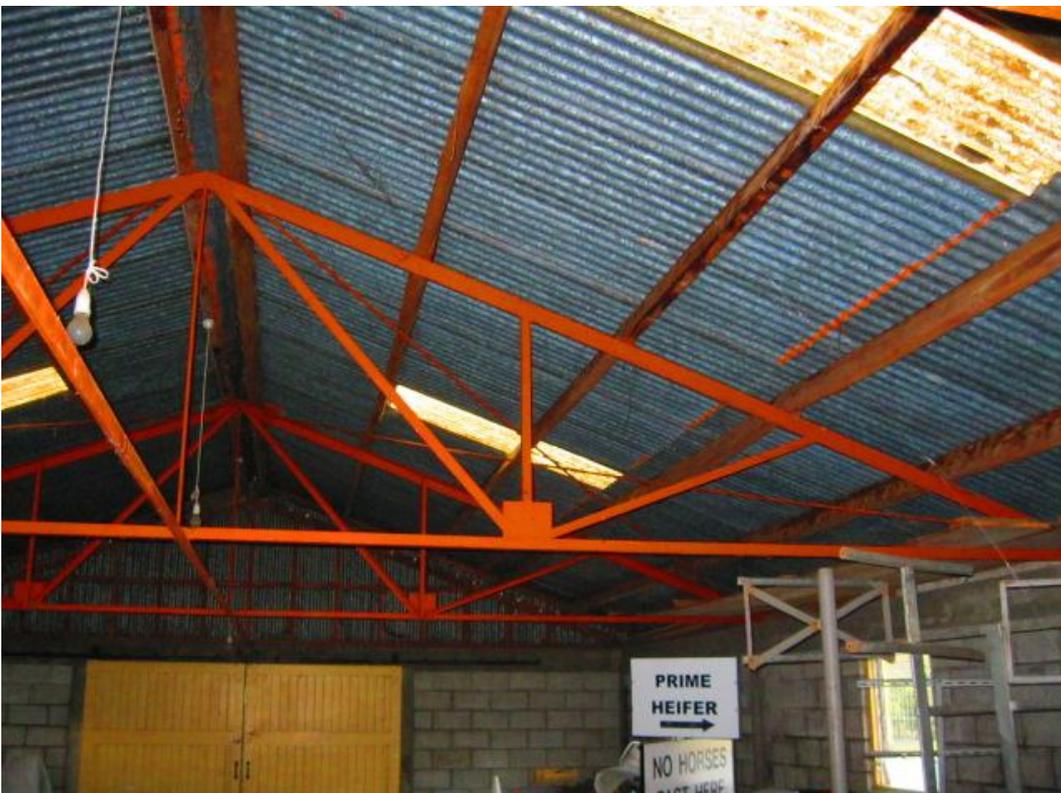
Photograph 6 Steel roof cross bracing visible in roof space
