Awa-iti Domain Shed 005
PRK 3746 BLDG 005
Detailed Engineering Evaluation
Quantitative Report
Version FINAL

4313 Christchurch Akaroa Road,
Little River.

Christchurch City Council

Date
26/9/13

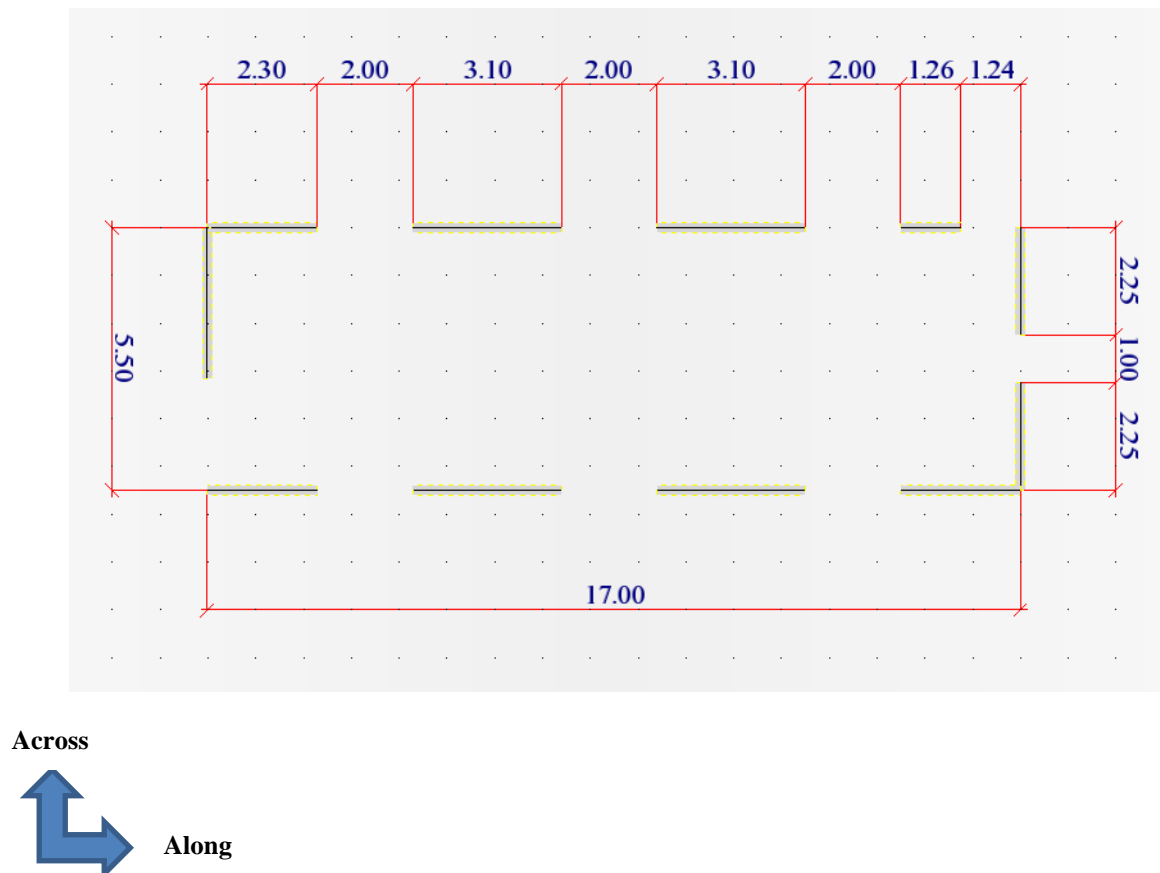
Figure 2 Plan sketch showing key structural elements

Lateral loads acting on the structure in both the long and short directions of the building are resisted by timber framed, particleboard lined walls. Lateral forces acting on the roof structure are distributed to the walls through diaphragm action of the lined ceiling. The walls are distributed around the perimeter of the building in both the long and short directions. The walls then transfer the lateral loads to the perimeter foundations.

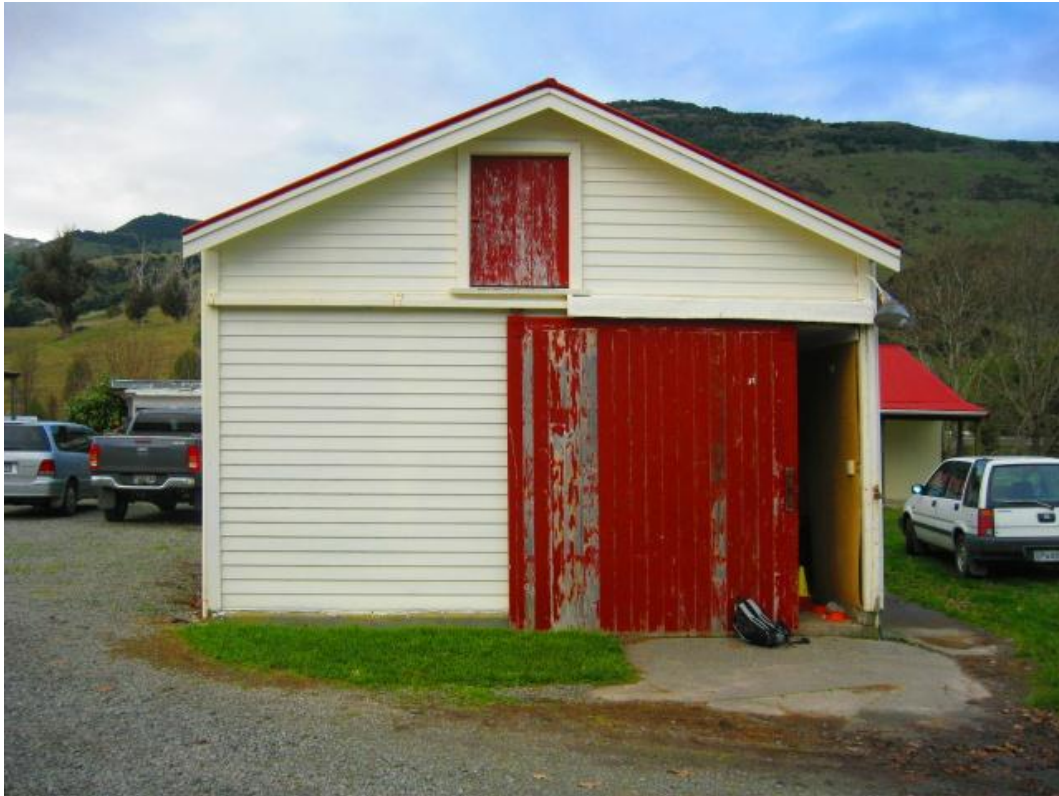
Photograph 1 Transverse gable wall

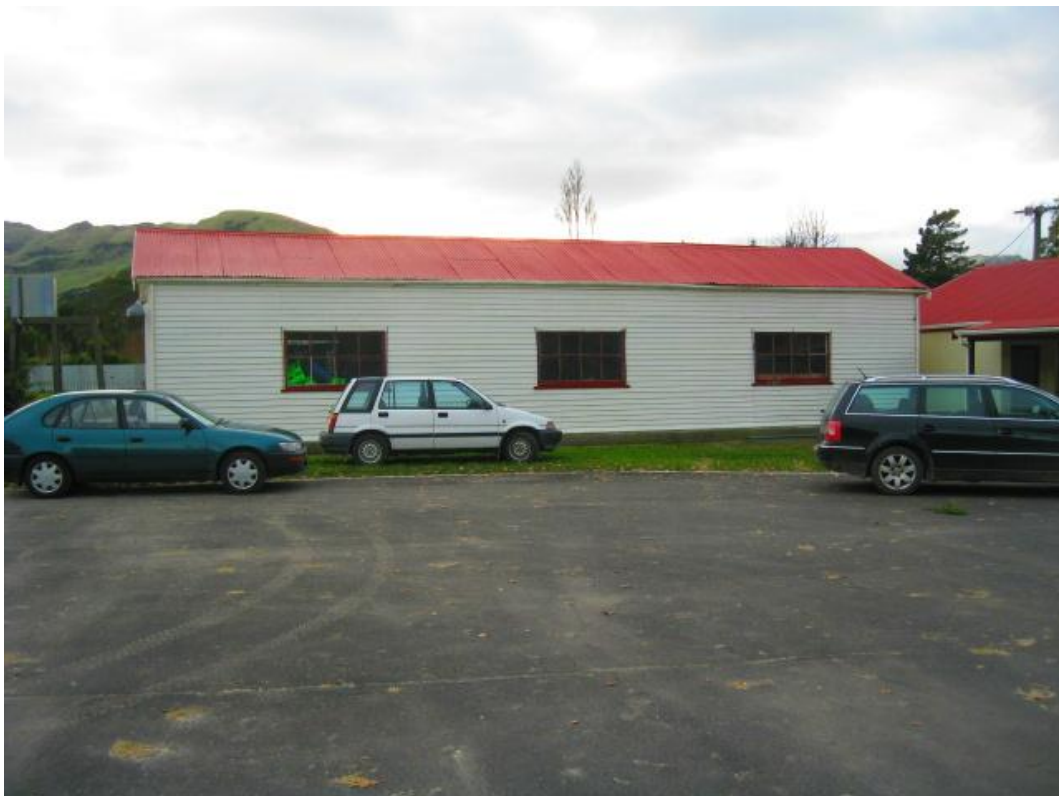
Photograph 2 Longitudinal wall

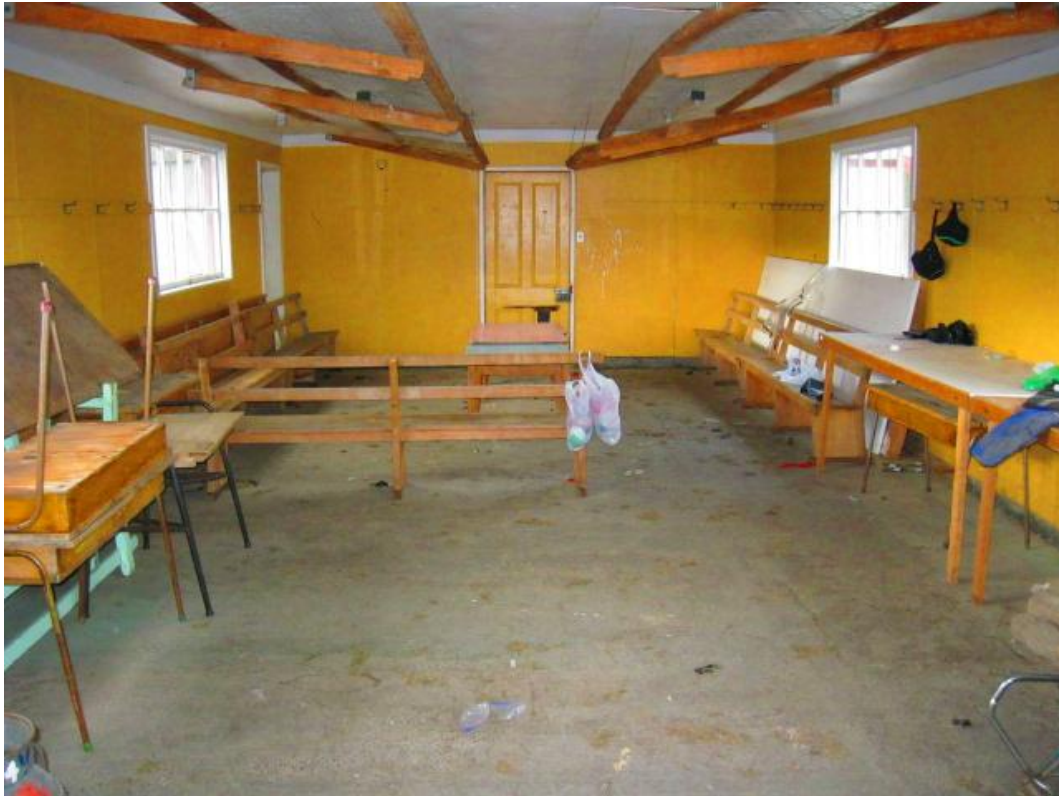
Photograph 3 Internal view showing eastern gable

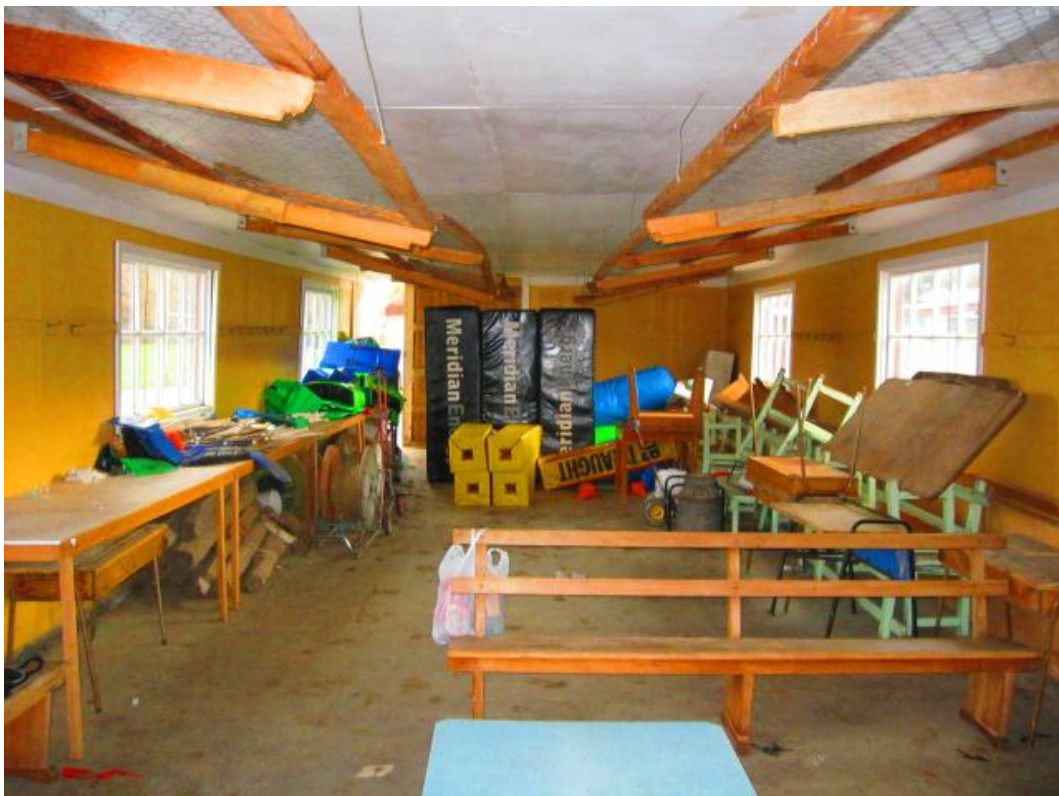
Photograph 4 Internal view showing western gable

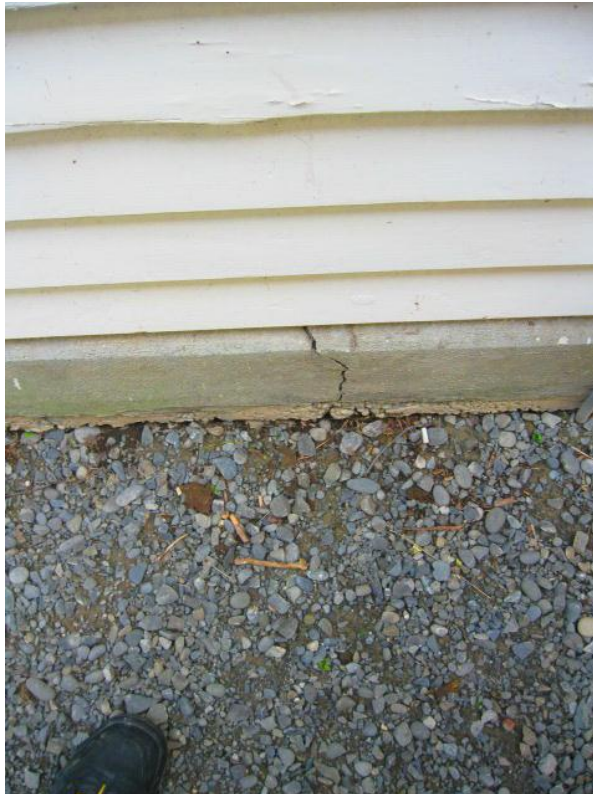
Cracking was noted at several locations on the building's perimeter foundation. Several of the cracks penetrate through the concrete foundation.

Photograph 5 Typical of cracking to the foundations

Furthermore, repair work should be carried out on all cracking observed in the perimeter foundations of the building.

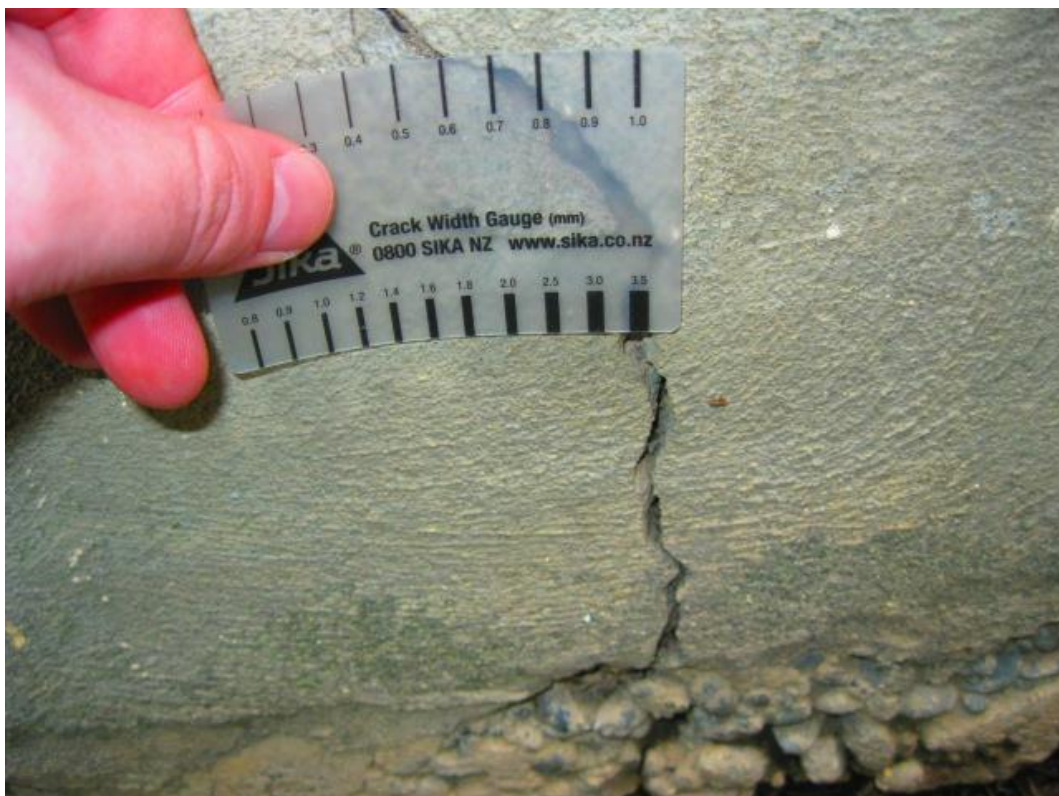
Photograph 6 Crack width is greater than 3.5 mm
