Biddick Courts BE 0707 EQ2

**Detailed Engineering Evaluation
Quantitative Assessment Report**

**14 Claydon Place, Dallington
Christchurch**

Date: August 2015
Reference: 6-QUCC1.98
Status: Final – R1

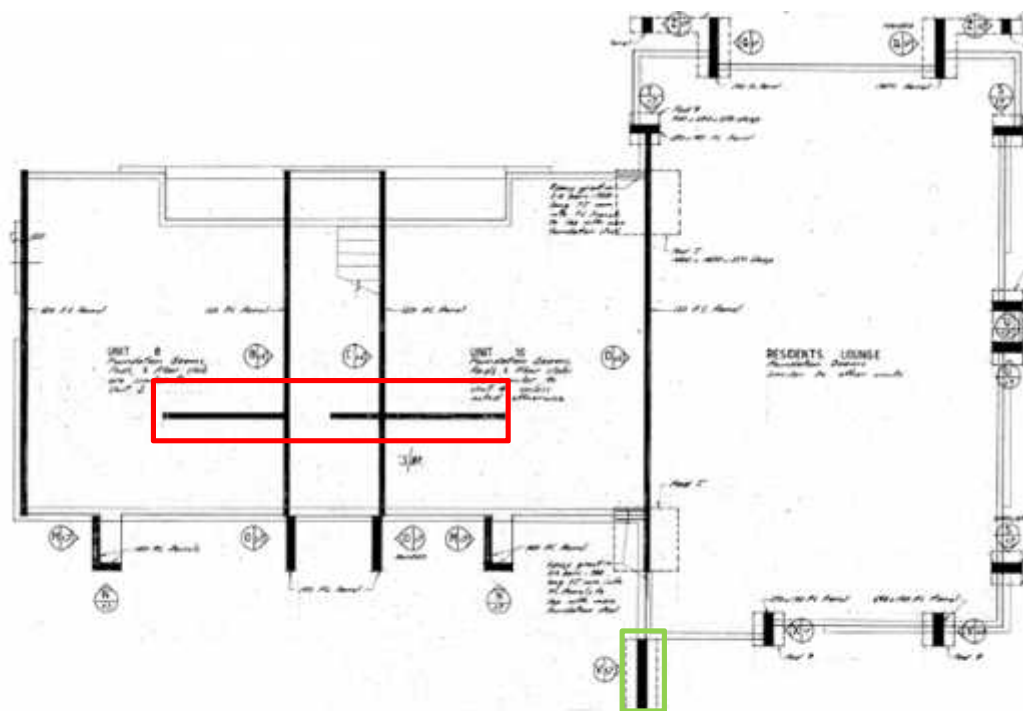
Figure 7 - Locations of strengthening brackets (red rectangle) and replaced wall (green rectangle) in Block B.

The purpose of this scheme was to improve the %NBS of the structure to above 33% NBS and remove the brittle failure mechanism in the concrete panels. The slopes on the floor have not been addressed so the strengthening is considered interim.

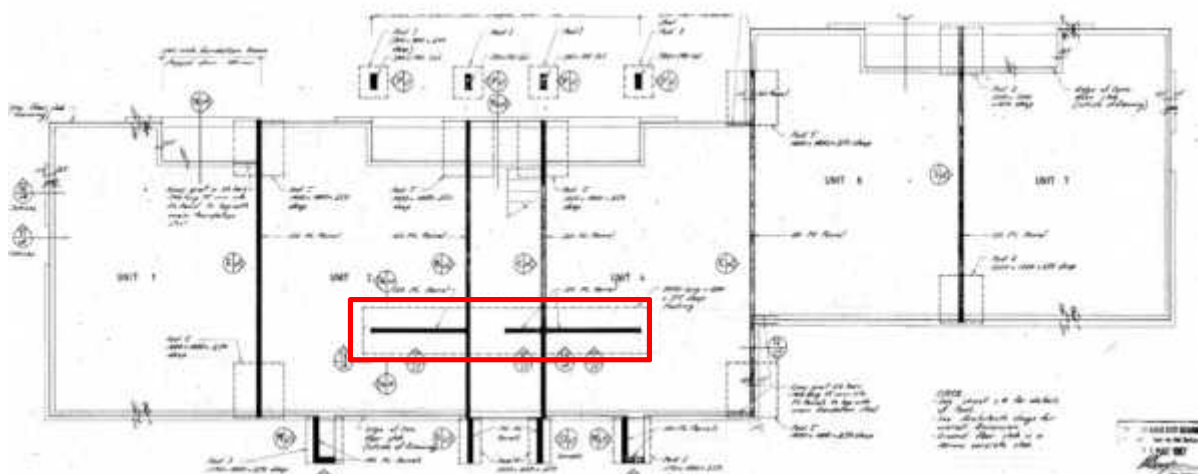
Figure 8 - Locations of strengthening brackets (red rectangle) in Block A.

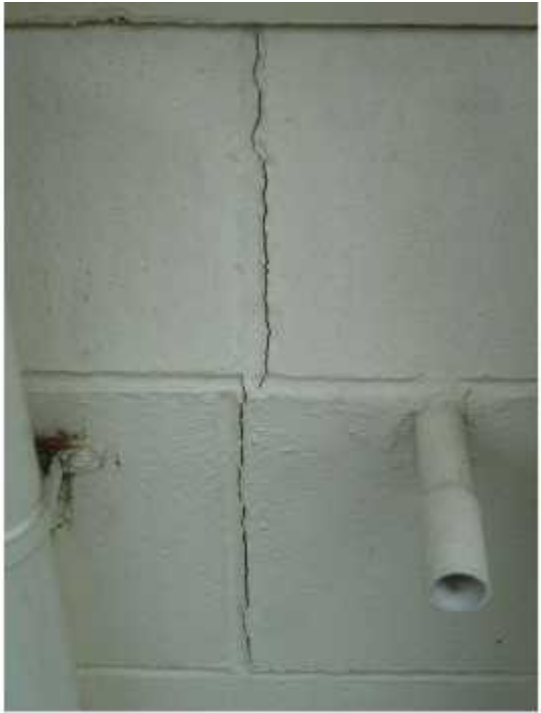
7	Cracking at unit 6

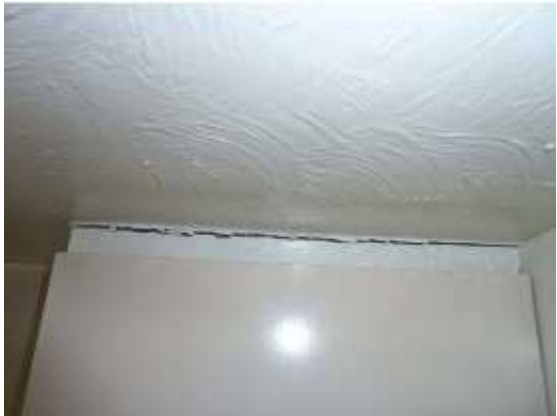
8	Cracking inside unit 6

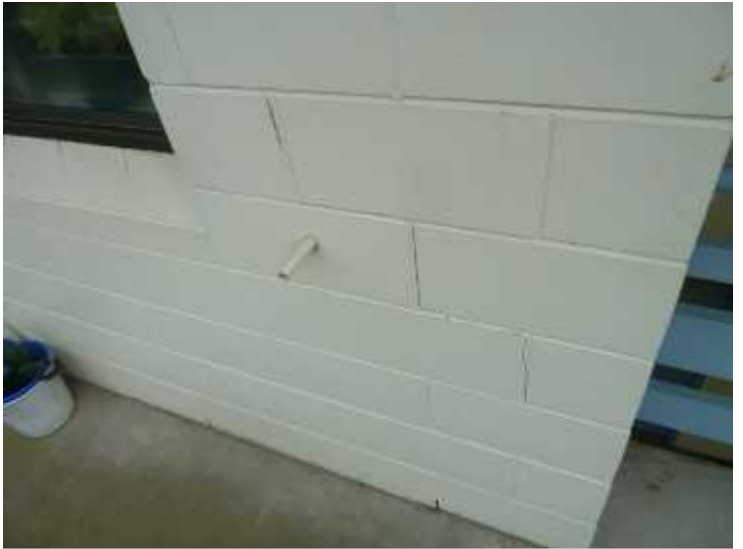
5	Cracking at unit 8

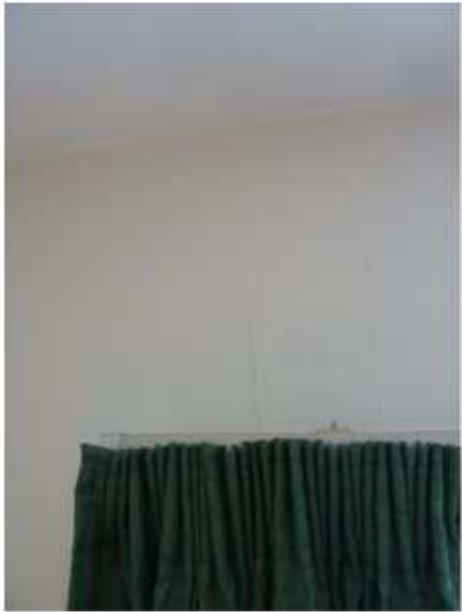
6	Cracking in unit 8

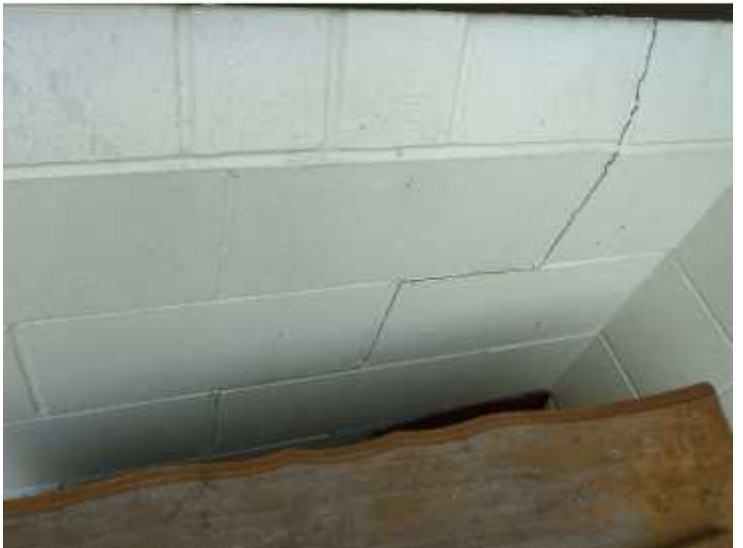
7	Cracking at unit 11

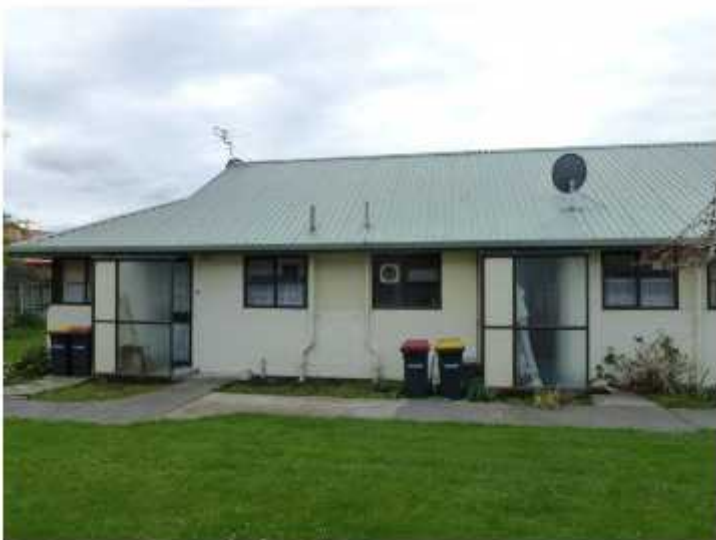
3	Cracking at unit 12

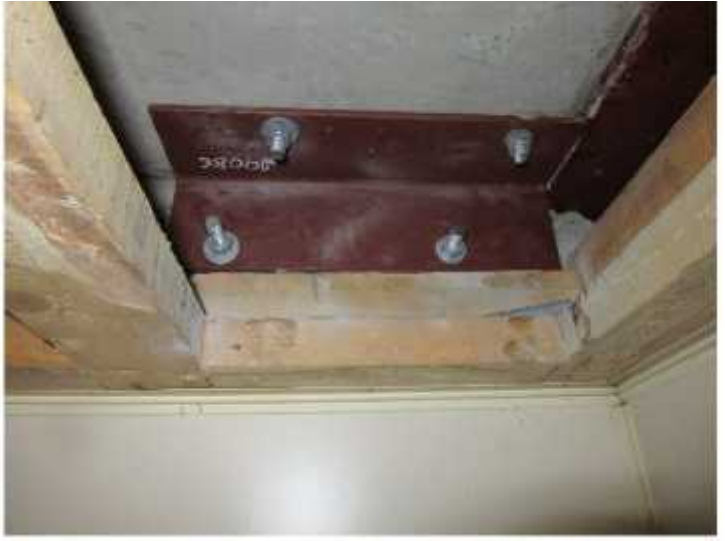
Interim Strengthening Scheme to Blocks A and B and Wall Replacement		
1	Brackets installed in bathroom ceilings.

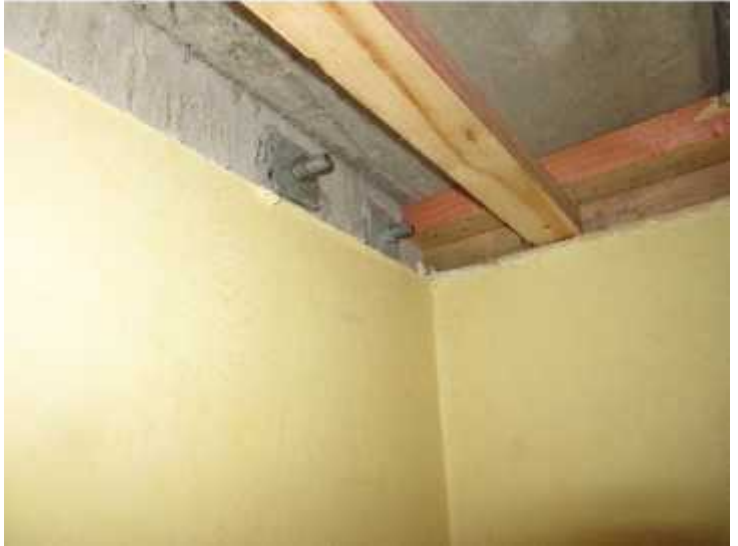
2	Reverse side of connections.

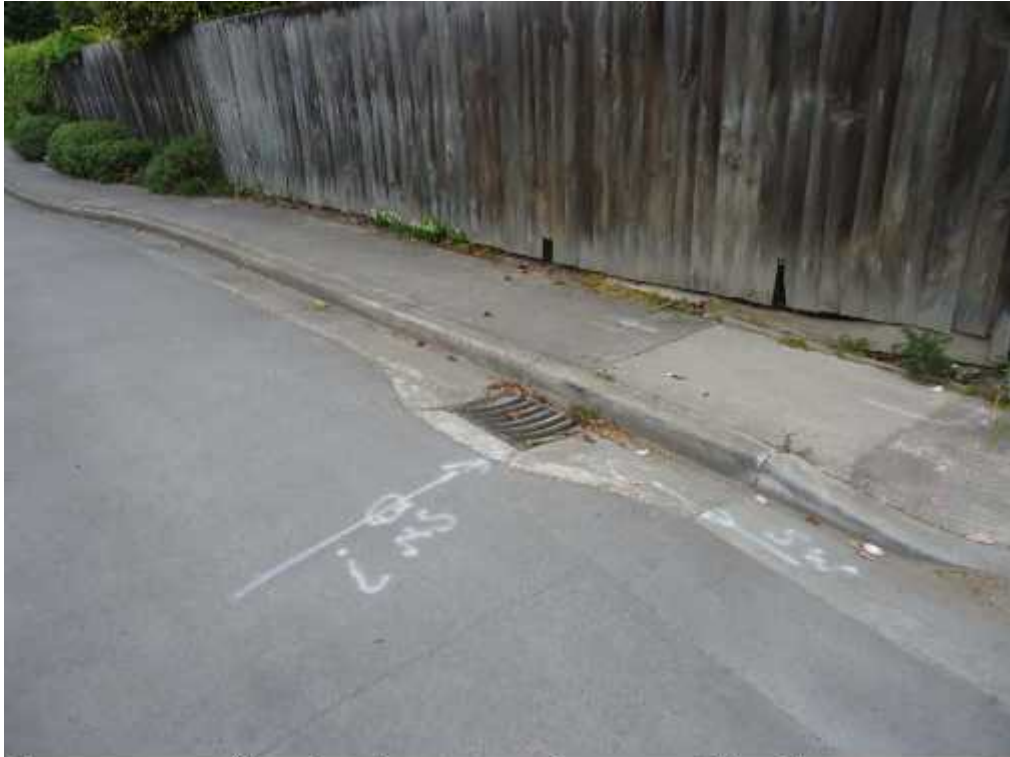
Figure 1: Up to 50 mm of heaving has occurred surrounding the storm water sewer in the entrance area.

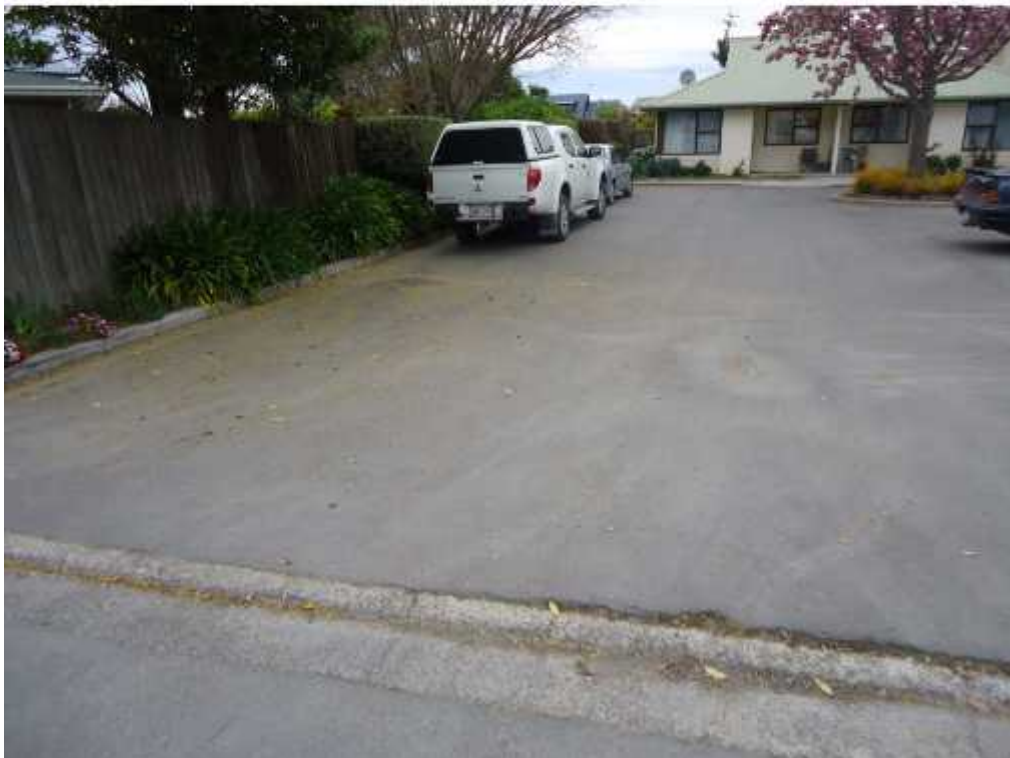
Figure 2: An area of the south car park (approximately 6.5 m X 7.0 m) has undergone heaving and settlement.

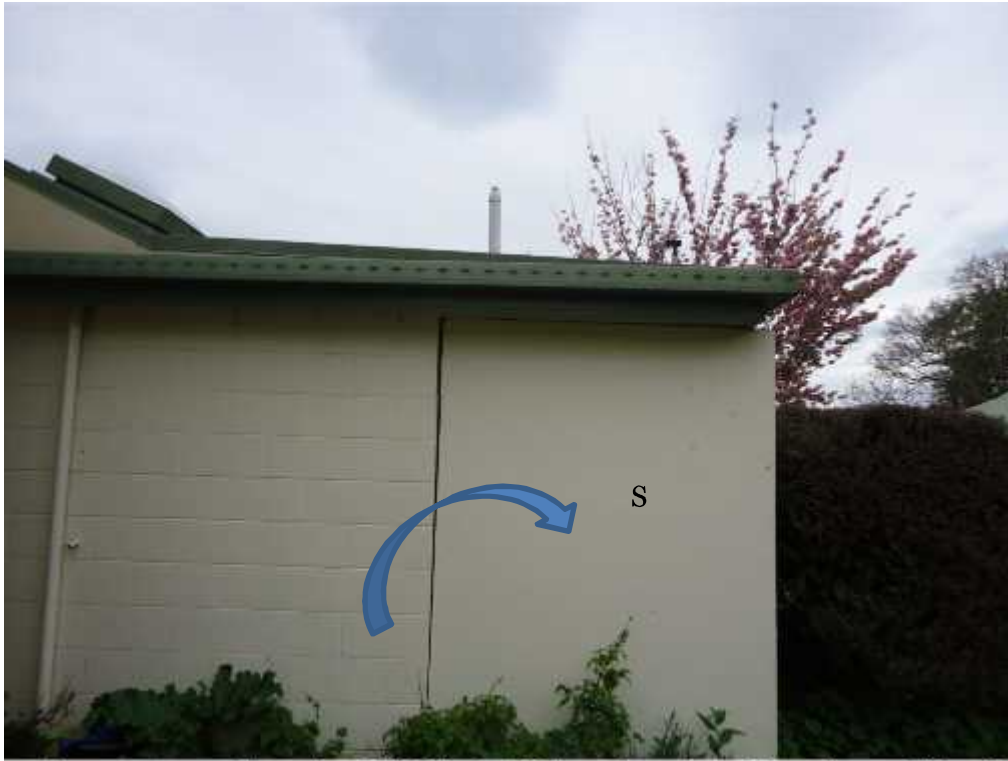
Figure 3: A 20mm crack at the Middle building that detaches the walling from the cladding.

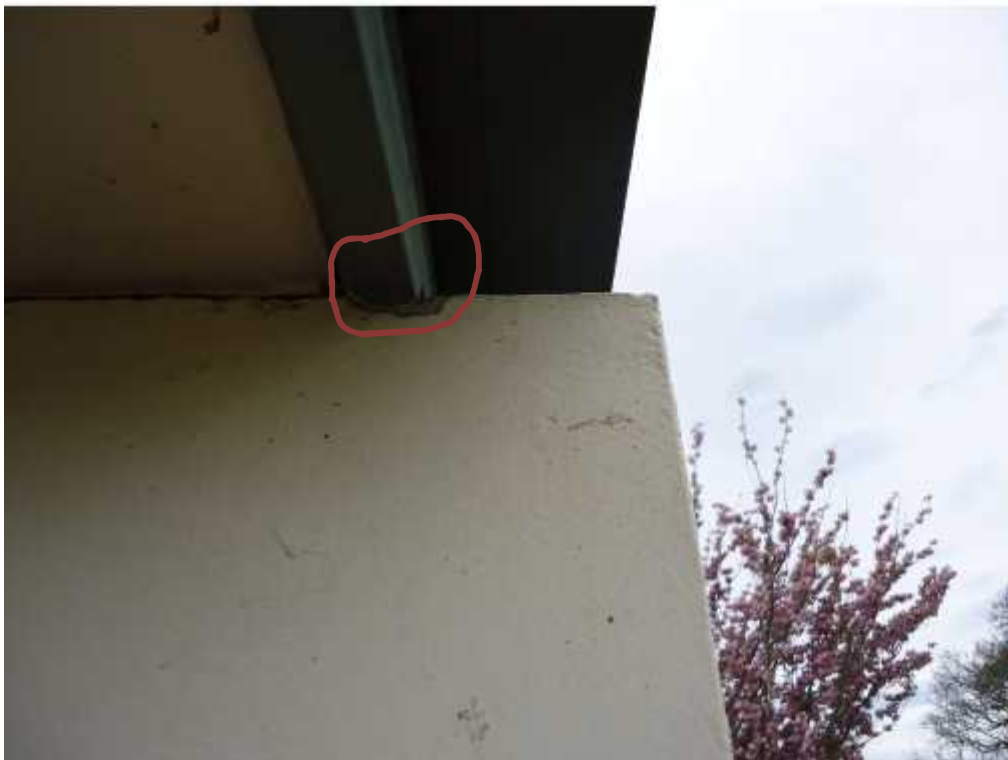
Figure 4: Adjacent panel to that shown in Figure 7, indicating similar movement.

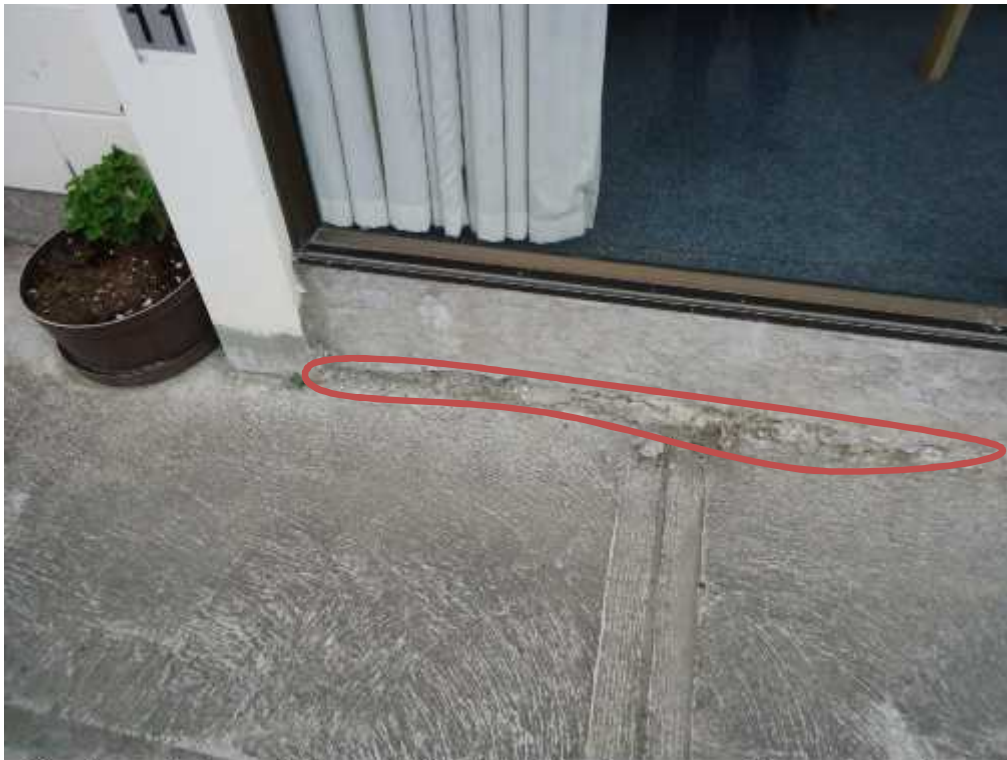
Figure 5: The foundation of the middle building is exposed by 70 mm from its initial position due to possible settlement of the surrounding ground. (Middle building, east side).

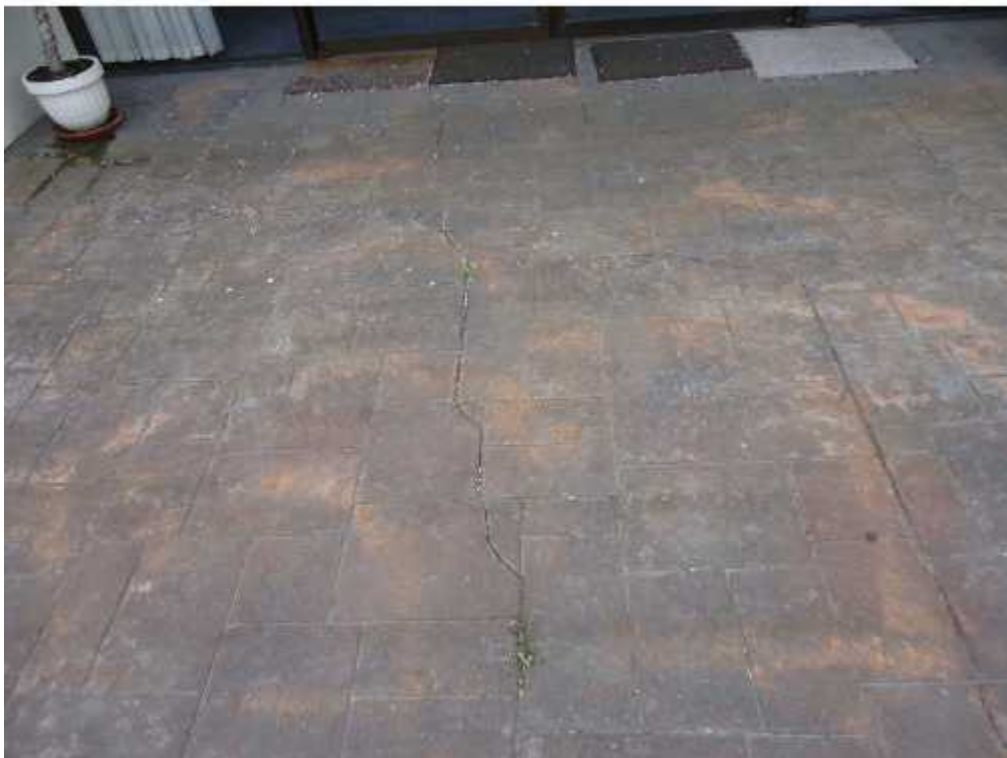
Figure 6: Longitudinal 5 mm wide cracks outside the residents' lounge, Middle building on stone paved entrance.

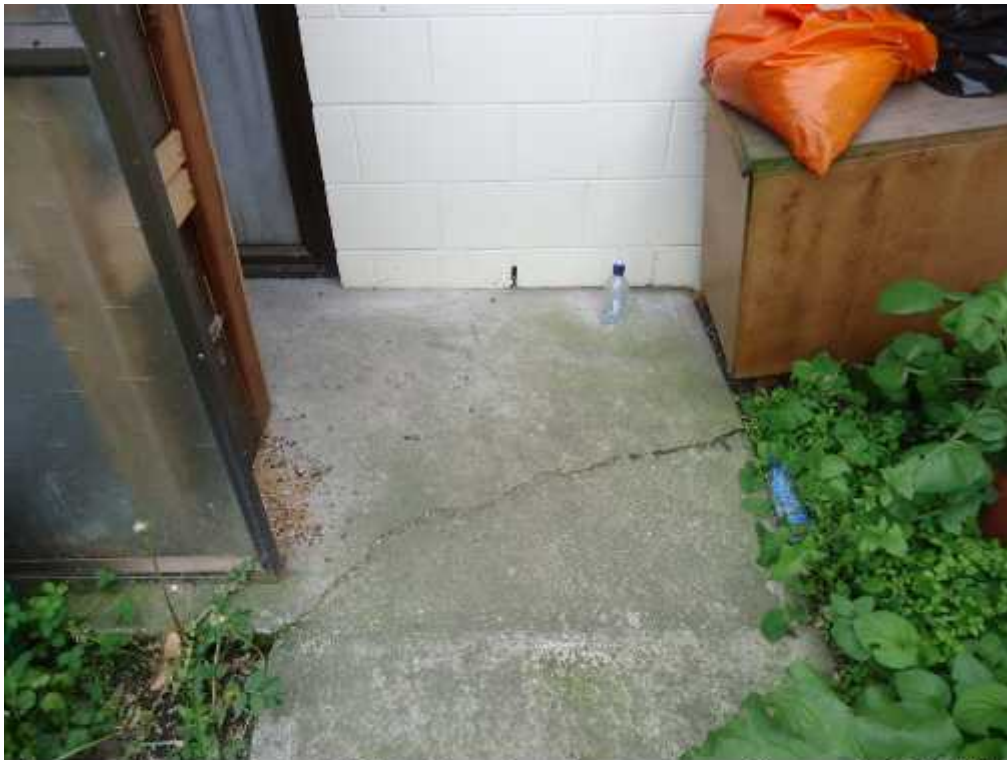
Figure 7: A 5 mm diagonal crack developed at the concrete footpath, Middle building. There are no signs of damage on the cladding.

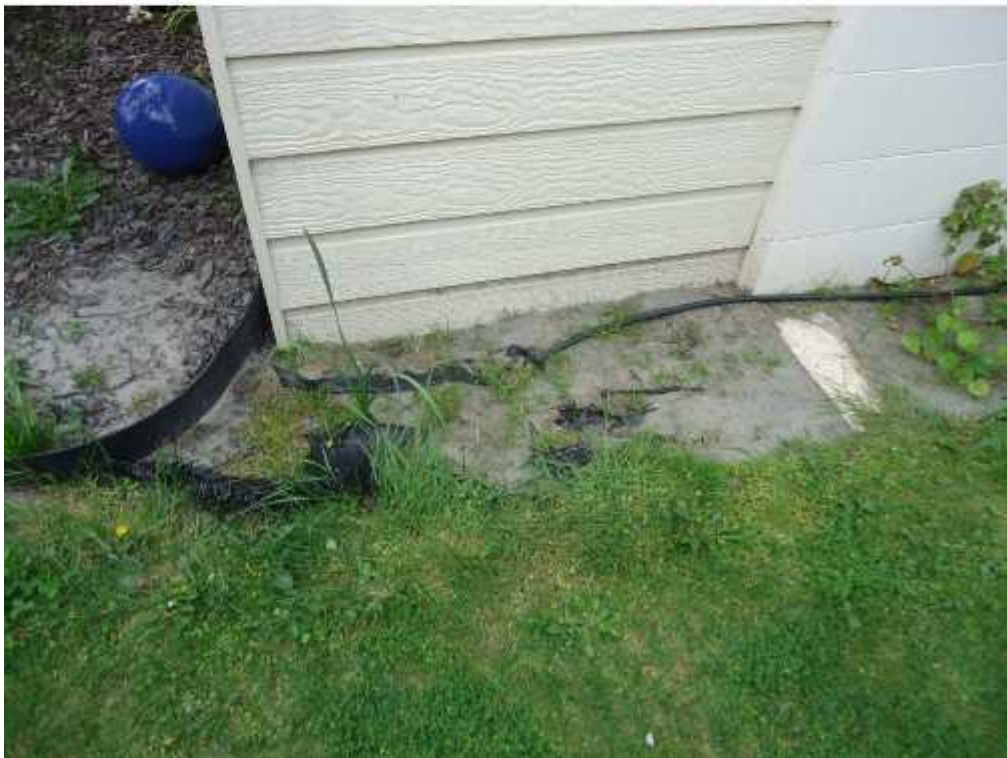
Figure 8: Liquefied material ejected (grey silt with some fine sand) from sand boils that surrounded the Middle building.

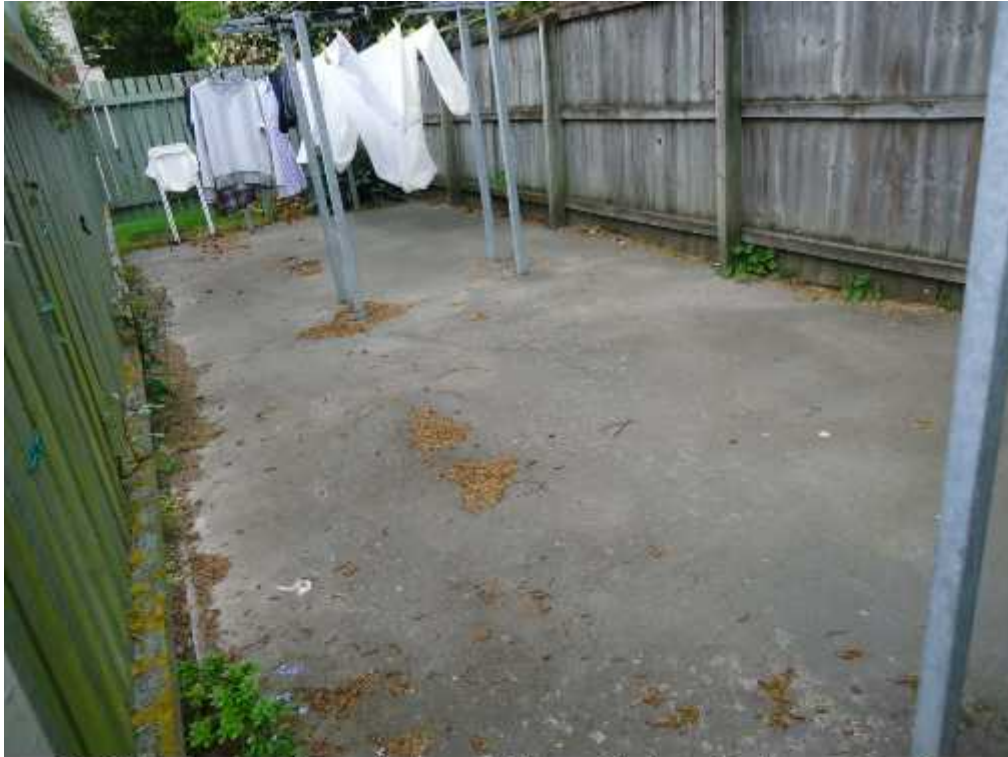
Figure 9: Undulating surface of the residents clothes drying areas. Some minor cracking up to 5 mm wide.

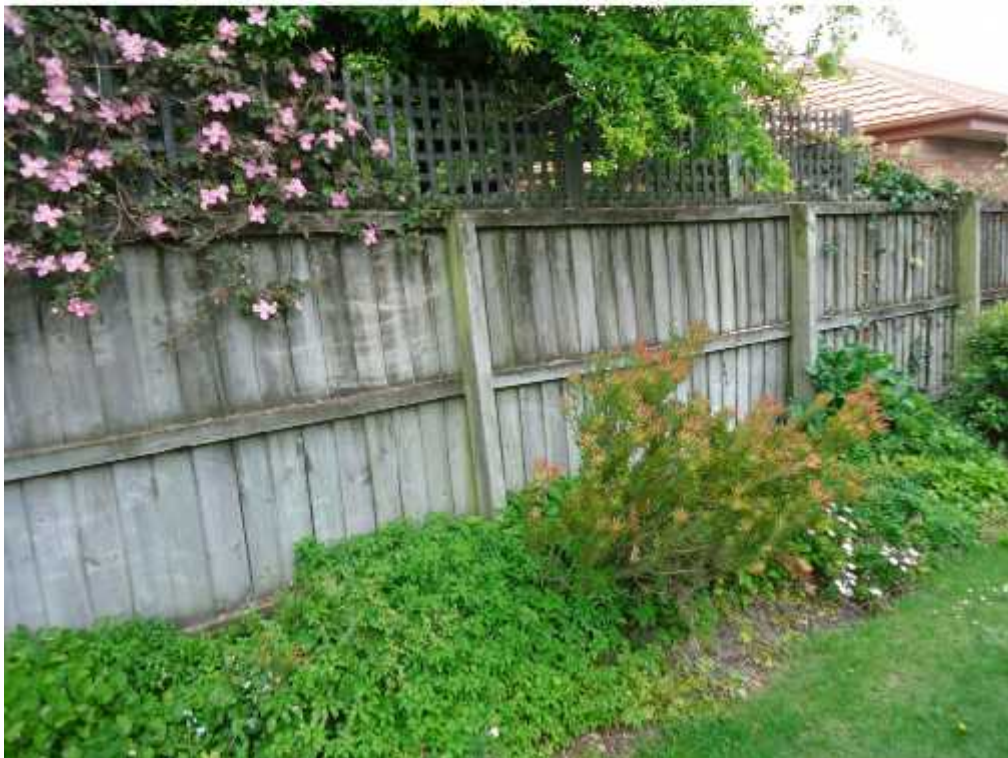
Figure 10: A wooden fence at the West side of Biddick Courts that leans outwards towards the adjacent property. The tilt is estimated as 10°.

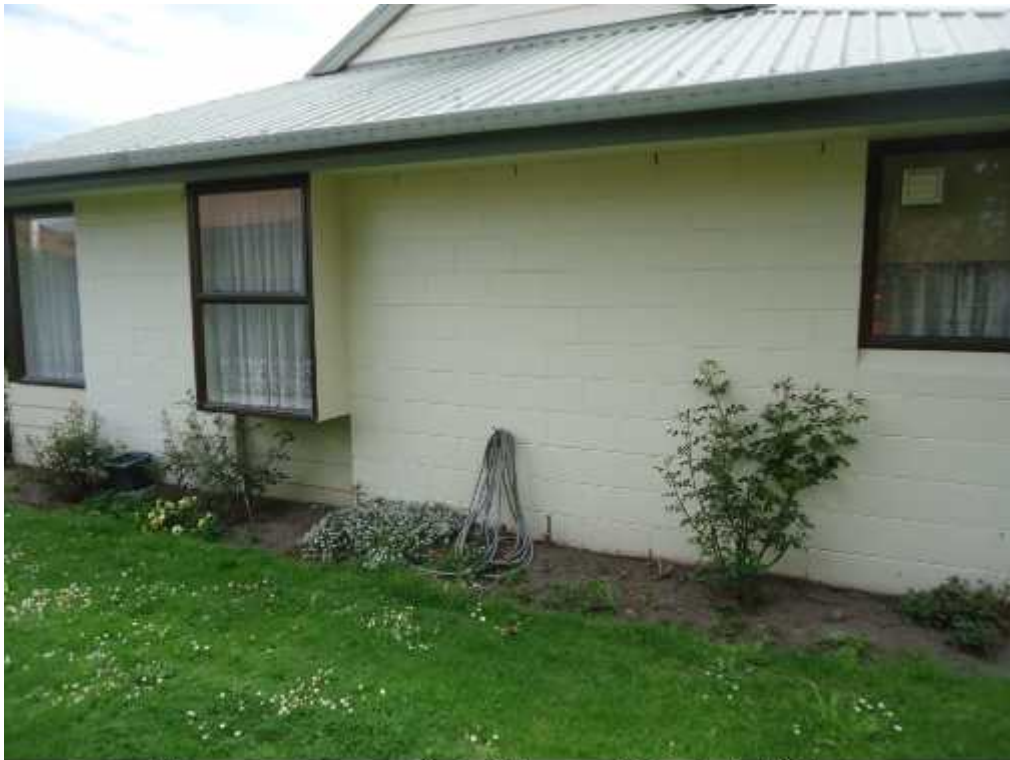
Figure 11: External claddings of North building.

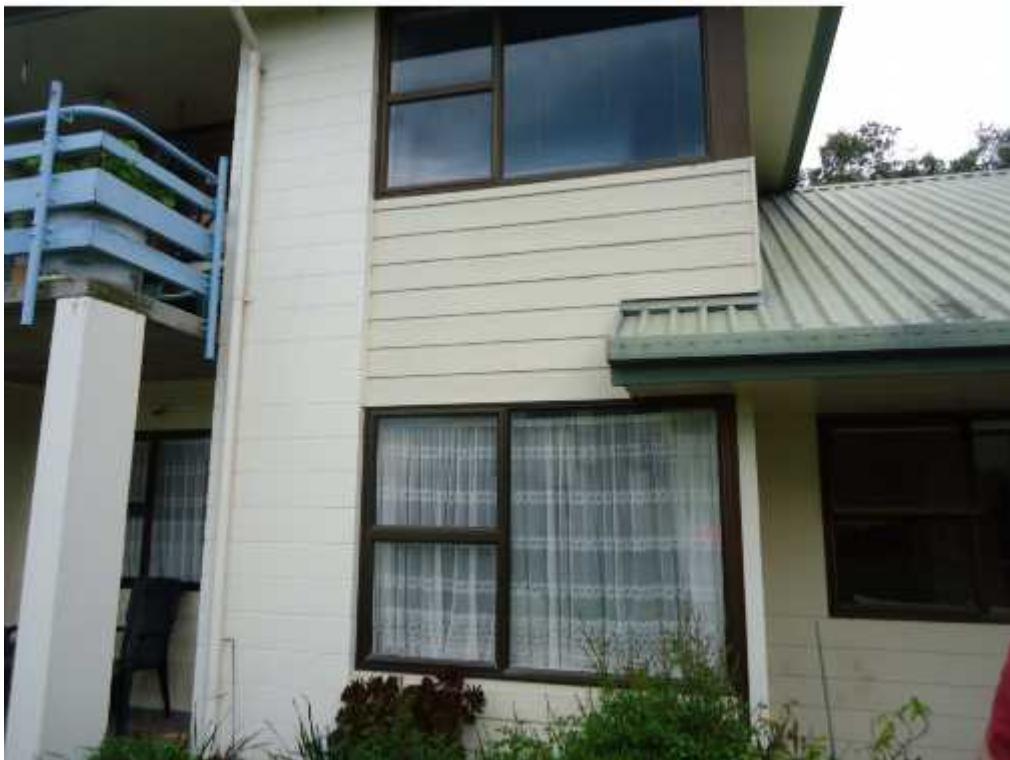
Figure 12: A general view of the west side of the South building. The building has no signs of significant damage.

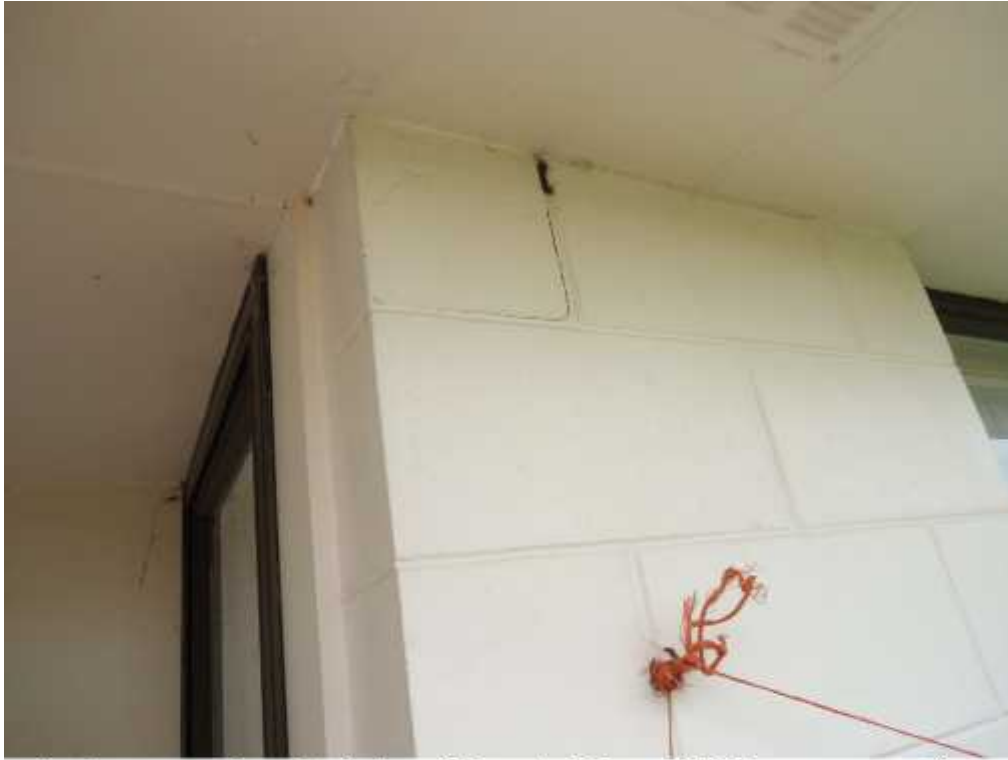
Figure 13: A minor crack at the joint of the cladding. Width: 5-10mm. The crack does not appear to penetrate through the cladding in the North side of the North building.

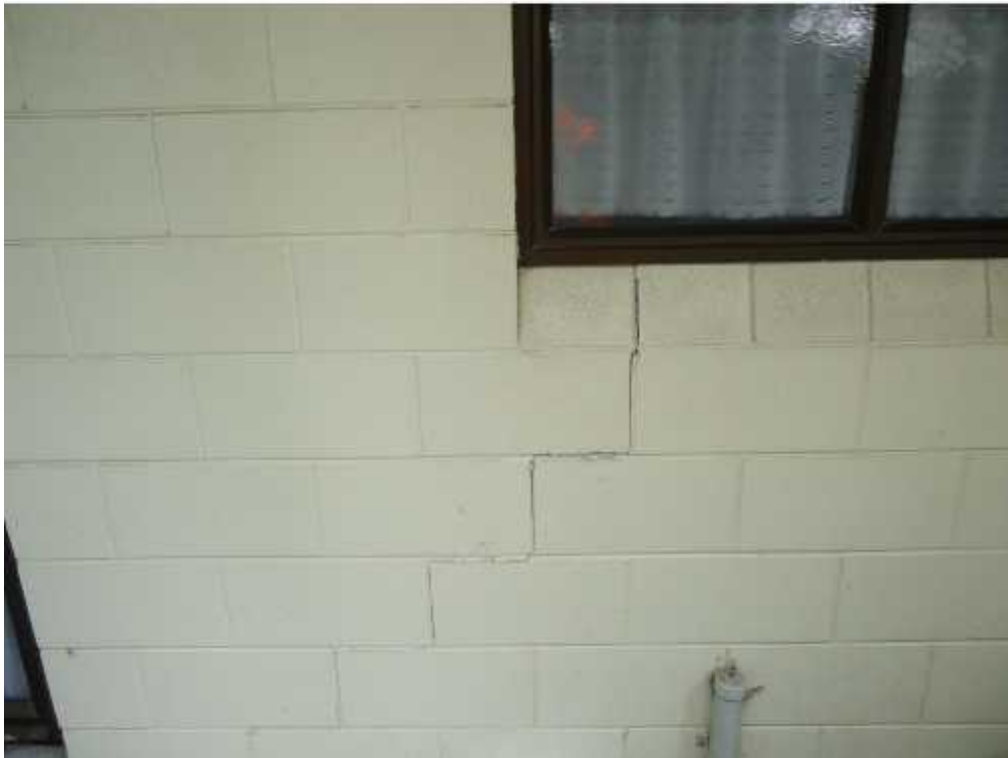
Figure 14: Stepped pattern of crack <5mm just below the window of flat 3, South building.

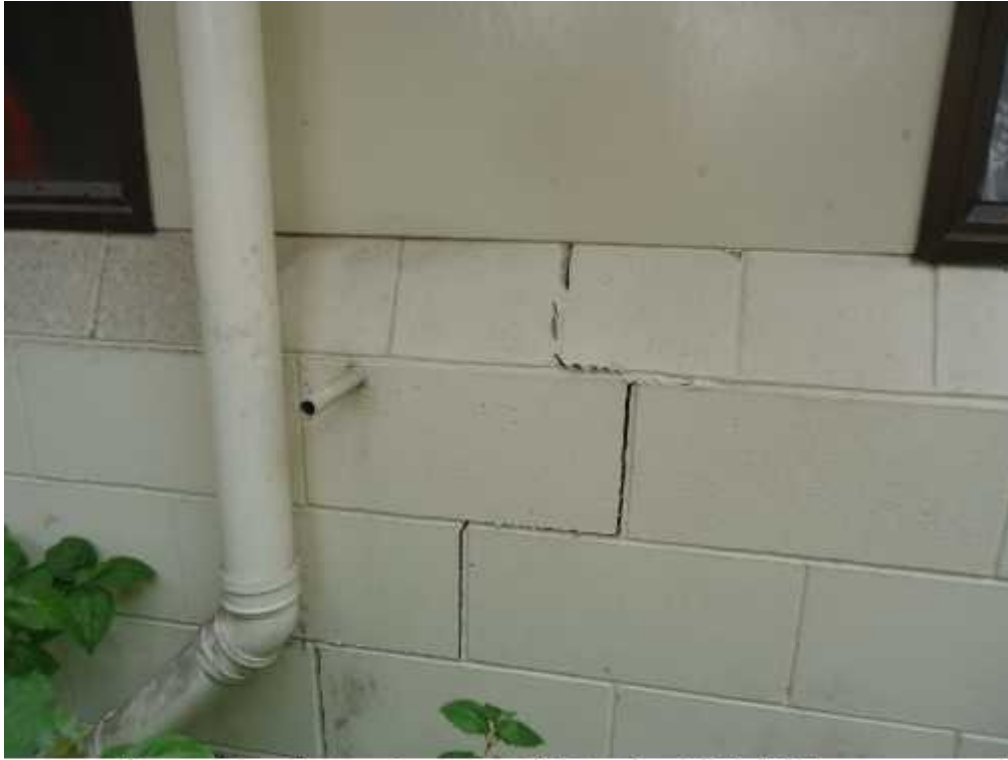
Figure 15: Stepped settlement crack at flat 1, South building, 3-5mm wide.

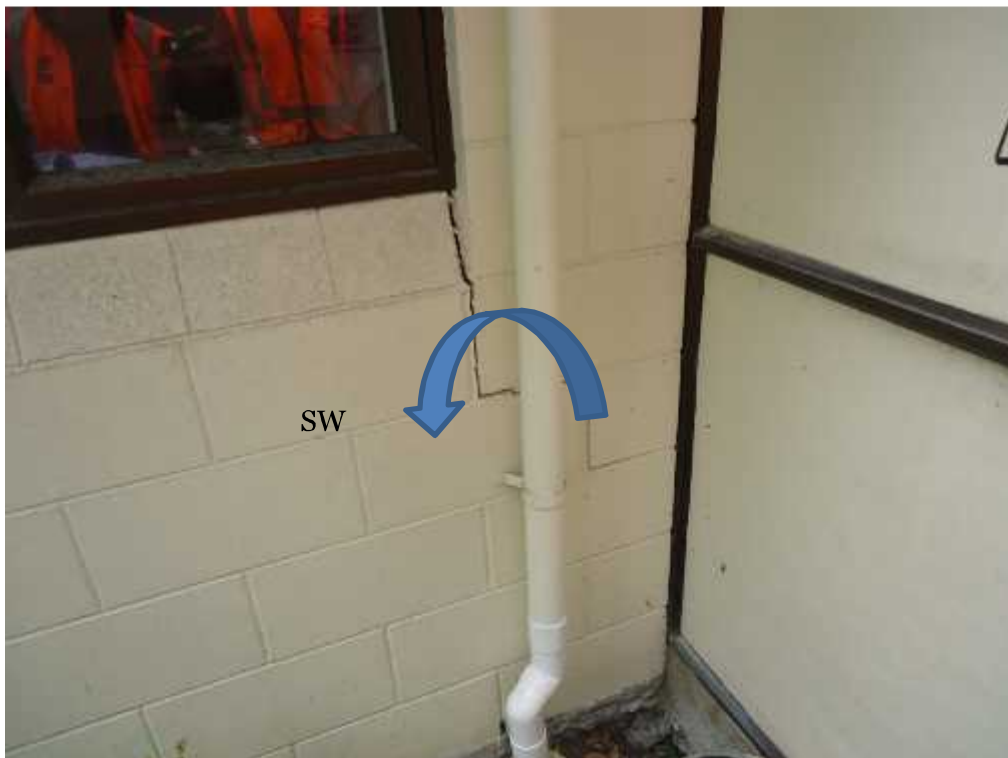
Figure 16: Settlement crack below the corner of the window, South building. The crack has width $<5\text{mm}$ and possibly penetrates through the wall. Movement may have taken place towards the South west.

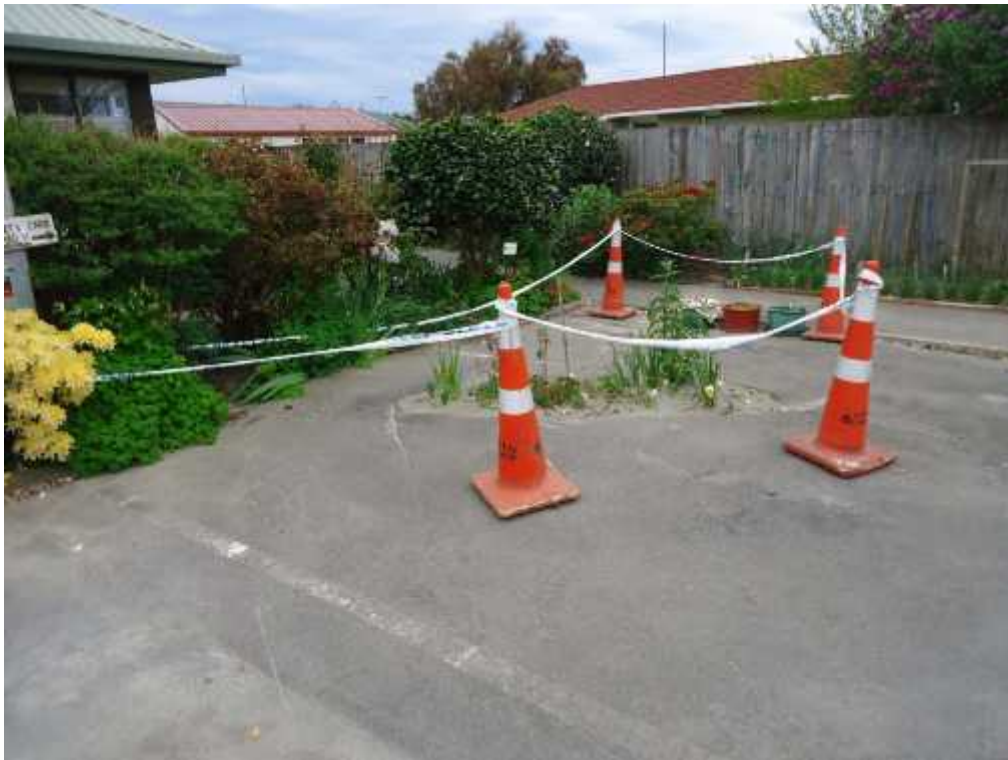
Figure 17: South side of the North building, as a result of liquefaction during 13th June 2011 earthquake. The dimensions of the bulge are 4.50 m X 3 m and the ground heave is 100 mm. Ejected Silty material (grey, non-plastic) is deposited.
