Bishopdale Community Crèche

Detailed Engineering Evaluation

Quantitative Assessment Report

Date: 30 March 2012

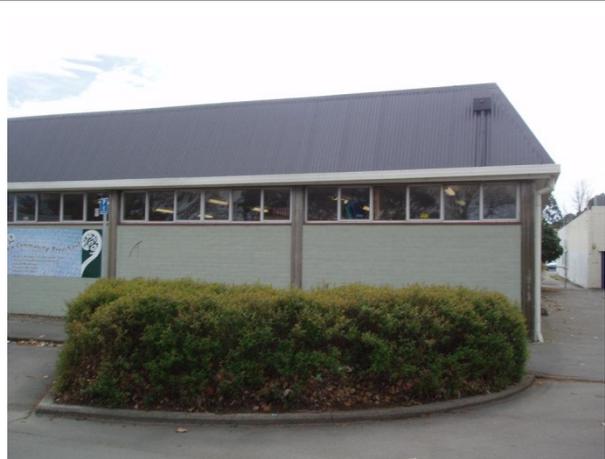
- c. At the southwest and portion of the southeast elevation, the cavity walls do not have adequate strength to resist out-of-plane forces resulting in approximately 13% NBS. Although failure of this wall will not lead to collapse, the wall is approximately 2.4m high and failure could lead to injury to occupants or pedestrians near the wall.

3. Remove and replace unreinforced block walls with reinforced block wall. Alternatively, shotcrete the interior of the block walls.
4. Tie the exterior leaf of “la strada” stone to the inner leaf using through rods and expansion anchors or proprietary “Helifix” type anchors. Provide out-of-plane support to the inner leaf (see item 3 above). Fill the cavity with grout.

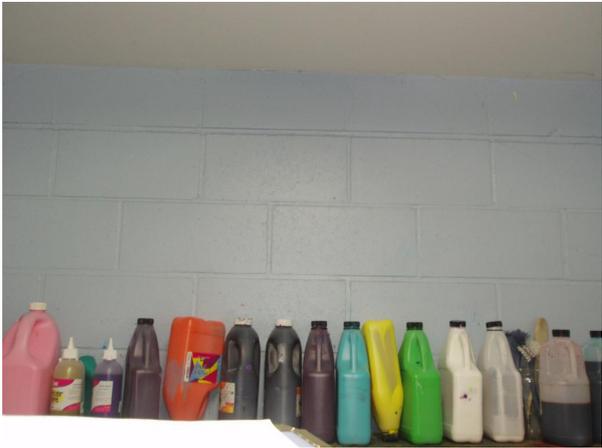
- In the art storage room there is a horizontal crack on the external (south east) wall at about 2.0m high. This is marking out the position of an old door opening which has been blocked up in the past.
- On one blockwork column supporting the canopy to the northwest side there is a crack through the block at low level. However, observing the crack closely shows that there is paint inside the crack from when the column was last repainted. We were informed that the paint was “several years ago” and maybe even up to 10 years. The crack therefore pre-dates any of the recent seismic events.

<p>5.</p>	<p>Horizontal crack on wall in art store</p>

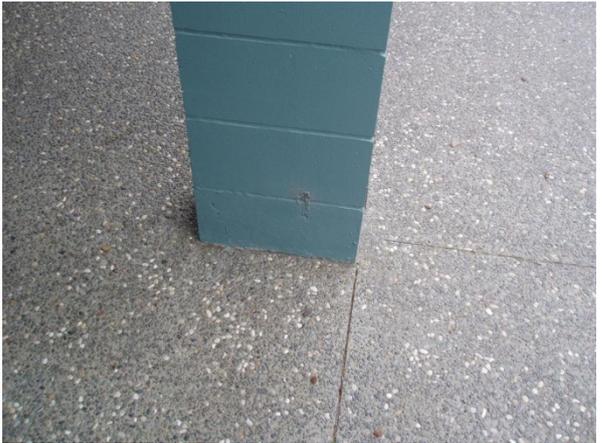
<p>6.</p>	<p>Crack on column at south west corner (paint filled)</p>

7. Provide supplementary column supports on either side of the unreinforced block columns at the veranda canopy. Alternatively, replace the block columns with steel columns.

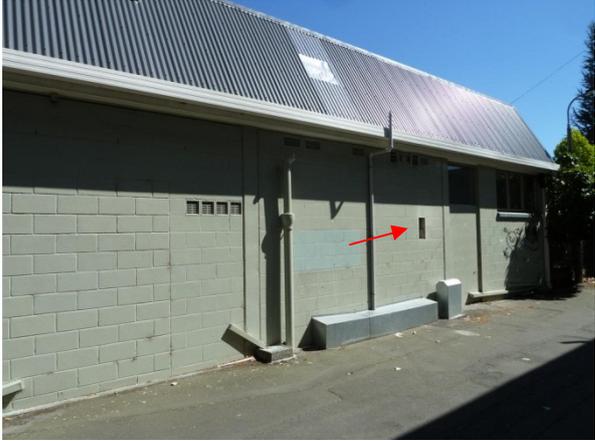
<p>7.</p>	<p>Field investigation of southeast wall. Face shell removed and block is not filled.</p>

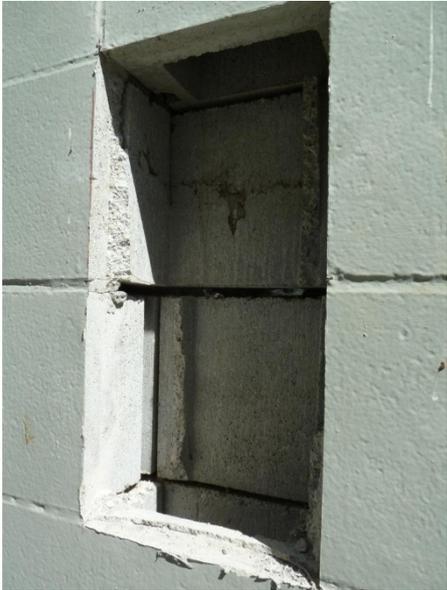
<p>8.</p>	<p>Field investigation of southeast wall. Face shell removed and block is not filled.</p>

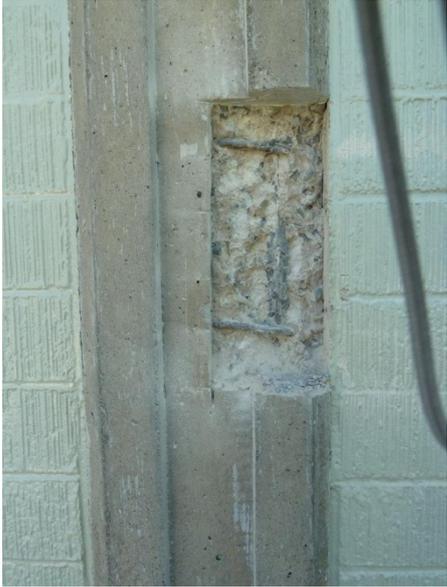
<p>9.</p>	<p>Field investigation of concrete column at southwest elevation.</p>

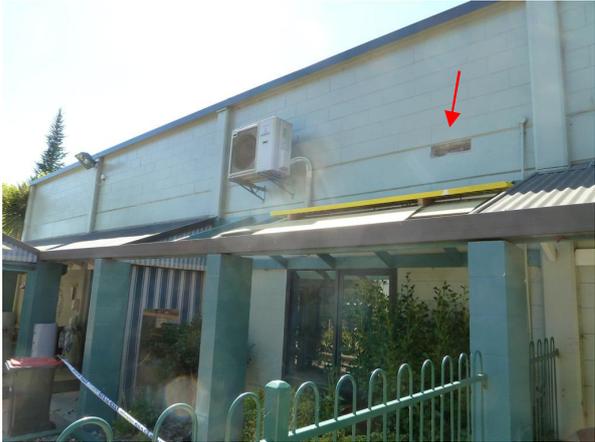
<p>10.</p>	<p>Field investigation of concrete beam at northwest elevation.</p>

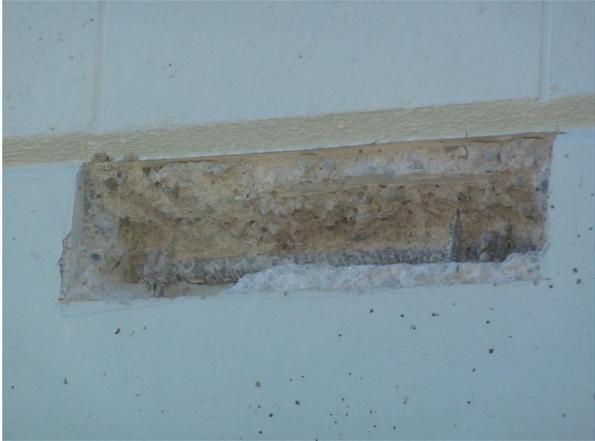
<p>11.</p>	<p>Field investigation of concrete beam at northwest elevation.</p>

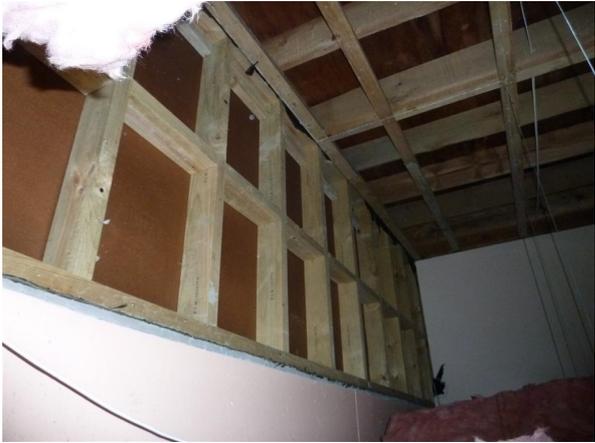
<p>12.</p>	<p>Timber wall at northeast elevation above concrete beam. Interior side is not sheathed.</p>

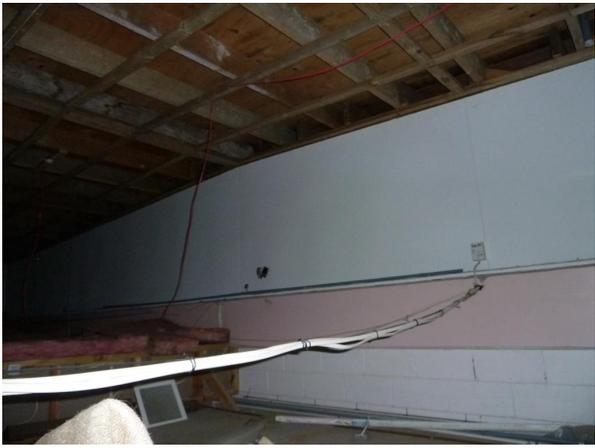
<p>13.</p>	<p>Timber wall between original crèche and addition above concrete beam.</p>

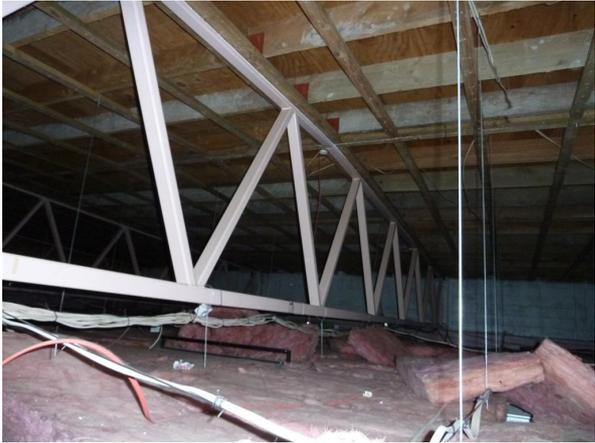
- a. At the northwest elevation, the steel truss connections are not adequate to resist the out-of-plane loading from the block wall. The failure mode is in flexure of the steel connector plates. Although the failure is a ductile type failure, given the consequence of failure that the roof trusses may lose their support, this condition should be addressed.

<p>14.</p>	<p>Steel truss.</p>
