Botanic Gardens Cycle Shelter
PRK 1566 BLDG 019
Detailed Engineering Evaluation
Qualitative Report
Version Final

7 Rolleston Avenue, Christchurch

Christchurch City Council

Date
15th May 2013

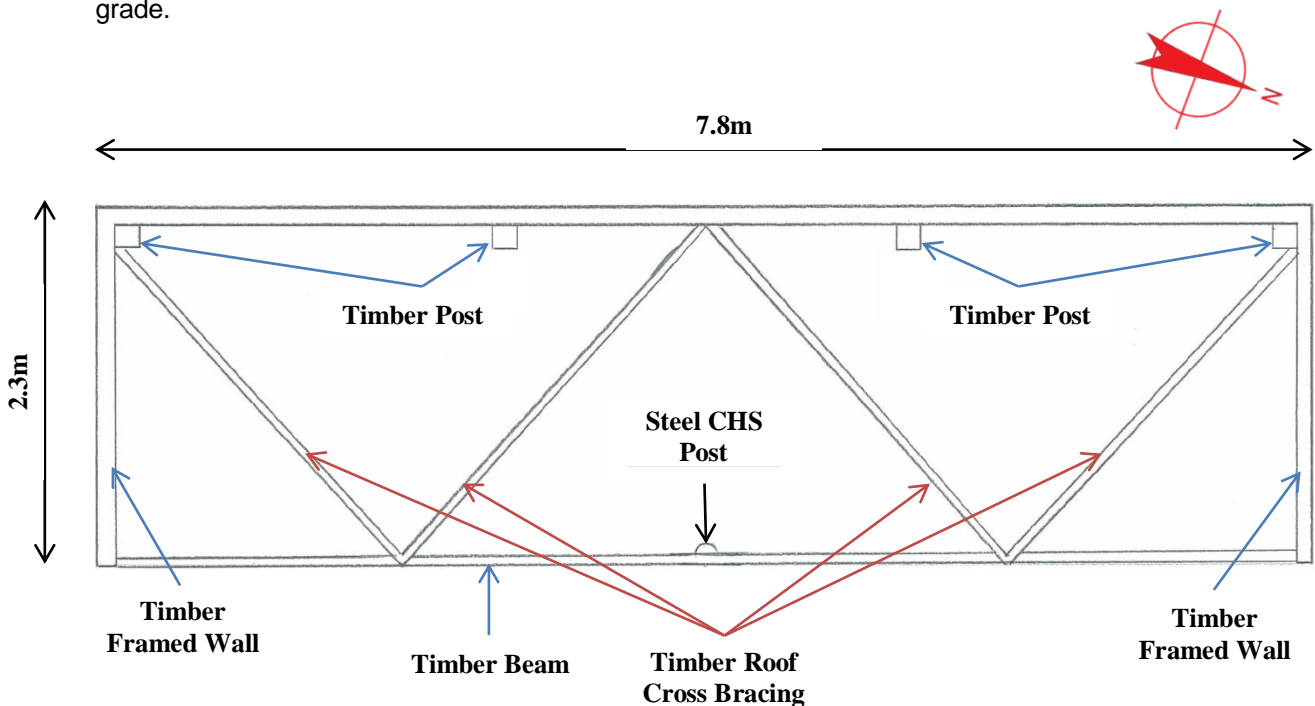
Figure 2 Plan Sketch Showing Key Structural Elements

The building footprint is approximately 18 m². The length of the building is 7.8 m and the width is 2.3 m. The building is 2 m in height and it is situated approximately 40 m south from the banks of the Avon River.

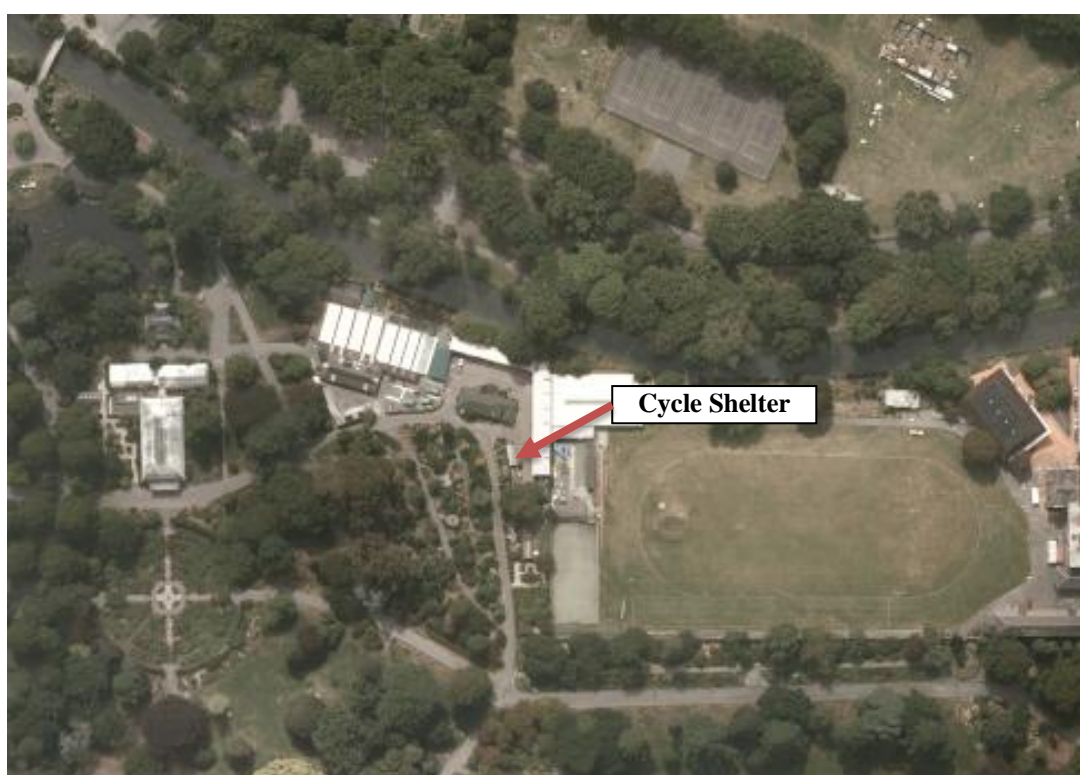
Figure 3 Post February 2011 Earthquake Aerial Photography²

Aerial photography taken following the 22 February 2011 earthquake shows moderate amounts of liquefaction on the northern side of the Avon and in Victoria Lake, in the top-left and top-right corners of Figure 3. However, there is no evidence of liquefaction at the surface within the botanic gardens themselves.

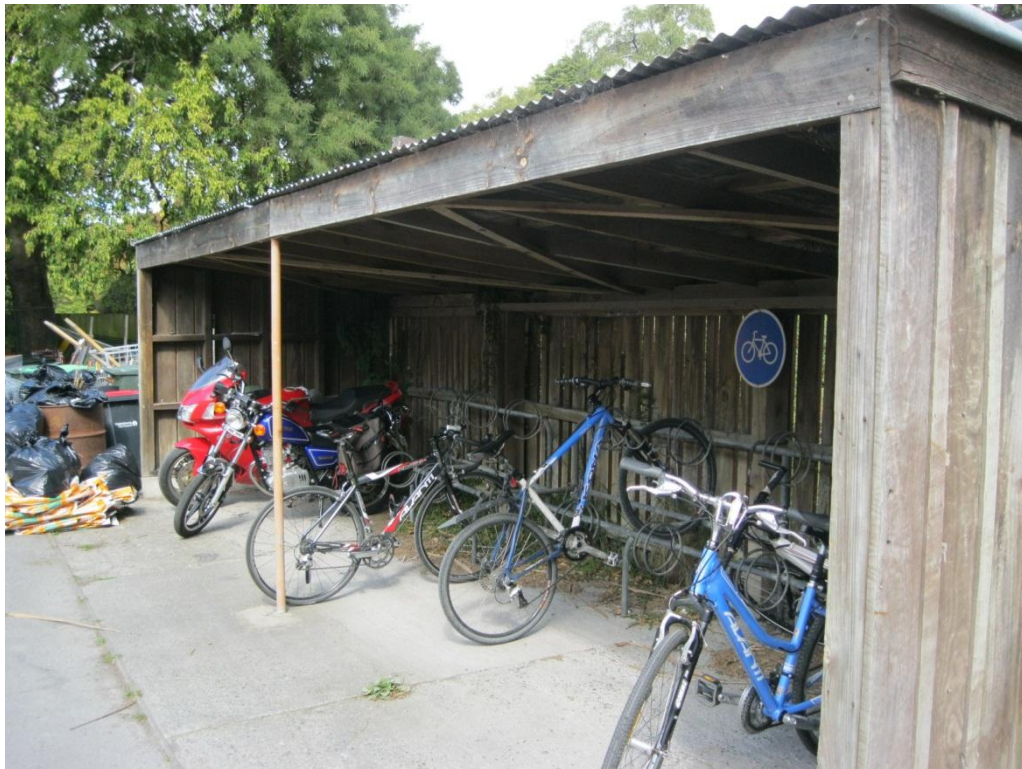
Photograph 2 Eastern side of the cycle shelter. All structural elements are clearly visible.

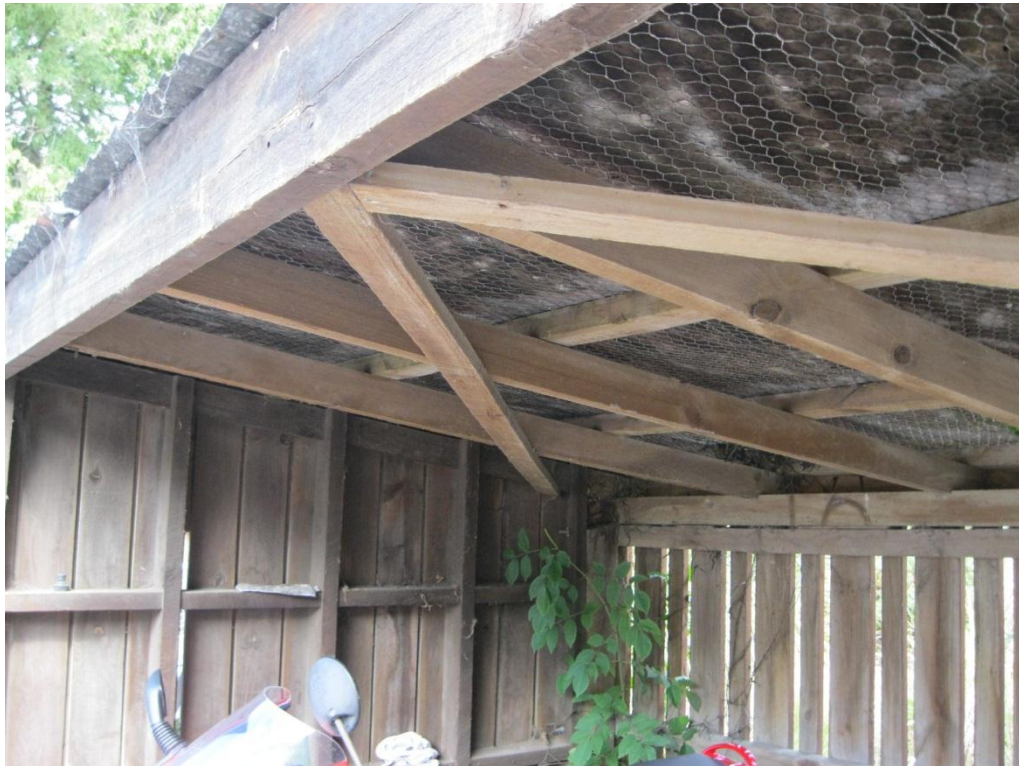
No damage was evident to the roof structure.

Photograph 3 Underside of the roof of the building showing cross bracing, rafters, purlins and metal cladding.

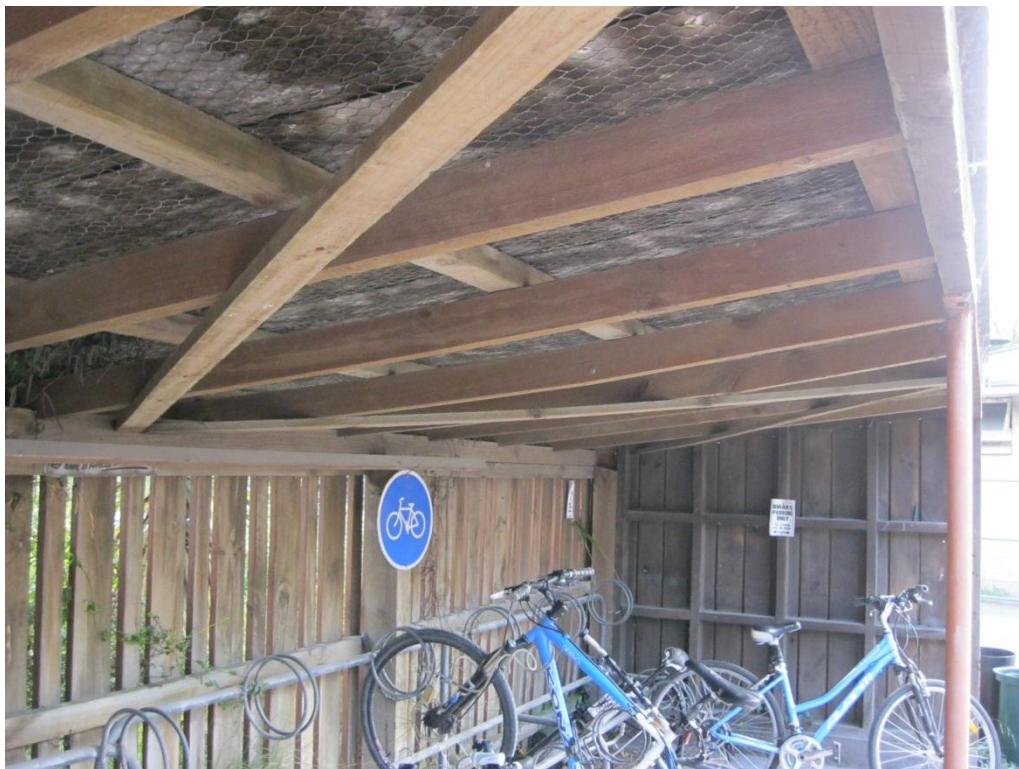
Photograph 4 Internal view showing steel CHS post at front and timber post system at the rear. Timber framed end walls are clearly visible.

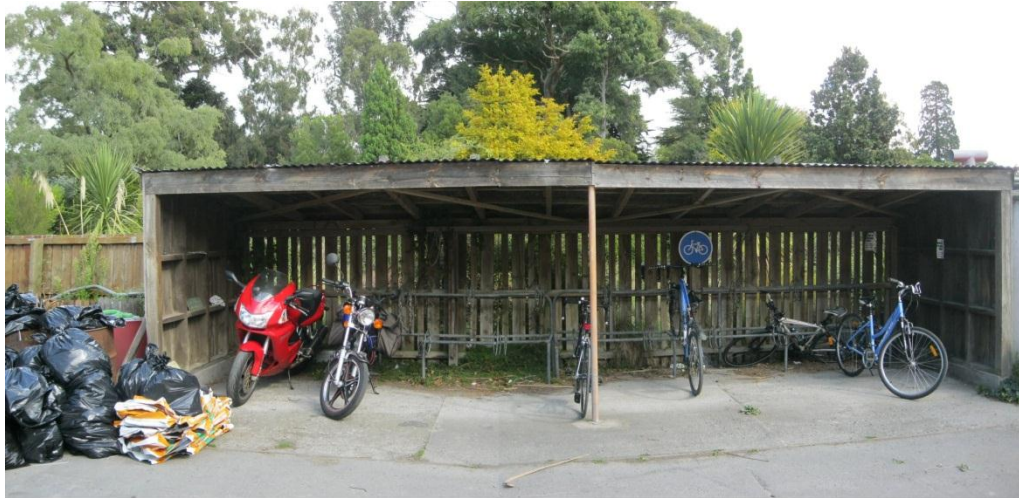
Photograph 5 Eastern view of the cycle shelter.
