Fern House, Botanic Gardens

Detailed Engineering Evaluation (Rev R2)

Quantitative Assessment Report

Christchurch City Council

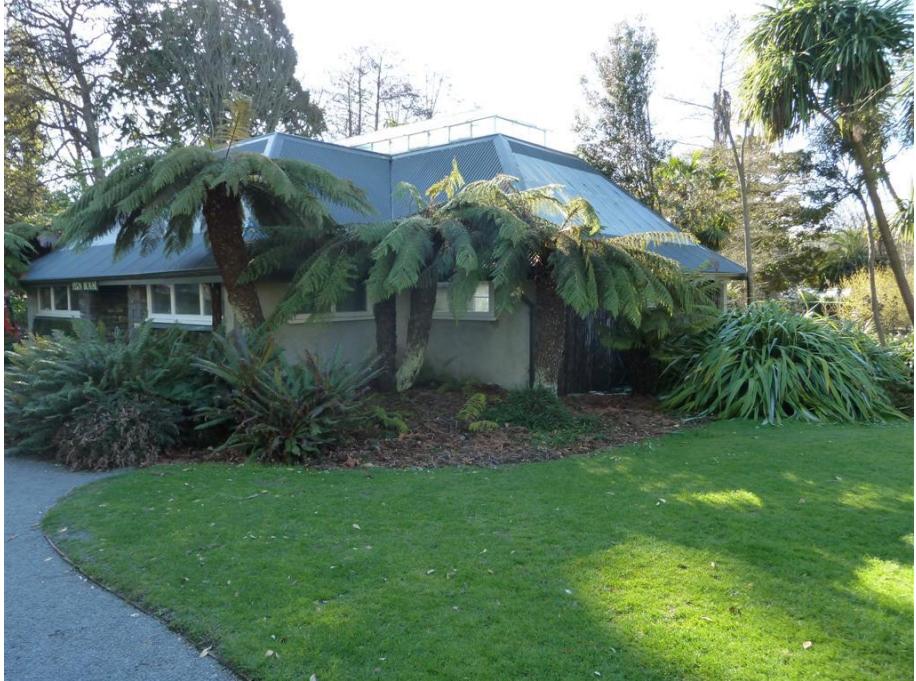
Fern House, Botanic Gardens, Christchurch		
No.	Item description	Photo
<u>General</u>		
1	View onto building entrance

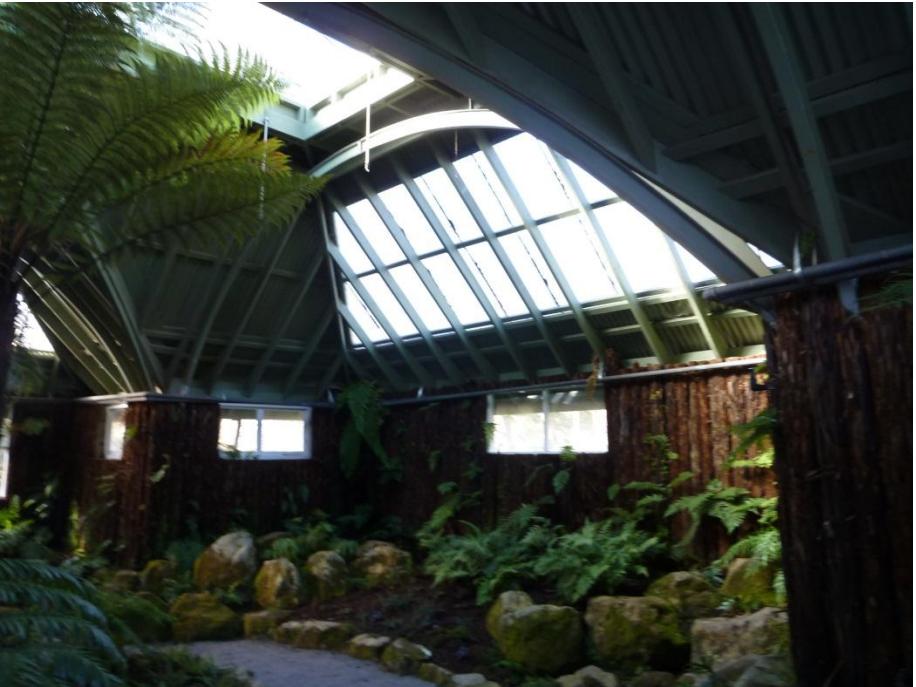
2	Steel arch springing from perimeter walls

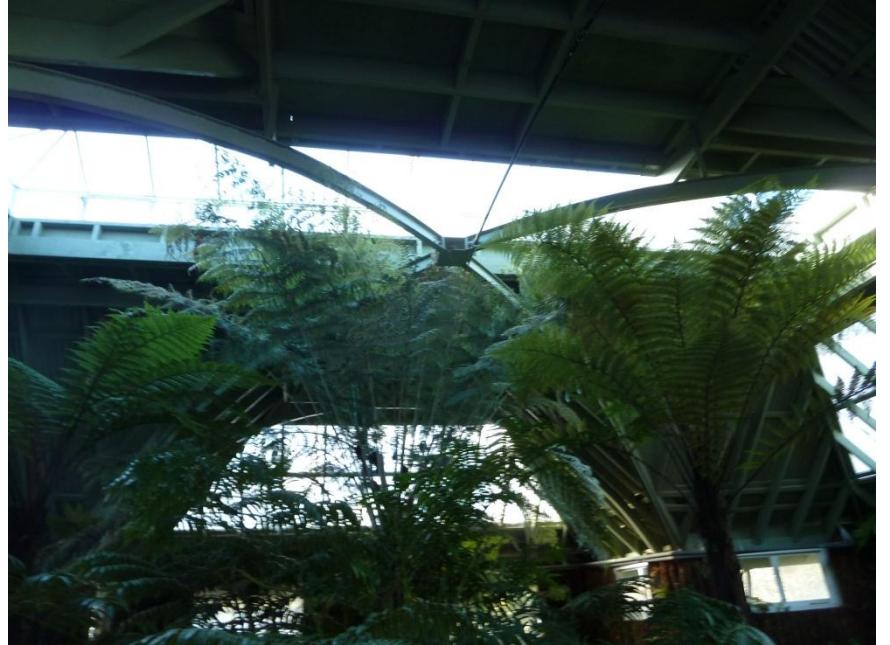
3	Steel arches crossing at apex and supporting roof lantern over

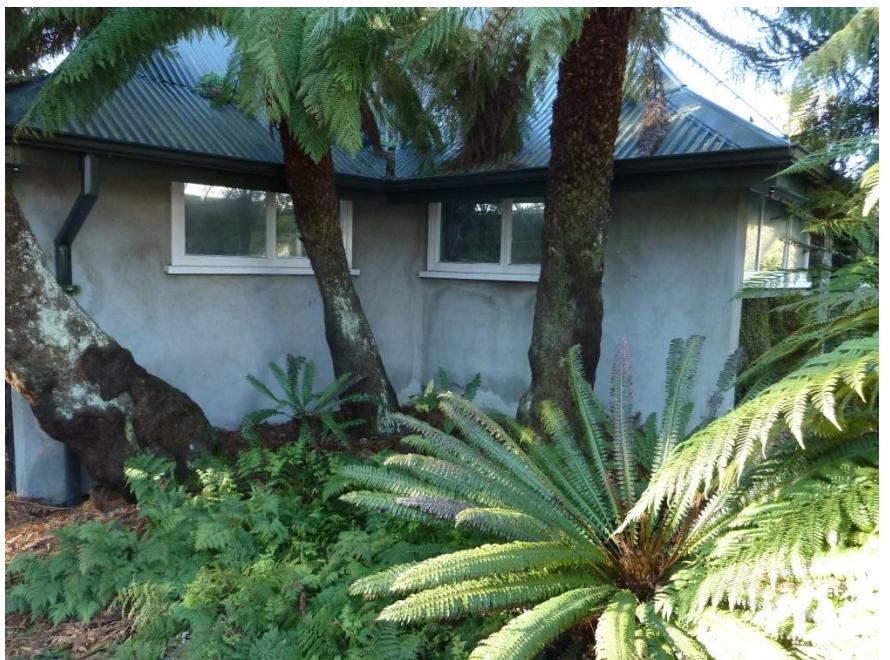
4	Typical reinforced concrete wall
