**Botanic Gardens Petrol Store**  
PRK 1566 BLDG 042 EQ2  
**Detailed Engineering Evaluation**  
**Quantitative Report**

## Detailed Engineering Evaluation Quantitative Report

Date: October 2012

Botanic Gardens, Christchurch

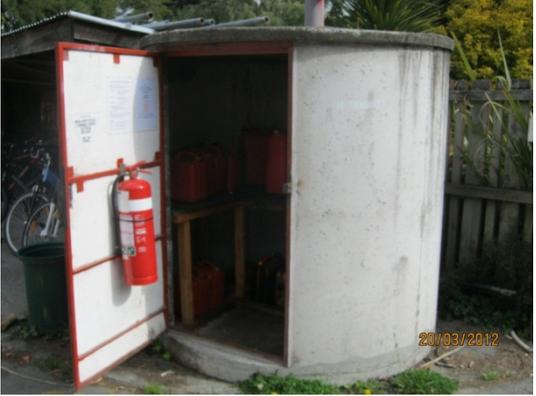
Petrol Store – Christchurch Botanic Gardens		
No.	Item description	Photo
1.	Overall photo of Petrol Store

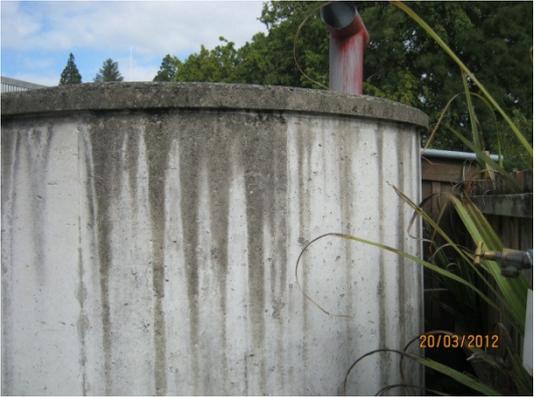
A photograph of a cylindrical, light-colored metal petrol store with its door open. A red fire extinguisher is mounted on the inside of the door. A bicycle is visible inside the store. The date 20/03/2012 is visible in the bottom right corner of the photo.
2.	Lid of Petrol Store and exhaust pipe

- a) The lid should be mechanically fixed to the walls to prevent it falling off if subjected to high vertical accelerations.

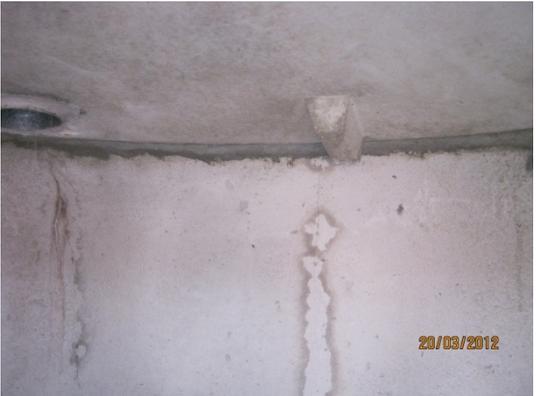
A close-up photograph of the top of the petrol store, showing the concrete lid and a red exhaust pipe protruding from the center. The date 20/03/2012 is visible in the bottom right corner of the photo.
3.	Shear lugs on lid

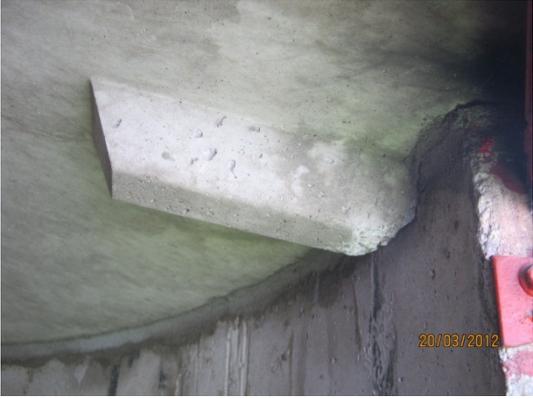
The structure shows only minor cracking and spalling, however it is deemed this is a result of age and usage. No intrusive investigation was undertaken.

4.	Defects as a result of usage and age
