**Botanical Gardens
Toilet Block
PRK 1566 BLDG 024**

**Detailed Engineering Evaluation
Quantitative Assessment Report**

Date: May 2013

Reference: 6-QC109.00

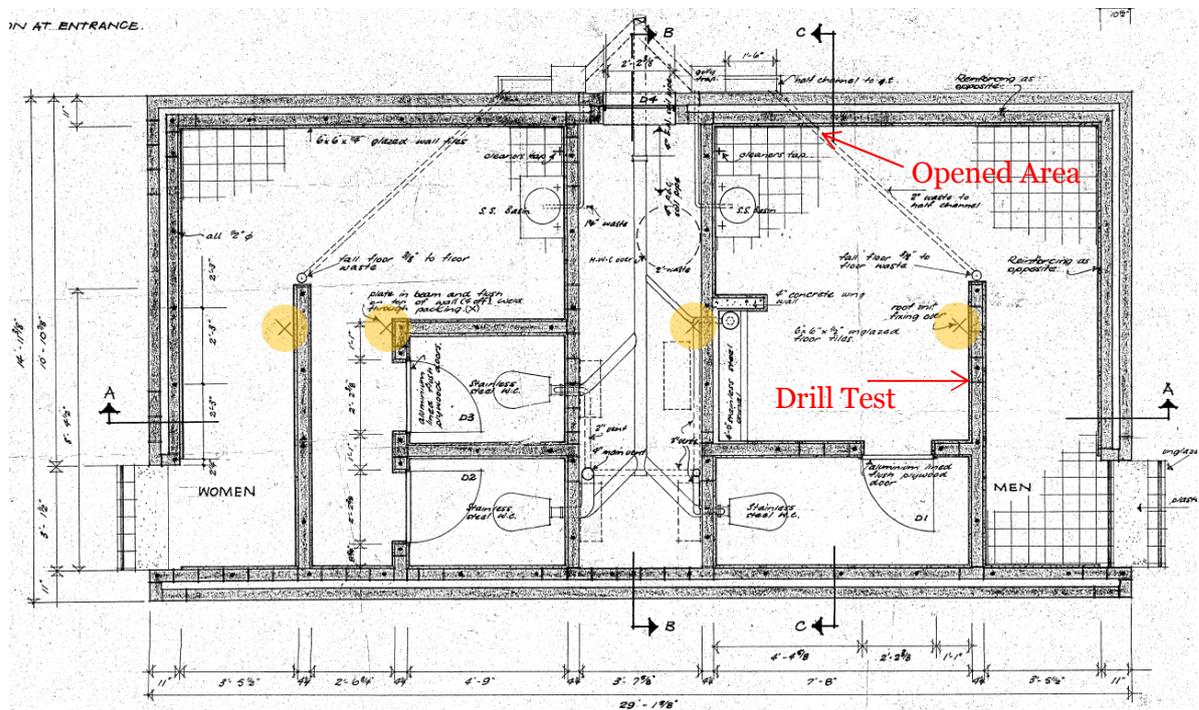
Figure 2: Wall plan of the toilets highlighting indicative locations of roof fixings.

Lateral restraint of the building is provided by the shear capacity of the reinforced brick walls. The original drawings indicate that the concrete roof is fixed to the walls in four discrete locations with cast in weld plates in the walls and roof units as shown in Figure 2. The analysis was conducted assuming the roof was physically fixed only at these four locations, with a contribution from friction between the roof units and bond beam on the front and rear walls.

drilling into one wall and opening up a small area (one brick) of another. The positions of these works are indicated in Figure 2.

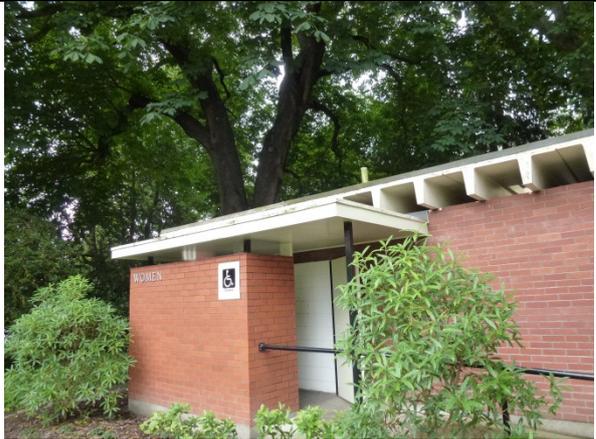
Botanic Gardens Toilet Block		
No.	Item description	Photo
General		
1.	South elevation and new extension.

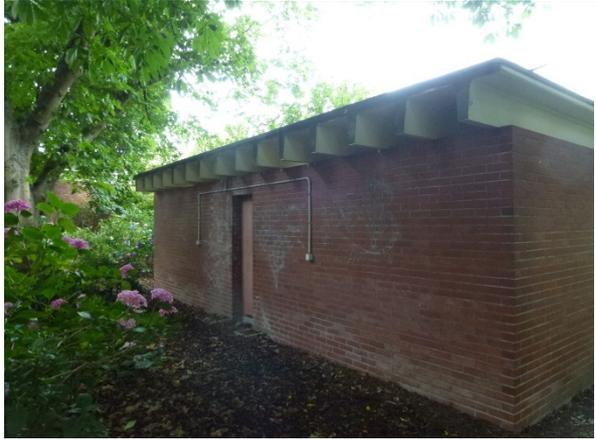
2.	North elevation.

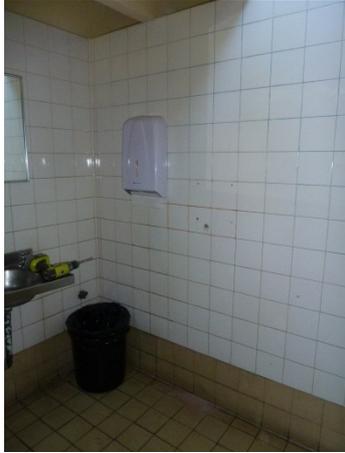
3.	View of the internal tiled wall in the male toilets where rebar was exposed.

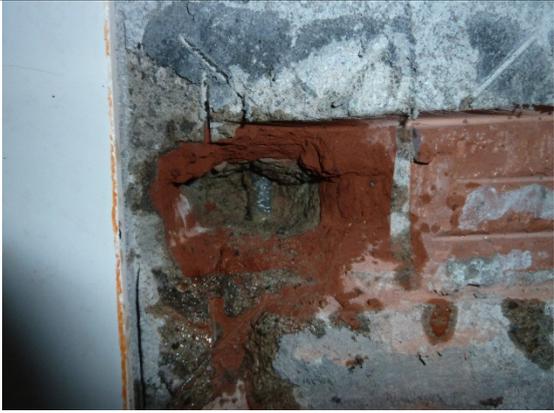
4.	Reinforcing bar exposed (1/2 inch diameter - approximately 12mm) in the north wall.

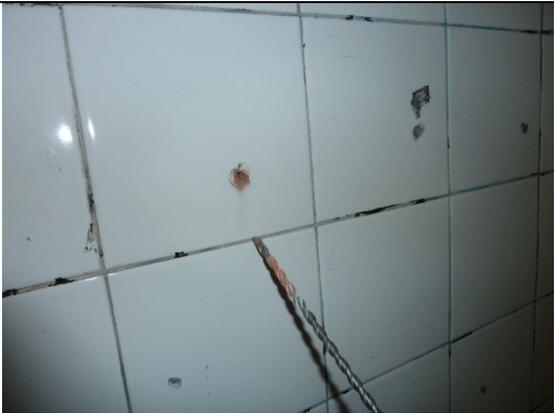
5.	Drill test of the internal divider wall of the male toilets confirming it is made of brick.

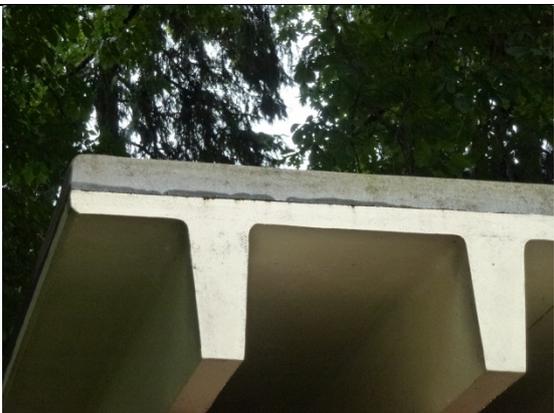
6.	View of a double-tee roof beam unit with 65mm topping

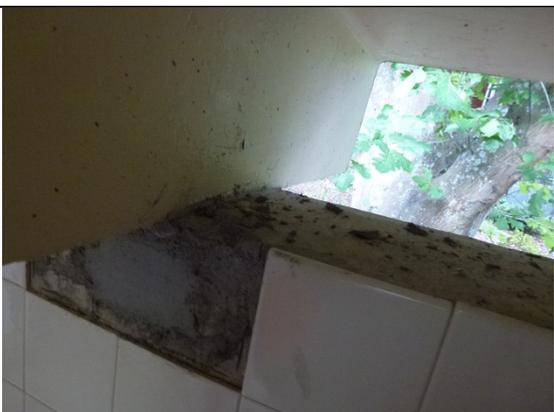
The building has a seismic capacity of 37% NBS, as governed by the capacity of the connection between the roof and the walls in the transverse direction. This result is based on the assumption that some lateral load from the roof will be resisted by friction between the underside of the roof T-beams and the top of the reinforced masonry walls, with the remainder of the load passing through the connections. Friction is not considered to be a reliable load path and if these connections were to fail in a design level earthquake, the roof may permanently displace/rotate relative to the walls. It is unlikely that the level of relative displacement/rotation will lead to collapse of the roof or the building as a whole, but it has the potential to lead to costly repairs. We highly recommend strengthening the roof to wall connections in order to increase the robustness of the structure as a whole, and to mitigate against future potential damage.

7.	View of a double-tee beam bearing on a wall

It is recommended that strengthening options be developed to increase the seismic capacity of the building to greater than 67%NBS and to provide a more robust seismic load resisting system for the roof.
