**Brougham Village Blocks F and I  
Detailed Engineering Evaluation  
Quantitative Report**

Date: October 2012  
Reference: 6-QUCCC.92  
Status: Final

Brougham Village Blocks F and I  
BU 1072-007 EQ2 and BU 1072-010 EQ2

402 Brougham Street, Sydenham, Christchurch and 131 Hastings Street, Sydenham, Christchurch

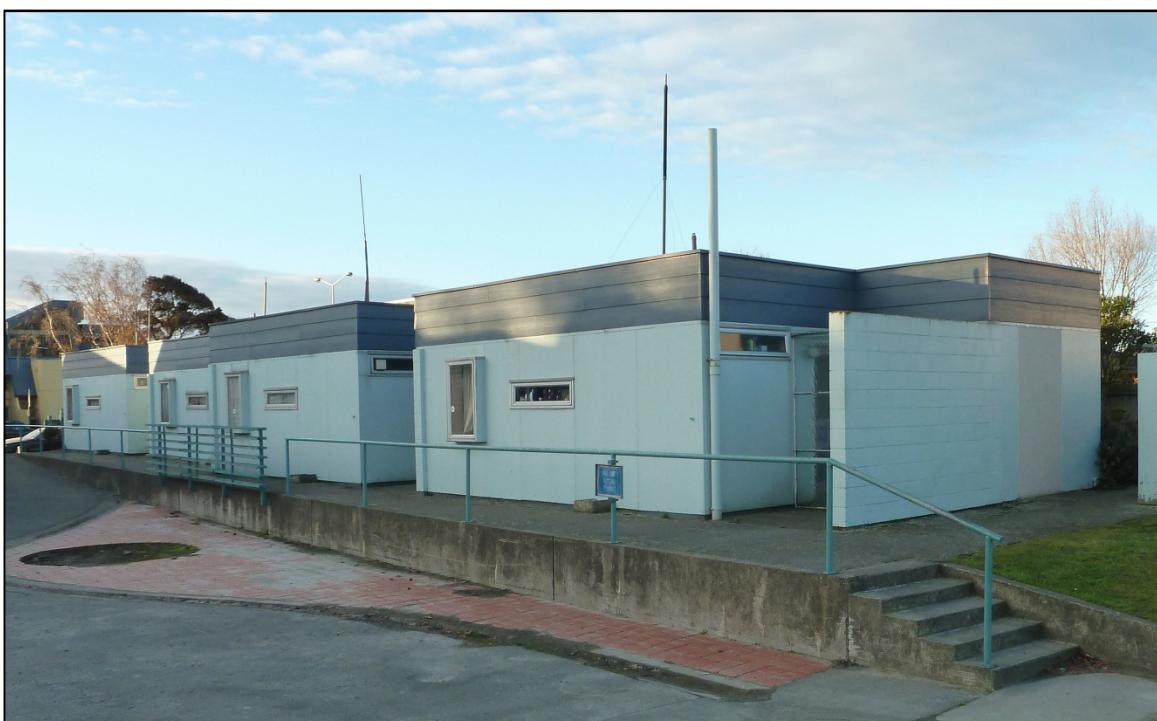
Block F appears to have suffered little damage as a result of the recent earthquakes, with damage limited to minor cracking to wall linings at door lintels.

*View of Block F from the south west*

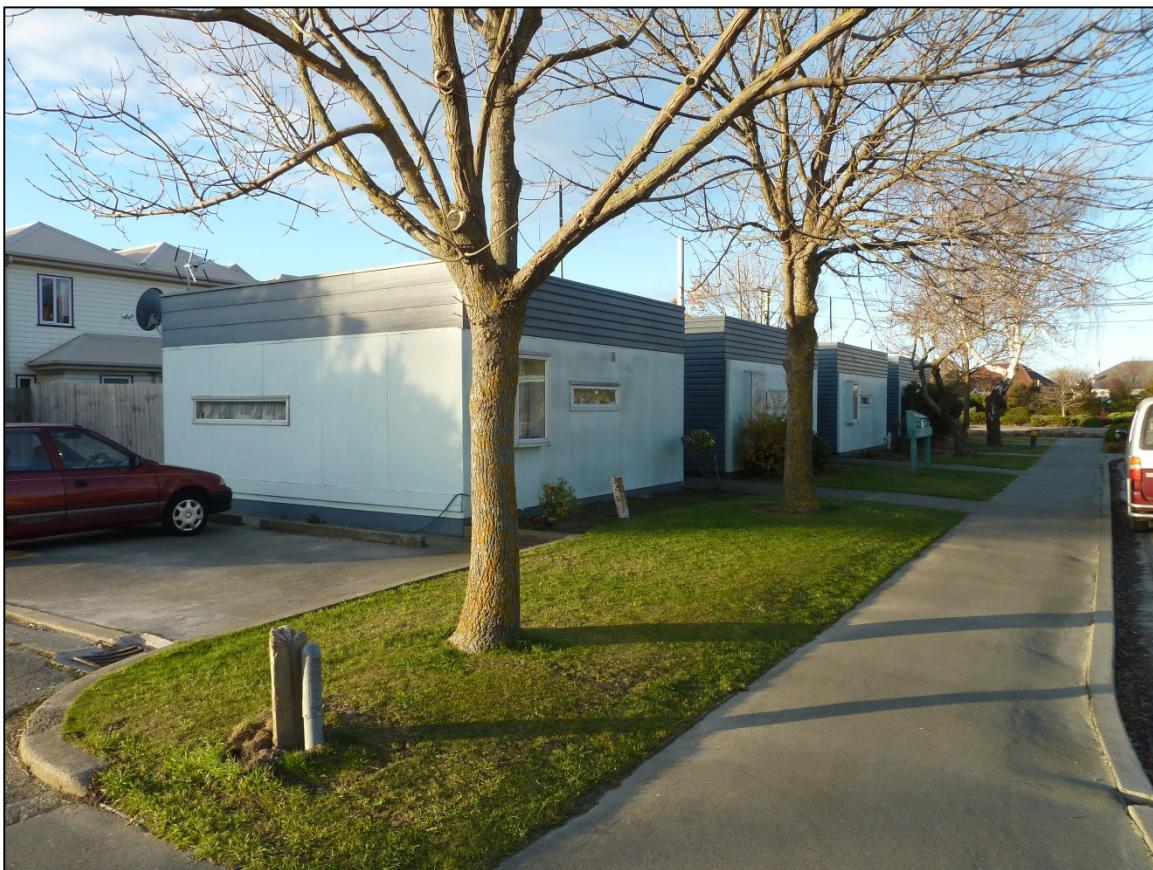
Block I has suffered areas of minor wall lining (GIB) cracking. Unit 67 (2/131 Hastings Street) has suffered liquefaction damage in the lounge and appears to have suffered consequential damage from a leaking roof which may have been caused by the earthquakes.

*View of Block I from the south west*

- (a) Repair the damage to the unit at 2/131 Hastings Street.
- (b) As the building is above 67% NBS there is no regulatory requirement to upgrade the building, although the building owner may still wish to investigate further an upgrade scheme to higher level of structural compliance.

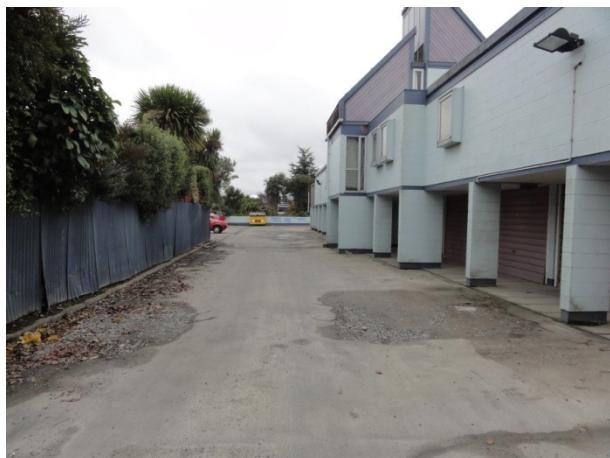
View East, damage to Asphalt

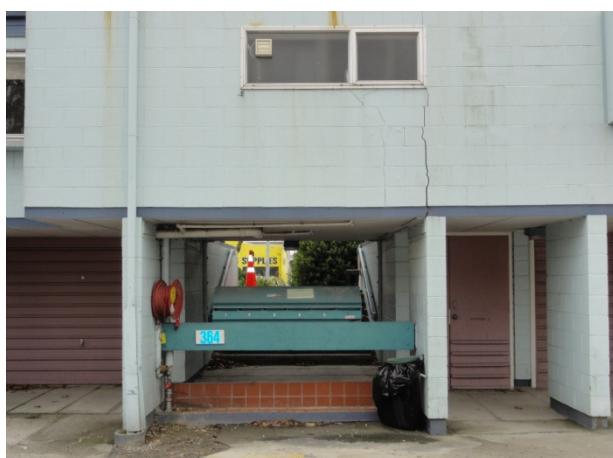
Structural Damage to 2<sup>nd</sup> and 3<sup>rd</sup> Storey at Unit 364

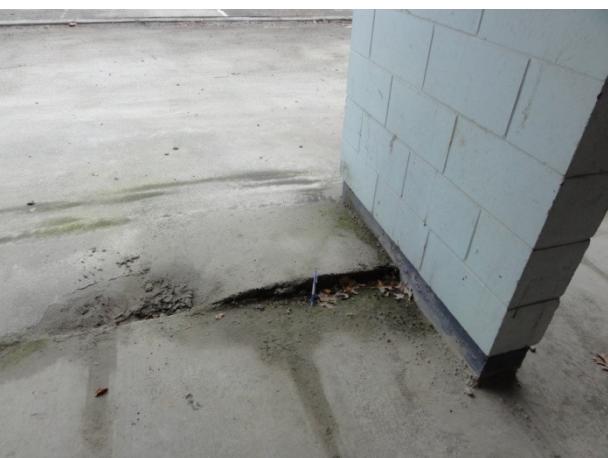
Ground Heave at footing adjacent to Unit 364

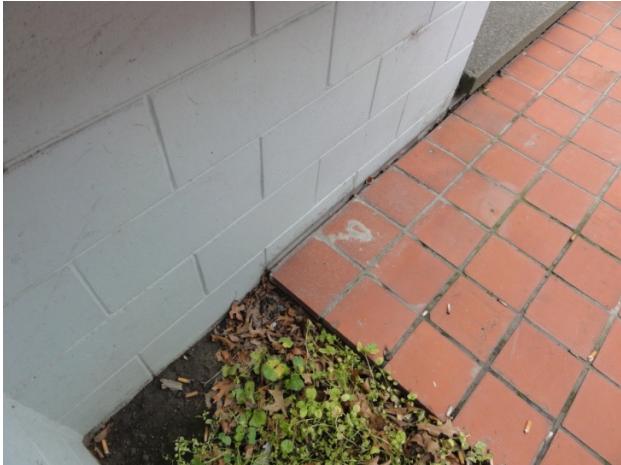
10mm crack, movement towards Brougham Street at Unit 368

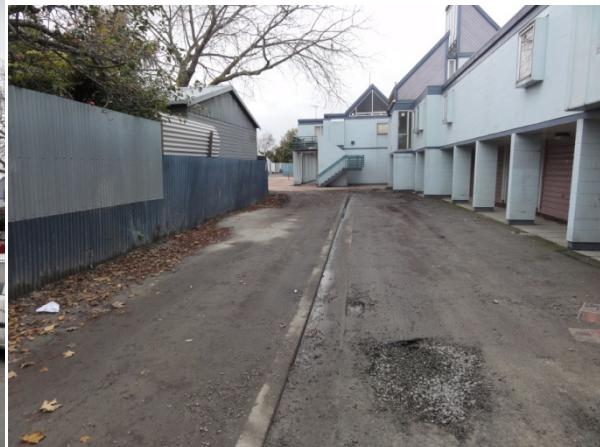
Heave and damage to driveway.

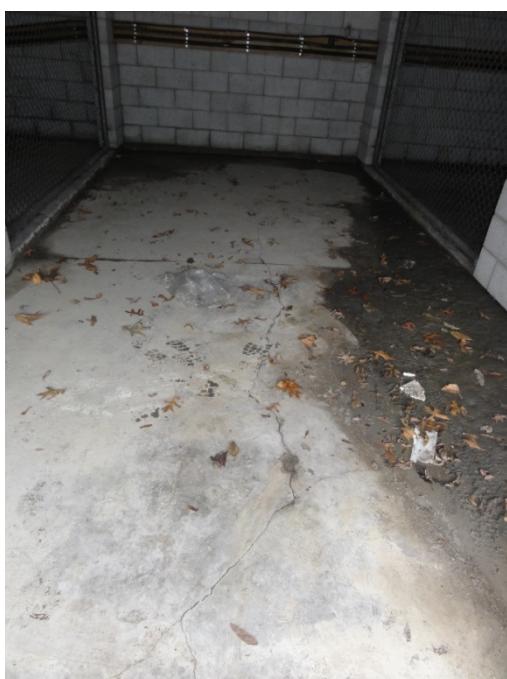
Garage 33 near Unit 388 crack in floor slab and liquefaction

1. Inspect the ground floor slabs within all the Garages for units 356 to 400, to check for subsidence and liquefaction damage.
2. Excavate and inspect foundations in key areas to confirm there has been no damage or ground disruption.
3. Undertake a Level Survey of the buildings.

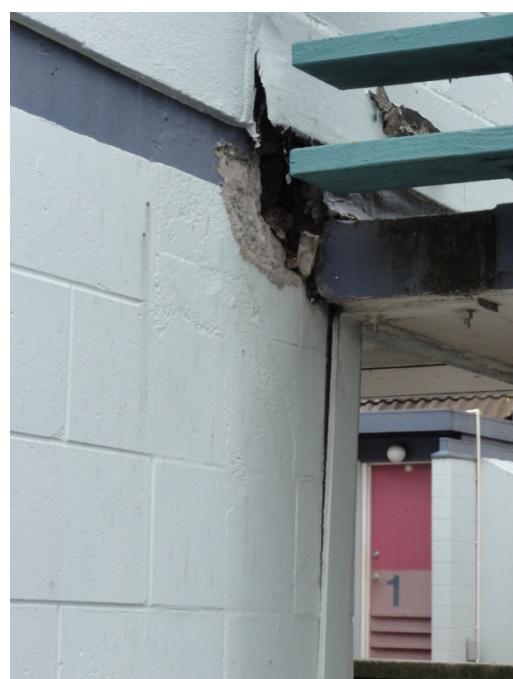
Typical Structural Damage

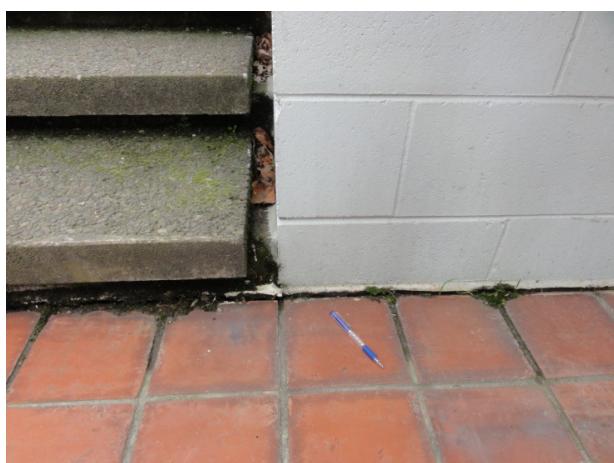
10mm settlement of patio tiles

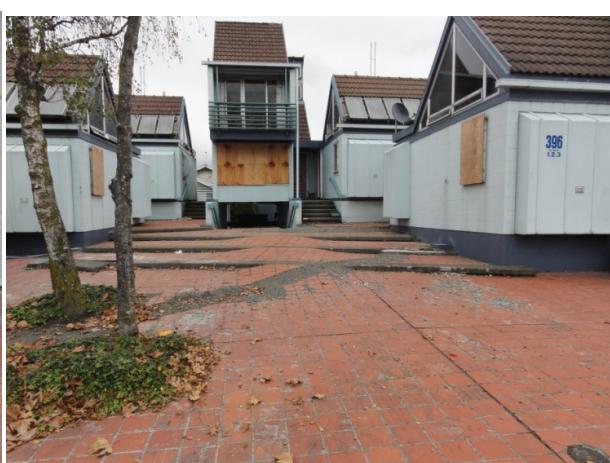
Typical damage to buried services

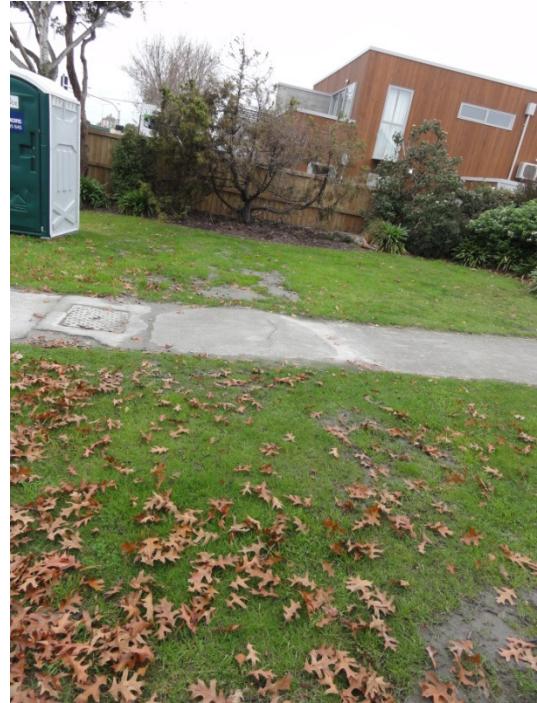
Ground Heave above service trench

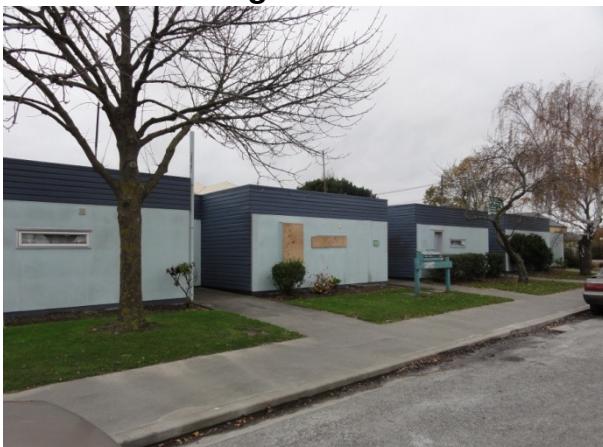
No visible damage, unit 2 yellow stickered due to severe liquefaction

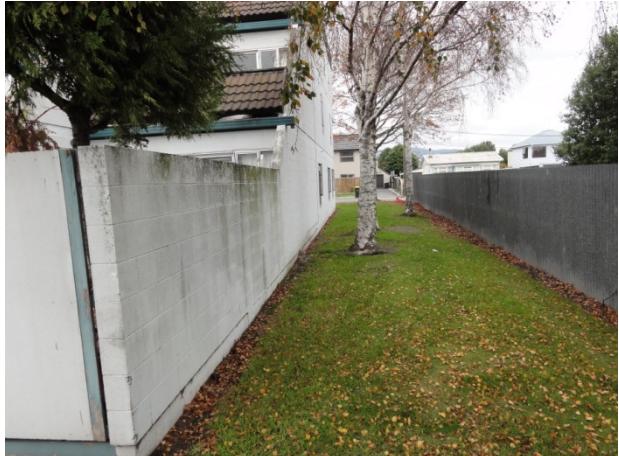
Western limit, no damage visible

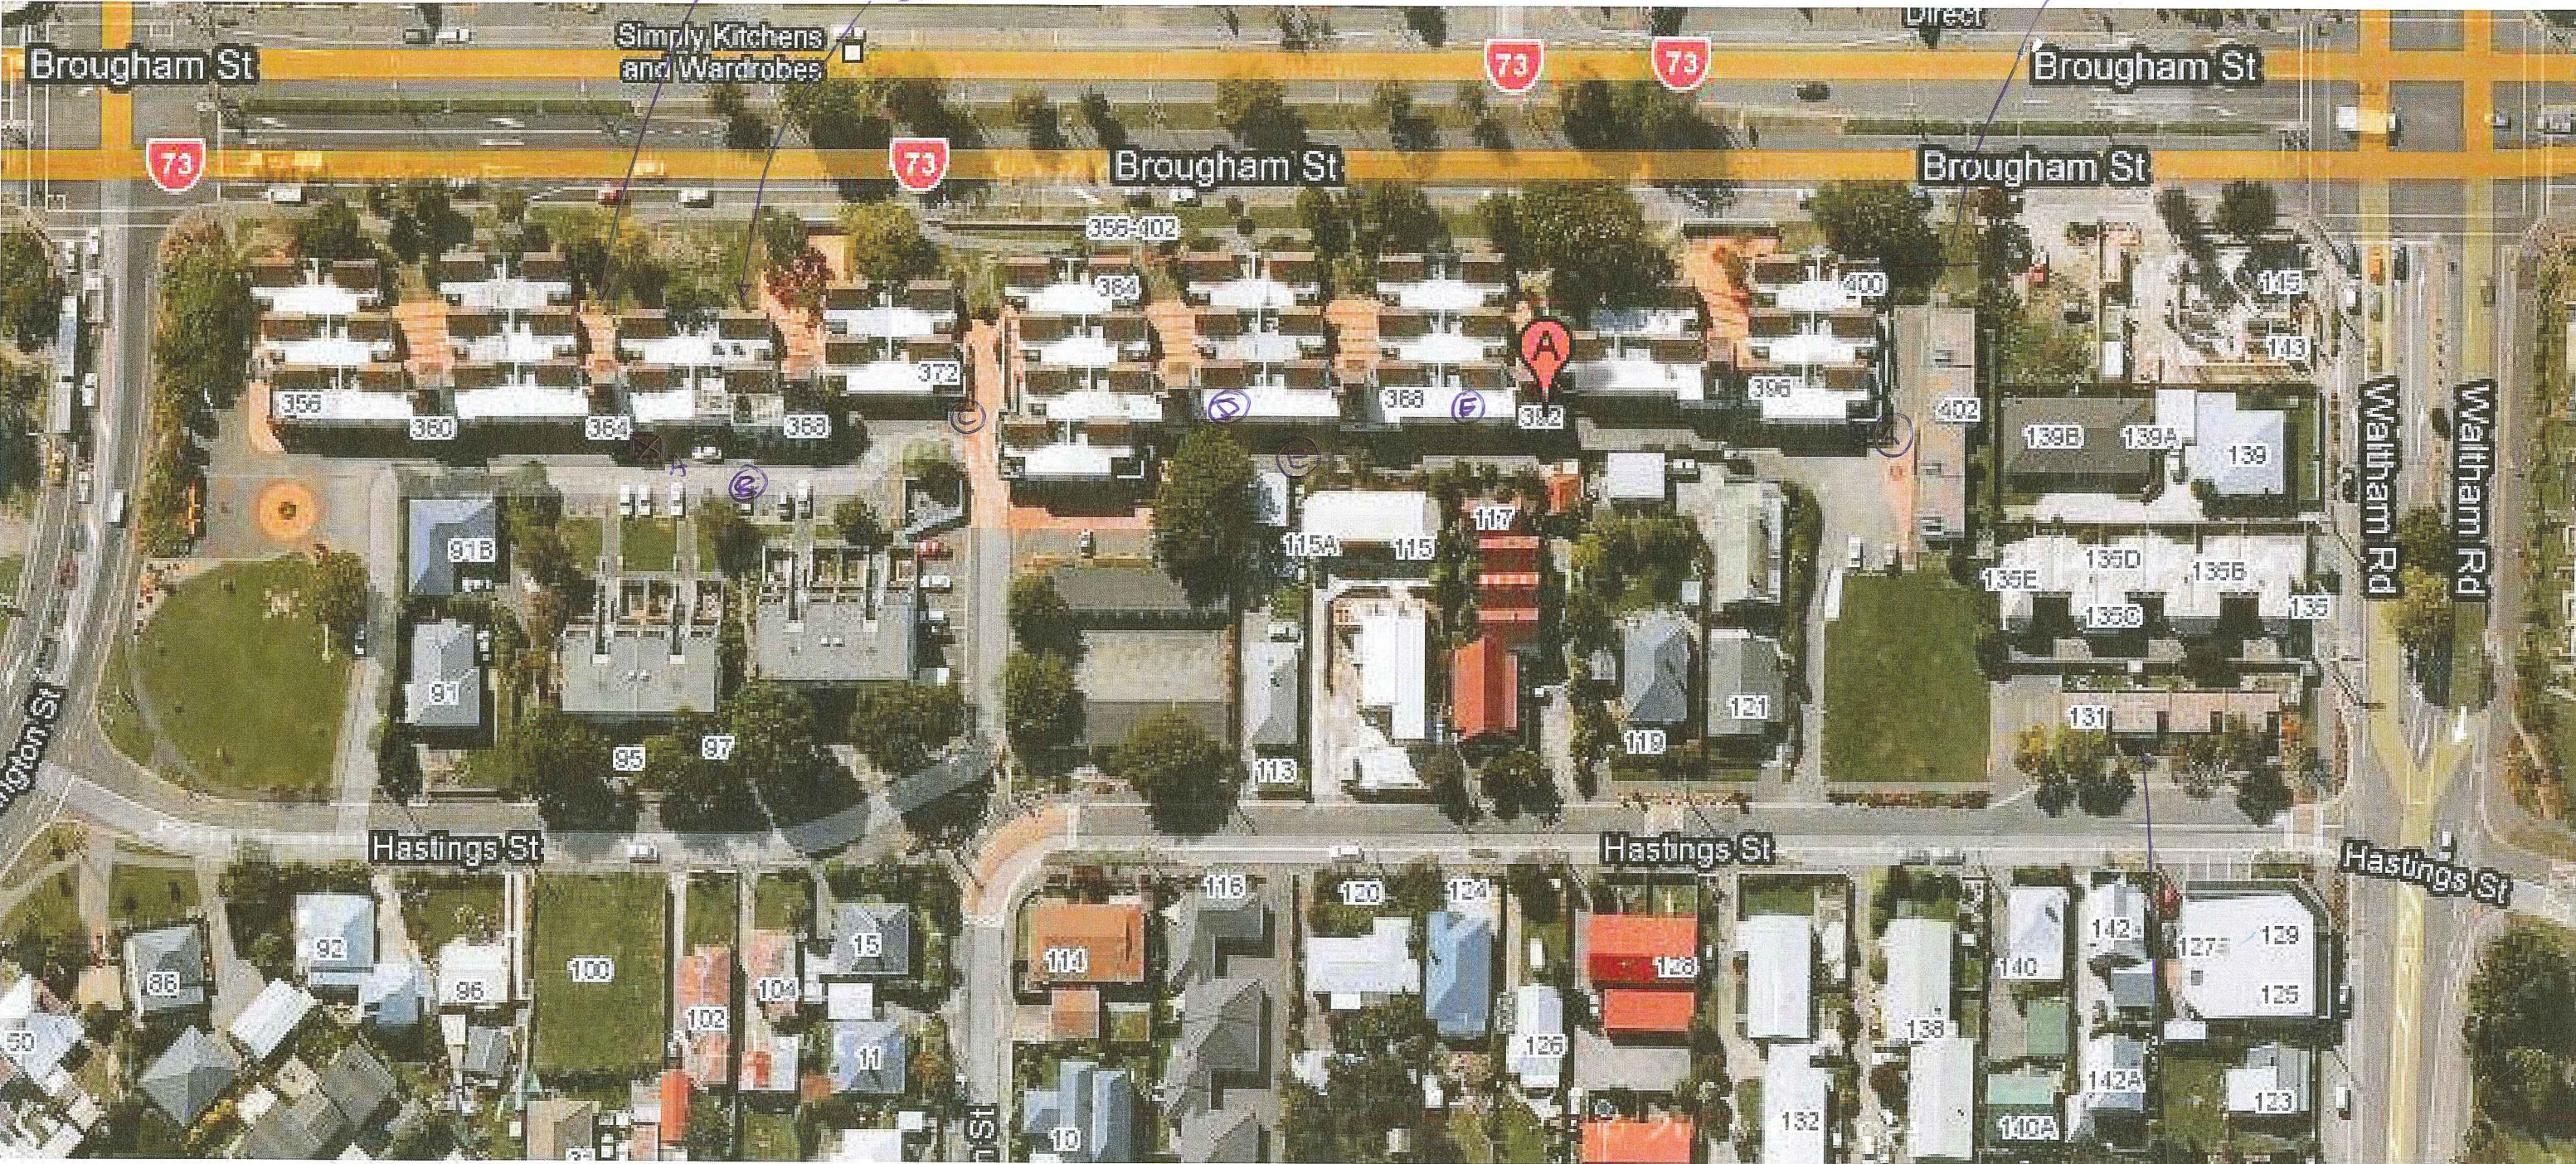
- (A) Wind heave 80mm
  - (B) Damage to carpark Area
  - (C) Damage to buried services
  - (D) Severe cracking in 1st Floor Slab.
  - (E) Heave in driveway 100mm
  - (F) Garage 33 Cracking in ground floor slab.
  - (G) Damaged services.
