Charteris Bay Boat Ramp Toilets
PRK 3581 BLDG 001
Detailed Engineering Evaluation
Quantitative Report
Version FINAL

Marine Road, Charteris Bay

Christchurch City Council

Date
09th May 2013

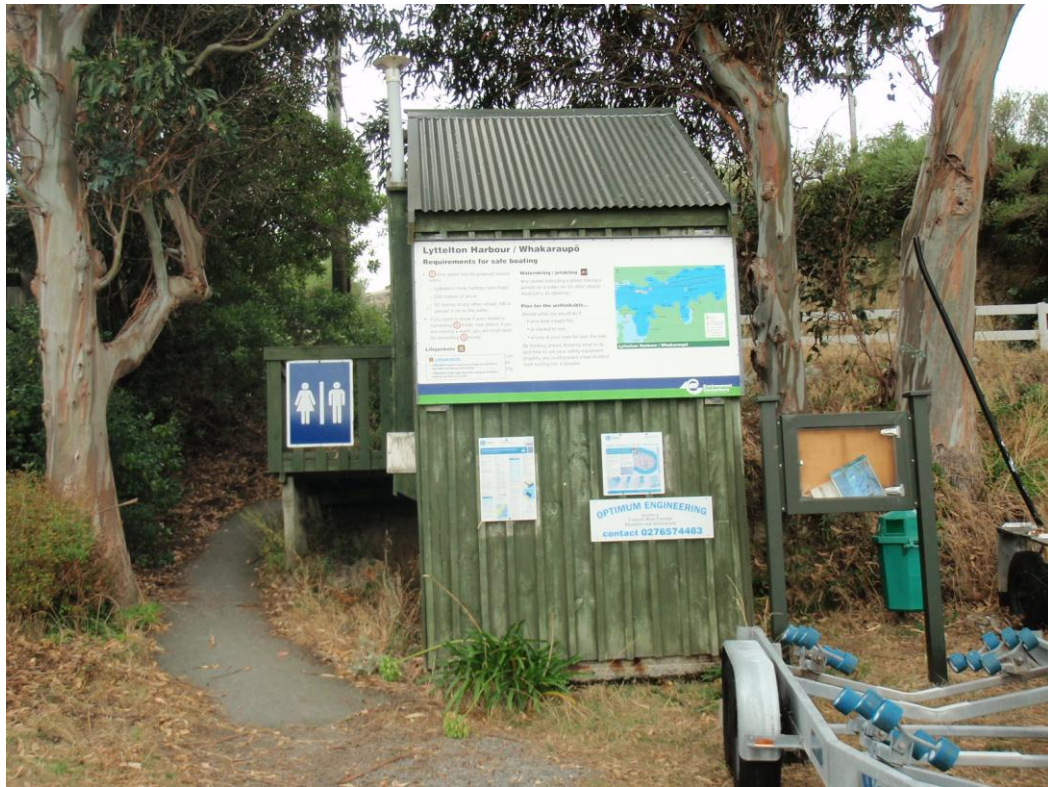
Photograph 1: West elevation

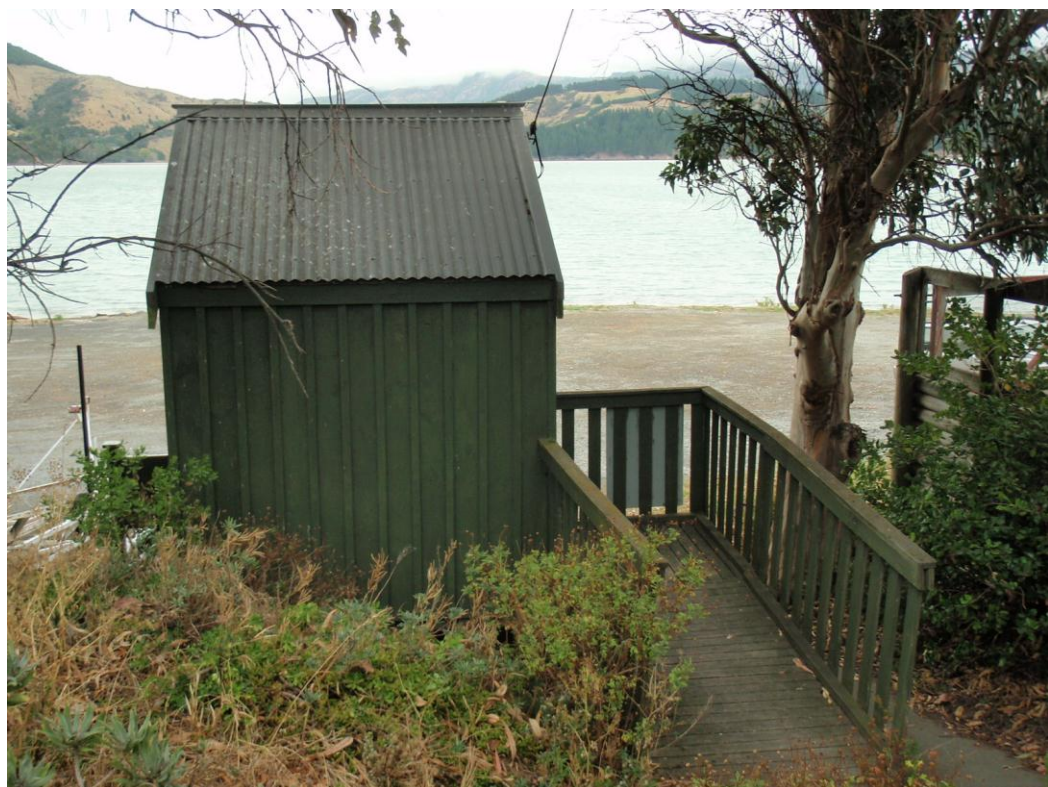
Photograph 2: East elevation

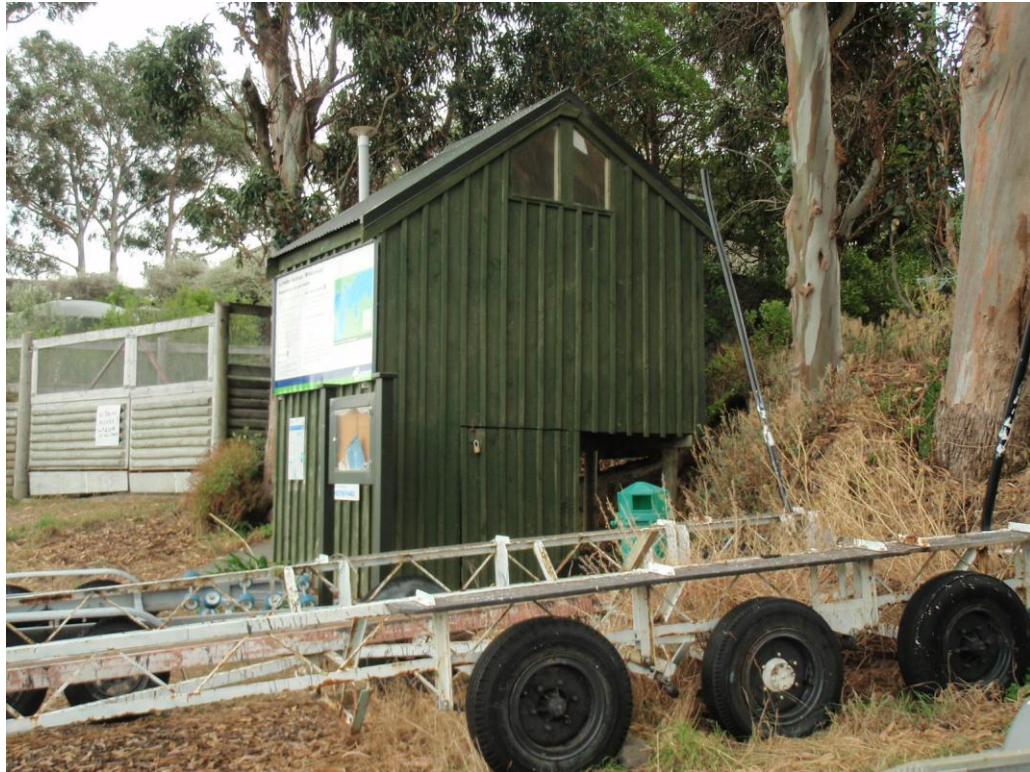
Photograph 3: South elevation

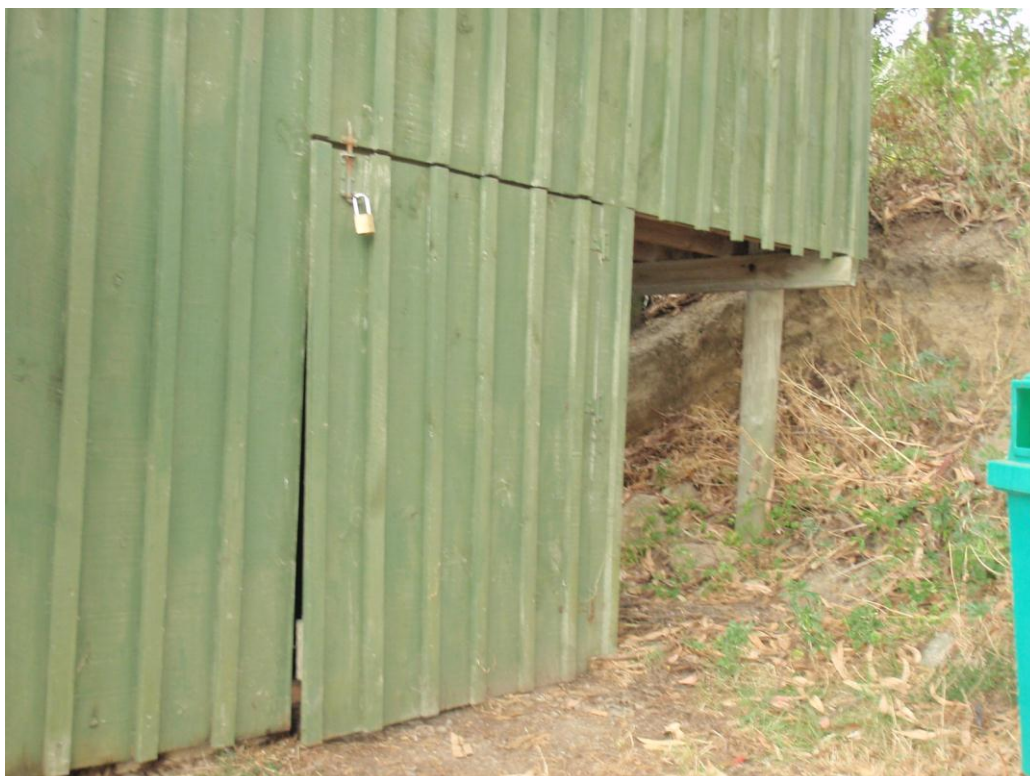
Photograph 4: Access door to subfloor space

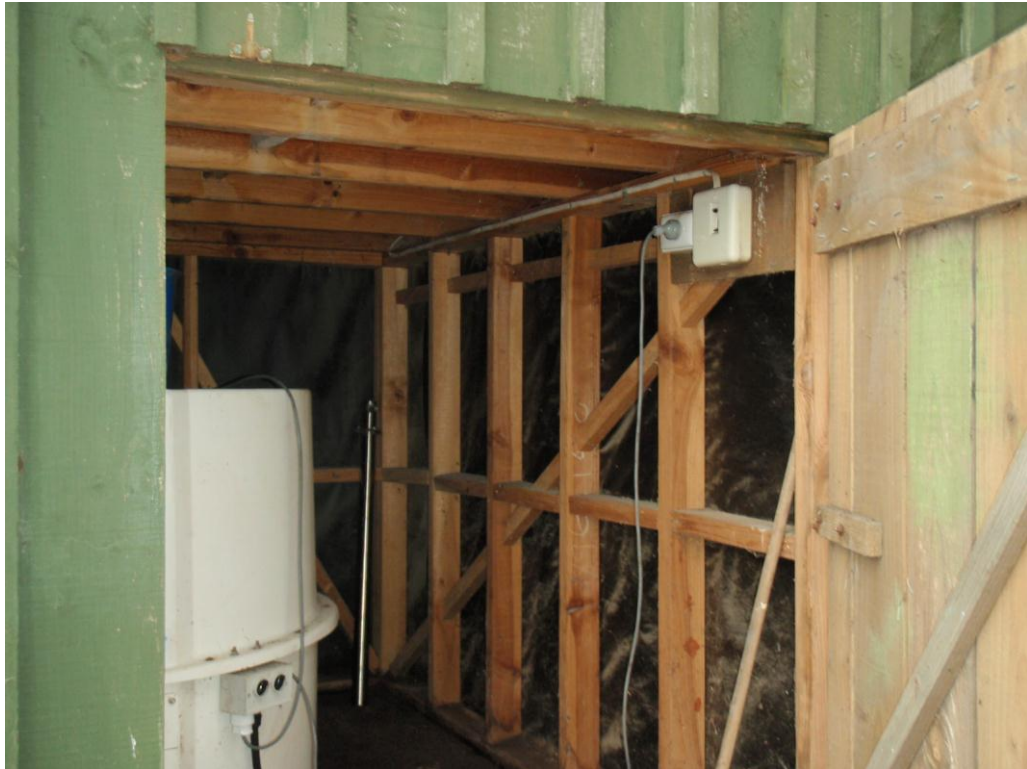
Photograph 5: View of timber framed subfloor walls

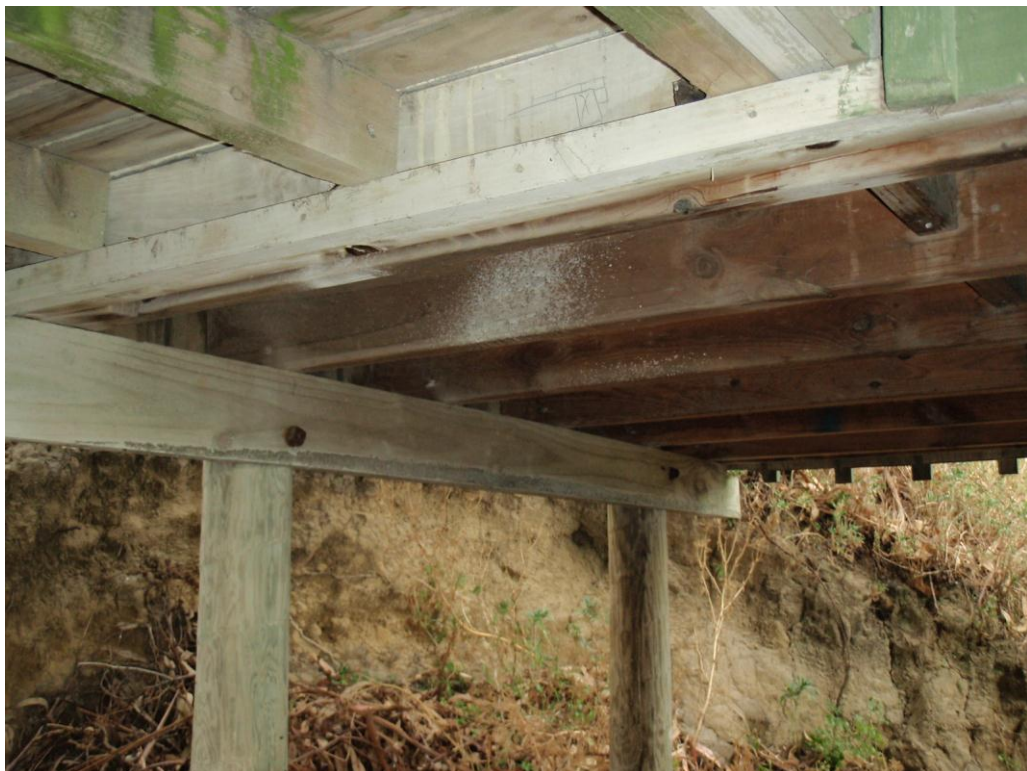
Photograph 6: View of timber bearer and timber piles forming the subfloor structure

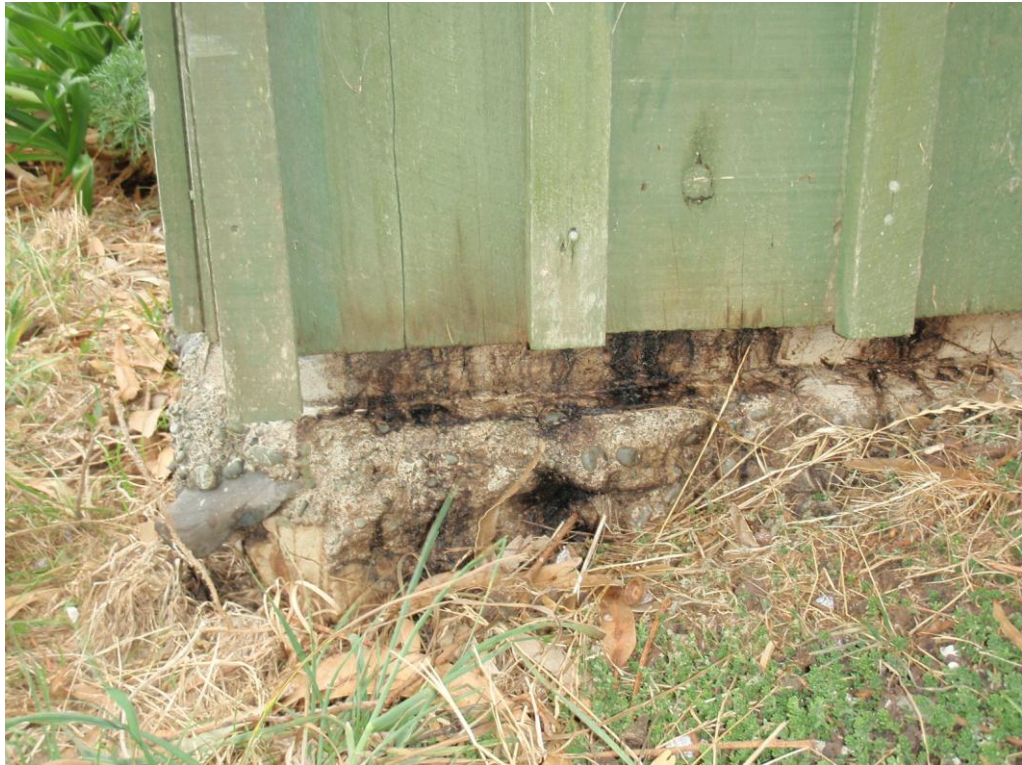
Photograph 7: Concrete slab-on-grade foundation

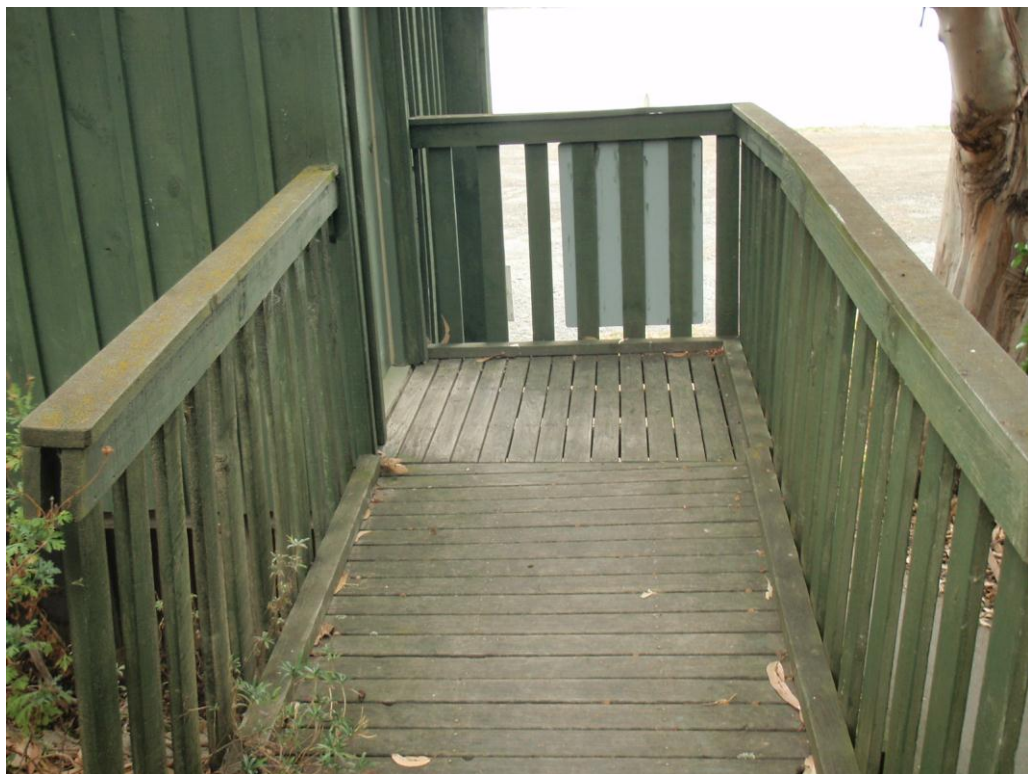
Photograph 8: Timber access ramp

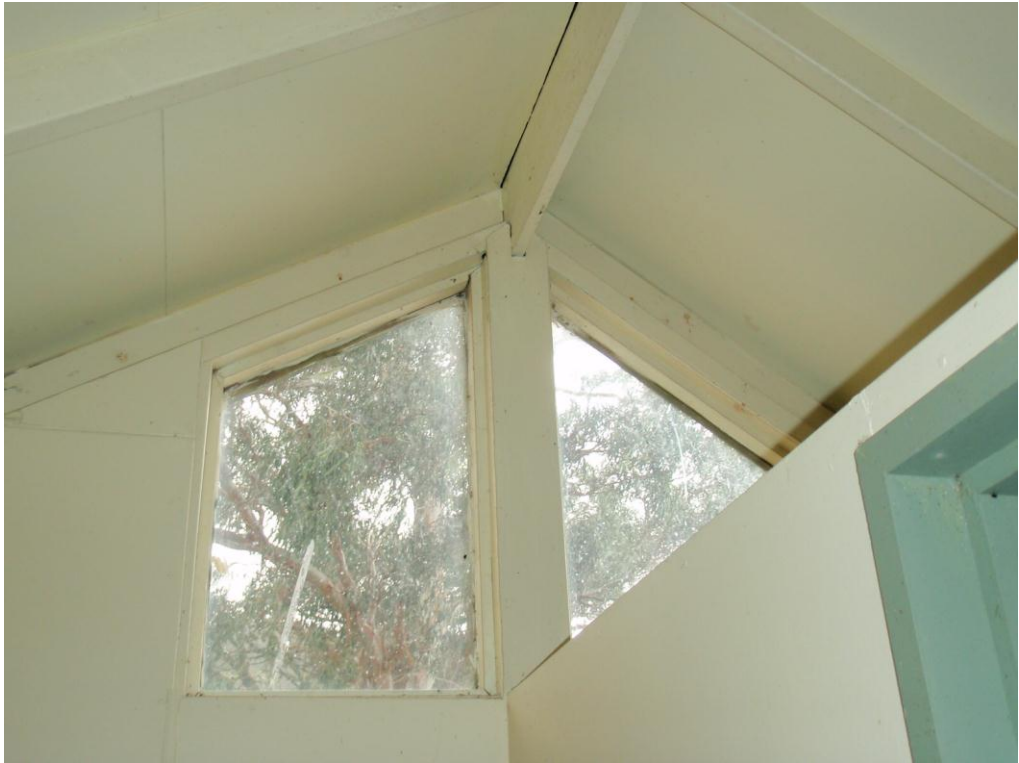
Photograph 9: View of internal walls

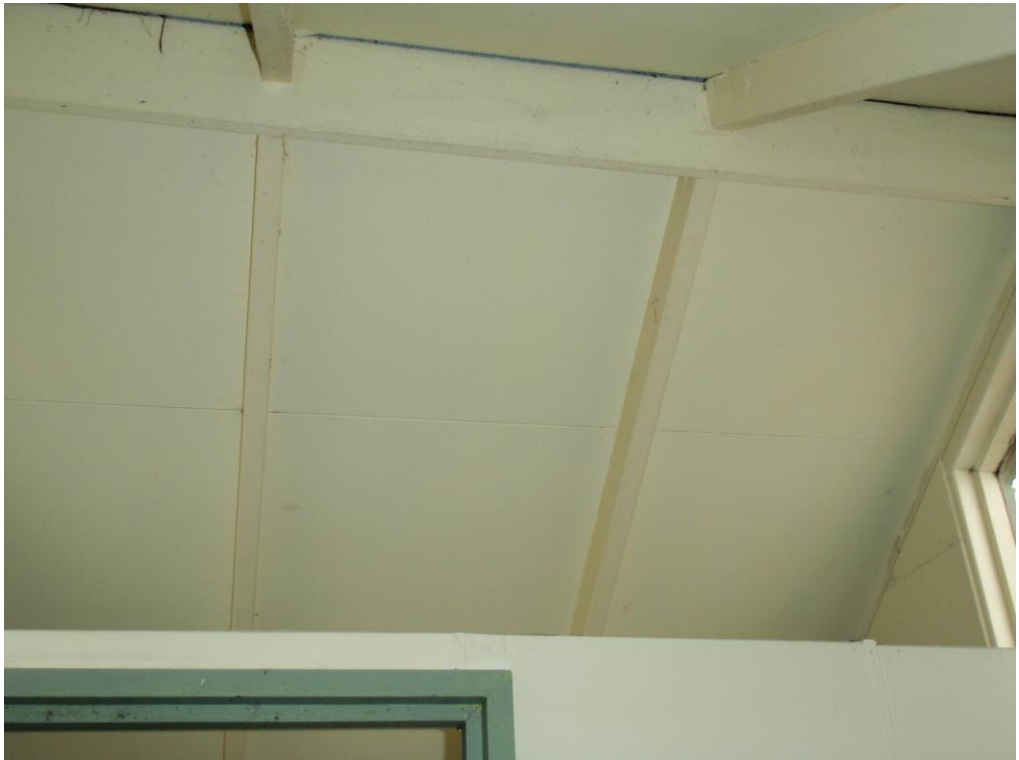
Photograph 10: View of roof rafters and plywood lined ceiling
