# **Collett Courts Complex BE 3516 EQ2**

**Detailed Engineering Evaluation  
Quantitative Assessment Report**

**15 Exeter Place, Lyttelton, Christchurch**

Date: March 2013  
Reference: 6-QUCC1.12  
Status: Final V2

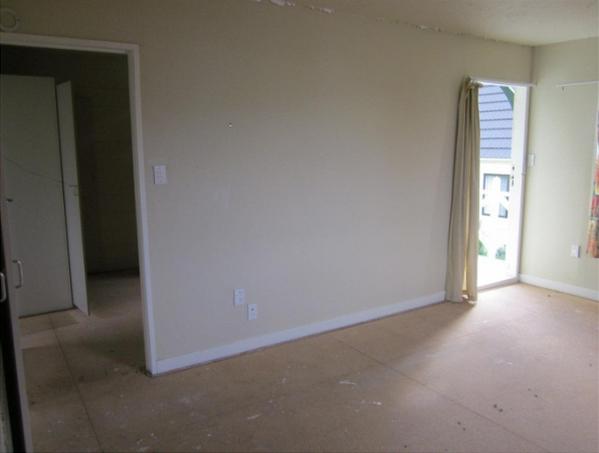
5	Damage in Interior of Unit 3 - cracking along wall to ceiling joint.

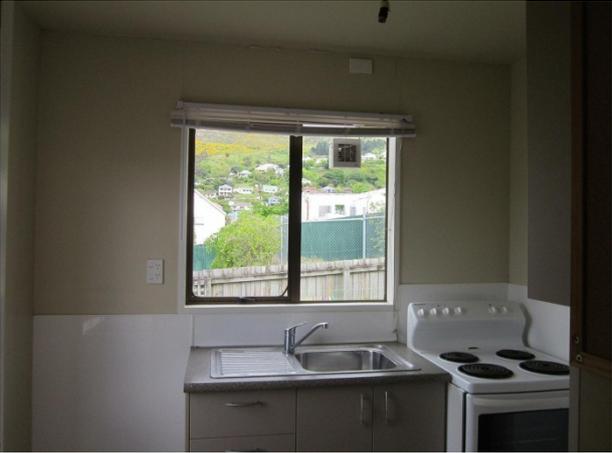
6	Damage in Interior of Unit 3 - cracking along wall to ceiling joint.

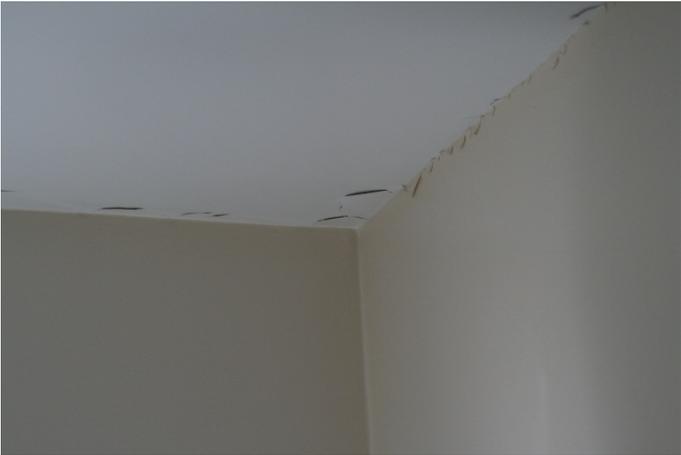
7	Damage in Interior of Unit 3 - cracking along wall to ceiling joint.

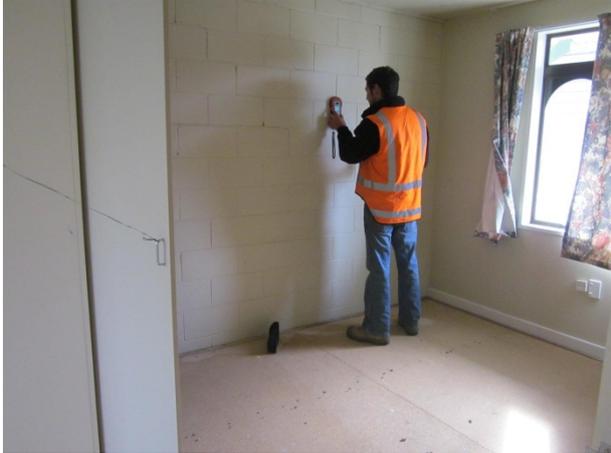
Cracking of the mortar in the masonry block partition wall was observed.

8	Damage in Interior of Unit 3 – minor stepping of mortar joint.

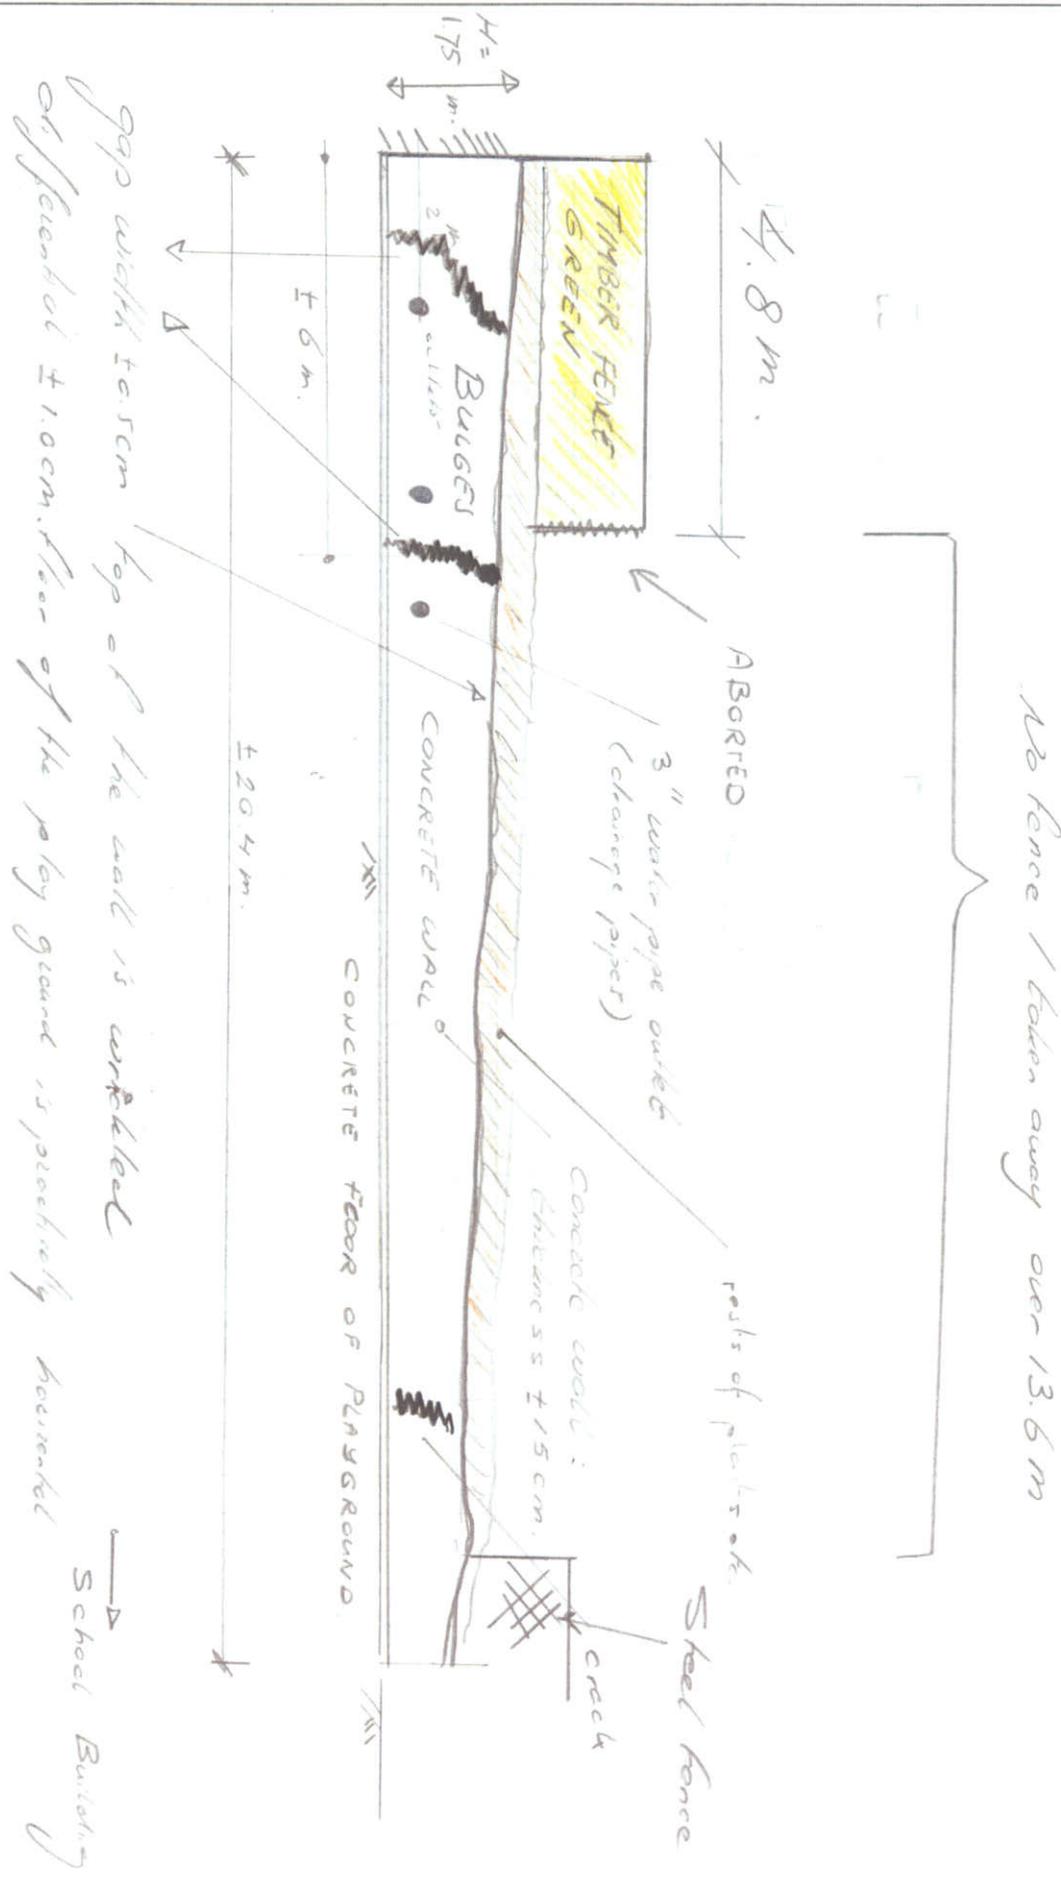
*Inspection notes being maintained. / check on site building*  
 Major defect defects:  
 No fence taken away over 13.6 m

*gap width to 5cm top of the wall is unlevelled*  
*on level to ± 1.00m floor of the play ground is probably horizontal*
