**Denton Oval**  
**BU 0770-003 EQ2**  
Detailed Engineering Evaluation  
Quantitative Report  
Version FINAL

442 Main South Road, Hornby

Christchurch City Council

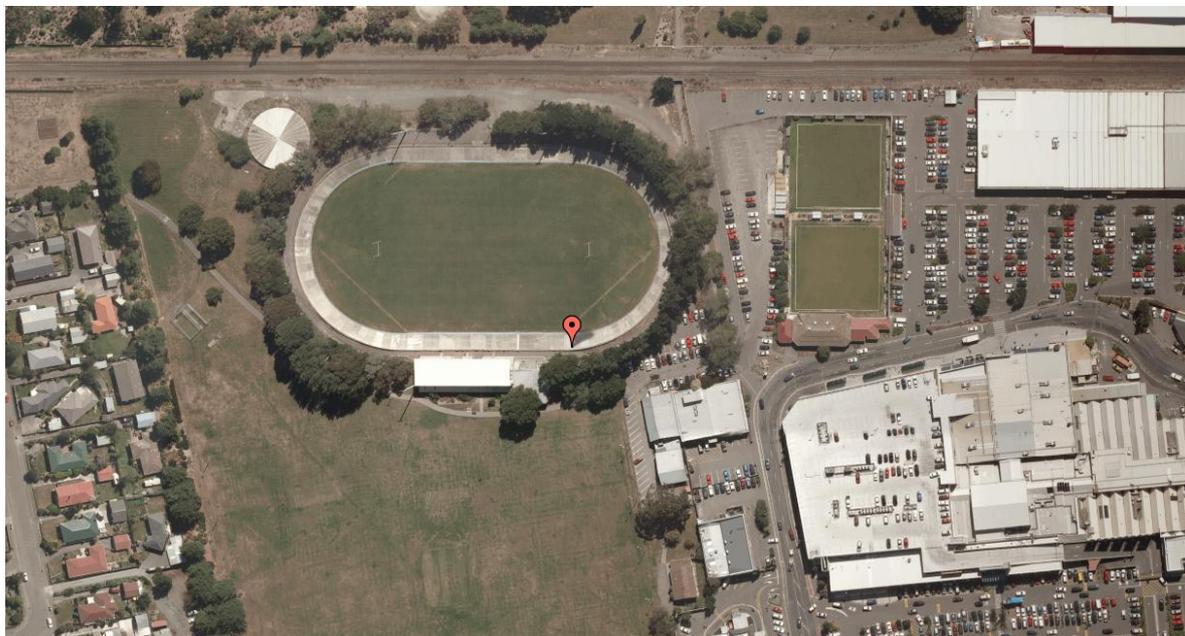
**Figure 8 Post February 2011 Earthquake Aerial Photography<sup>2</sup>**

Aerial photography taken following the 22 February 2011 earthquake (Figure 8) shows no signs of liquefaction outside the building footprint or adjacent to the site.

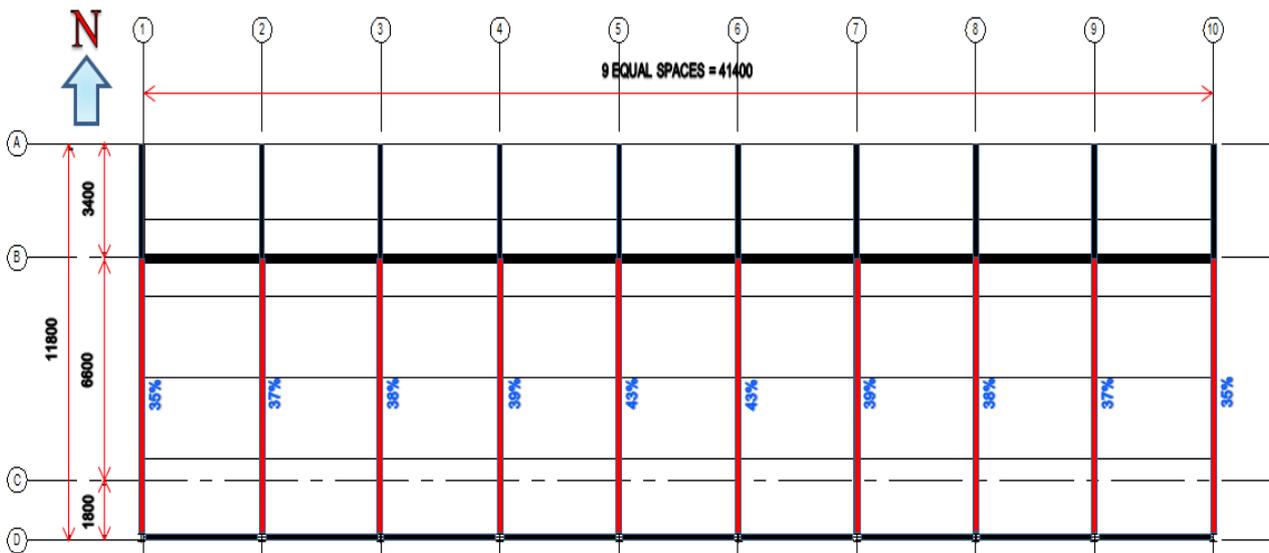
Ten (10) steel rafters rated below 67% NBS and they are highlighted in red in the figure below. The lowest rating achieved is 35% NBS.

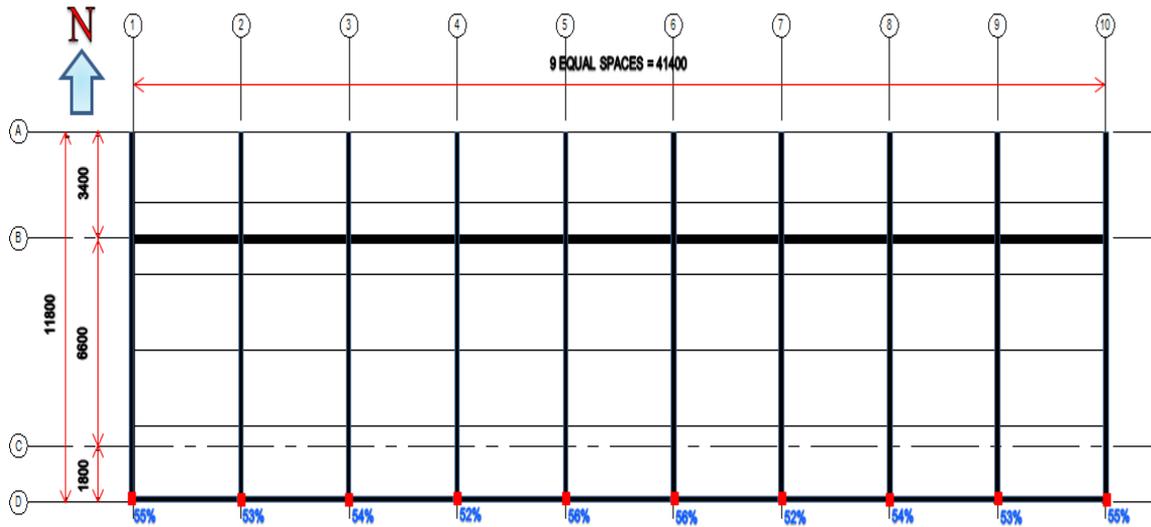
Ten (10) steel columns rated below 67% NBS. They are highlighted in red in the figure below.

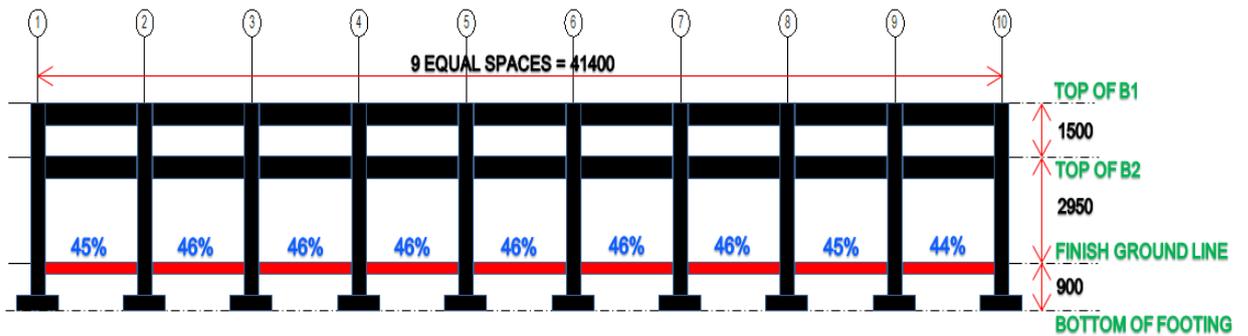
Nine (9) reinforced concrete footing tie beams rated below 67% NBS and they are highlighted in red in the figure below. The lowest rating achieved is 44% NBS.

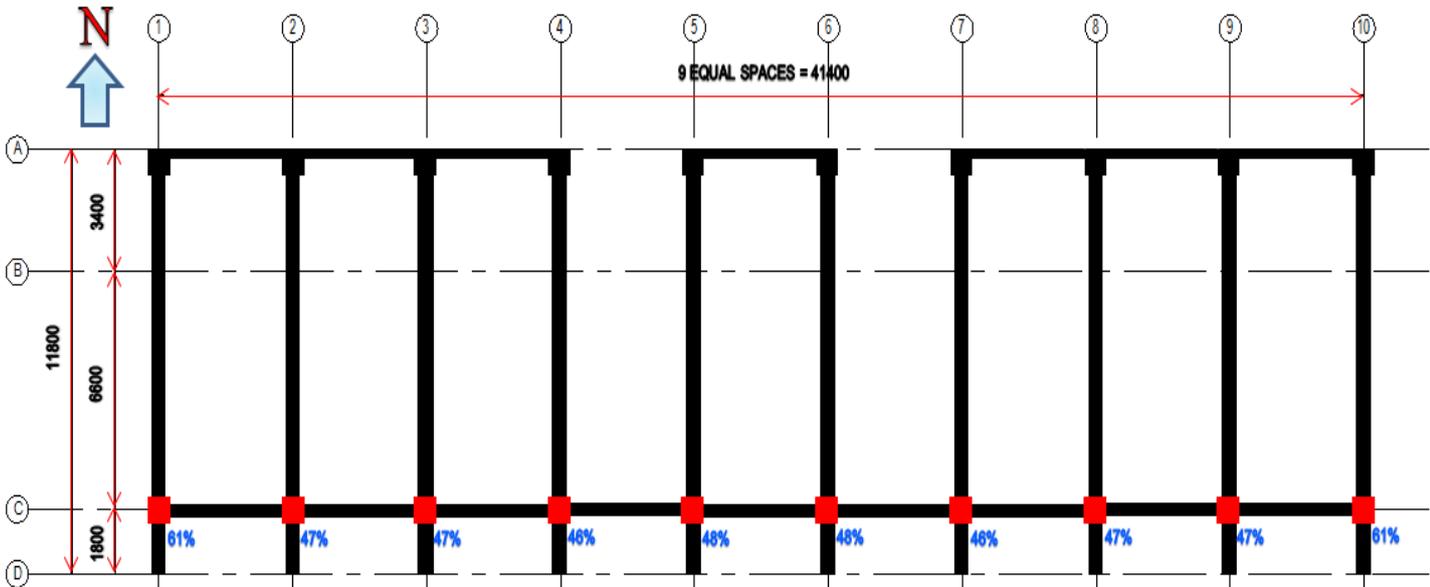
Ten (10) reinforced concrete columns rated below 67% NBS and they are highlighted in red in the figure below. The lowest rating achieved is 52% NBS.

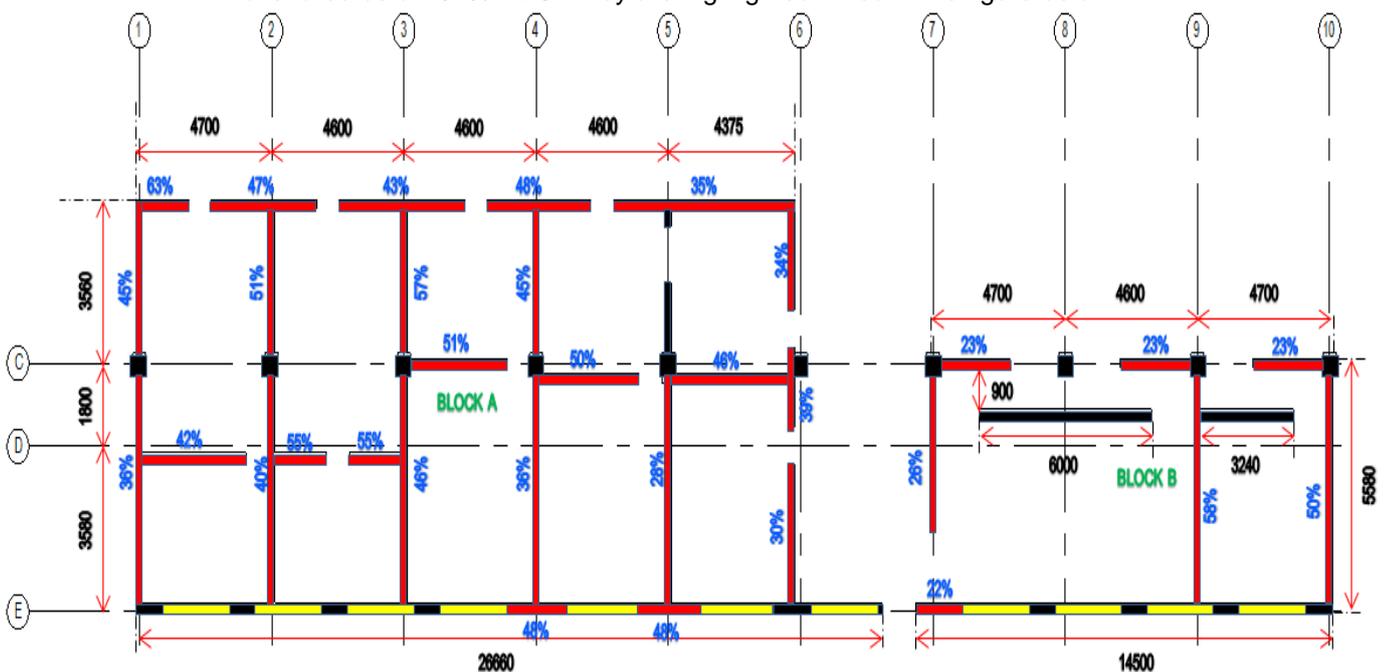
Block A - Three (3) unreinforced masonry wall rated below 34% NBS and twenty two (22) unreinforced masonry walls rated below 67% NBS. They are highlighted in red in the figure below.

Block B - Five (5) unreinforced masonry wall rated below 34% NBS and two (2) unreinforced masonry walls rated below 67% NBS. They are highlighted in red in the figure below.

Based on the quantitative analysis done for the structure, it is found that the lowest rating achieved is 22% NBS. This rating comes from the unreinforced masonry wall in Block B of Amenity building. This is to be expected since there is virtually no vertical or horizontal reinforcement present in the walls. It would appear that the amenity building, considering the materials used and the prevailing codes and standards at the time it was constructed, serves only to carry gravity loads and not lateral loads.

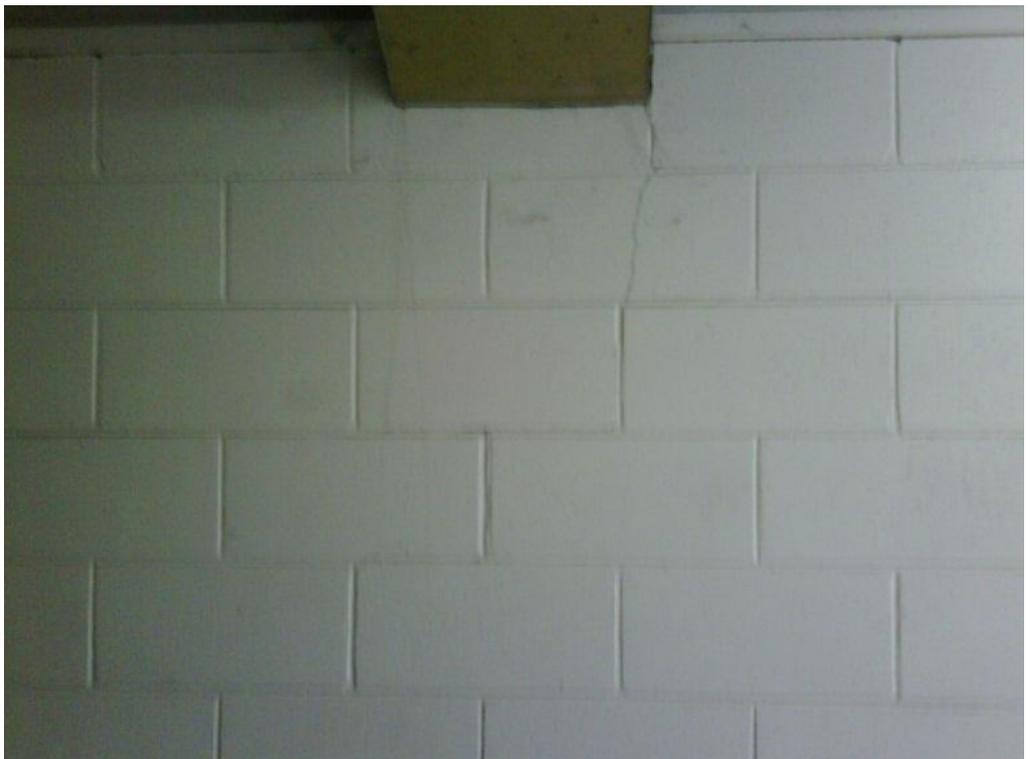
Minor cracking was noted in the concrete masonry partition wall that was built around one of the beams supporting the stand seating as can be seen in Photograph 6.

**Photograph 6 Cracking in concrete masonry wall where beam has moved relative to the wall.**

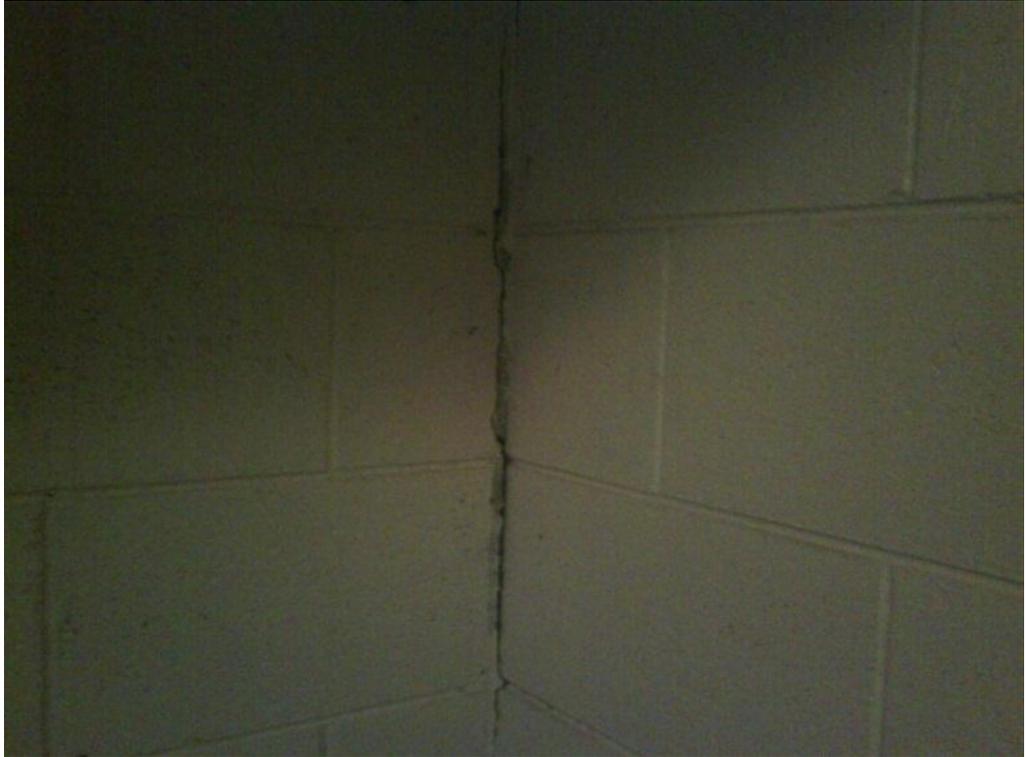
Minor cracking was also noted in a number of the concrete masonry walls of the changing room areas. These cracks have typically occurred around the doorways and in the corners of the rooms as can be seen in Photograph 7.

**Photograph 7 Cracking in the corner between concrete masonry walls in changing rooms.**

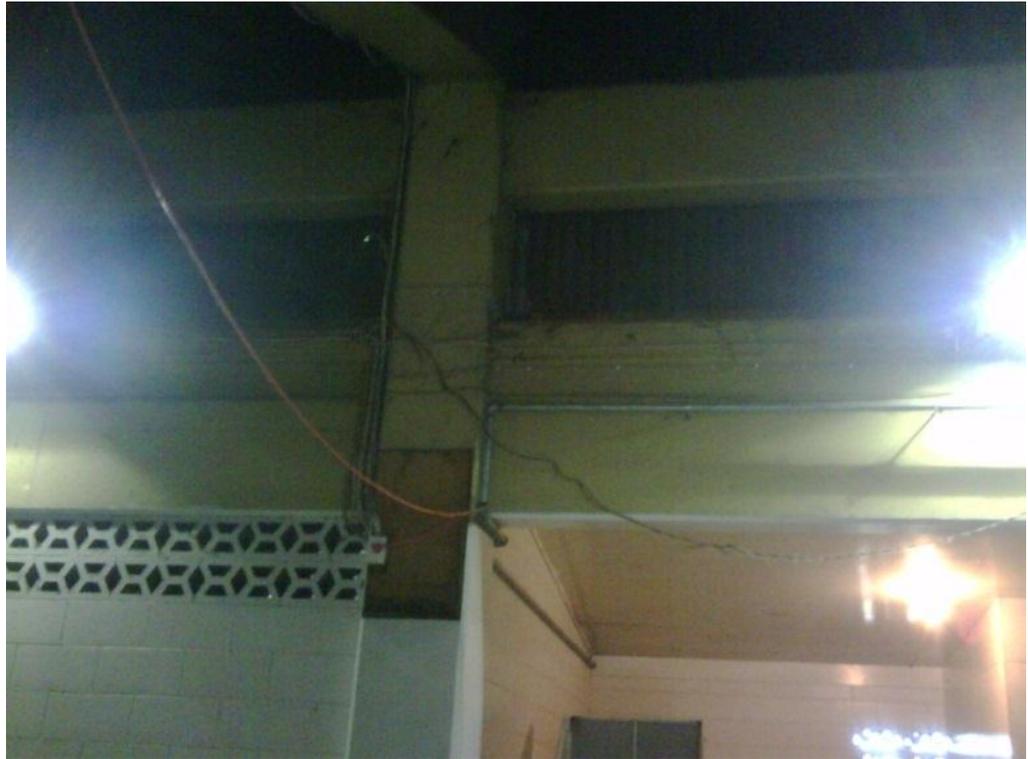
**Photograph 11 Beam-column joints in frame running along building. Note the short column between the beams.**
