# **Dover Courts Housing Complex PRO 0619**

**Detailed Engineering Evaluation  
Quantitative Assessment Report**

**26 Dover Street, St Albans,  
Christchurch 8014**

Date: September 2013  
Reference: 6-QC337.00  
Status: Final

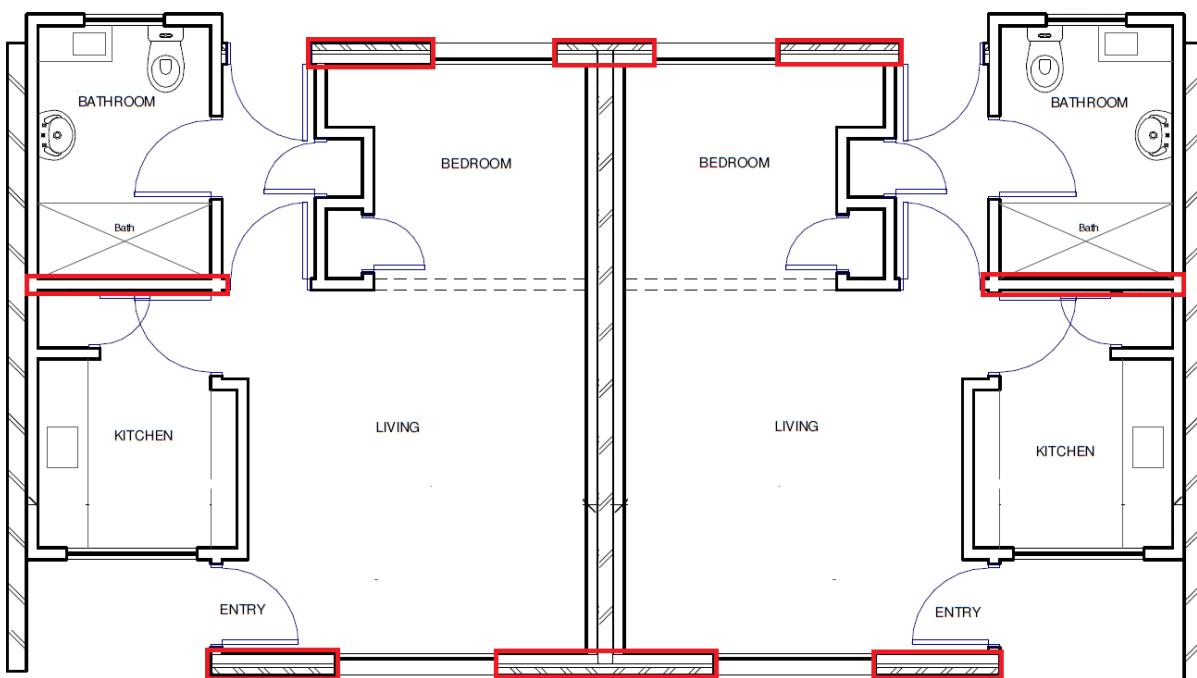
**Figure 6: Walls used for Bracing in the Longitudinal Direction.**

The residential units have capacities of 58% NBS and are limited by the in-plane shear capacity lined timber-framed shear walls in the longitudinal direction.

Building Description	Critical element	% NBS based on calculated capacity in longitudinal direction	% NBS based on calculated capacity in transverse direction.
Blocks A-G	Bracing capacity of structural walls.	58%	100%

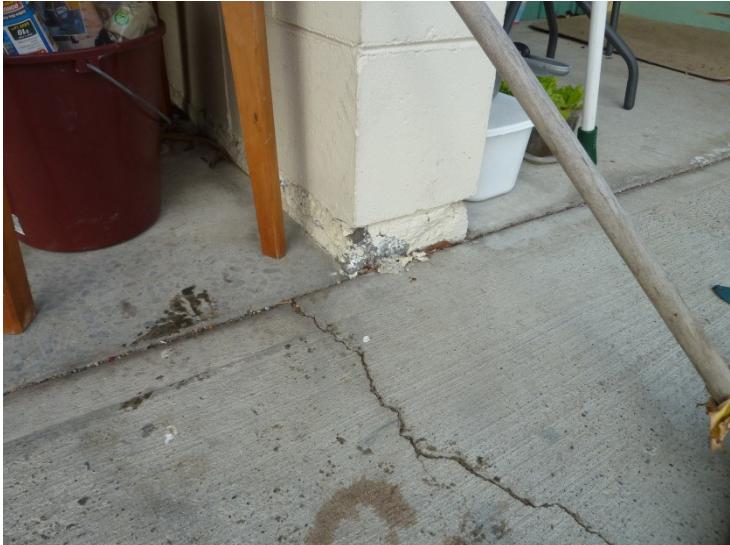
4	Cracking of exterior pavement.

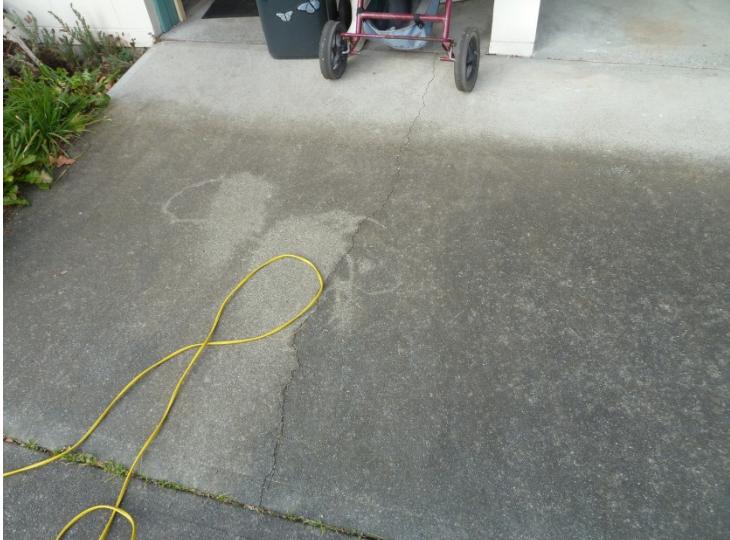
5	Cracking of exterior pavement.

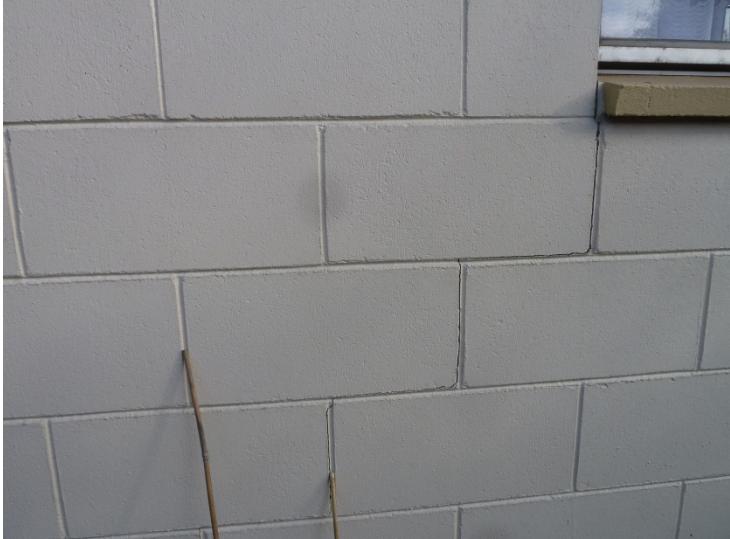
Stepped cracking in the concrete block veneer exterior cladding mortar joints was observed on some units (Photo 6 and 7).

6	Stepped cracking of block veneer cladding.

- All buildings be strengthened to at least 67% NBS.
- Veneer at height (gable ends) have the veneer ties checked.
- Cosmetic repairs are undertaken.

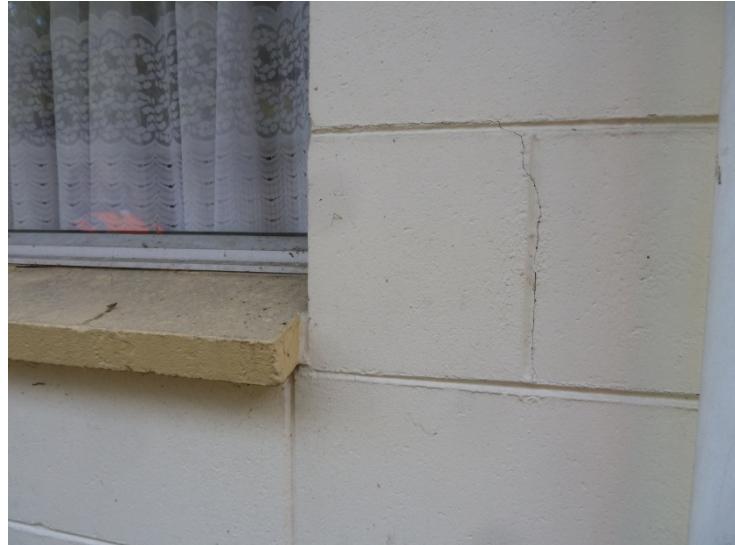
7	Stepped cracking of block veneer cladding.

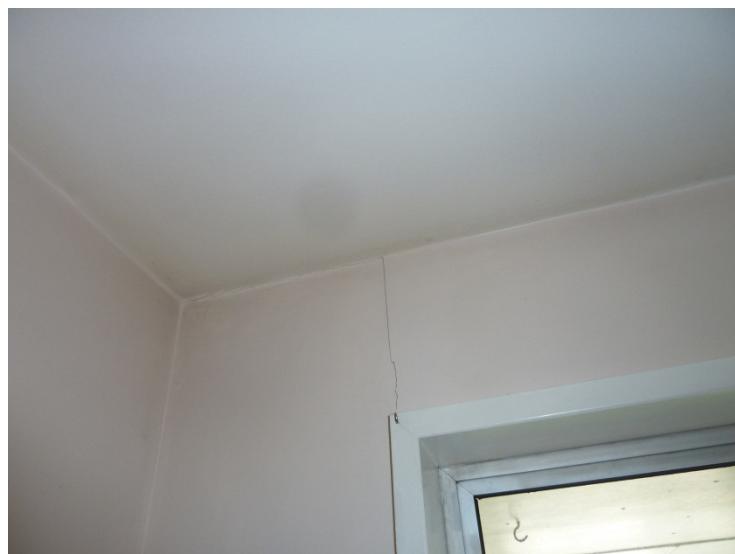
Minimal cracking of plasterboard ceiling diaphragms and wall linings was observed in the units. This form of damage is common throughout the units.

9	Typical cracking to plasterboard wall lining above window.
