CHRISTCHURCH CITY COUNCIL
BU 0572-001 EQ2
Edgar McIntosh Park – Plant Room
Condell Avenue, Papanui

QUALITATIVE ASSESSMENT REPORT

- Rev B
- 05 November 2012

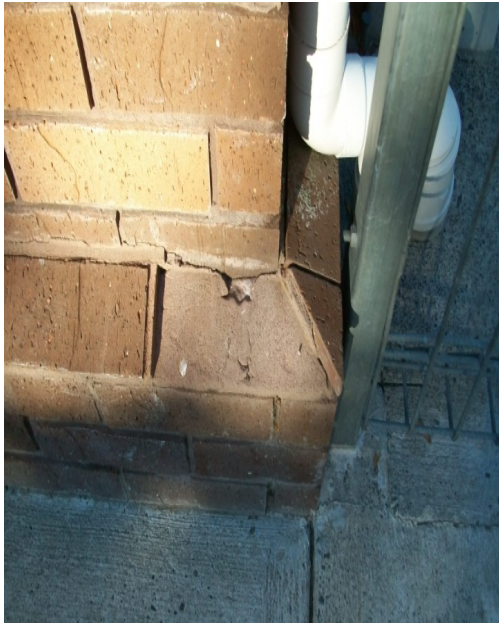
- 1) Various capping bricks around the top of the foundations have come loose or fallen off. Similar damage also occurs around the base of the pergola columns. (PHOTO 5, 6, 7 & 8)
- 2) Guttering along the north face has been damaged, however this most likely due to the heavy snow loads experienced in Christchurch in 2011 and therefore is not earthquake damage. (PHOTO 2 & 3)
- 3) No visual evidence of settlement was noted at this site. Therefore a level survey is not required at this stage of assessment.

Photo 5: Missing Capping Brick at the Top of The Foundation

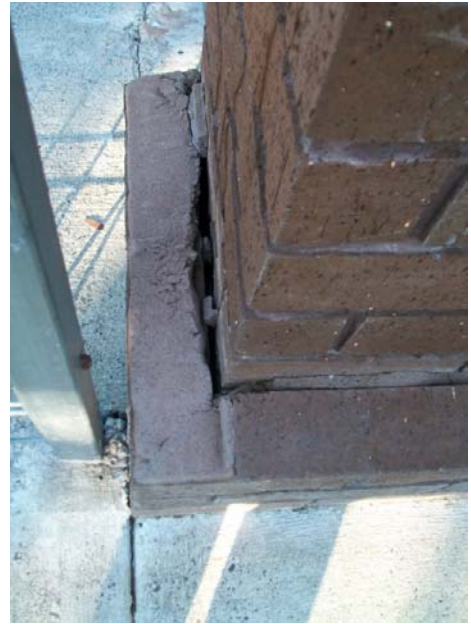
Photo 6: Missing Capping Bricks at the Top of The Foundation

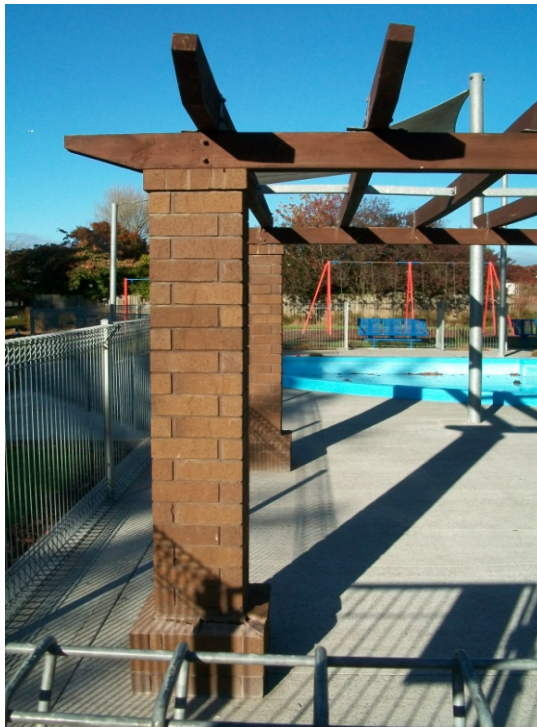
Photo 7: Pergola Column

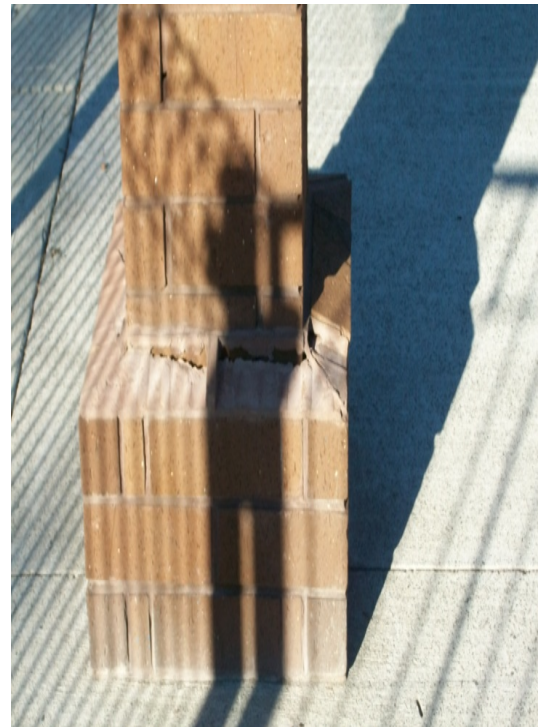
Photo 8: Missing Capping Bricks

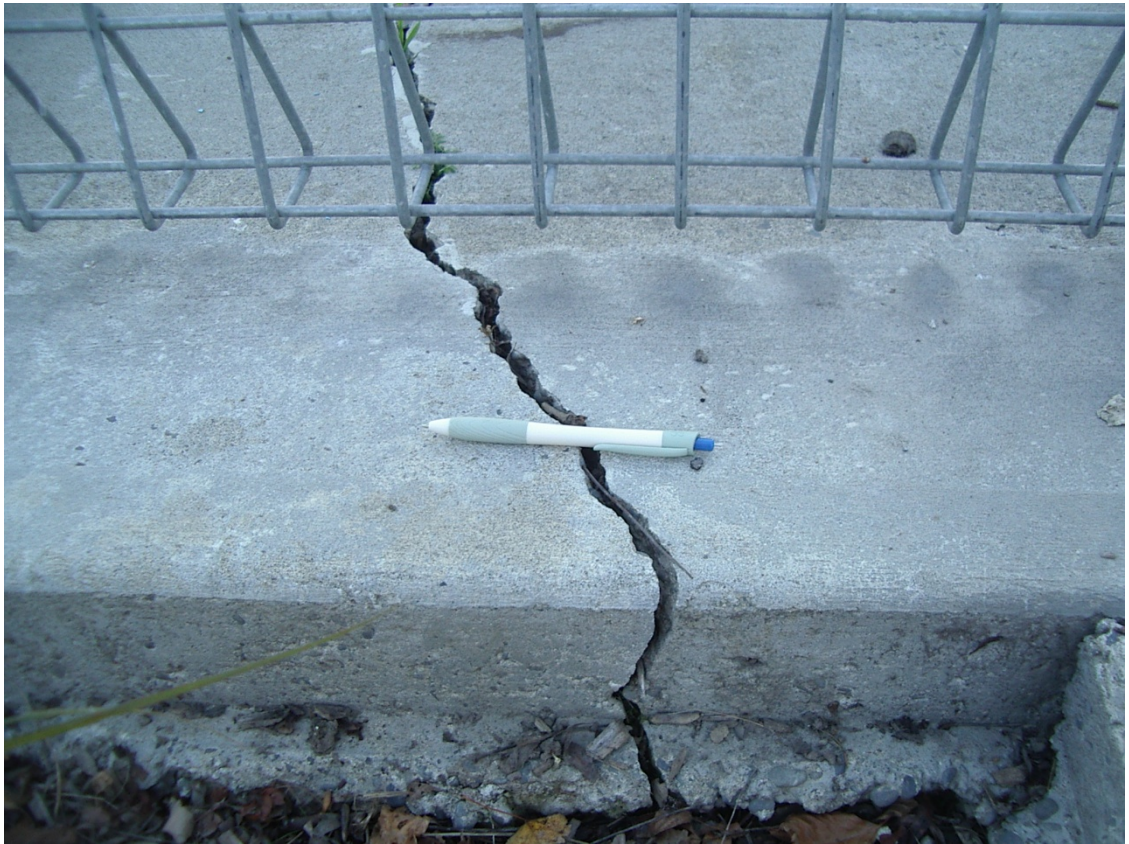
There was no further land damage noted on the grassed area surrounding the playground, there is no evidence of liquefaction having occurred. However, there is slight differential settlement of some concrete paving around the park area.

■ **Figure 6 Observed cracking around the seating area near the paddling pool**

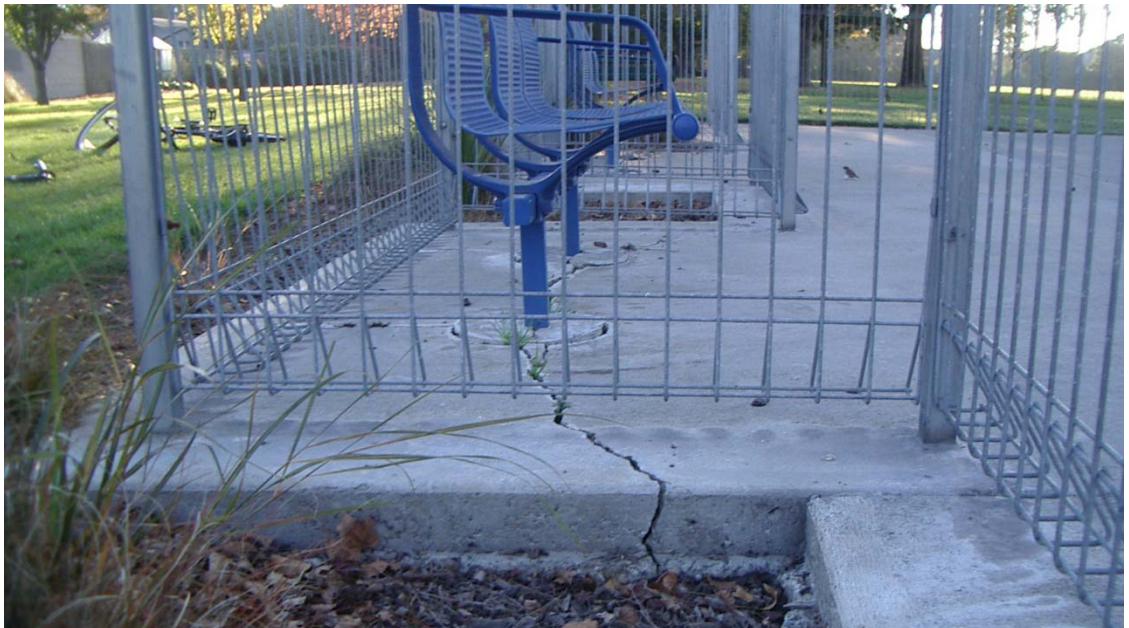
■ **Figure 7 Observed cracking around the seating area**
