Elmwood Park Toilets  
Qualitative Engineering Evaluation

**Reference:** 229182

**Prepared for:**  
Christchurch City  
Council

Functional Location ID: PRK 0590 BLDG 001 EQ2

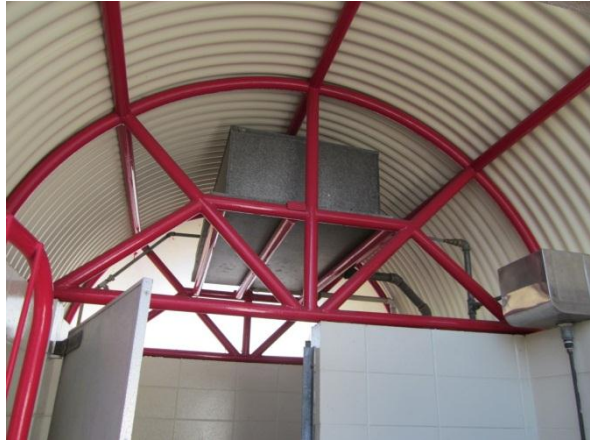
Interior view of steel trusses.

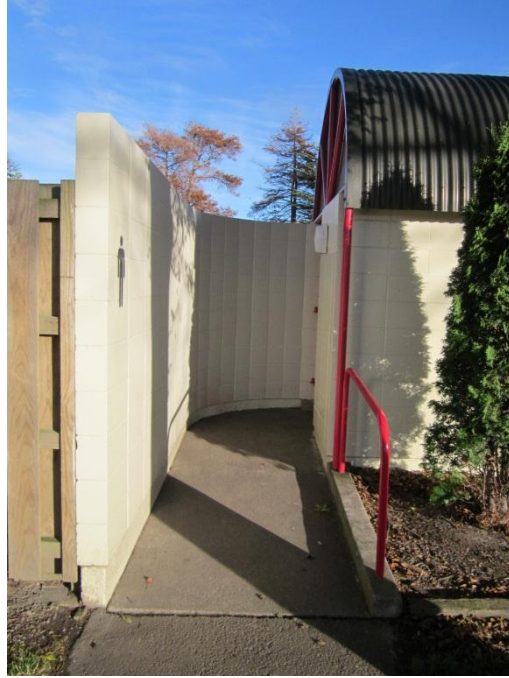
View of external reinforced concrete block-walls (South end).

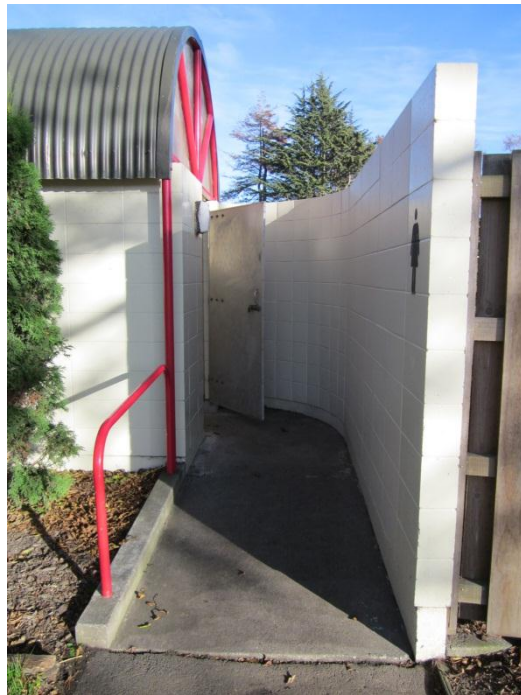
View of external reinforced concrete block-walls (North end).

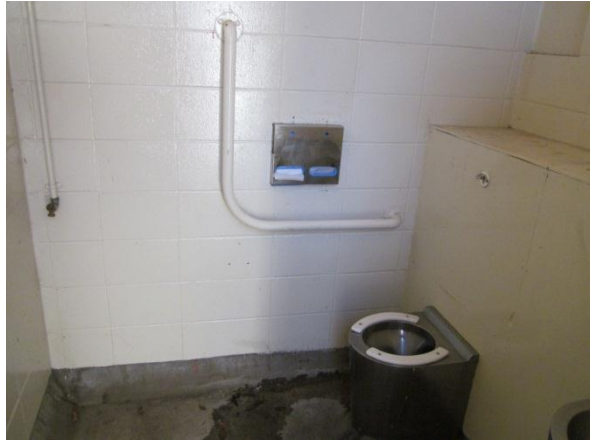
Interior view of reinforced concrete block-walls.

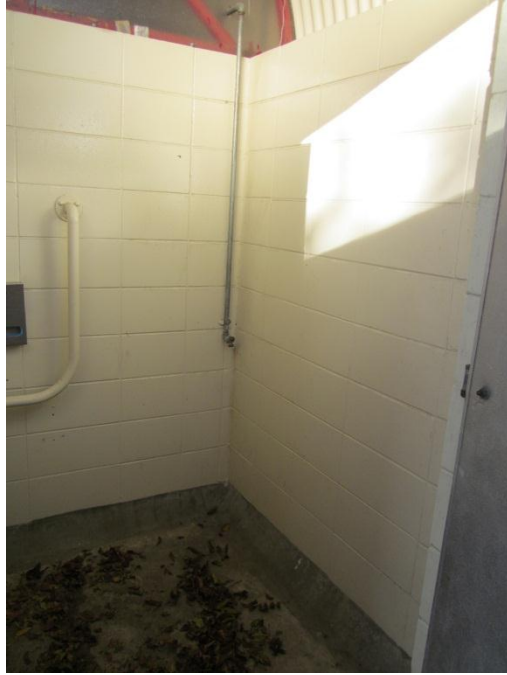
Interior view of reinforced concrete block-walls.
