# **Governors Bay Pool Shed by Playground BU 3569-001 EQ2**

**Detailed Engineering Evaluation  
Quantitative Assessment Report**

Date: 20 February 2013  
Reference: 6-QUCCC.61  
Status: Final

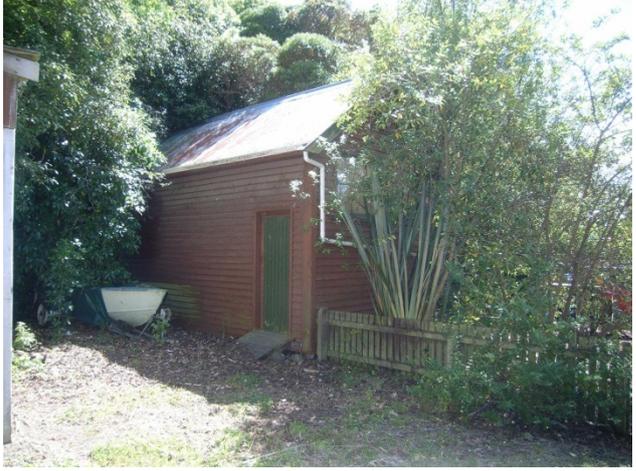
Site Name		
No.	Item description	Photo
General		
1.	Rear and end walls

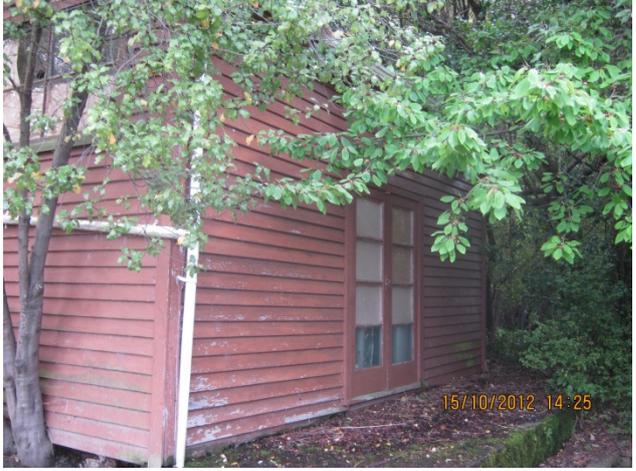
2.	Front and end walls

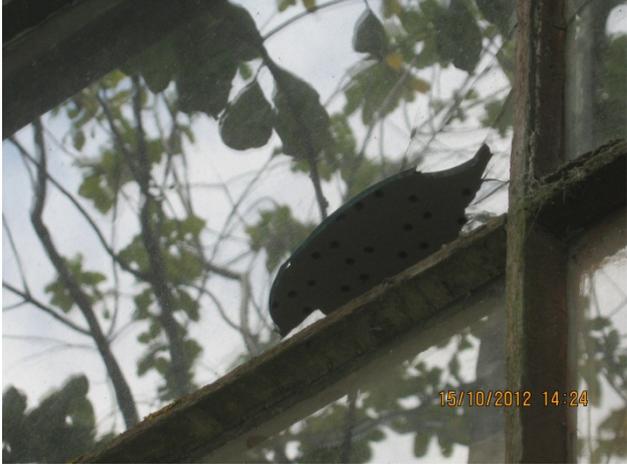
No significant structural damage has been observed following visual inspections undertaken following the 22 February earthquake. However, a portion of glazing has been damaged, indicating that large displacements may have occurred during seismic activity.

3.	Glazing damage

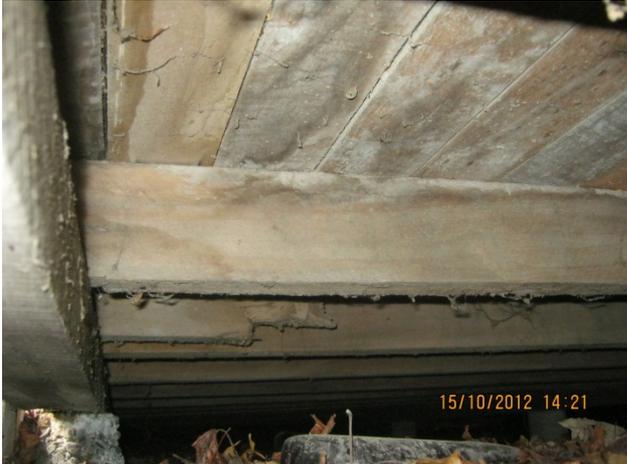
The structure has been found to have a seismic capacity of 48%NBS due to a lack of tie down in the connection between floor bearers and footings and therefore is not classed as an earthquake prone building.

Although 48%NBS may appear low, this building is not considered as a significant hazard. This is due to the expectation that, if the footing tie down were to fail during a seismic event, the consequences would be minimal given that the structure sits on ground on one side and only 200mm off the ground on the other side.

4.	No connection between bearer and pile evident

- (a) Strengthening options be developed to increase the seismic capacity of the shed to at least 67%NBS.
- (b) The maintenance issue of the rotting timber members around the base of the structure is considered by CCC in the future.

<b>Recommendations</b>	Level of repair/strengthening required: <u>minor structural</u>	Describe: <u>floorboards to be removed for new bearer</u>
	Building Consent required: <u>no</u>	Describe: <u>to pier connections</u>
	Interim occupancy recommendations: <u>full occupancy</u>	Describe: <u></u>
Along	Assessed %NBS before: <u>48%</u>	##### %NBS from IEP below
	Assessed %NBS after: <u>48%</u>	If IEP not used, please detail assessment methodology: <u>Quantitative</u>
Across	Assessed %NBS before: <u>48%</u>	##### %NBS from IEP below
	Assessed %NBS after: <u>48%</u>

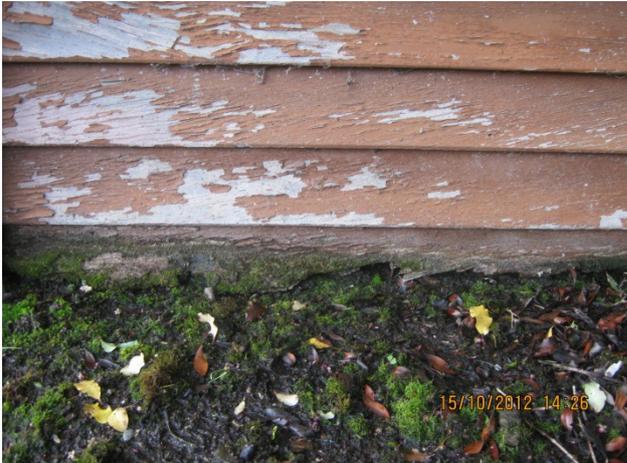
The timber members around the base of the structure are showing signs of rot, although this is not as a result of seismic activity, it is a maintenance issue.

5.	Evidence of rot on timber members around base

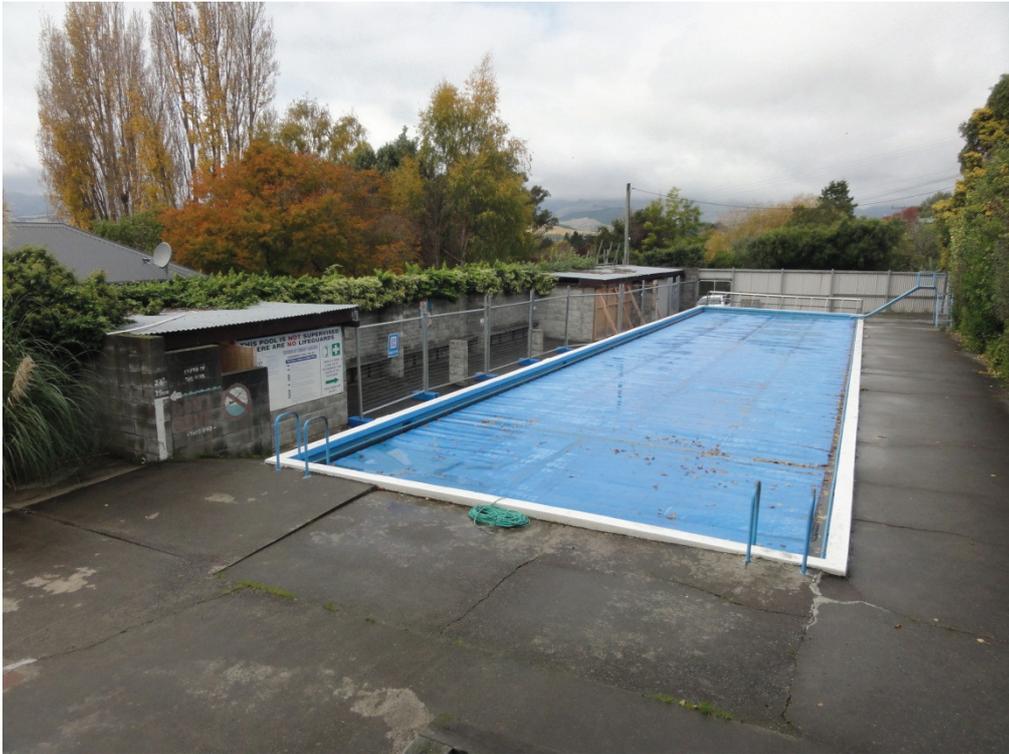
**Photo 1.** Pool service building on left, with concrete block wall on boundary. Note site slopes gently to far back left (SE)

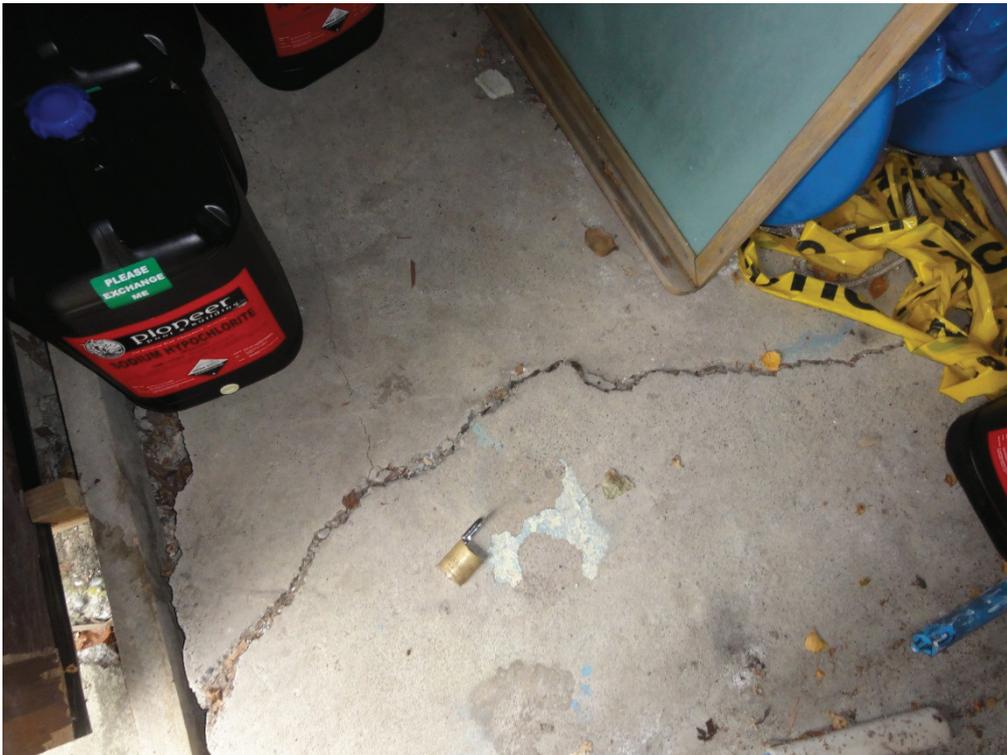
however no level survey has been completed. There was some differential settlement noted on paths around the pool. Discussions with the pool caretaker indicate cracking in the storeroom floor slab and paths was existing prior to the September 2010 earthquake.

**Photo 2.** Store room floor slab cracking

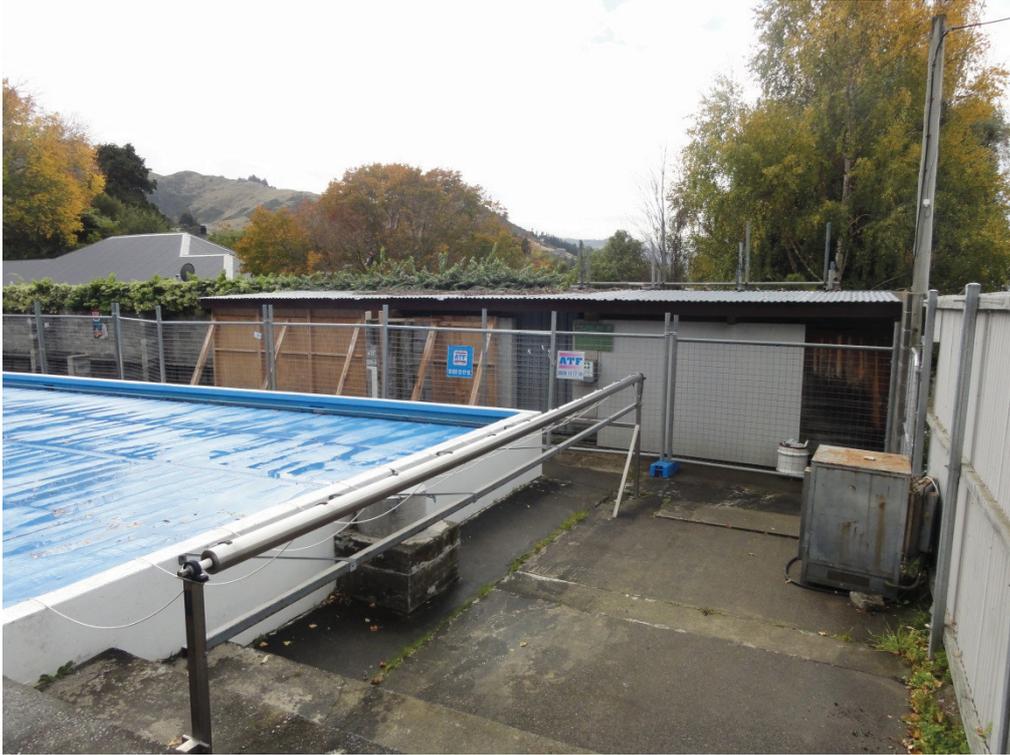
Cracking of the walls of the hollow concrete block buildings has occurred to the Governors Bay Pool buildings at 1 Cresswell Ave due to the Canterbury Earthquake Sequence following the 4 September 2010 earthquake. This has resulted in building closure, and propping of the structure has been required.

**Photo 3** Extensive propping of building. Paving slabs around pool tilted.

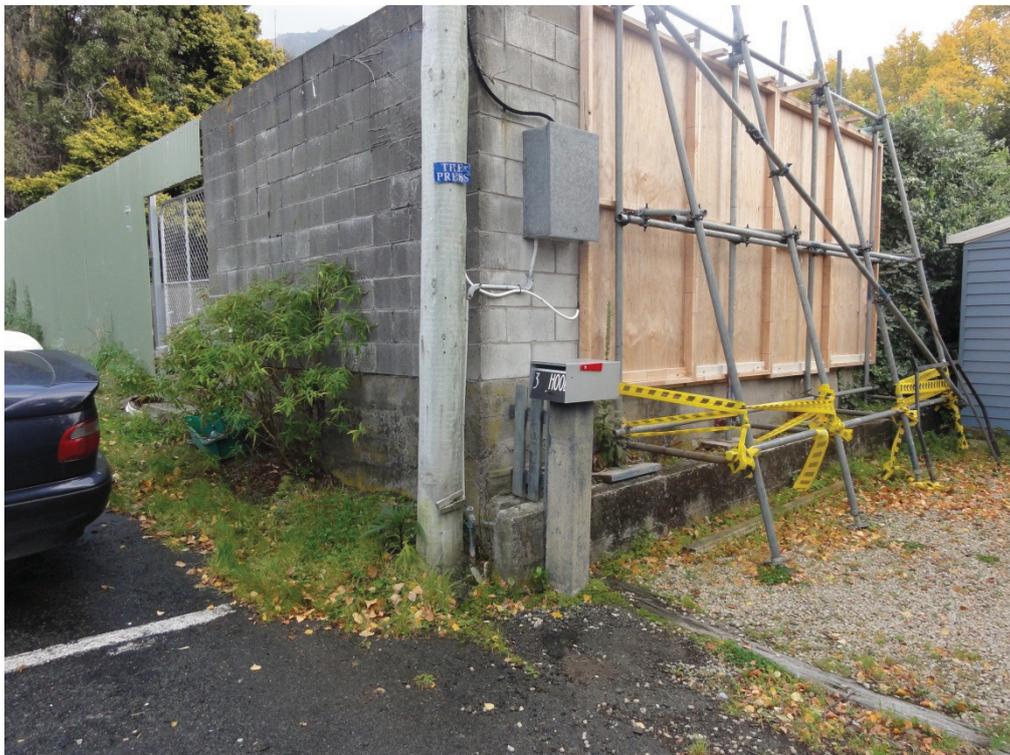
**Photo 4.** Blockwork on SE corner of building at back of storeroom propped.
