Christchurch City Council  
PRK\_3035\_BLDG\_002  
Greenwood Park Shed  
450 Summit Road

QUANTITATIVE REPORT  
FINAL

- Rev B
- 25 September 2013

QUANTITATIVE ASSESSMENT REPORT

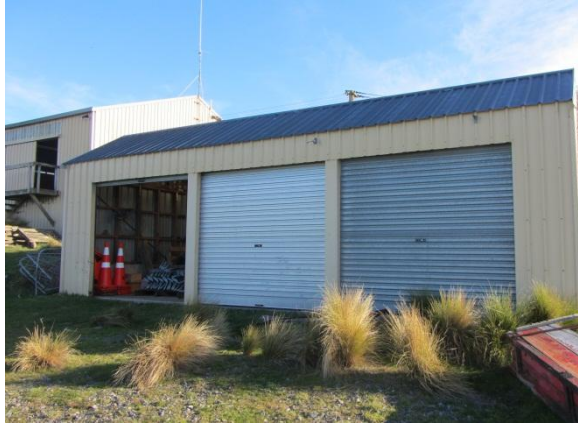
Photo 1: East elevation

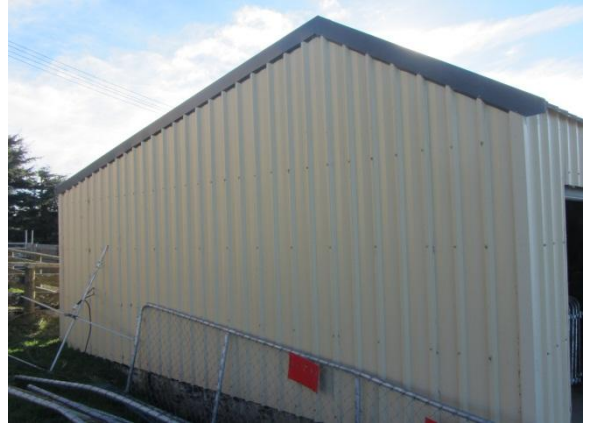
Photo 2: South elevation

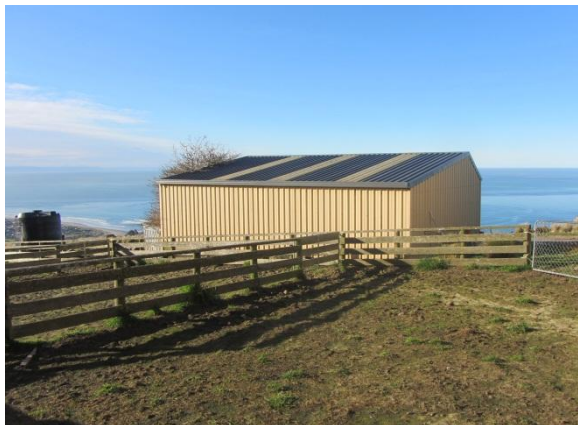
Photo 3: West elevation

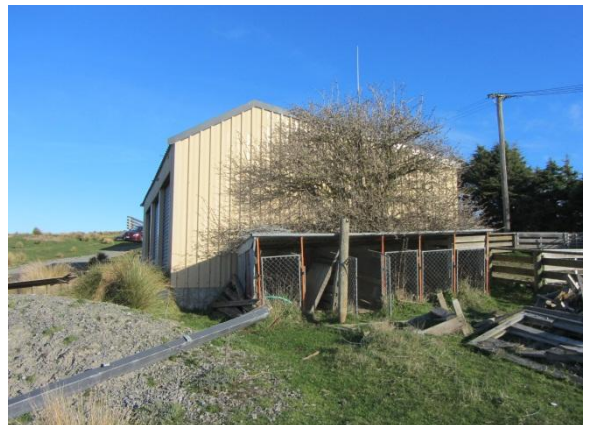
Photo 4: North elevation

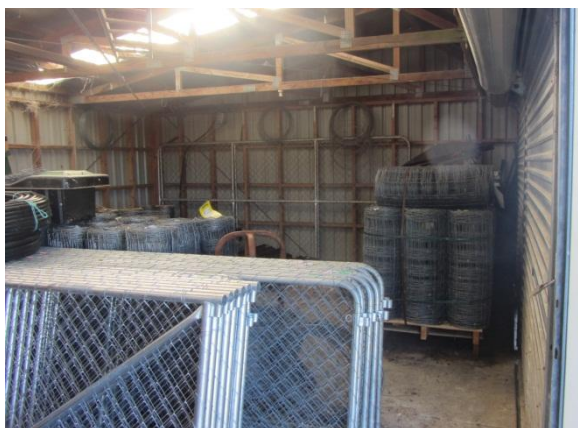
Photo 5: Interior view of north wall

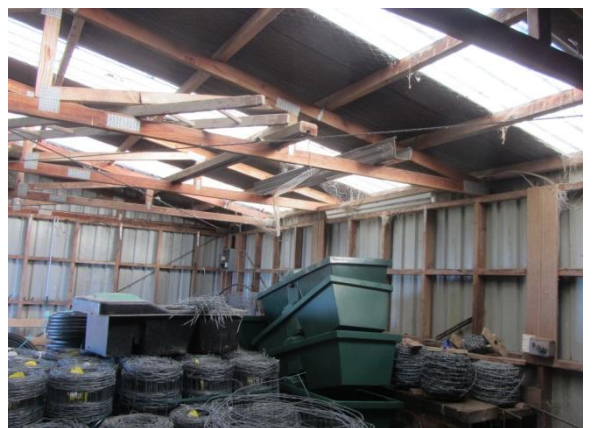
Photo 6: Interior view looking along west wall

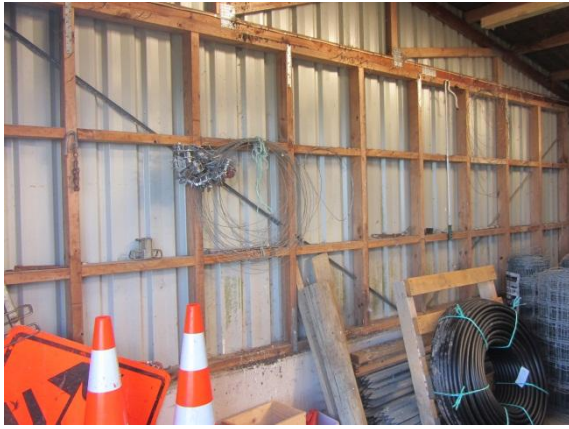
Photo 7: Interior view of south wall

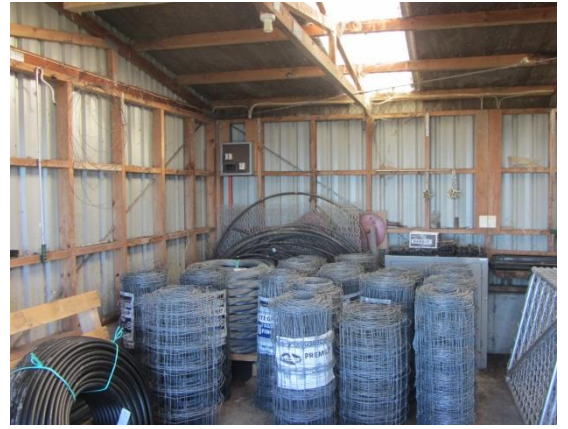
Photo 8: Interior view of west wall

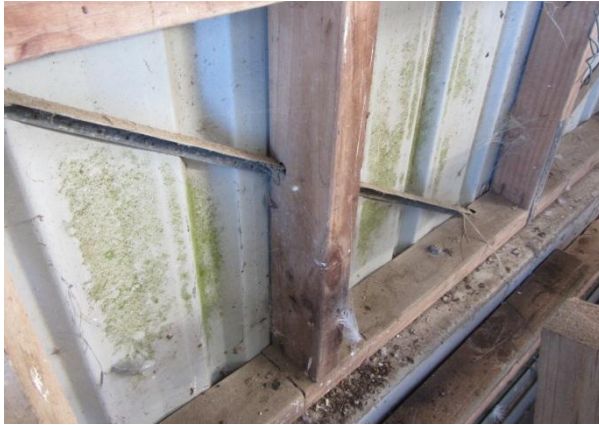
Photo 9: Close up view of the angle brace on south wall.

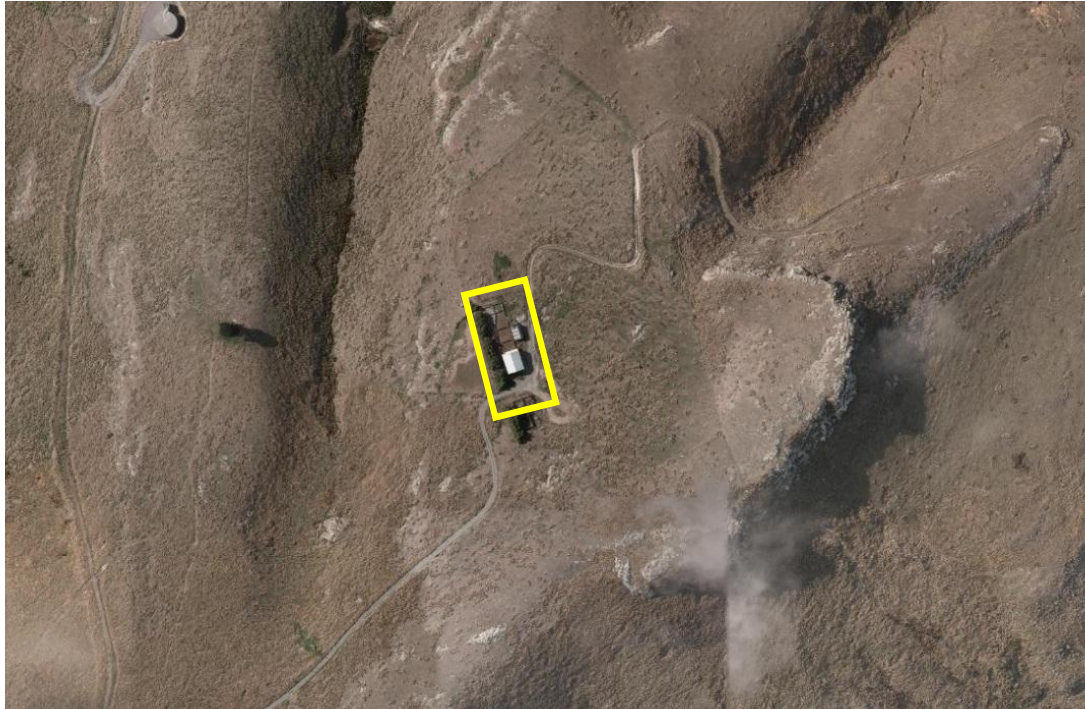
- **Figure 4 – Aerial photography from 24 Feb 2011 ([http://maps.cera.govt.nz/advanced-viewer/?Viewer=CERA\\_\\_Public](http://maps.cera.govt.nz/advanced-viewer/?Viewer=CERA__Public))**

Aerial photography taken after the 22 February 2011 event shows no evidence of land damage in the vicinity of the site. There is a rock bluff located to the east of the site; however rockfall would travel to the east away from the site.
