Christchurch City Council  
PRK\_0348\_BLDG\_002 EQ2  
Groynes Toilet & Yacht Club Pavilion  
182 Johns Rd

QUALITATIVE REPORT  
FINAL

- Rev B
- 23 September 2013

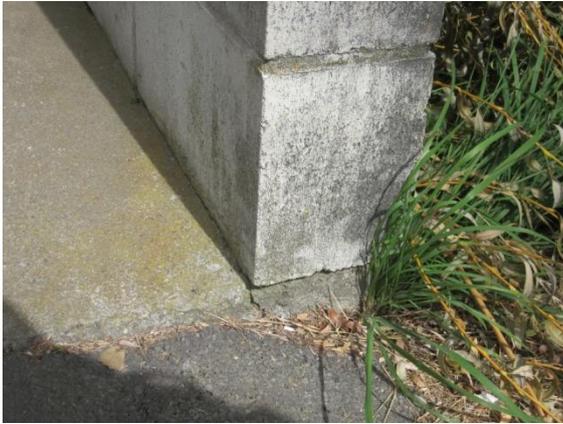
- 1) Minor cracking to the internal concrete slab on grade foundations
- 2) Hairline cracking through the mortar work joints

Photo 13: Minor cracking at the foot of the 150 series external walls

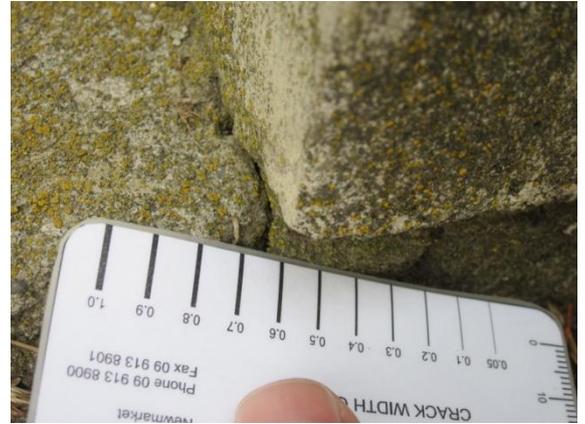
Photo 14: cracking approx 0.6mm at its widest

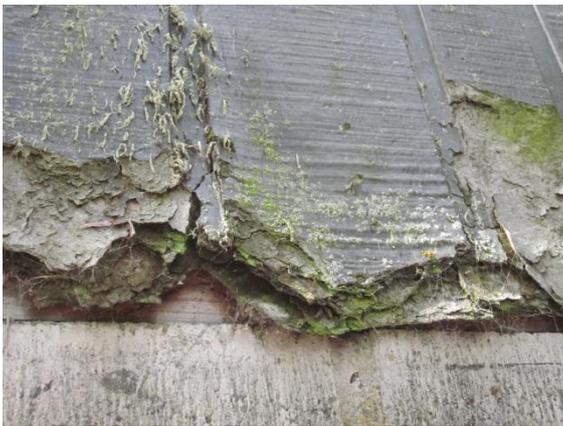
Photo 15: Rotting of the timber cladding

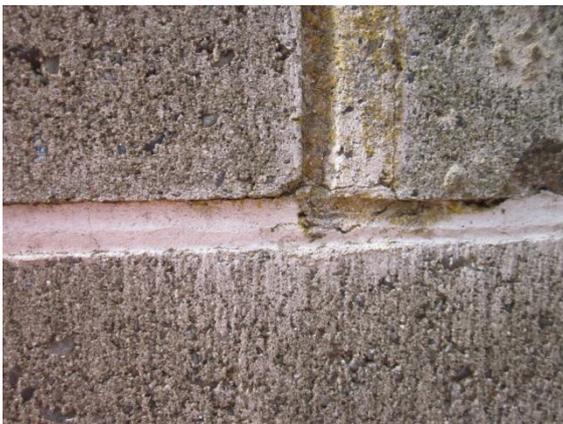
Photo 17: Left of photo shows possible repointing

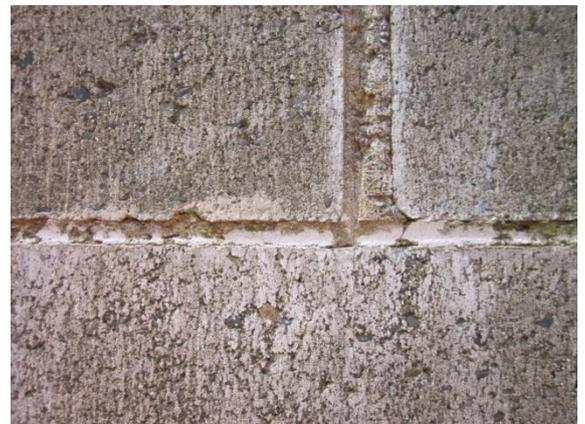
Photo 18: Weathered mortar joints

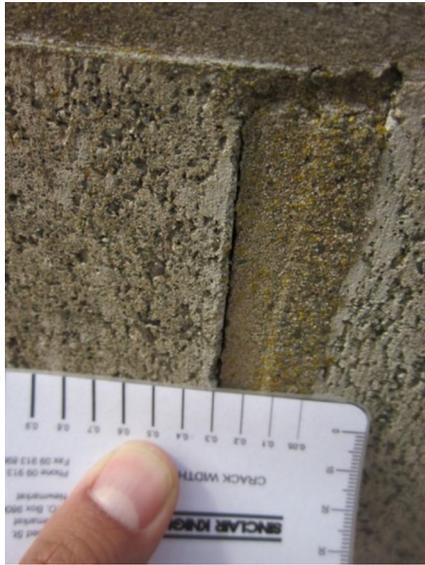
Photo 19: Cracking of approx 0.4mm

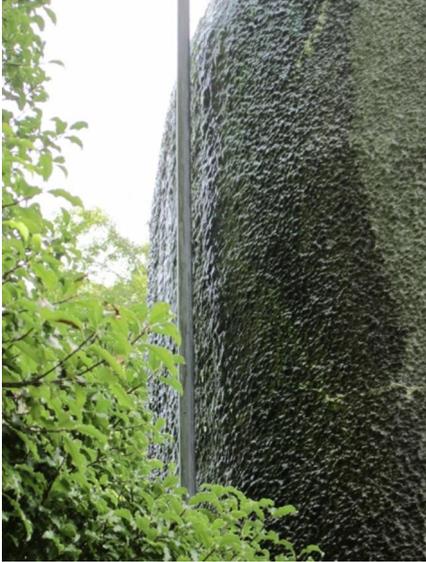
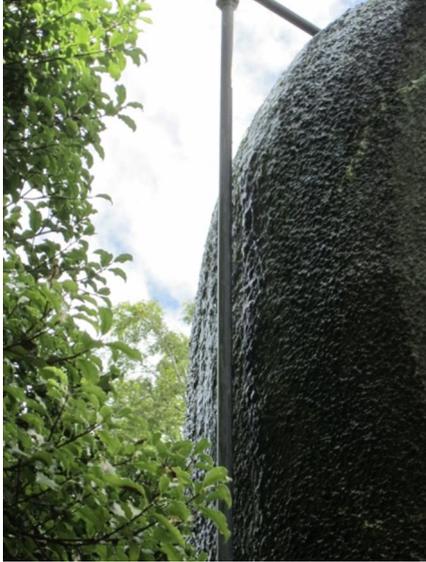
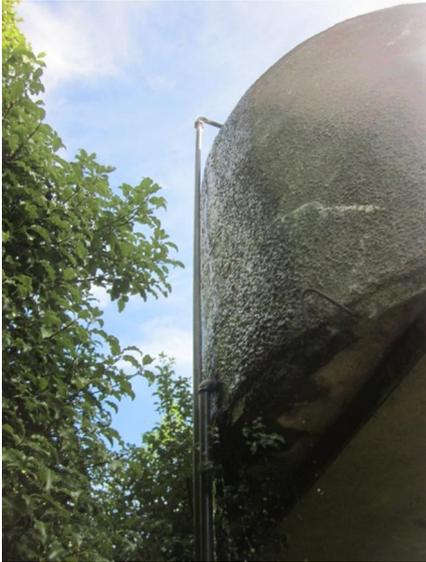
- 3) The water tower appeared to be leaking causing water ponding around the base of the structure. This ponding of water will likely adversely affect the buildings foundations making collapse of the building more likely.

<p>Photo 27: Rear of the water tank with water overflow</p>	<p>Photo 28: As per photo 27</p>

<p>Photo 29: as per photo 27</p>	<p>Photo 30: Water running off the water tank</p>

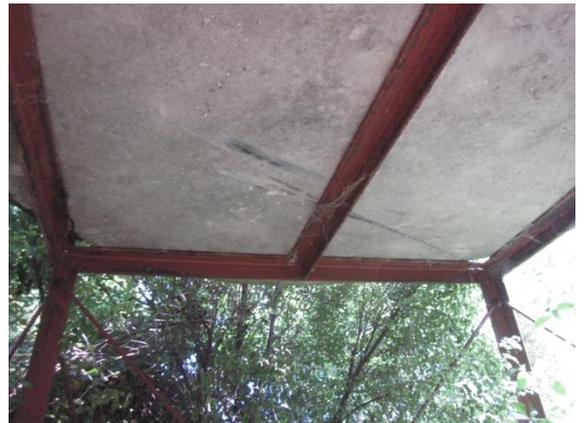
The water tower poses a potential hazard to the adjacent building as there is no visible connection between base and tank. A moderate earthquake may cause the friction forces holding the tank in place to be exceeded causing the structure to collapse.

The building has no critical structural weaknesses. The adjacent water tower, which poses a fall hazard to the Toilet and Yacht Club Pavilion, contains a critical structural weakness due to the absence of positive fixing of the tank to the supporting foundation.

Photo 34: No connections between tank and support were observed

- a) There is no damage to the building that would cause it to be unsafe to occupy.
- b) We consider that barriers around the building are not necessary.
- c) A Quantitative DEE or alternate solution is carried out for the water tower.

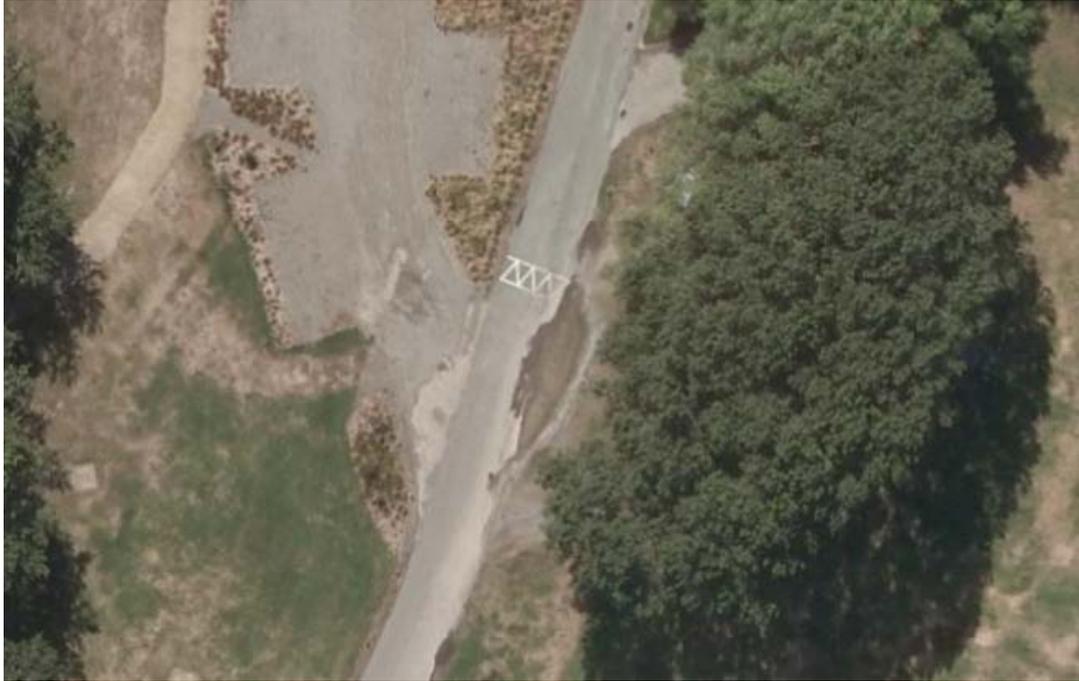
- **Figure 4 Aerial photograph showing liquefied material ejected near road way** (<http://viewers.geospatial.govt.nz/>)

The aerial photographs appears to show some evidence of liquefaction occurring on site due to the 22 February earthquake, with localised sand boils and liquefied material ejected near the road way visible in figure 4.
