Christchurch City Council
PRK_0348_BLDG_010 EQ2
Toilets Block No 2 Ground
The Groynes, 182 Johns Road

QUALITATIVE ASSESSMENT REPORT
FINAL

- Rev C
- 21 November 2012

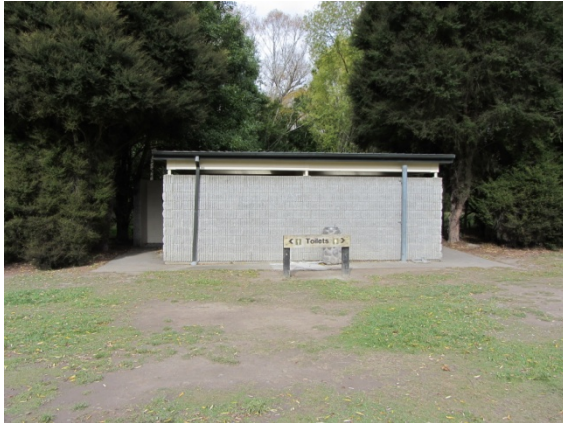
Photo 1: North Elevation. Mens toilet on the left and womens toilet on the right

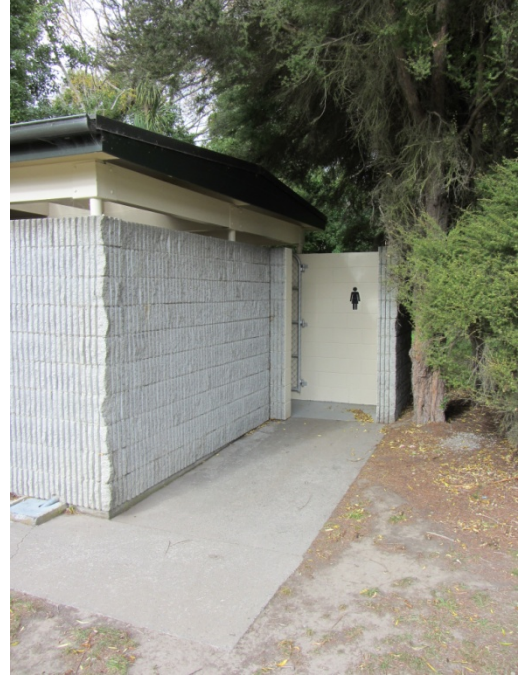
Photo 2: West Elevation. Womens toilet

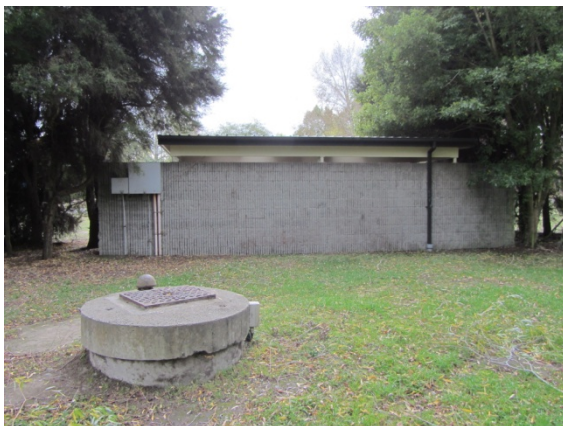
Photo 3: South Elevation

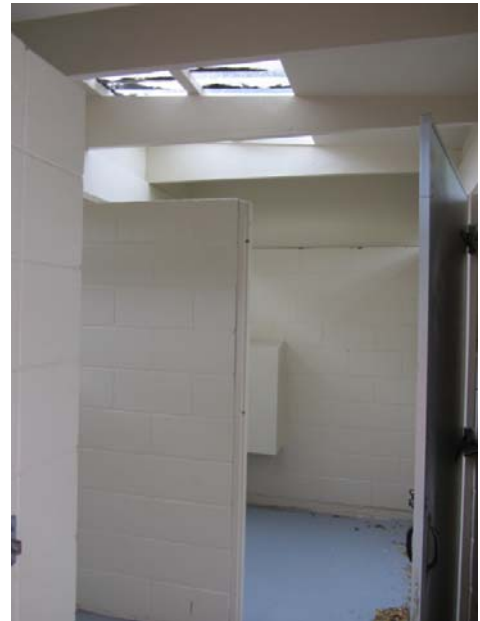
Photo 4: Interior of womens toilet

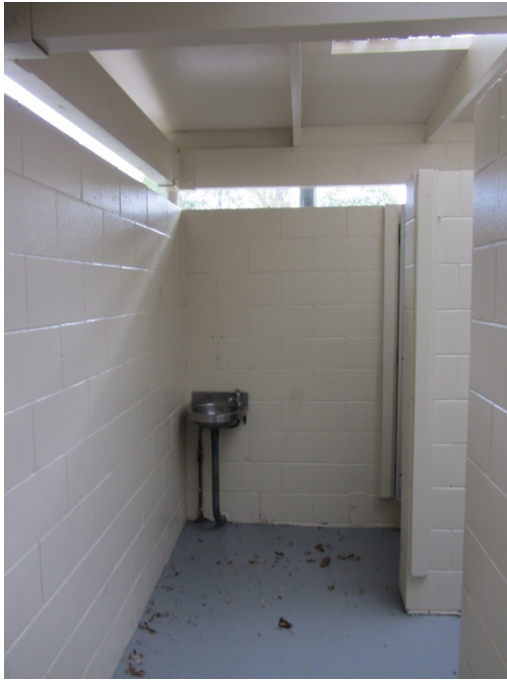
Photo 5: Interior of womens toilet

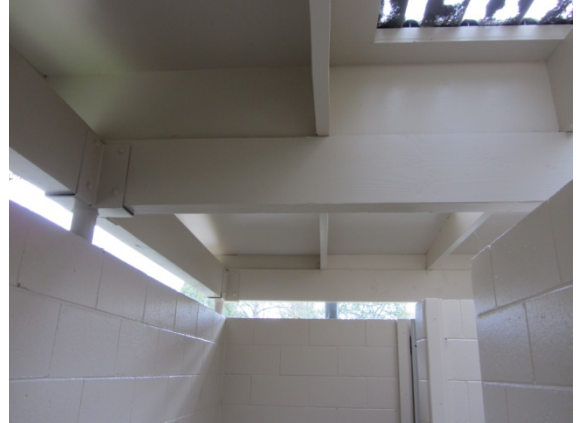
Photo 6: Roof structure

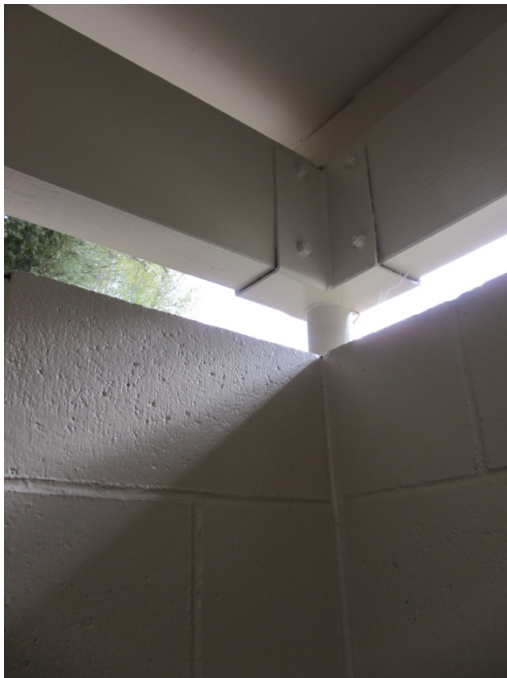
Photo 7: Steel tube connection

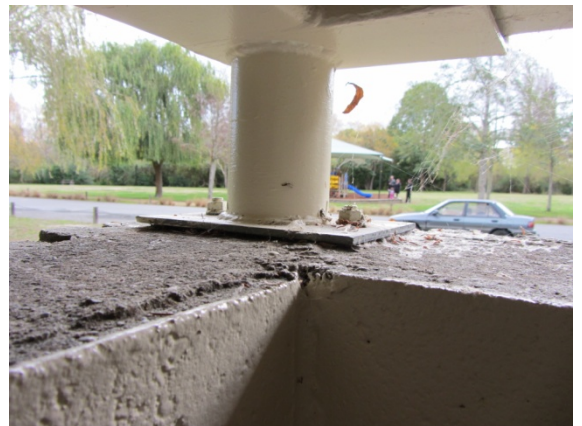
Photo 8: On top of masonry wall showing connection and filled masonry

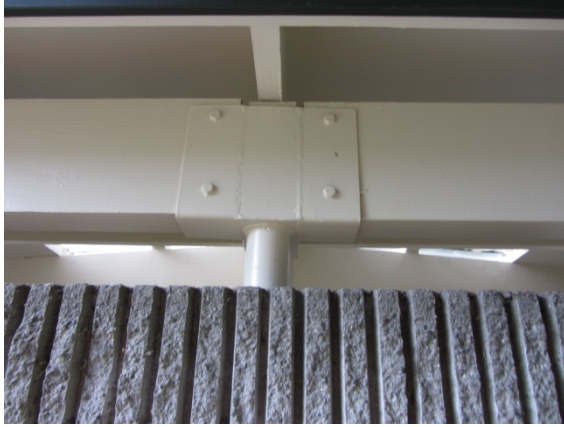
Photo 9: Exterior

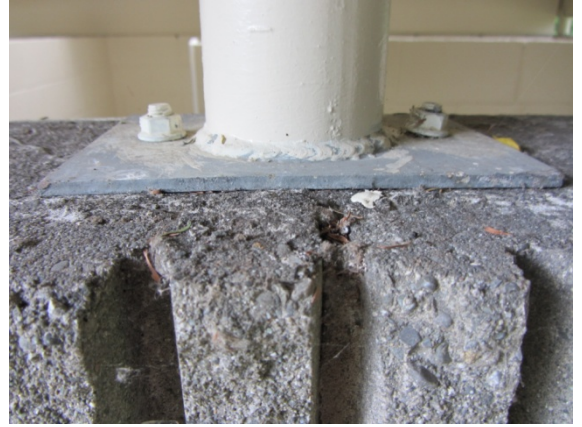
Photo 10: Roof connection

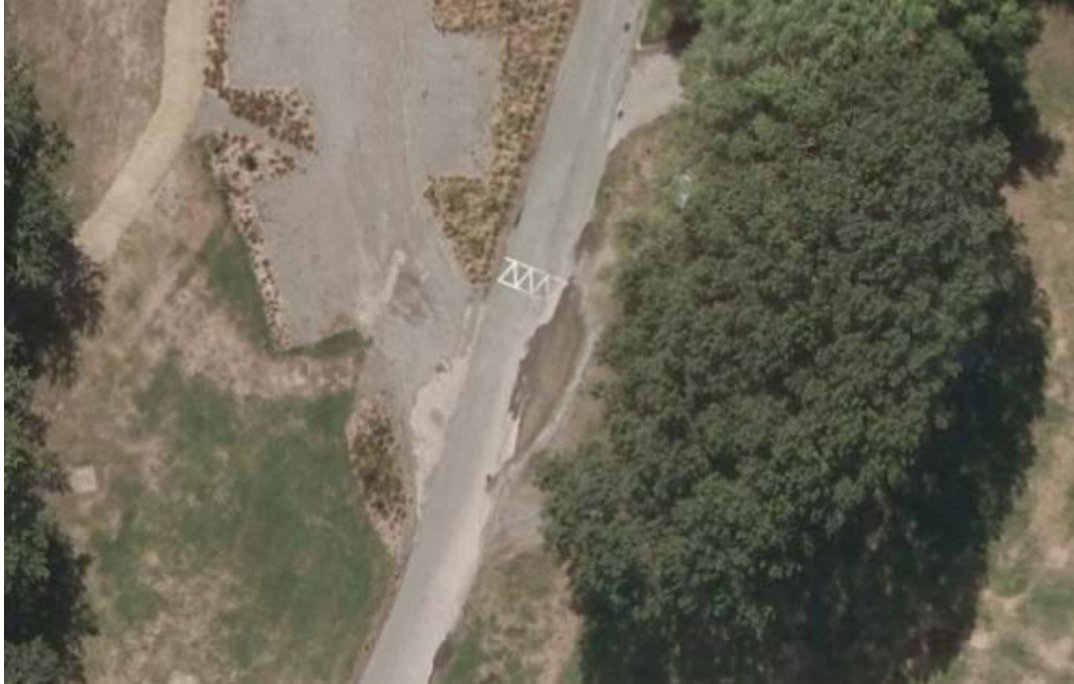
- **Figure 4 Aerial photograph showing liquefied material ejected near road way** (<http://viewers.geospatial.govt.nz/>)

The aerial photographs appears to show some evidence of liquefaction occurring on site due to the 22 February earthquake, with localised sand boils and liquefied material ejected near the road way visible in figure 4.
