Christchurch City Council
PRK_0348_BLDG_012 EQ2
The Groynes - Pump House
182 Johns Road

QUANTITATIVE ASSESSMENT REPORT
FINAL

- Rev B
- 27 February 2013

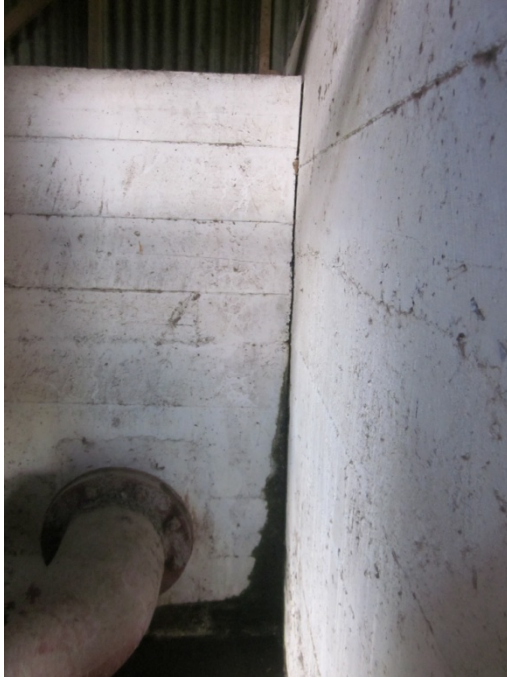
Photo 13: Walls separated at junction.

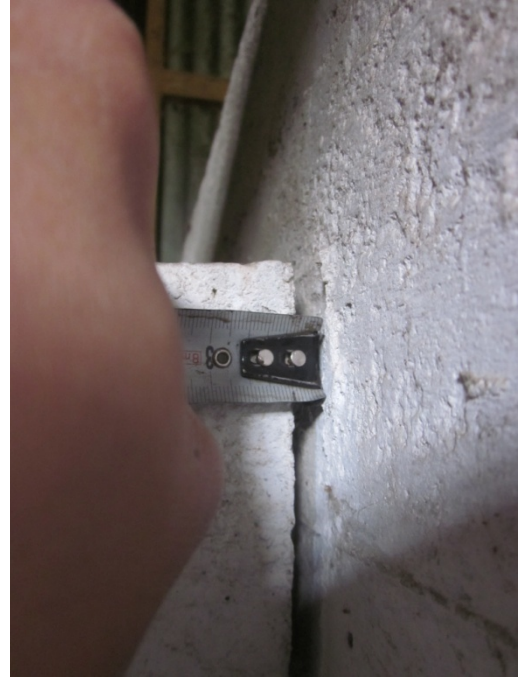
Photo 14: Close up of photo 13.

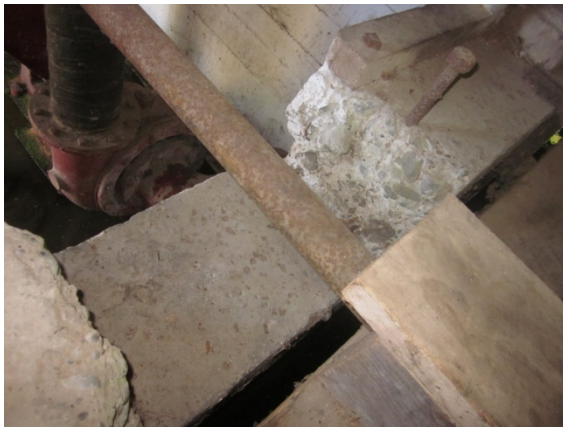
Photo 15: Cut out in interior wall exposes the quality of concrete.

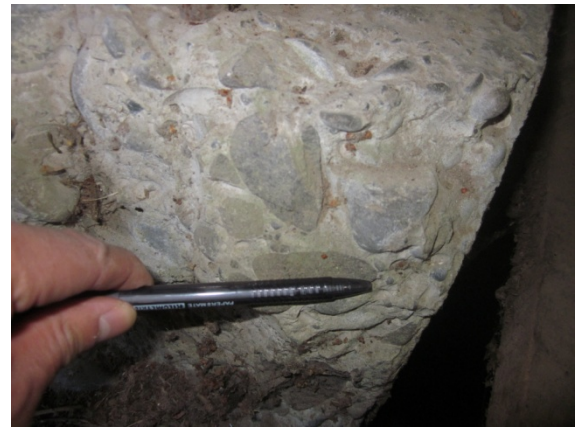
Photo 16: Close up of photo 15.

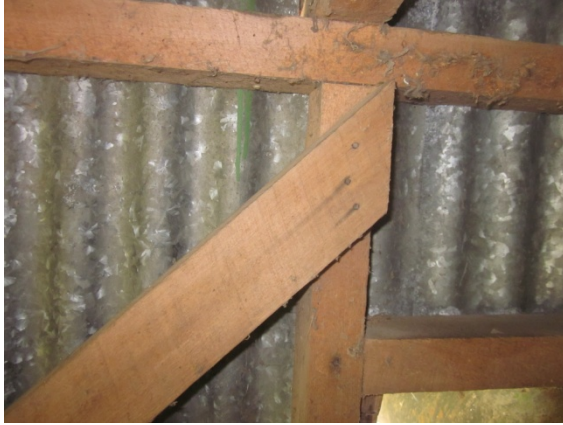
Photo 17: Connection of bracing elements in timber structure. Note that connection is made just with three nails.

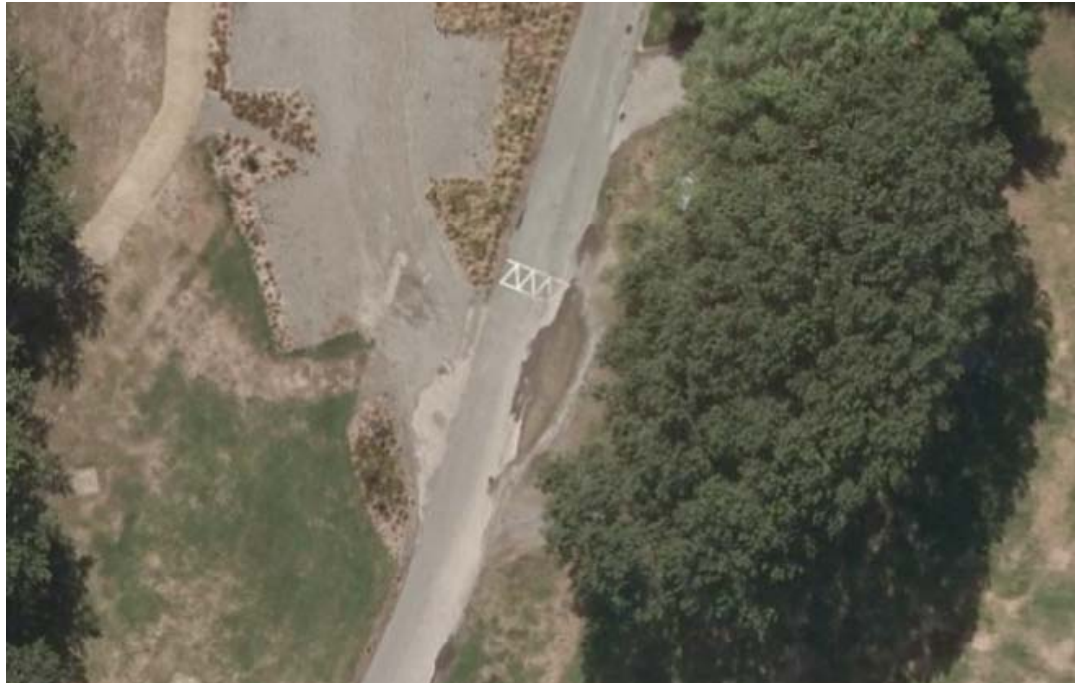
- **Figure 4 Aerial photograph showing liquefied material ejected near road way (<http://viewers.geospatial.govt.nz/>)**

The aerial photographs appears to show some evidence of liquefaction occurring on site due to the 22 February earthquake, with localised sand boils and liquefied material ejected near the road way visible in figure 4.
