CHRISTCHURCH CITY COUNCIL
PRK_1190_BLDG_001 EQ2
North Hagley Pumphouse
10 Riccarton Ave, Christchurch Central

QUALITATIVE ASSESSMENT REPORT
FINAL

- Rev B
- 25 March 2013

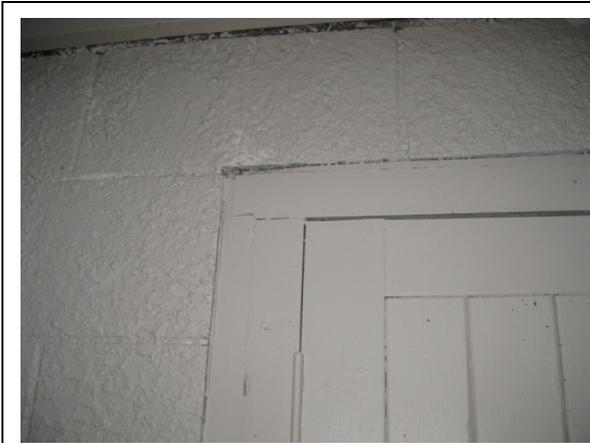
- 1) Gaps opening up between timber elements.
- 2) Longitudinal cracking in timber roof edge beam was noted, but this is believed to be due to age of the structure and is not earthquake-related damage.
- 3) Impact damage was noted on the timber doorframe above the door on the north side, but this is not earthquake-related damage.

Photo 5: Gaps opening up between timber elements in the doorframe on the north side.

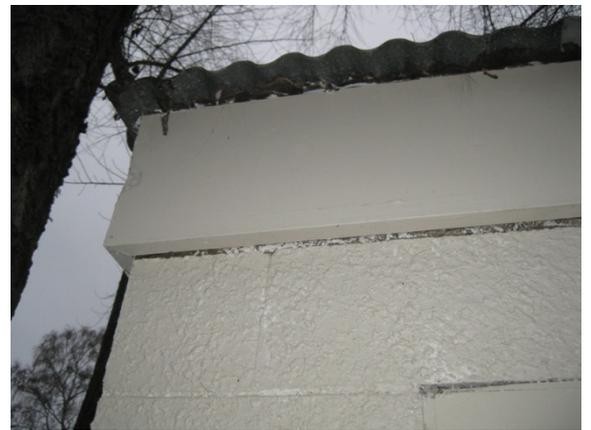
Photo 6: Gap opening up between masonry wall and timber roof edge beam on north side.

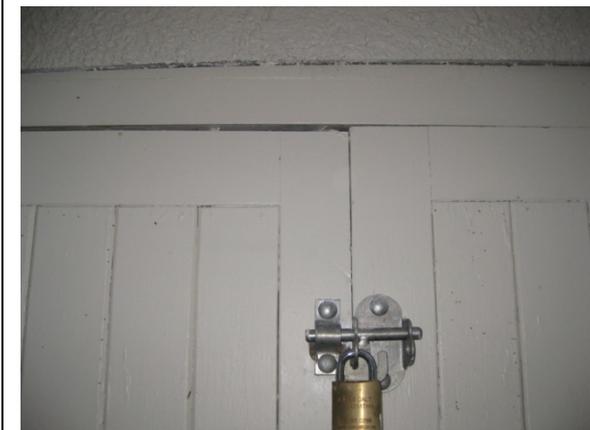
Photo 7: Gaps opening up between timber elements in the doorframe on the north side.

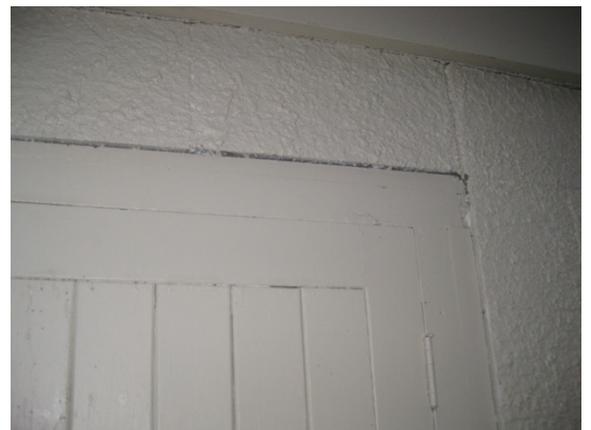
Photo 8: Gaps opening up between timber elements in the doorframe on the north side.

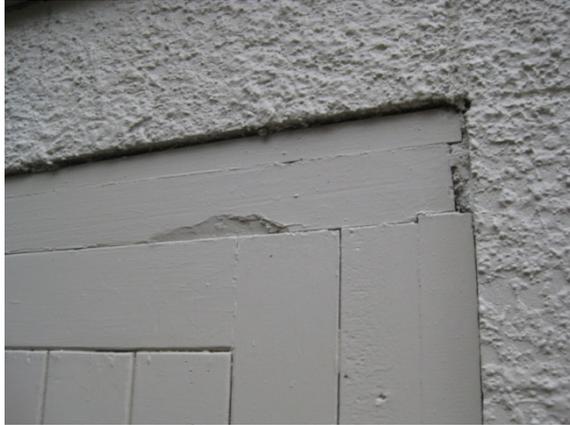
<p>Photo 9: Existing impact damage to timber doorframe on the north side.</p>	<p>Photo 10: Level of the path is one block higher than the ground level at the entrance to the pumphouse on the north side.</p>

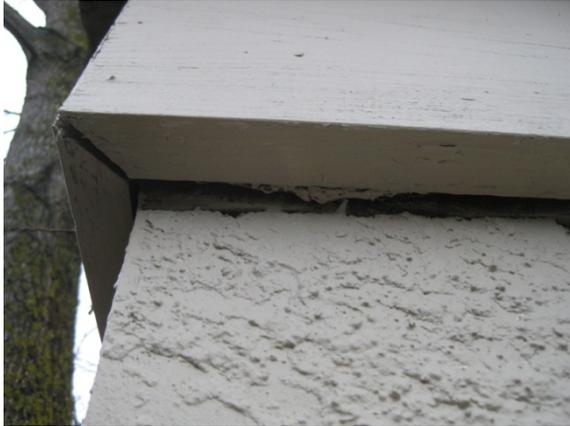
<p>Photo 11: Gaps opening up between masonry wall and timber roof edge beam on northwest side.</p>	<p>Photo 12: Longitudinal cracking on timber roof edge beam on west side.</p>

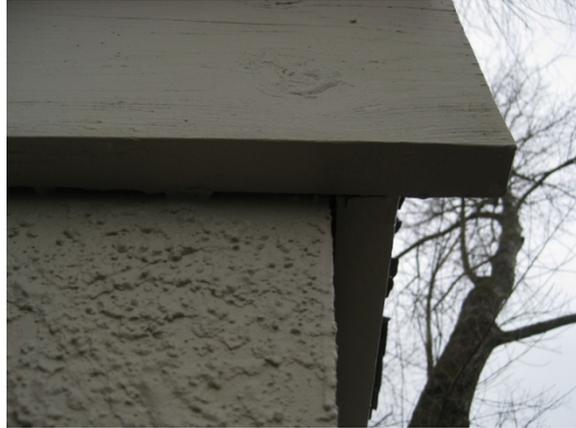
Photo 13: Gap opening up between masonry wall and timber roof edge beam on west side.

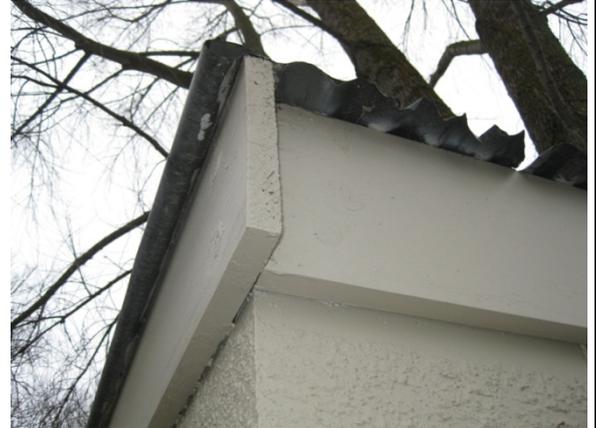
Photo 14: Overhang of 250 x 30 timber roof edge beam.

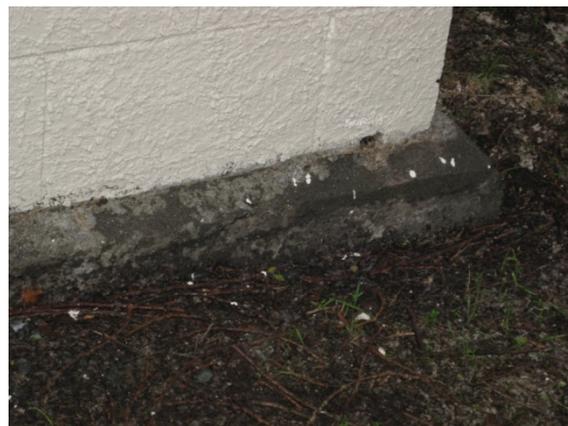
Photo 15: Concrete slab footing exposed on southwest corner.

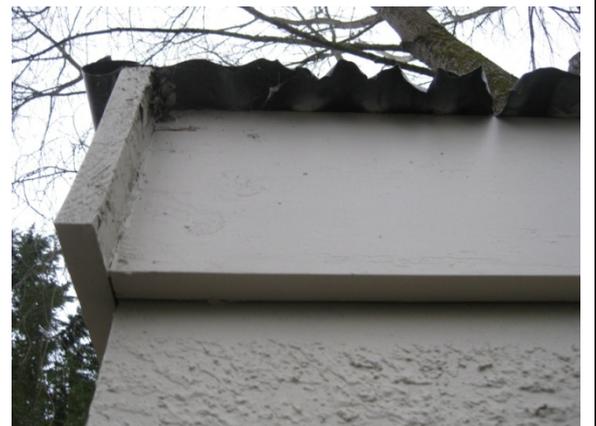
Photo 16: Gap opening up between masonry wall and timber roof edge beam on south side.

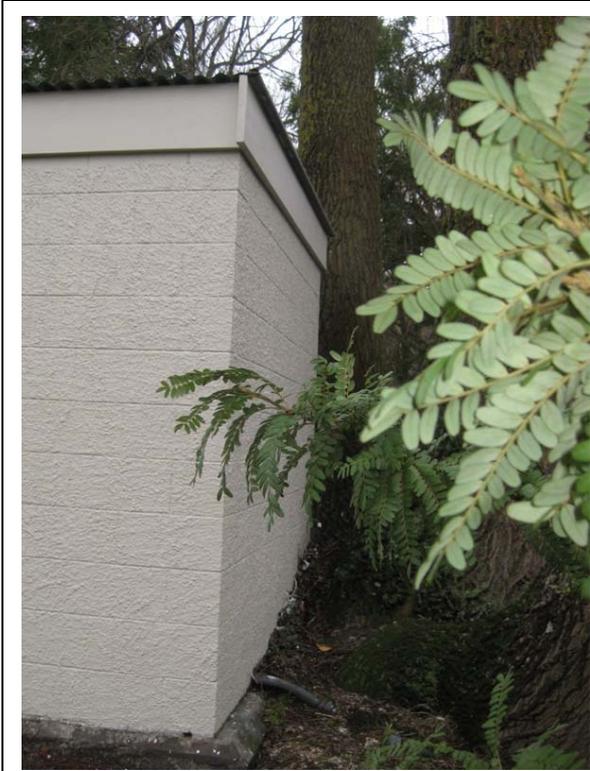
The building is located in North Hagley Park, east of the croquet courts at 10 Riccarton Ave. There is one building on this site. The building has one storey that is currently utilised as a pumphouse. The building is believed to be constructed from unreinforced masonry walls. The roof appears to be timber-framed, with corrugated metal roof sheeting. The ground floor appears to be supported on a concrete slab foundation. It is assumed the building was designed and constructed in the 1970's. It is roughly 5m away from a waterway and is located very close to a tree, which may have structural implications to the block walls in the future.

Photo 17: Close proximity of pumphouse to nearby tree.

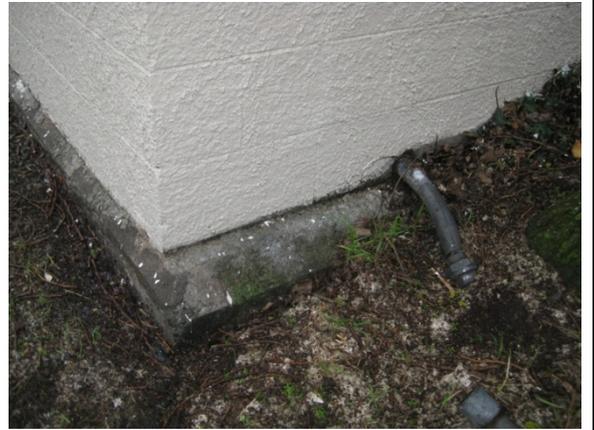
Photo 18: Concrete slab footing exposed on southeast corner.

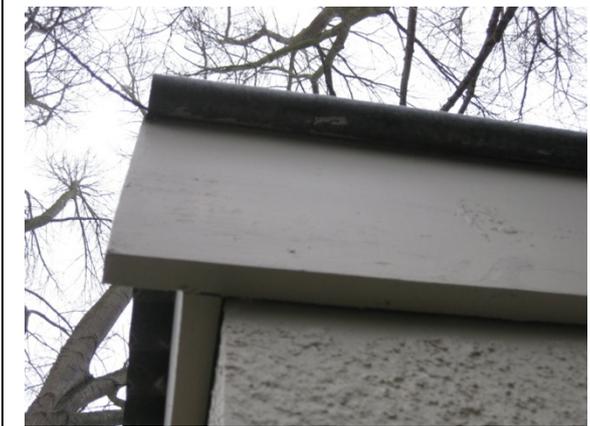
Photo 19: Gap opening up between masonry wall and timber roof edge beam on east side.

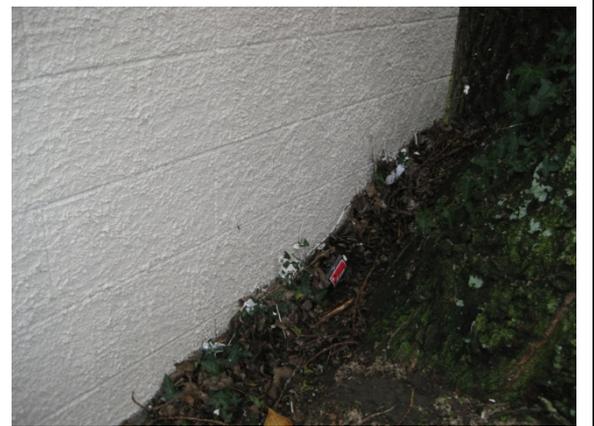
Photo 20: Sloped ground profile on northeast side influenced by nearby tree.

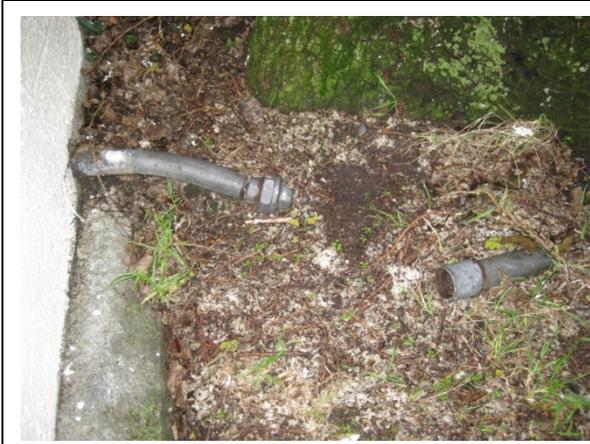
Photo 21: Disrupted connection on east side of pumphouse.

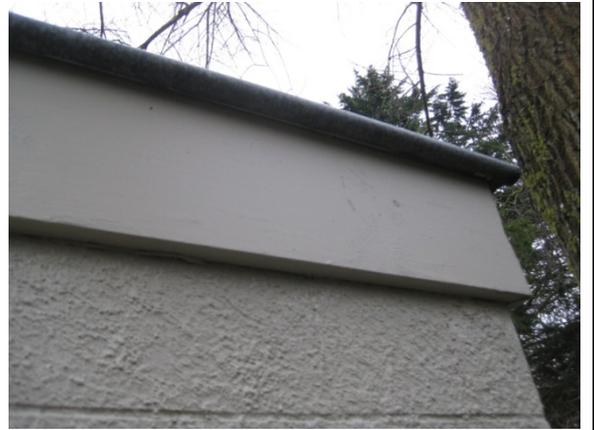
Photo 22: Gap opening up between masonry wall and timber roof edge beam on east side.

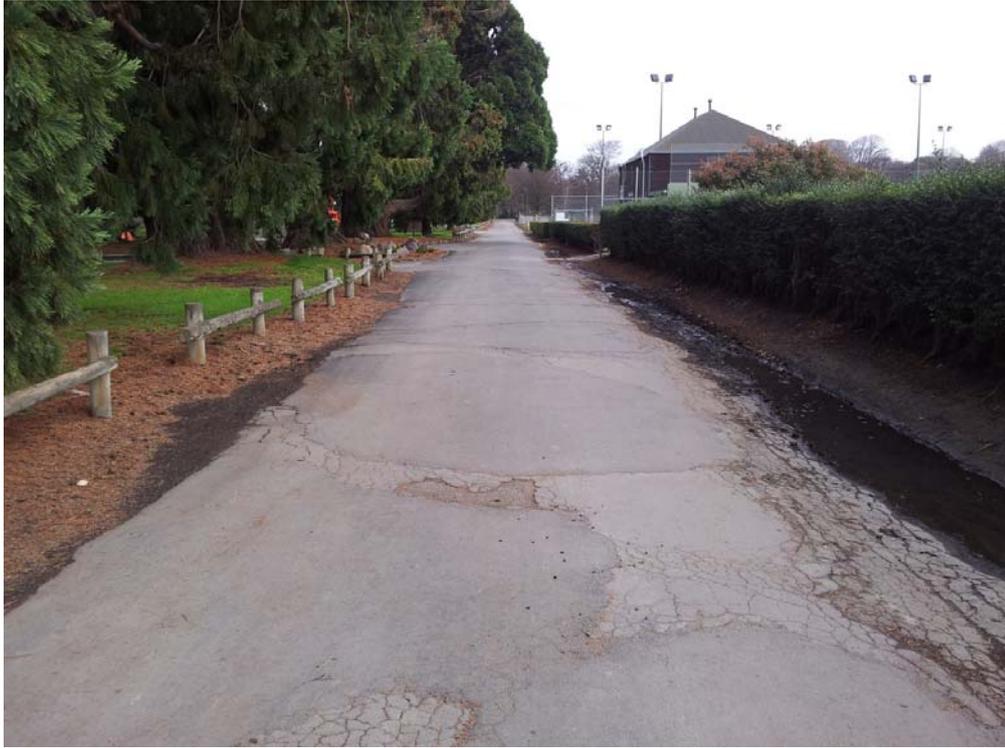
No apparent evidence of liquefaction or land damage was observed on site. However, resealed patches and undulations in the road surface were observed on the above driveway. These are likely to have occurred as a result of the earthquake however it is not clear what state of repair the driveway was in prior to the earthquake events.

■ **Figure 9 – Observed damage to the above driveway**
