Groundsman's House  
Qualitative Engineering Evaluation

**Reference:** 229614  
**Prepared for:**  
Christchurch City Council

**Functional Location ID:** PRK 1507 BLDG 030

**Date:** 5 July 2013

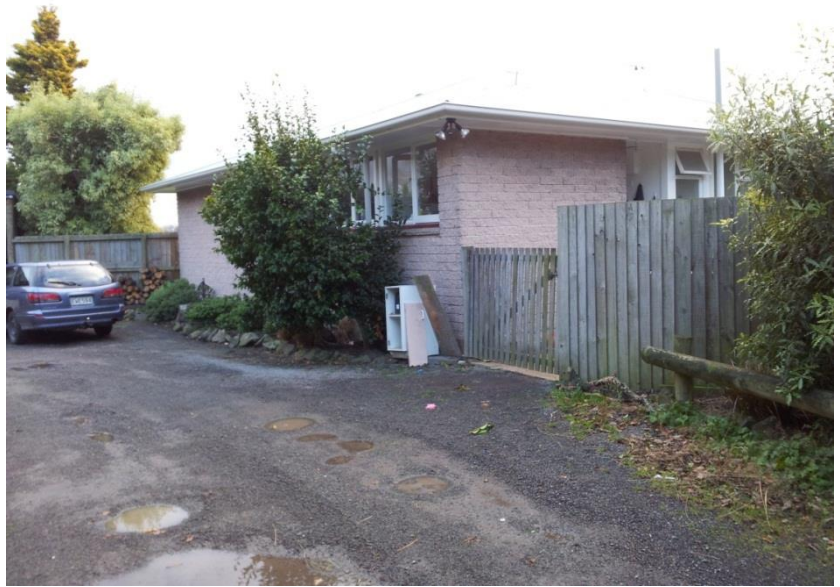
4) Northern elevation of the building.

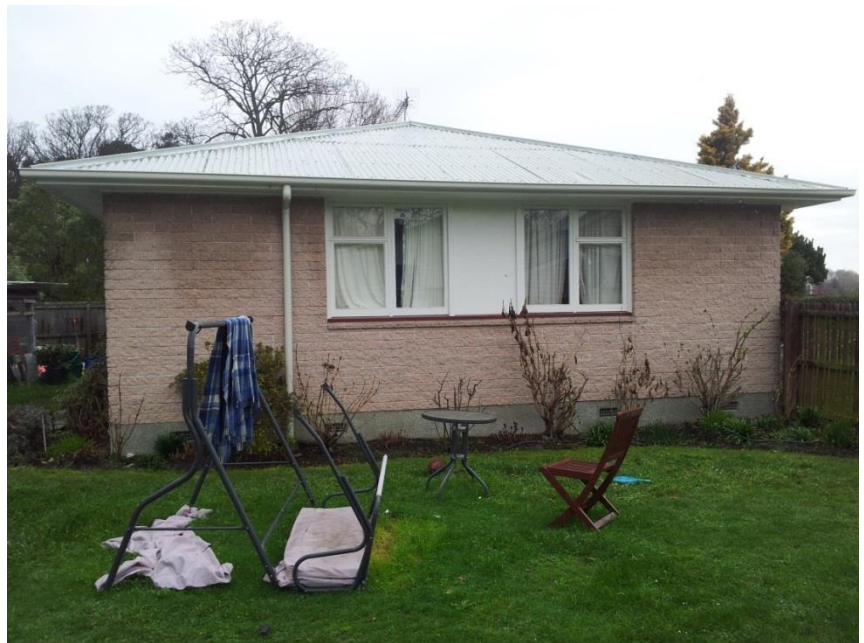
5) Western elevation of the building.

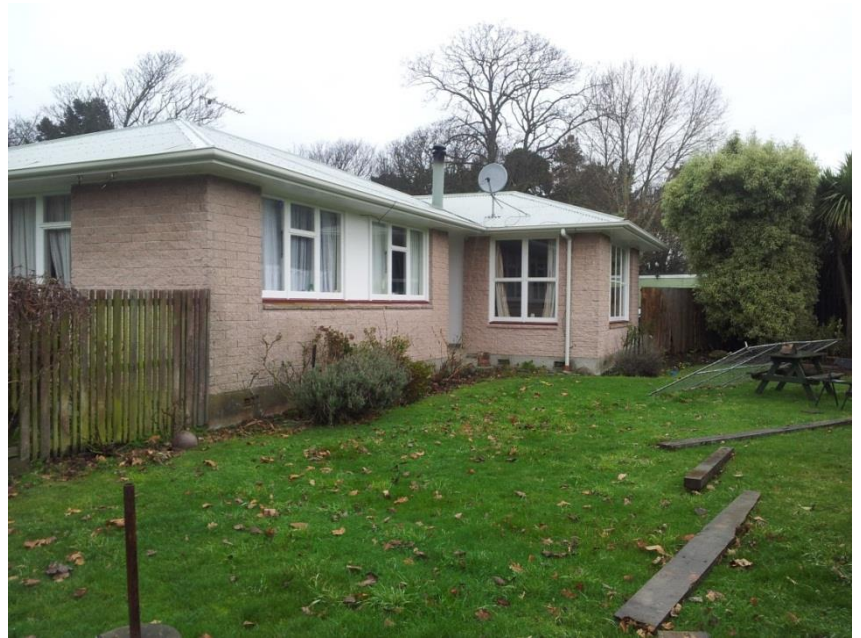
6) Eastern elevation of the building.

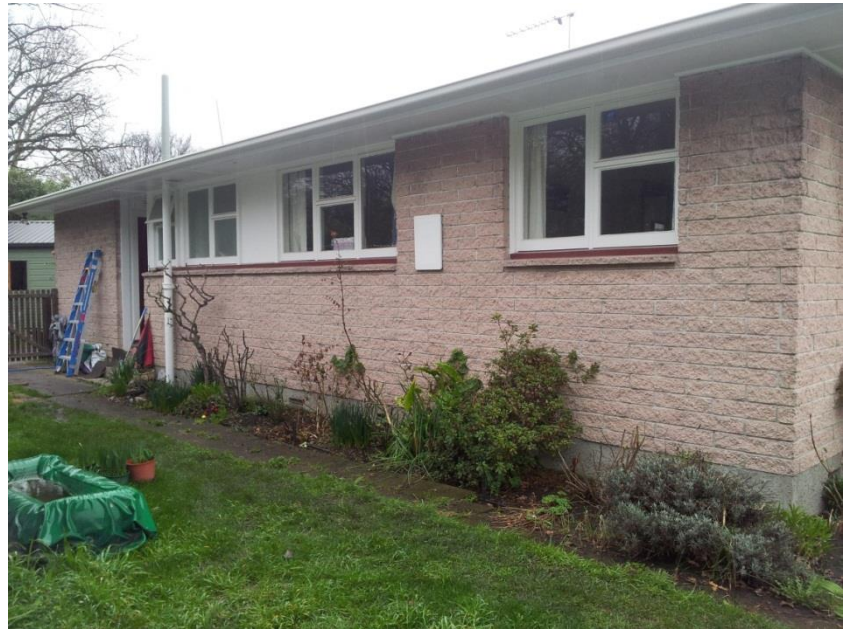
The Groundsman's House has performed well but has suffered minor damage to the external cladding. The masonry has fine step cracking in the mortar around windows however, as the bricks are used only for architectural purposes, the damage does not influence the lateral force resisting system.

7) Cracking to external masonry cladding.

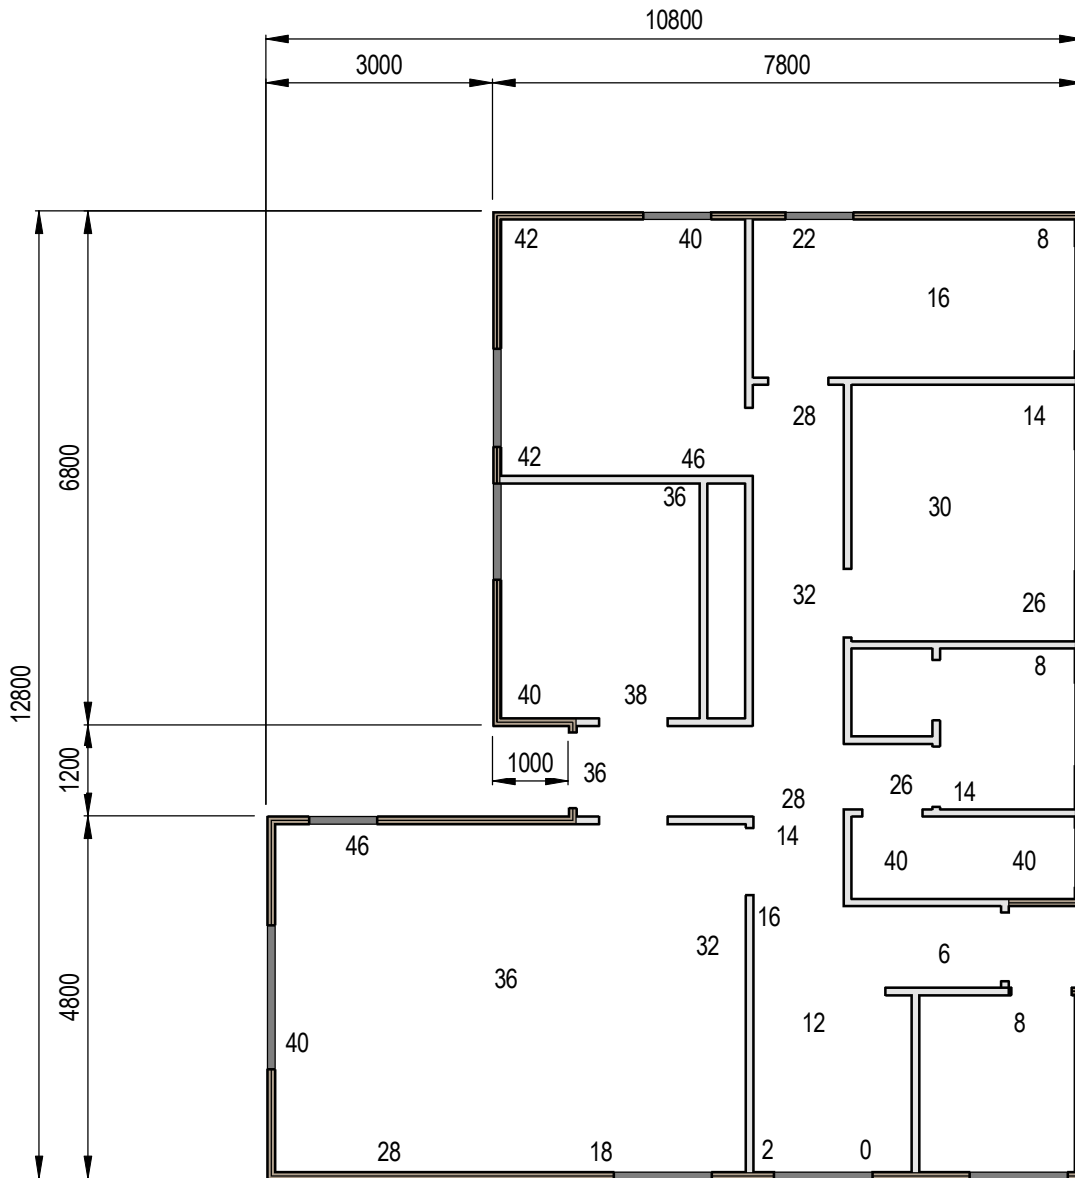
# FLOOR LEVELS PLAN

The floor levels for the Groundsman's House were found to be within the recommended tolerances although the slope approaches 0.5% in several locations and it has a maximum variation in floor levels of 46mm.
