CHRISTCHURCH CITY COUNCIL  
PRK\_1507\_BLDG\_014 EQ2  
South Hagley Park – Rugby Toilets  
Hagley Park, Christchurch Central

QUALITATIVE ASSESSMENT REPORT

- Rev B
- 23 May 2013

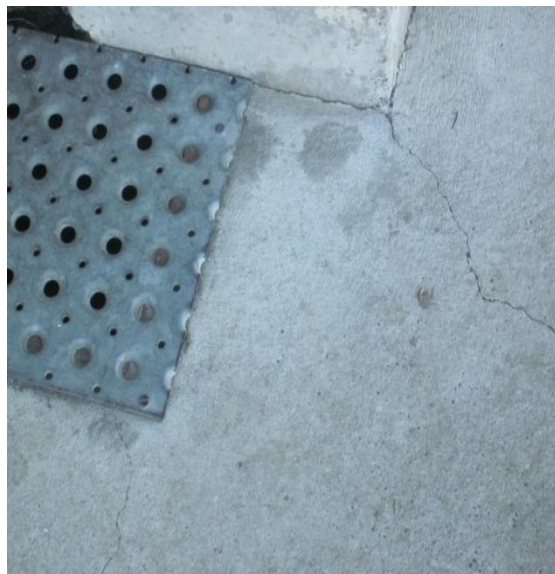
Photo 11: Crack in external concrete ground slab on the southeast corner.

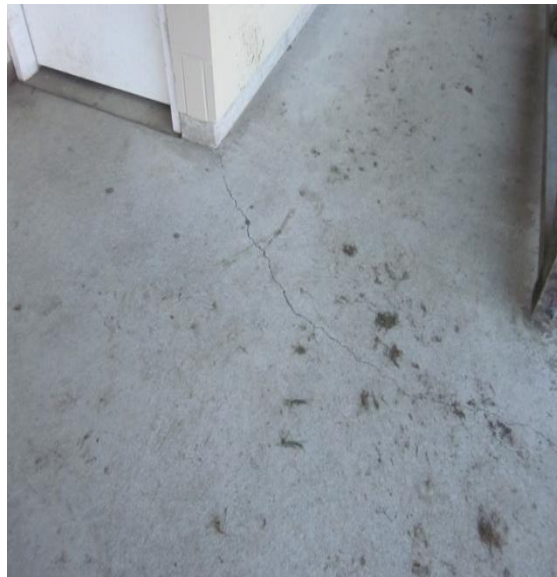
Photo 15: Crack in external concrete ground slab on east side.

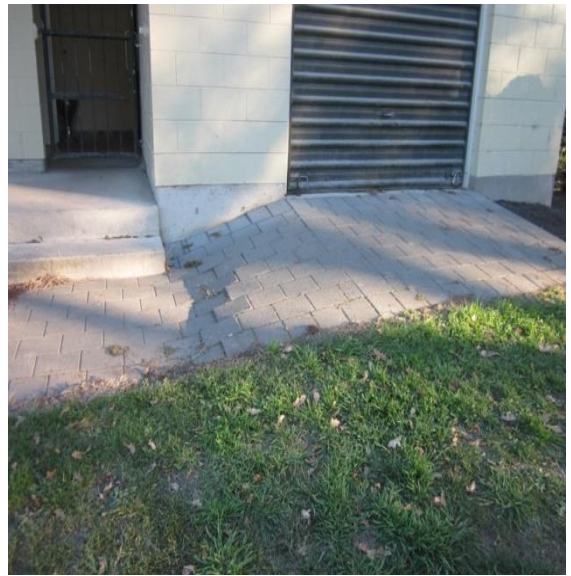
Photo 18: Ground level change on north side.

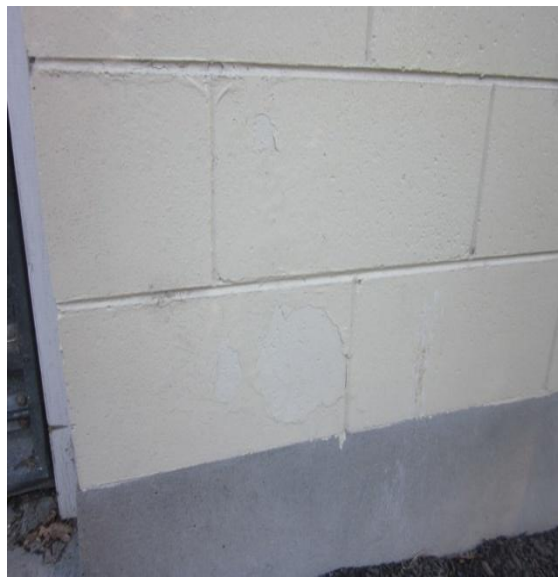
Photo 19: Existing paint damage to north masonry wall.

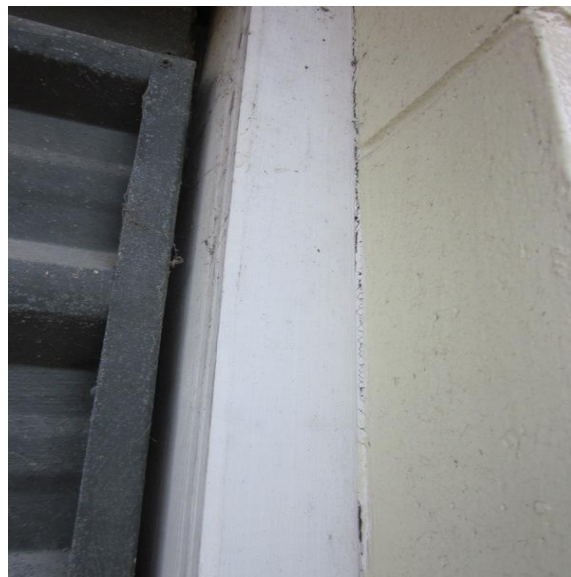
- 1) Hairline cracks running vertically through masonry on the west wall.
- 2) Gap opening up between masonry wall and timber doorframe on the north side.
- 3) Gap opening up between concrete strip under masonry wall and external concrete ground slab on the east side.
- 4) Hairline cracks in external ground slab on east side.
- 5) Existing damage to paintwork was noted on the north side, but is not believed to be as a result of earthquake damage.

Photo 20: Gap opening up between timber doorframe and masonry wall on north side.

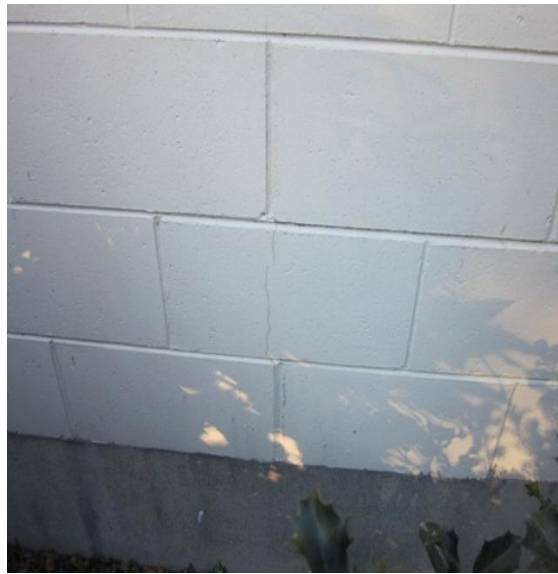
Photo 21: Vertical crack through masonry block on west wall.

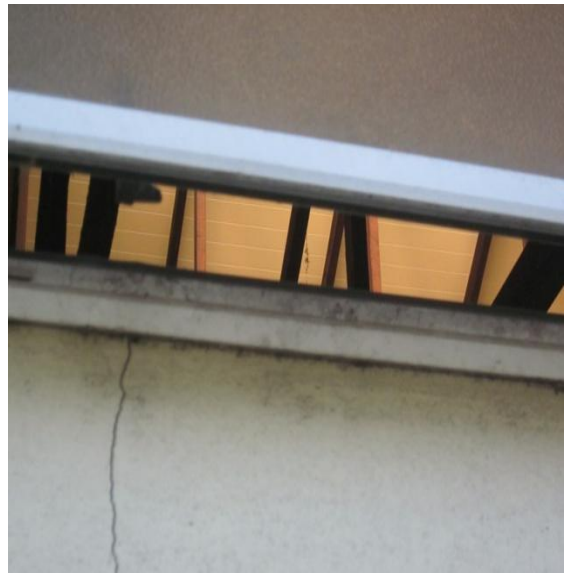
Photo 22: Vertical crack through masonry block on west wall and evidence of timber rafters inside.

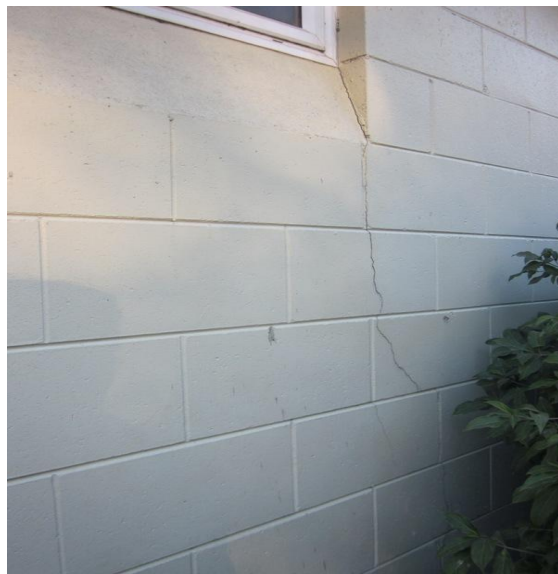
Photo 23: Vertical crack through masonry blocks on west wall.

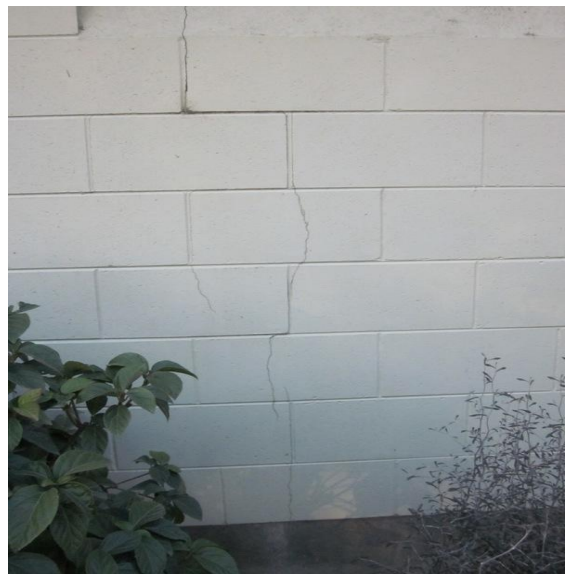
Photo 24: Vertical crack through masonry blocks on west wall.

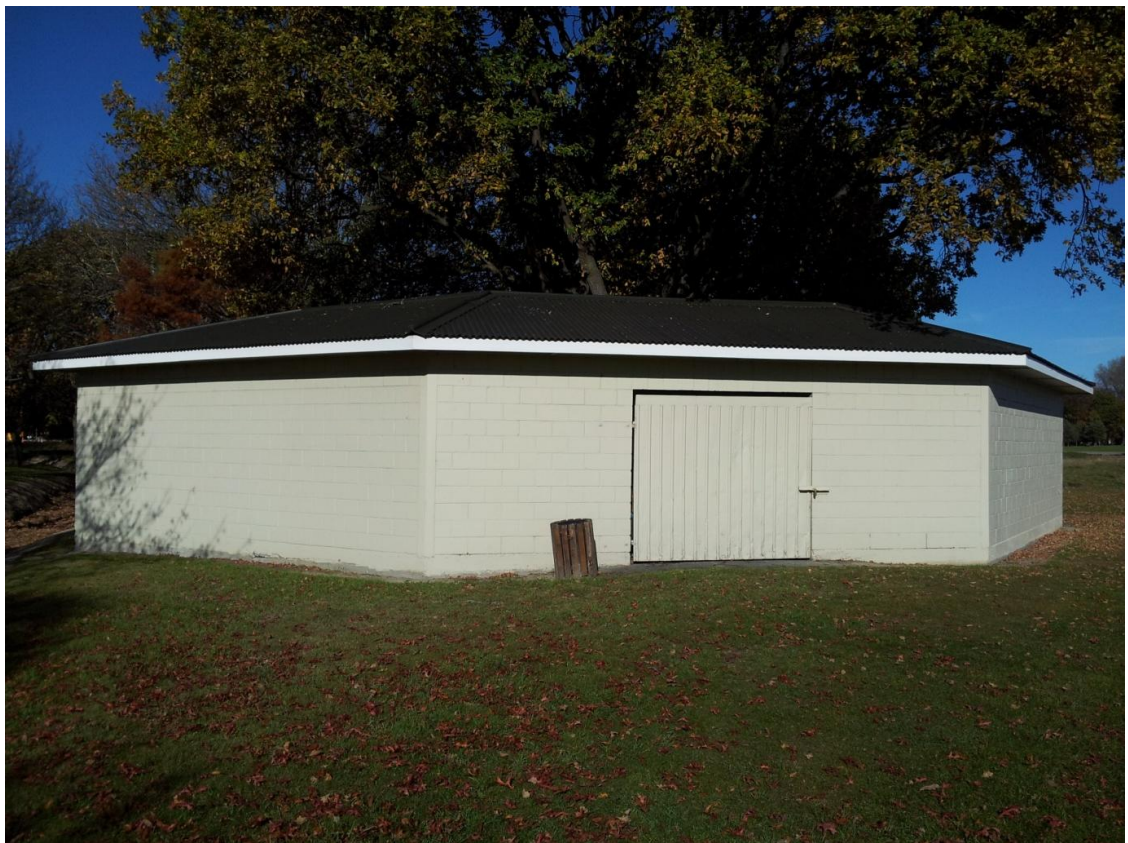
■ **Figure 7 Overview of structures – Pavilion**

The Pavilion was noted to be a masonry block building with sheet metal roof, slab on grade foundations. From the external inspection, cracking and spalling in concrete footing under masonry walls was observed on the west side of the building. Minor cracking in external concrete ground slab was also noted.

Some patches in grass were observed to the west of the building which may be evidence of liquefied material being ejected to the surface. No apparent land damage was observed on the site.

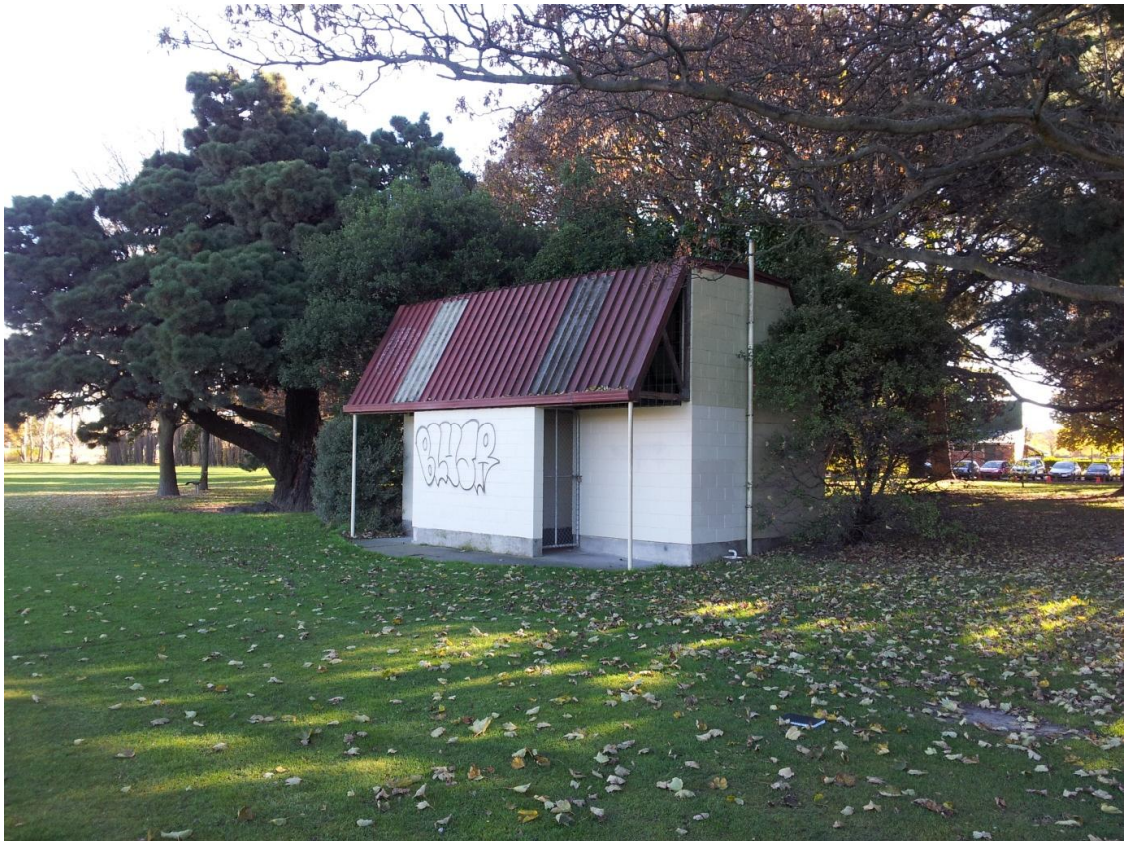
■ **Figure 8 Overview of structures – Hospital toilet**

The building was a masonry block construction with sheet metal roof and timber frames. The ground floor appeared to be supported on slab on grade foundation. Cracking and spalling of concrete footing was noted on the south east corner and some cracks were observed in external concrete ground slab.

No evidence of land damage was visible during the external inspection; however, the patchy grass present to the south of the building suggests that some liquefied material was ejected at surface due to the 22 February earthquake.

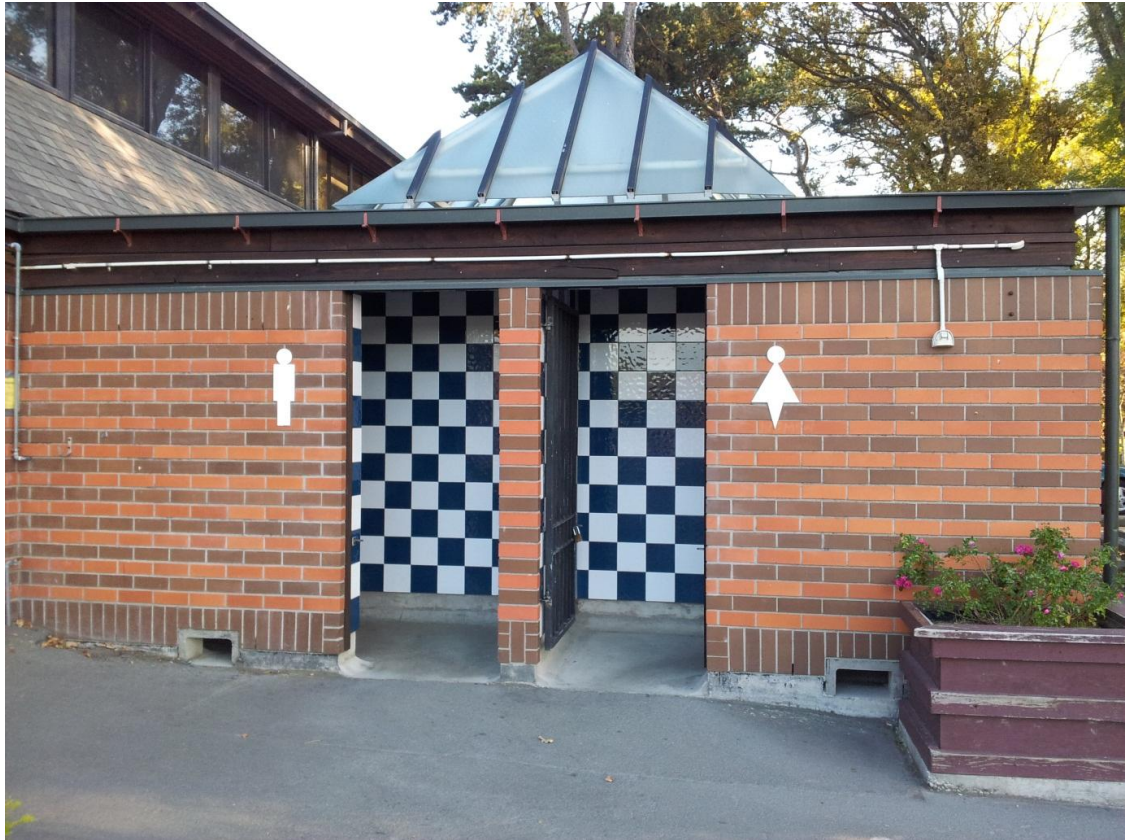
■ **Figure 9 Overview of structures – Netball toilets**

The toilet block was observed to comprise concrete walls with brick cladding and a timber-framed ceiling. The foundation was noted to be a slab on grade foundation and the roof appeared to be lightweight construction with a glazed skylight in the centre. The toilet block appeared to be attached to the Christchurch Netball Centre building. There were some gaps in the mortar between bricks at the footing and at the top of the wall.

Resealed patches were observed on the nearby netball courts, likely as a result of services being broken underneath. Surface cracks were also noted which had been sealed with resin. No evidence of liquefaction or land damage was visible during the external site inspection.

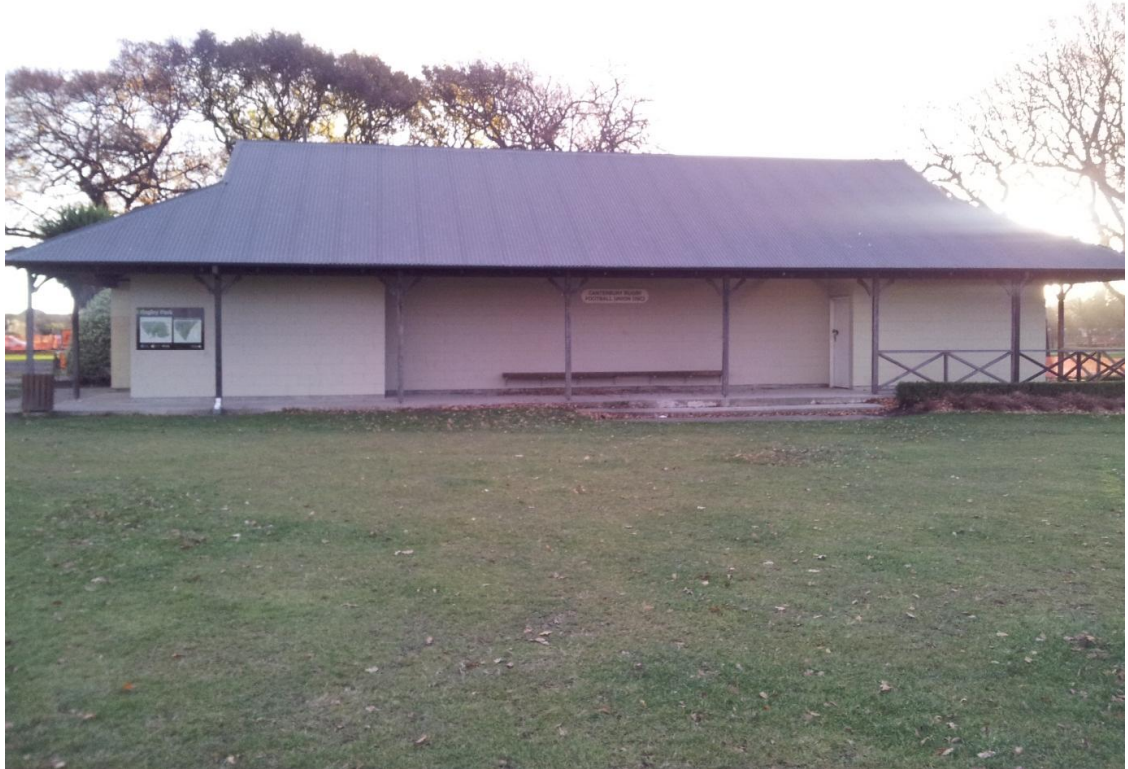
■ **Figure 10 Overview of structures – Rugby toilets**

The building was observed to be a masonry block building with sheet metal roof, slab on grade foundations. Some minor cracks in the masonry wall and external concrete slab were observed during the external inspection of the site. There was no evidence of surface expression of liquefaction or any land damage around the site.
