Halswell Aquatic Centre, Main Plant Room BU 1691-002 EQ2 & Swimming Club BU 1691-005 EQ2 Detailed Engineering Evaluation Quantitative Report

Prepared for Christchurch City Council (Client)

By Beca Carter Hollings & Ferner Ltd (Beca)

4 April 2014

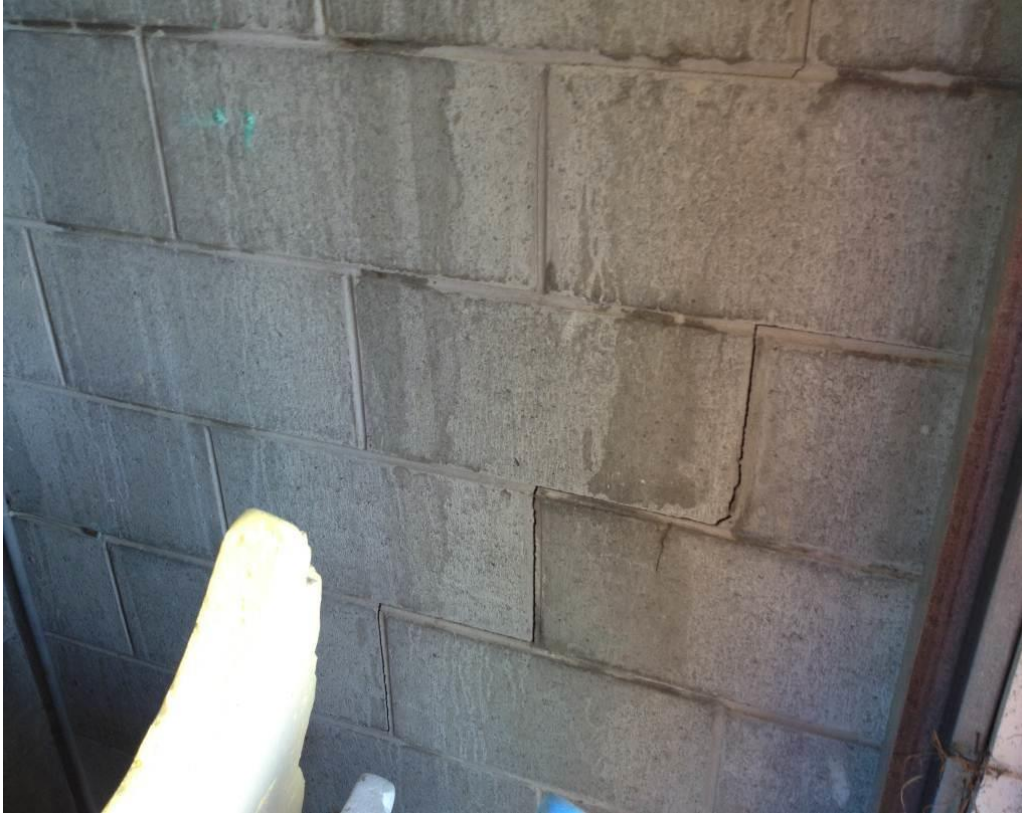
Photo 3: Blockwall at ground level.

Damage Description: Stepped cracks in mortar bed joints.

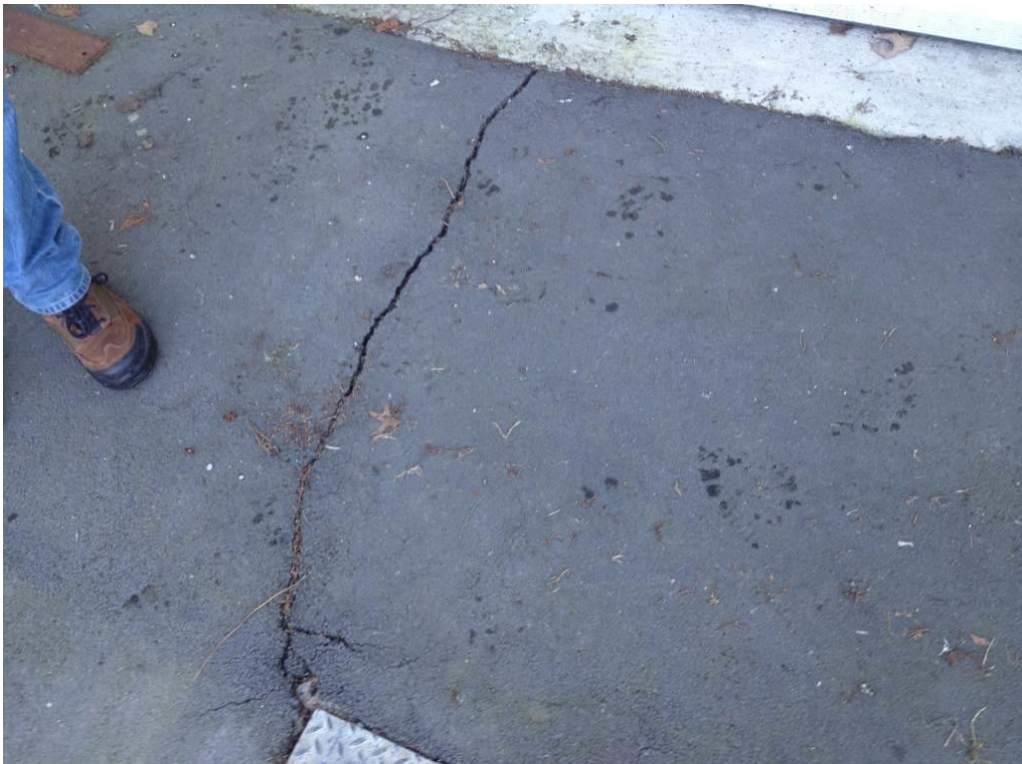
Photo 4: External asphalt pavement.

Damage Description: Ground cracks up to 10mm width

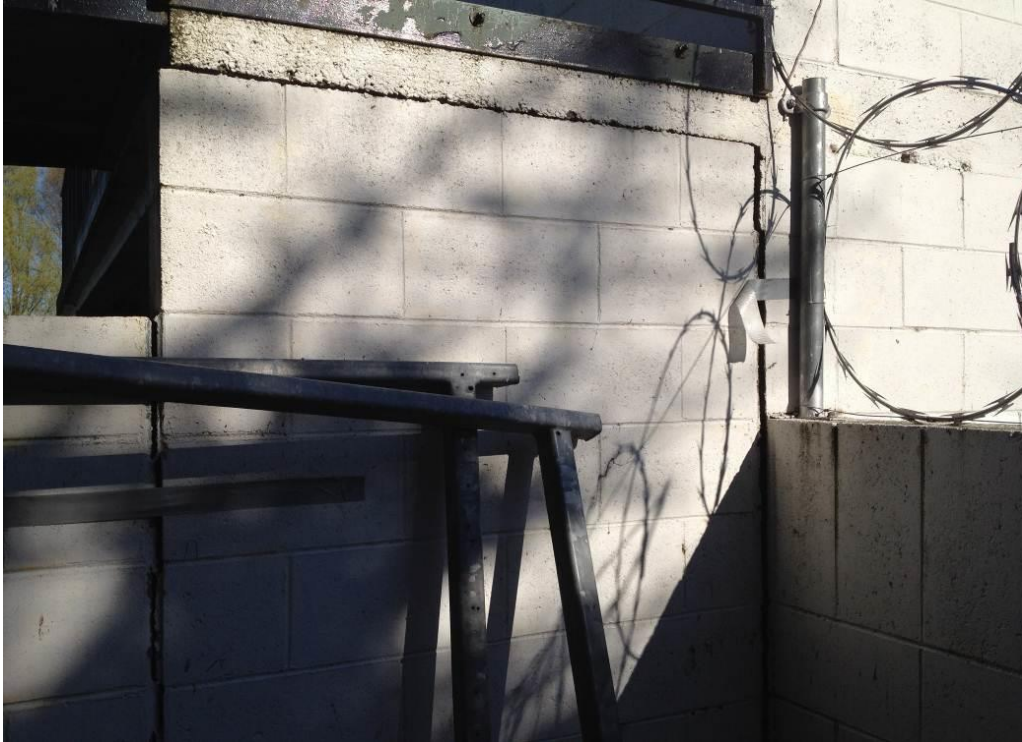
Photo 5: East blockwall supporting the exterior precast floor units

Permanent displacement of the east wall supporting the external deck was observed. A level survey was carried out for the Halswell Aquatic Centre (refer to Appendix C). A global verticality survey may reveal movement that could be described as damage under insurance entitlement.

- Inadequate connection of the external deck precast first floor to its supporting wall (east wall).
The supporting wall has sheared off and could cause partial collapse of the external deck. This raises uncertainty about the rest of the building in regards to the connections between the diaphragm floor structure and supporting walls, and the diaphragm roof structure and the supporting walls.

Damage Description: Blockwall displaced by 20 millimetres.

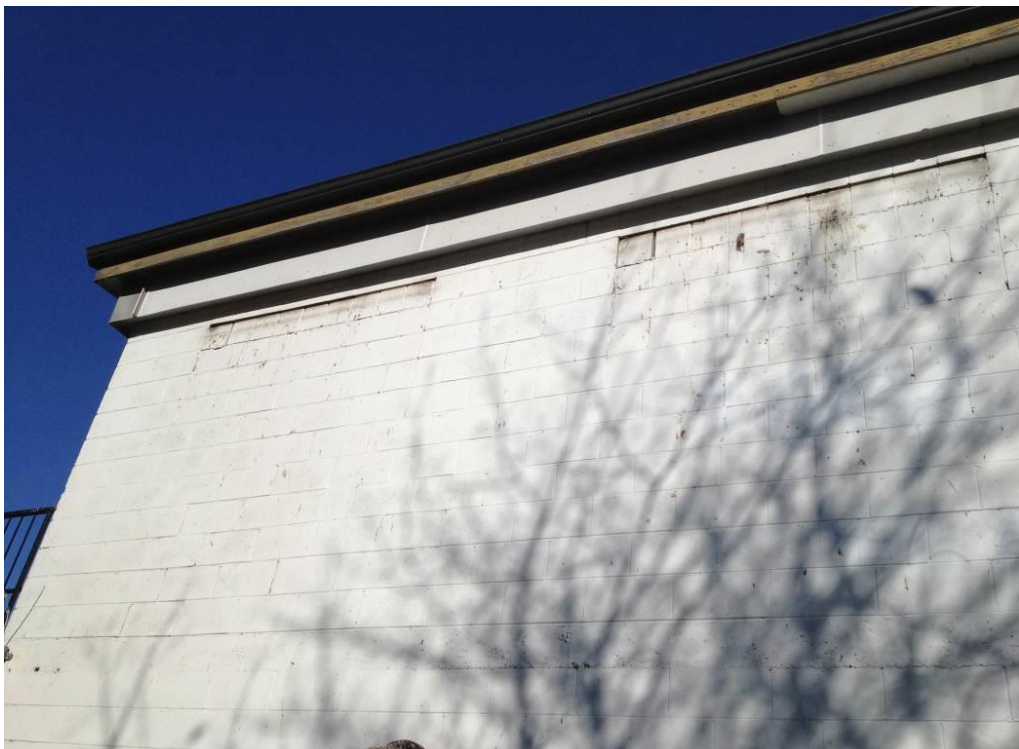
Photo 6: East wall showing blockwall infills

Damage Description: The blockwork window infill moved. Top course appears to be loose and dislodged.

Tape off area at rear - blockwork hazard

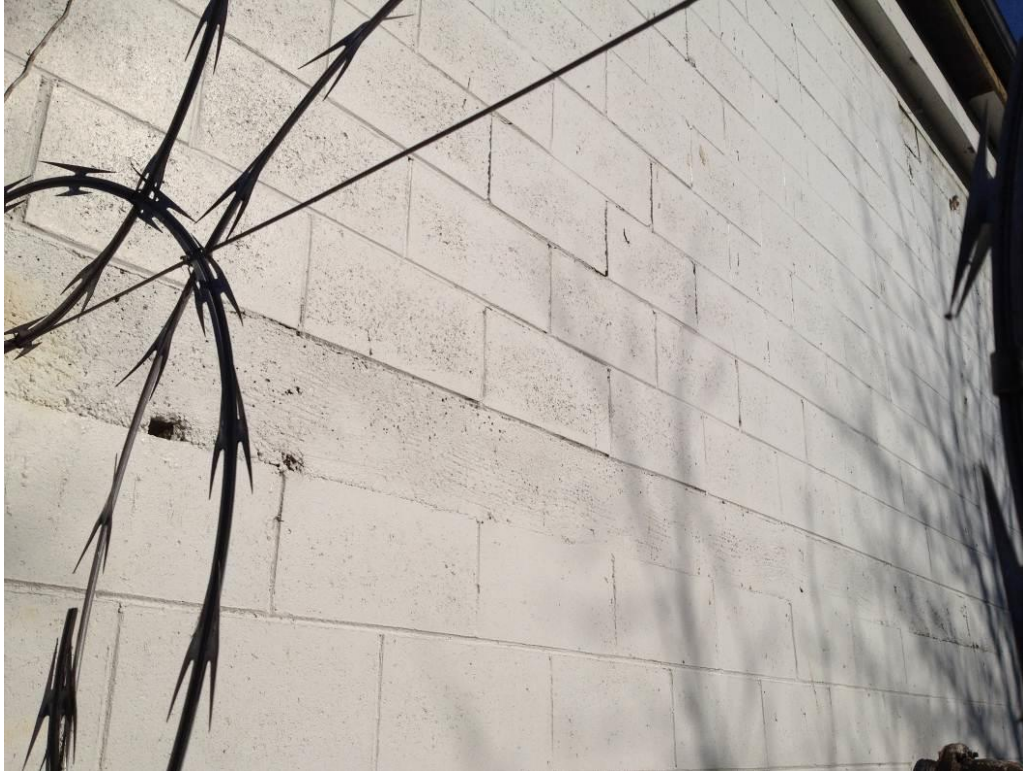
Photo 7: East blockwall elevation

Damage Description: Stepped cracks between the masonry concrete units.

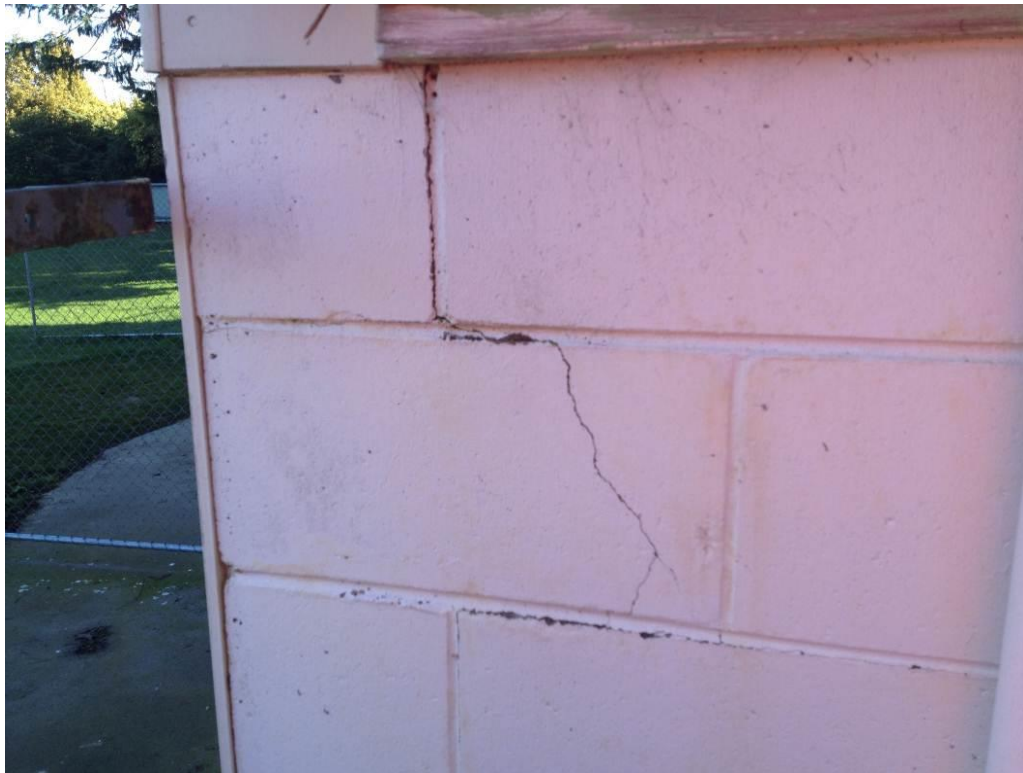
Photo 8: Ground level blockwall damage.

Damage Description: Mortar bed joint cracks and crack through the concrete block.

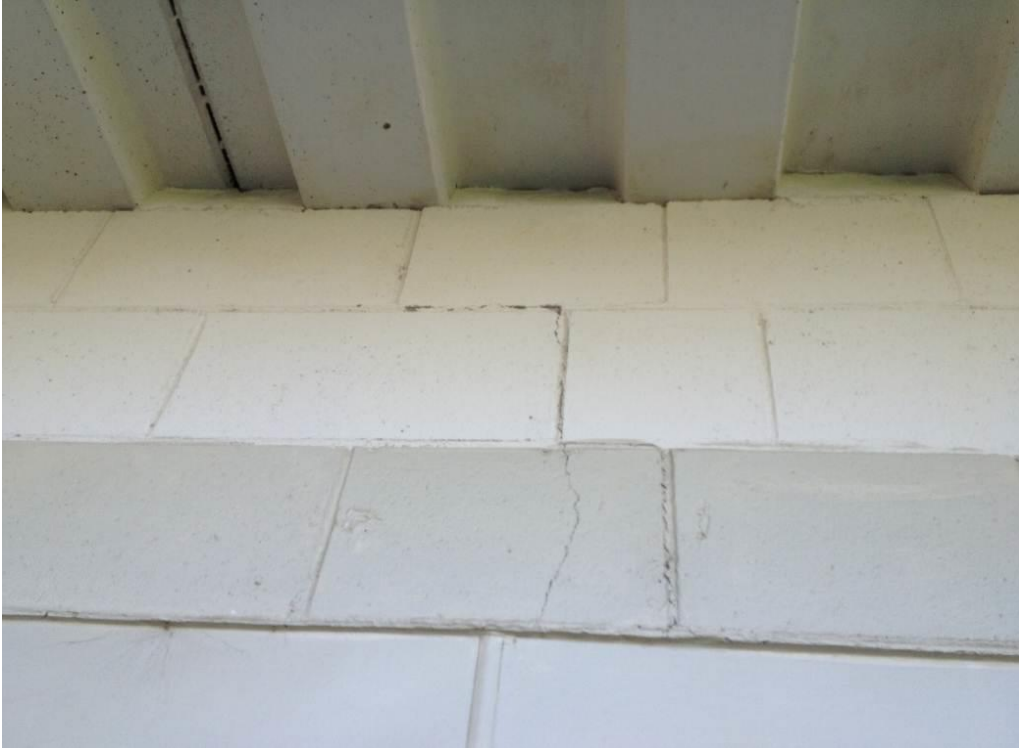
Photo 8: West blockwall underneath the precast floor units.

Damage Description: Vertical cracks in concrete masonry block lintel, mortar bed stepped cracking.

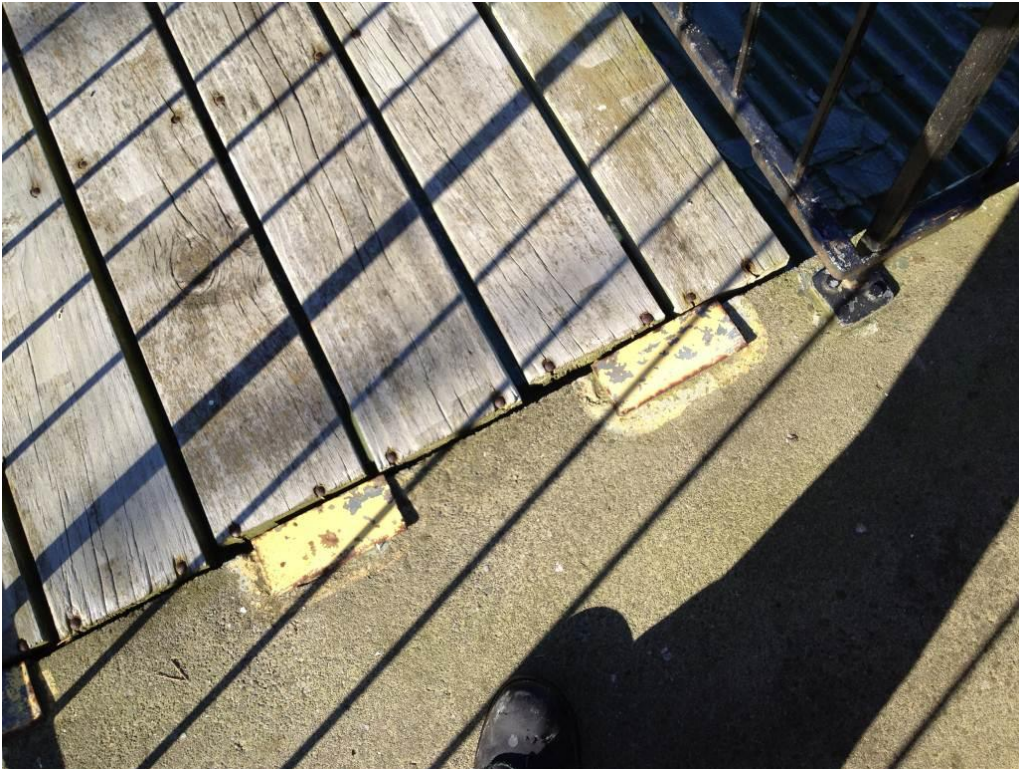
Photo 9: South staircase upper deck

Damage Description: Movement of stair relative to concrete deck.
