**Heathcote Domain
Former Tennis Club Shed
Detailed Engineering Evaluation
Quantitative Report
Christchurch City Council**

Date: 27 August 2012
Reference: 6-QUCC1.11
Status: Final

Heathcote Domain Former Tennis Club Shed
PRK 1880 BLDG 007 EQ2

Detailed Engineering Evaluation
Quantitative Report - SUMMARY
Final

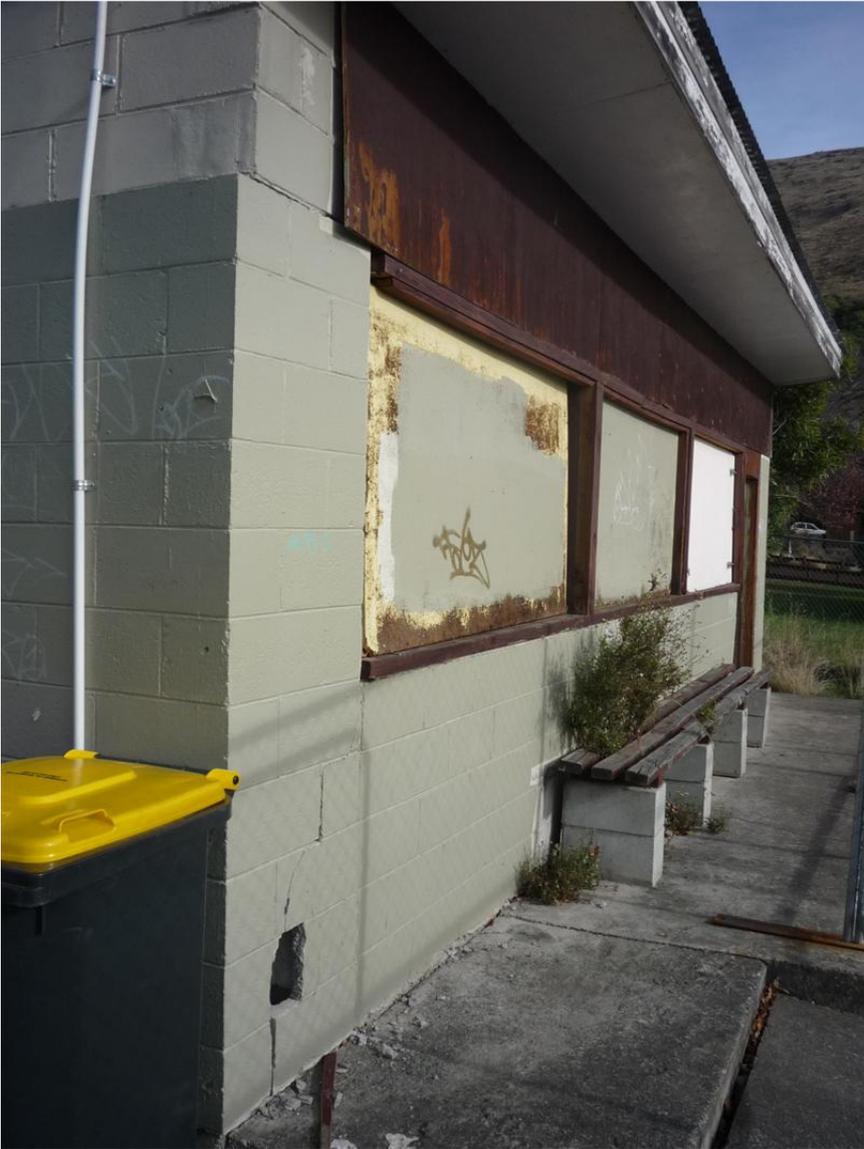
The two small piers at either end of the north side of the building would have failed quickly in the earthquake, leading to a torsional response from the building. This in turn would have increased the out-of-plane effects on the walls on the east and western sides leading to the lateral displacements seen in the building.

Photo 1: View of the north wall of the building

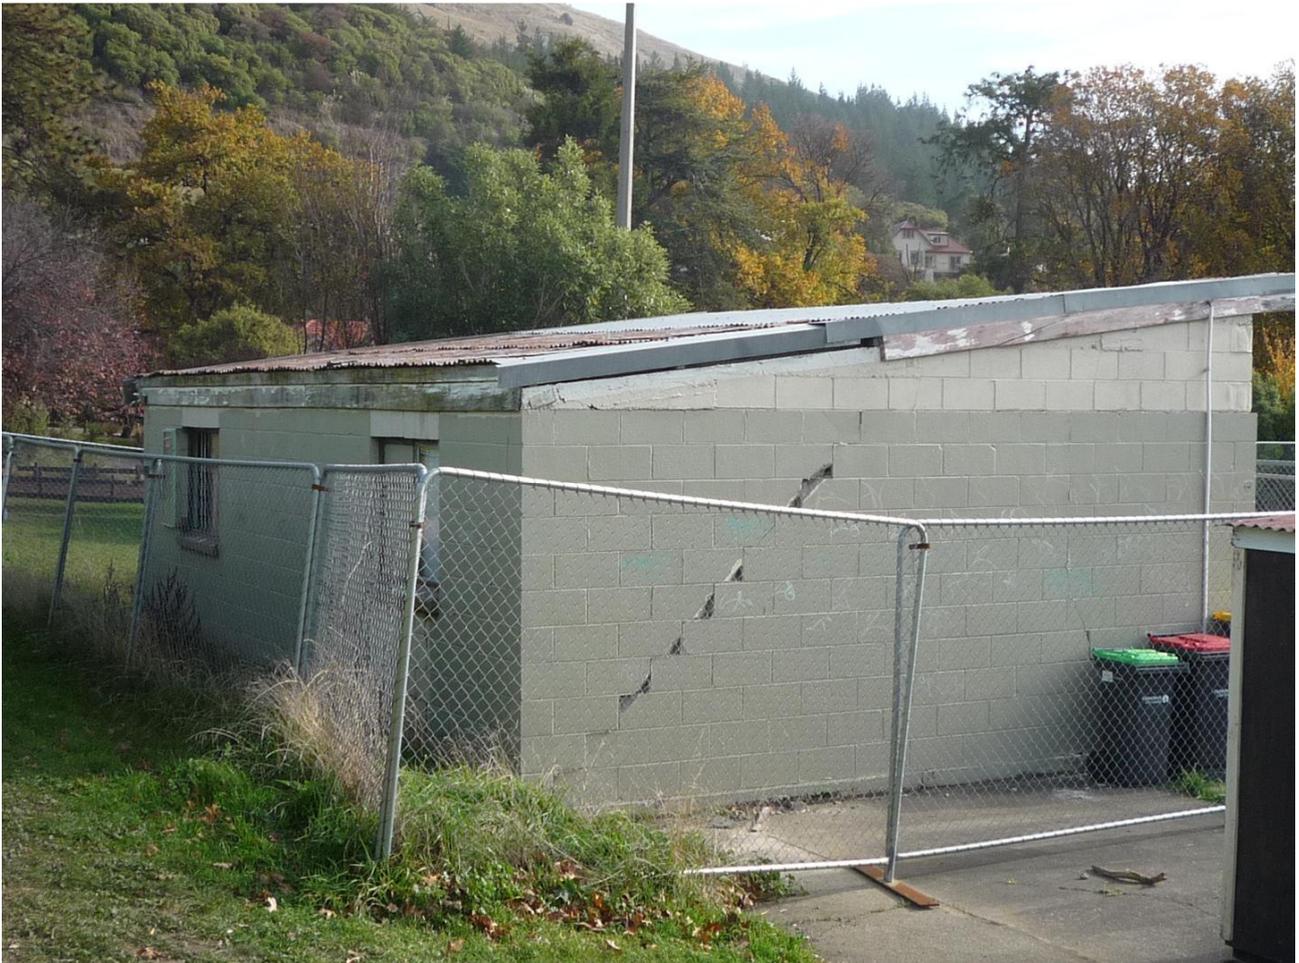
The building has a large number of cracks that are the result of seismic actions. Diagonal shear cracks are evident in all of the walls. Some of the cracks have caused pieces of the masonry block face shells to break off.

Photo 2: View of the large crack on the east wall

Any remedial options for increasing the seismic capacity to at least 67% NBS would need to address the large cracks in the walls throughout the building.

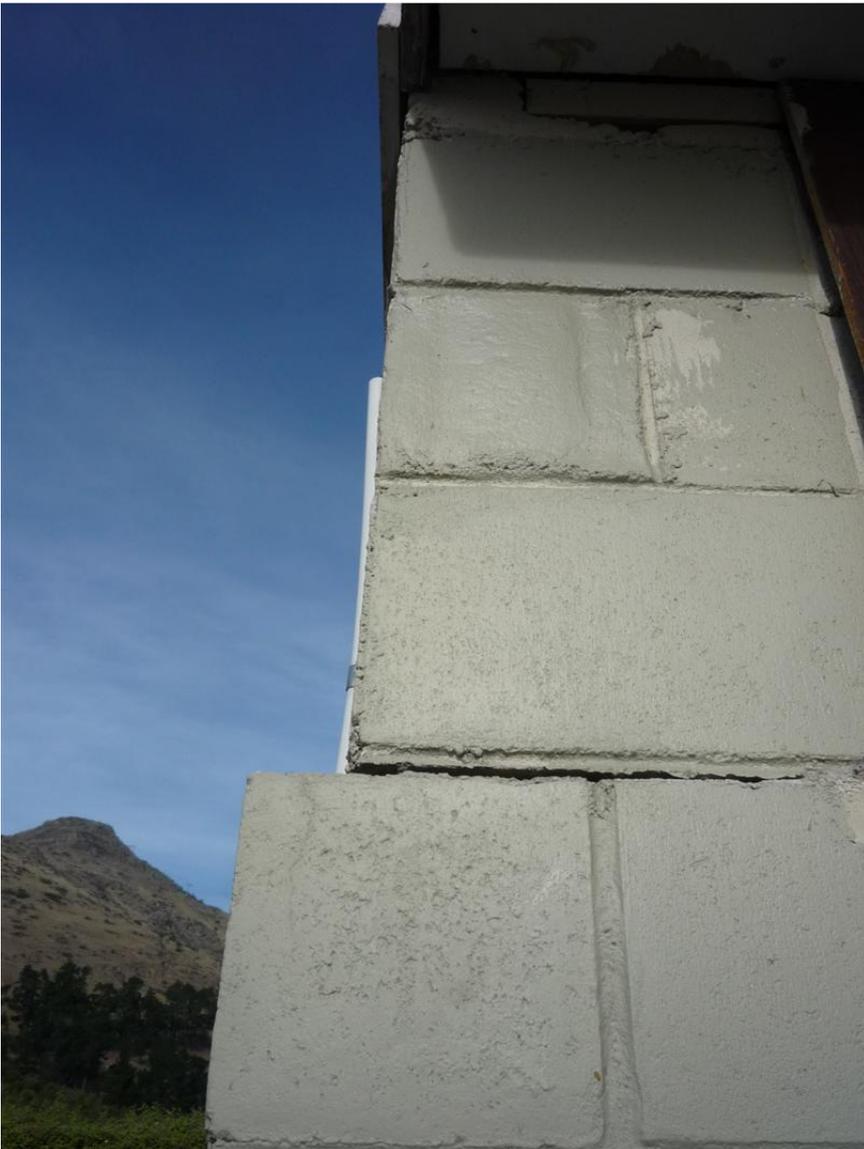
Horizontal cracks have also formed allowing the upper part of the east and west walls (and roof) to shift laterally compared to the lower portion of the wall. This is particularly evident on the north elevation. The east side wall has also broken away from the rest of the building and is leaning out of plane. The west wall appears to have also moved outward relative to the building foundation.

Photo 3: View of the wall lateral displacement near the top of the east wall

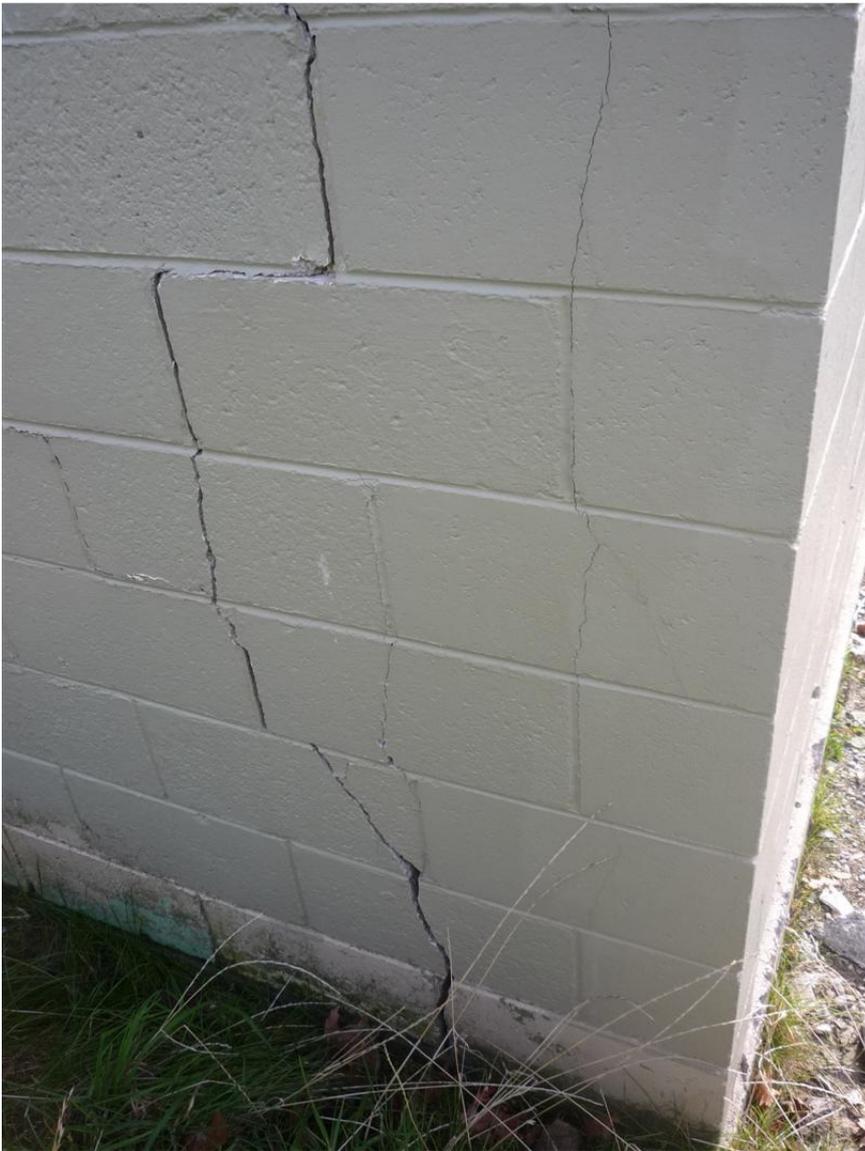
Due to the building's close proximity to the epicentre of the 22 February 2012 earthquake it experienced shaking greater than that of a design level earthquake which contributed to the large amount of damage. Another moderate seismic event could cause this building to collapse completely. The roof framing and friction between the masonry blocks are what is preventing partial collapse of the wall leaning out of plane.

Photo 4: View of the south wall showing the crack caused by the east wall leaning out of plane

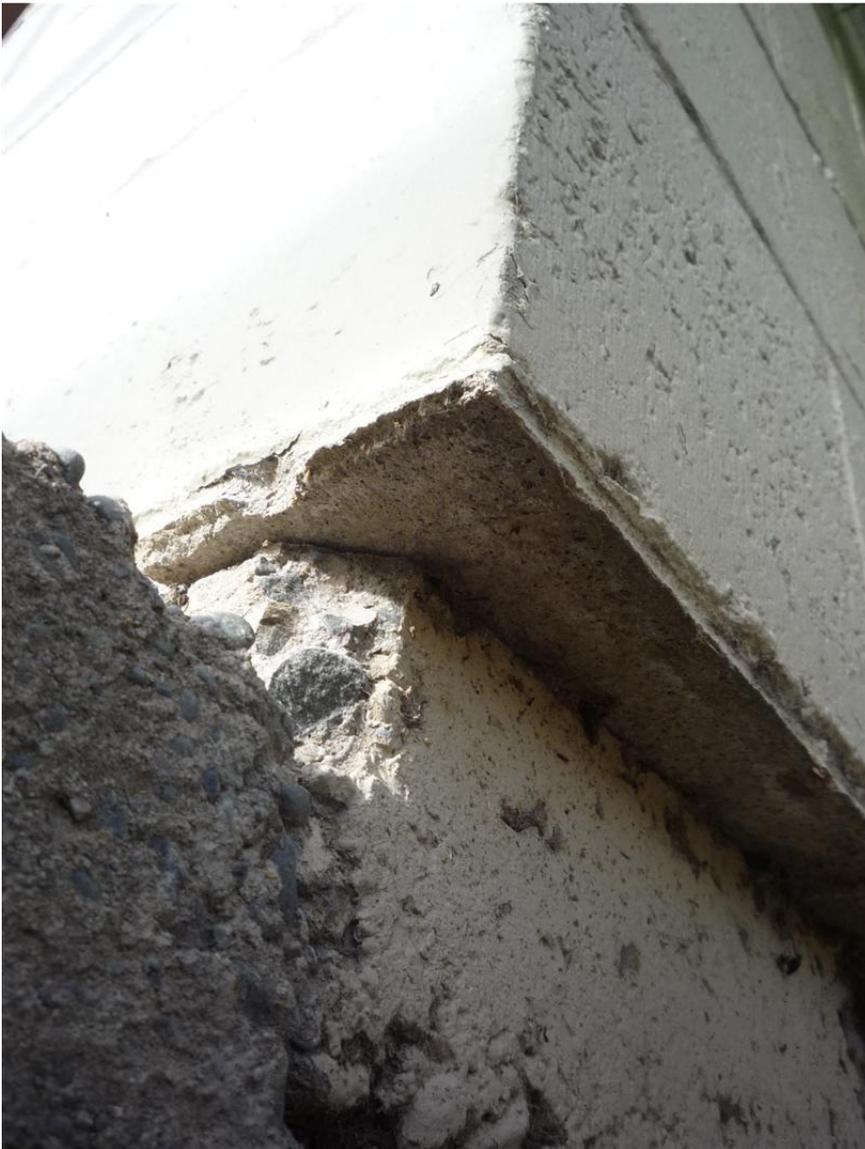
Photo 5: View of the west wall displacing laterally at the foundations

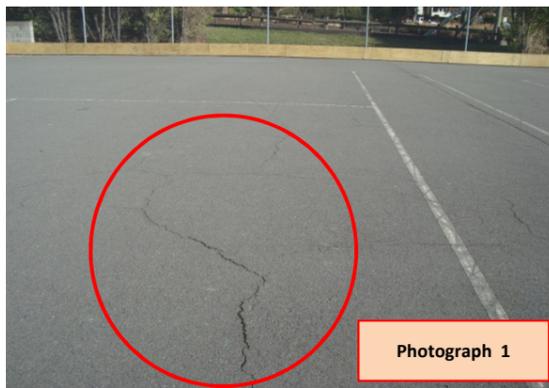
Photograph 1

- Hairline and web-like cracks observed in some places around the tennis court (Photograph 1, Appendix C).
- Corner wall of the concrete retaining structure leaning north by approximately 6 degrees (Photograph 3, Appendix C).

Hairline and web-like cracks observed on the ground in some places around the tennis court.

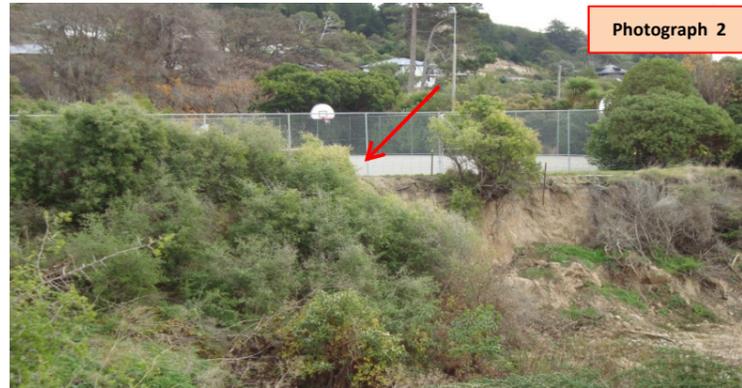
Photograph 2

Very steep slopes east of the tennis club fenced with warratahs and aluminum wire at the top

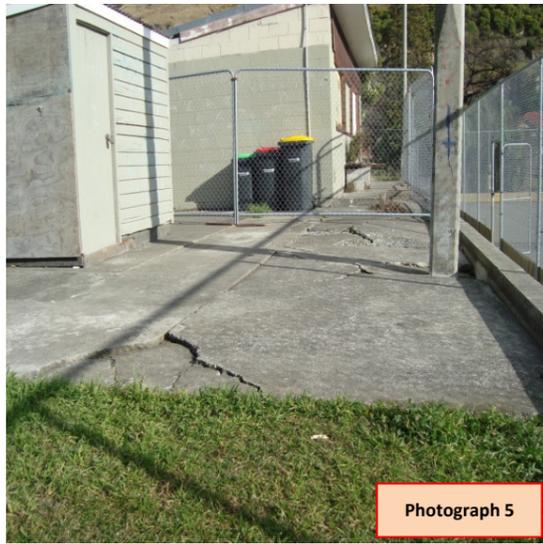
Photograph 5

- Timber storage shed founded on severely cracked concrete slab (Photograph 5, Appendix C).
- Light post leaning approximately 5 degrees north, with cracks radiating from the bottom of post (Photograph 6, Appendix C).

Timber storage shed on severely cracked concrete slab and apron area.

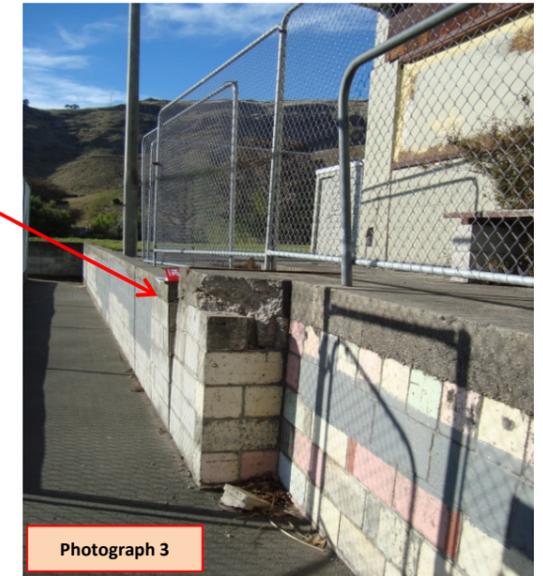
Photograph 3

Corner wall leaning north 100mm away from the Club Shed structure

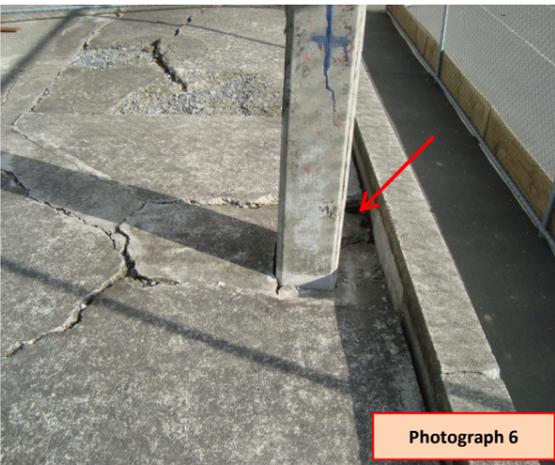
Photograph 6

The horizontal PGA recorded at Heathcote Valley Primary School was 1.5g. It was these very high PGAs which has caused the lateral movement of the ground as observed by the leaning retaining wall and the light post towards the north.

Light post slightly leaning north by approximately 5 degrees with respect to the vertical. Cracks radiating from the bottom of post.

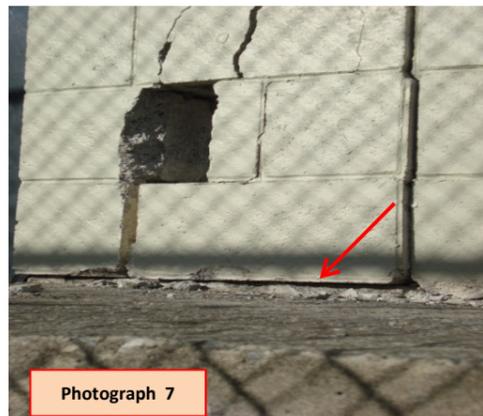
Photograph 7

- Vertical settlement of more than 10mm observed between the concrete block work and concrete slab (north elevation of the shed) (Photograph 7, Appendix C).

Vertical settlement of more than 10mm observed between the concrete block work and concrete slab (North elevation of the shed)

1. Undertake a floor level survey to ascertain if differential settlement has occurred to the foundations.
2. Set up monitoring of the crack widths and tilt is recommended.
3. Undertake repairs to concrete masonry wall.

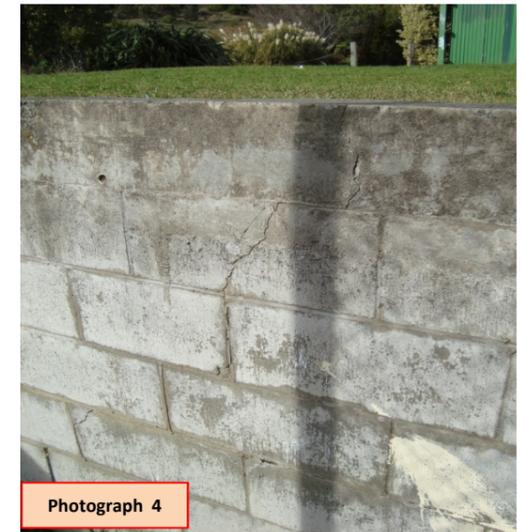
Photograph 4

- Concrete masonry retaining wall has sustained approximately 2mm to 3mm wide cracks on the face running from bottom to top of the wall (Photograph 4, Appendix C).

The concrete masonry retaining wall sustained cracks (≅ 2 to 3mm wide) on the face running from bottom to top of wall.

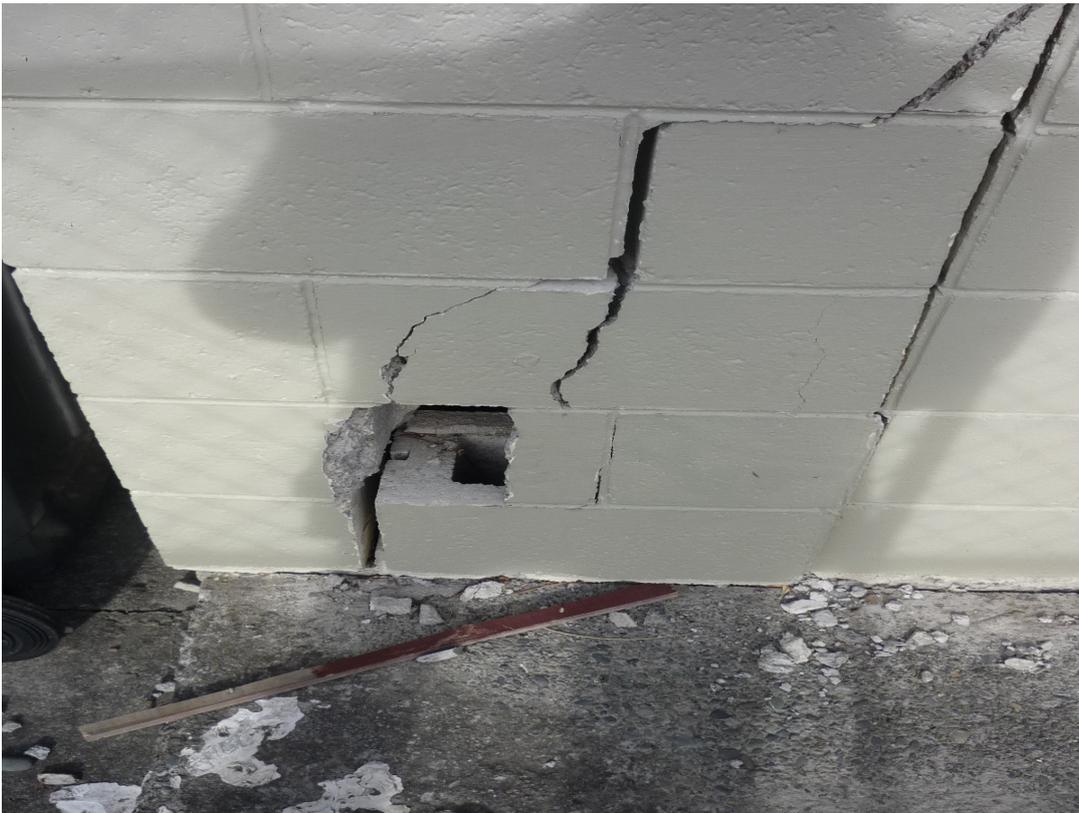
Photograph 2: View of the 10mm wide separation between the perimeter wall and the concrete slab.

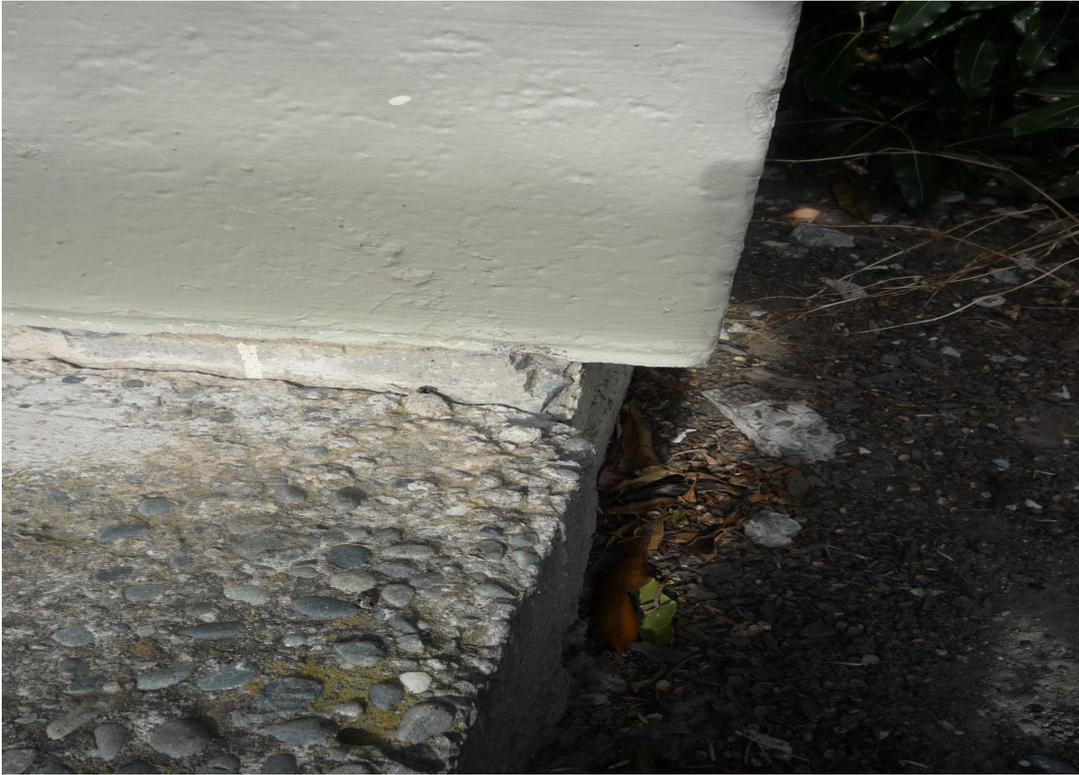
Photograph 3: View of the 20mm subsidence of the concrete slab from perimeter wall. (Located far west corner of the north elevation of the shed)

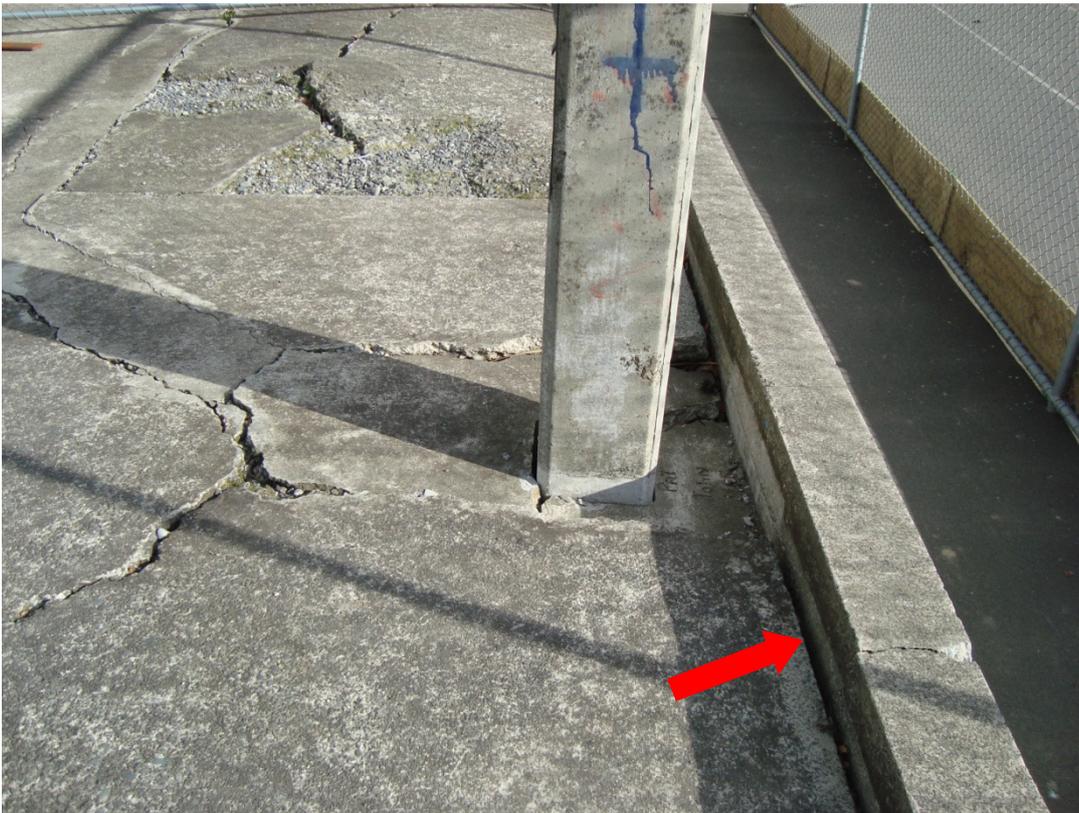
Photograph 4: View of the 20mm lateral movement of the retaining wall.
