Heathcote Domain Toilets
PRK 1880 BLDG 005
Detailed Engineering Evaluation
Qualitative Report
Version FINAL

40 Port Hills Rd
Heathcote Valley

Christchurch City Council

Date
20th May 2013

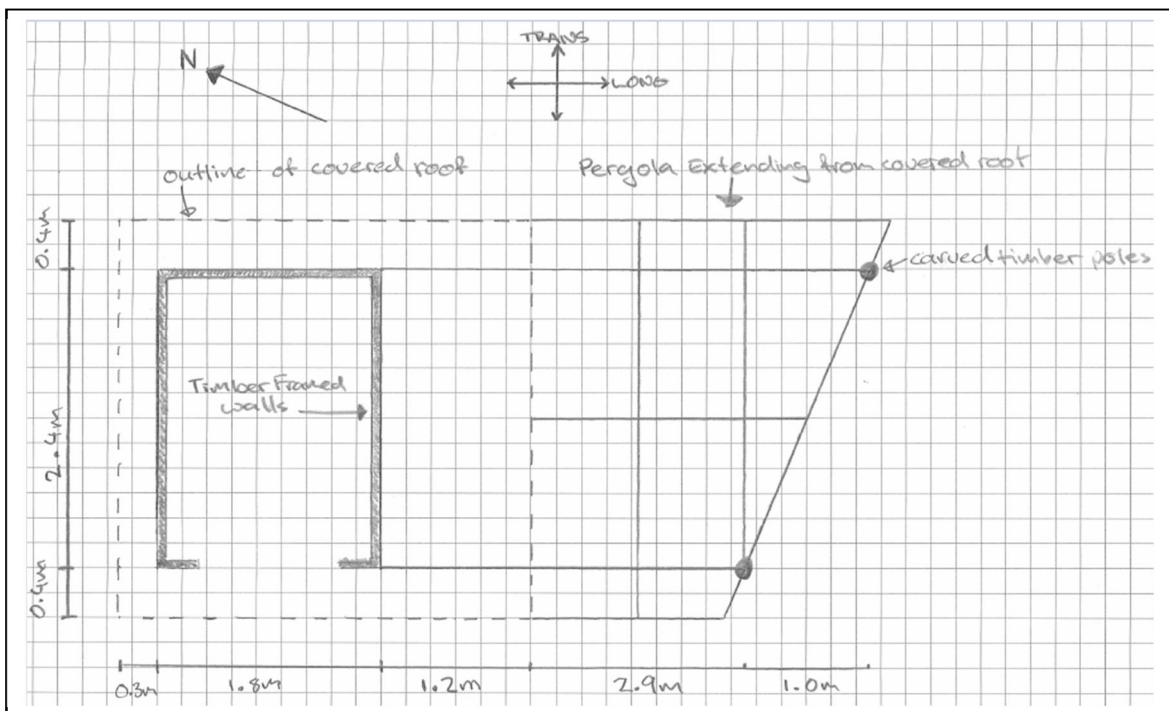
Figure 2 Plan Sketch Showing Key Structural Elements

The toilet block is 2.4m in length by 1.8m in width. The height of the eave at the north-western end is 2.2m. The roof extends over each of the walls to varying degrees (Figure 2). The pergola extends from the roof for up to 3.9 meters. The overall footprint of the building is approximately 11m².

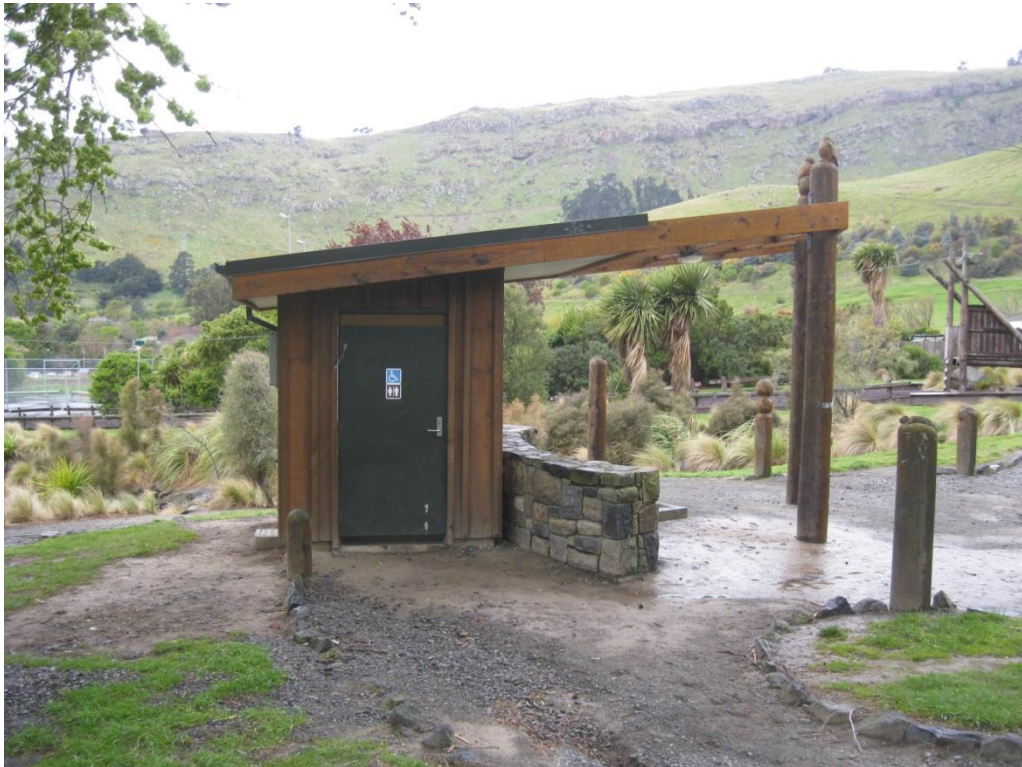
Photograph 1 Southwest elevation

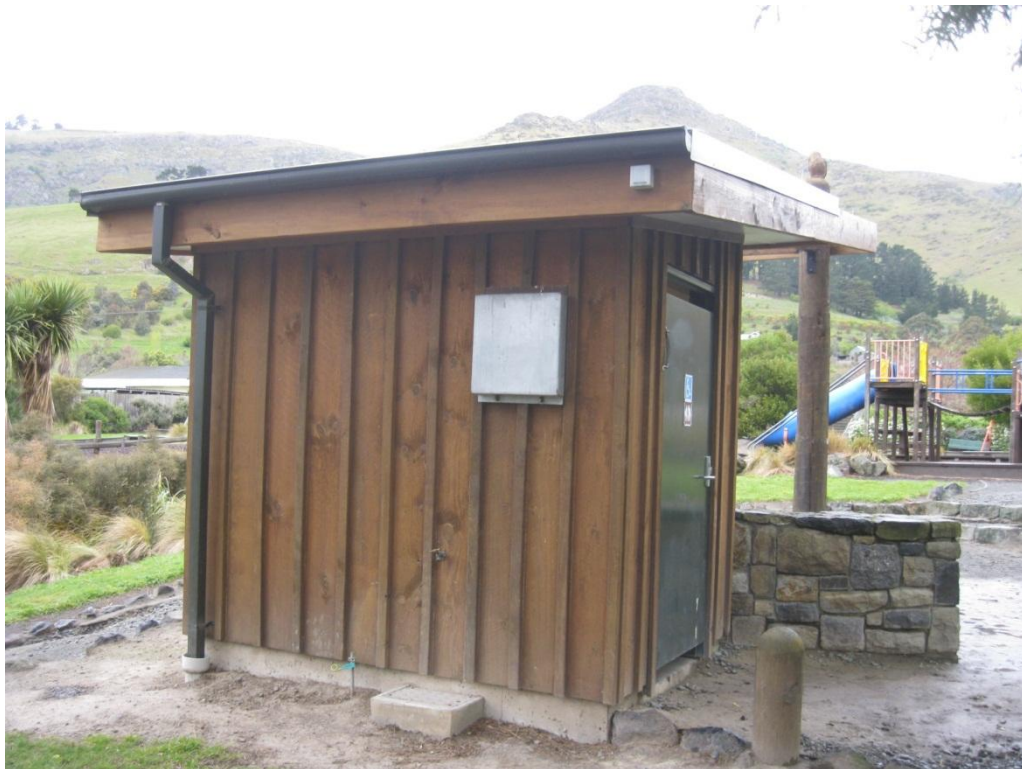
Photograph 2 View of the toilet from the northwest.

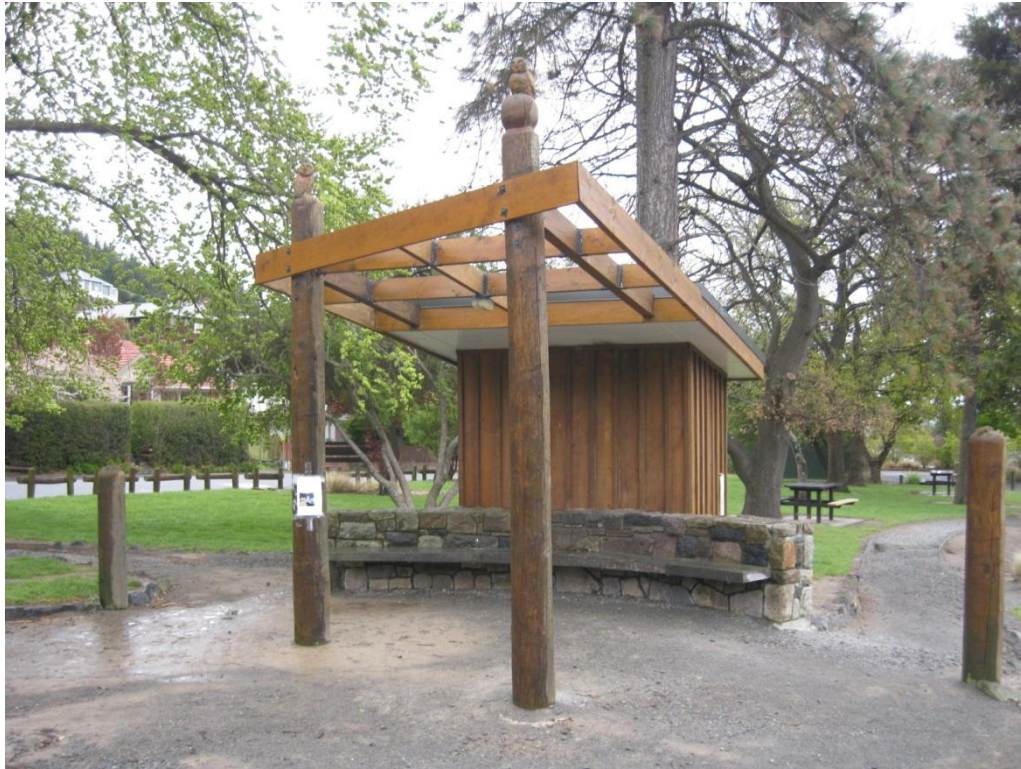
Photograph 3 View of the toilet from the south with pergola in front.

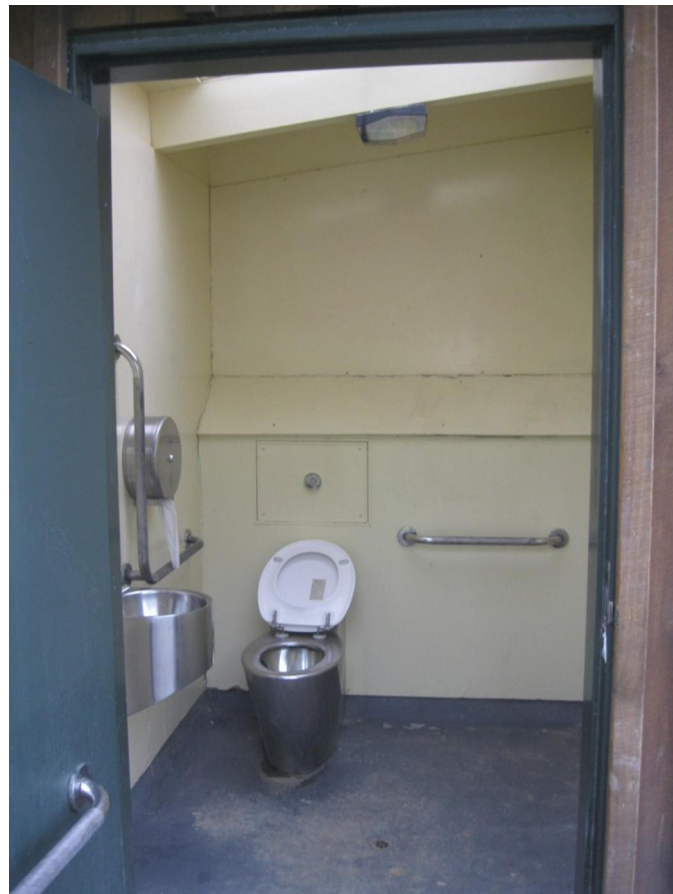
Photograph 4 Toilets interior.

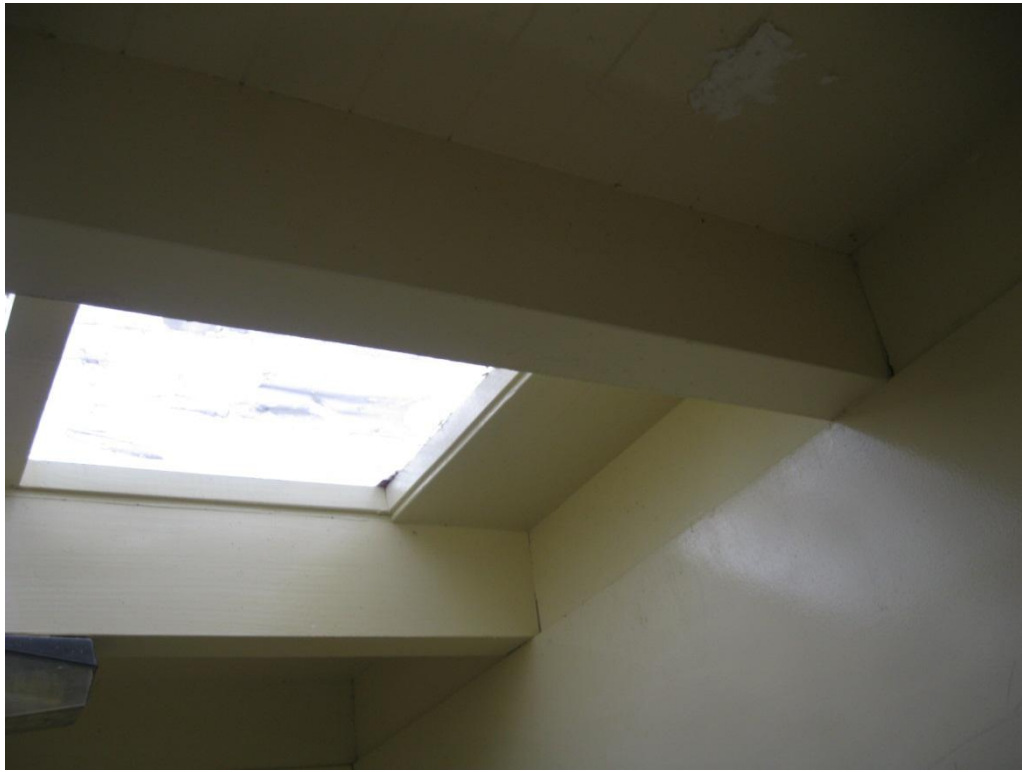
Roof elements such as grooved plywood, ceiling joists and beams were clearly visible and are expected to span adequately between supports and provide an effective roof diaphragm.

Photograph 5 Sun roof and timber beams.

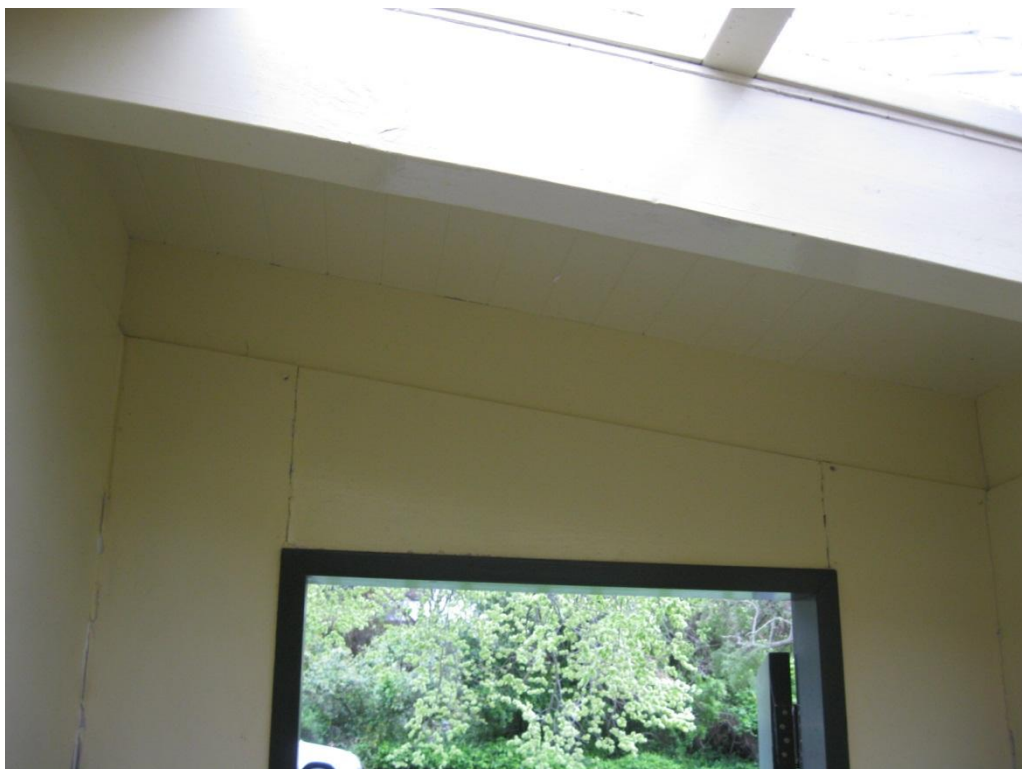
Photograph 6 Paint peeling at villa board lining joints.

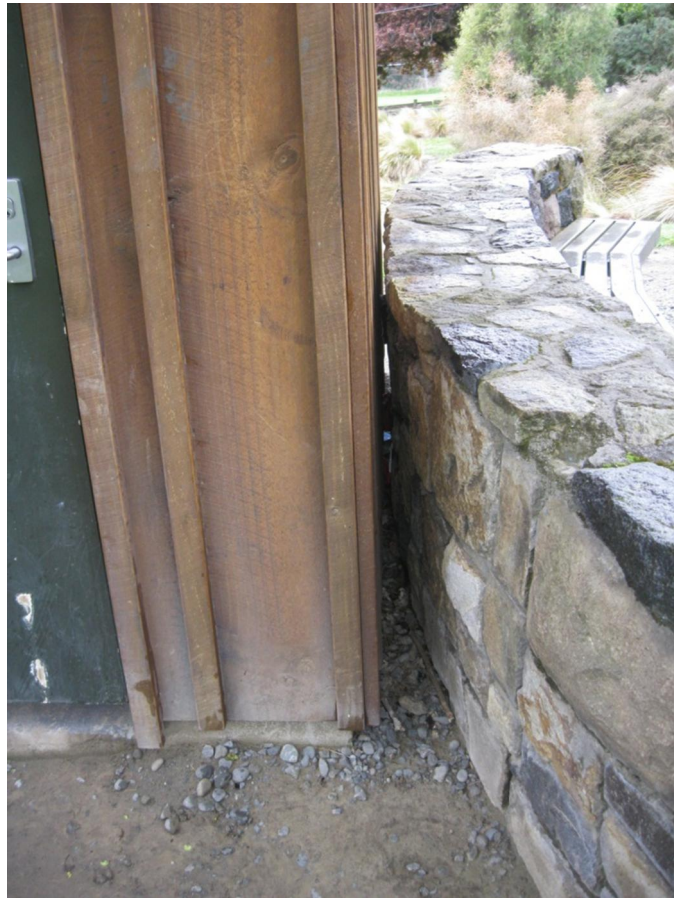
A 0.8m high stone wall is located on the south eastern face of the building. The wall is connected into the concrete slab through steel reinforcing.

Photograph 7 Stonewall at southeast face of the building
