**Toilet Block – Bishopsworth St /
Hillsborough Park
PRK_0962_BLDG_002 EQ2
Detailed Engineering Evaluation
Qualitative Report
Version Final**

Christchurch City Council

Date
1st October 2012

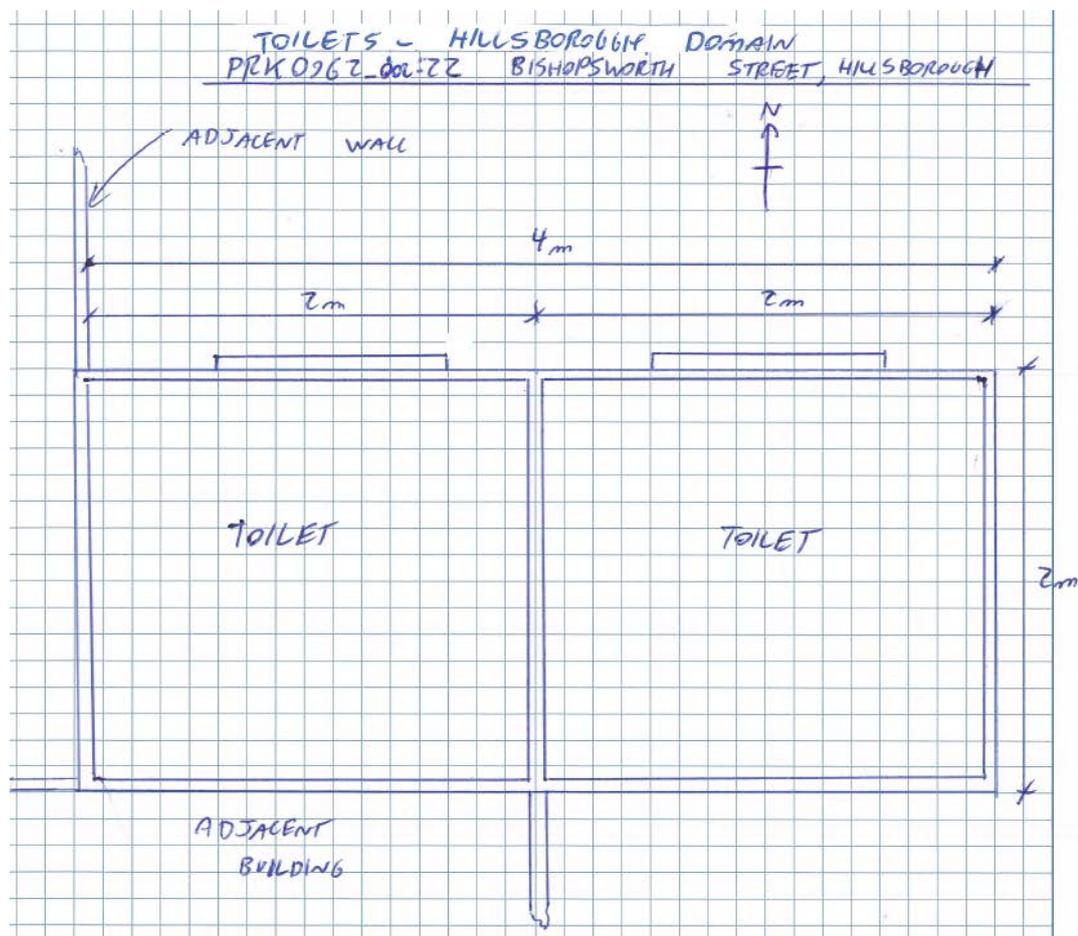
Figure 2 Plan Sketch Showing Key Structural Elements

The building is a simple single leaf of filled or partially filled concrete blockwork masonry. The single storey construction has a concrete slab on grade floor. The simple timber beam roof consists of lightweight metal cladding supported by timber purlins and beams.

Lateral loads acting on the structure are resisted by concrete masonry walls both along and across the dimensions of the building. The single internal blockwork wall offers additional lateral resistance across the structure. The masonry walls will transfer the lateral load from the roof down to the slab on grade foundation.

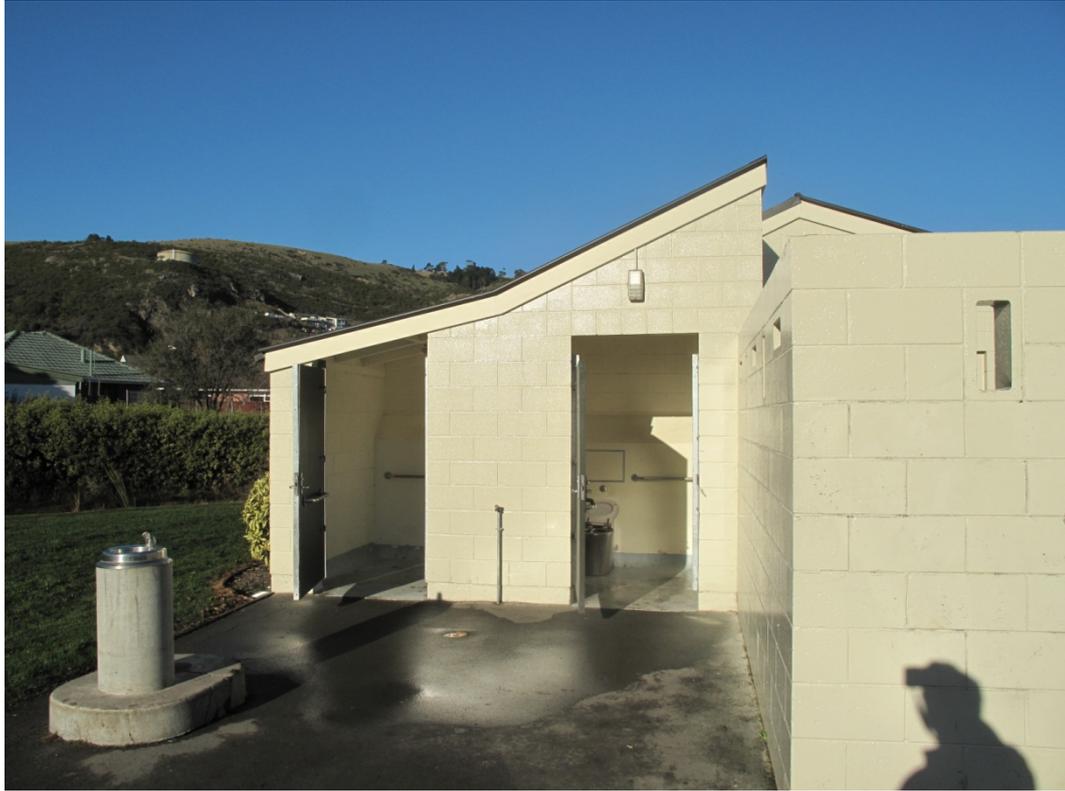
No damage was evident to the exterior of the building.

Photograph 1 North elevation.

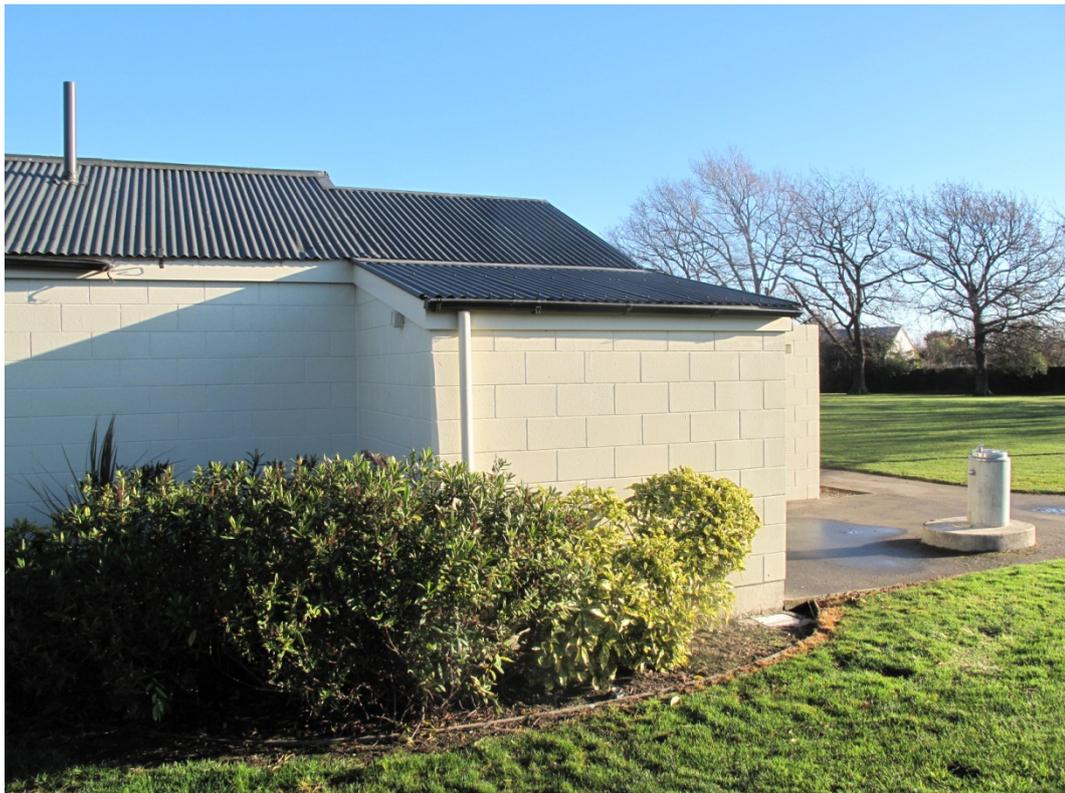
Photograph 2 View of the toilet block from the southeast

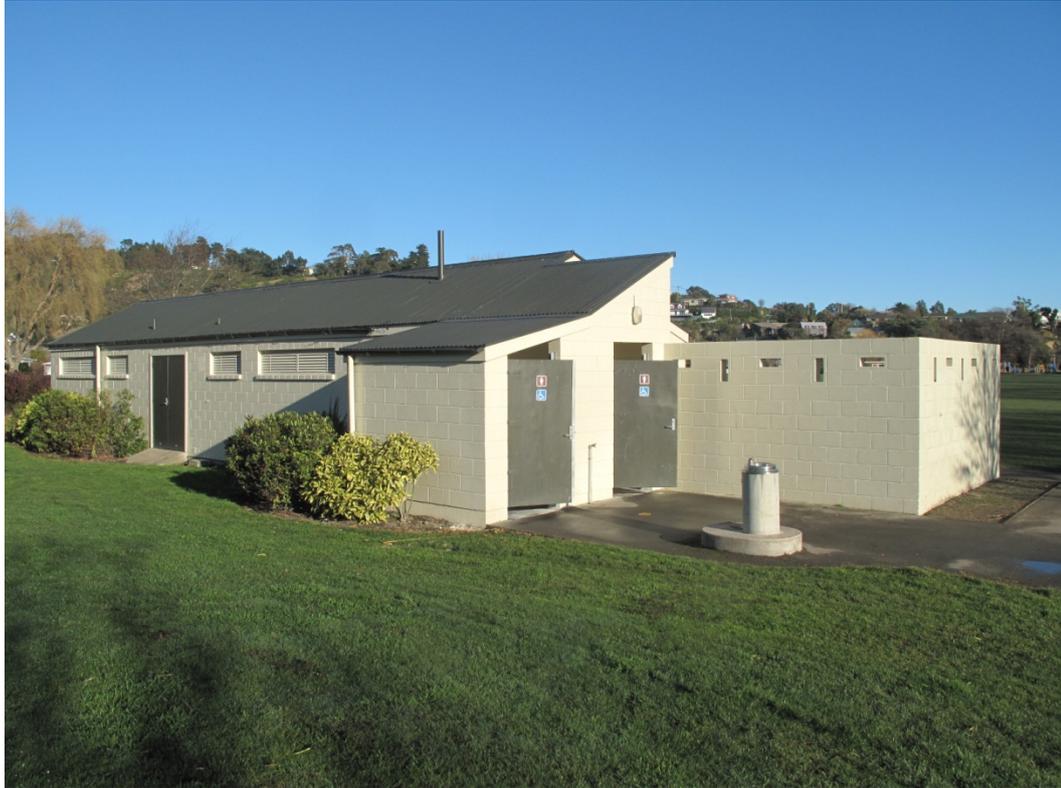
Photograph 3 View of the toilet block from the northeast.

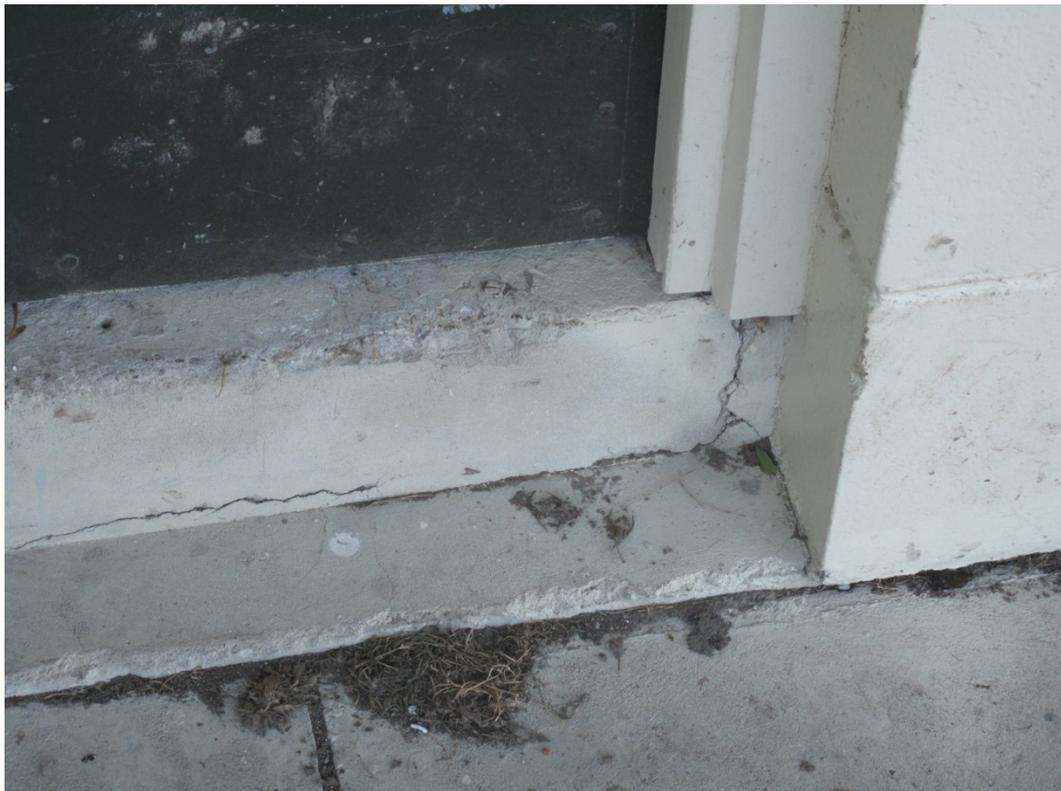
- Possible settlement has occurred nearby
- Minor cracks in the edge of the concrete slab-on-grade foundation

Minor cracks were noted at the edges of the slab on grade concrete floor at the entrances to the toilet block.

Photograph 4 Minor cracking at edges of slab on grade

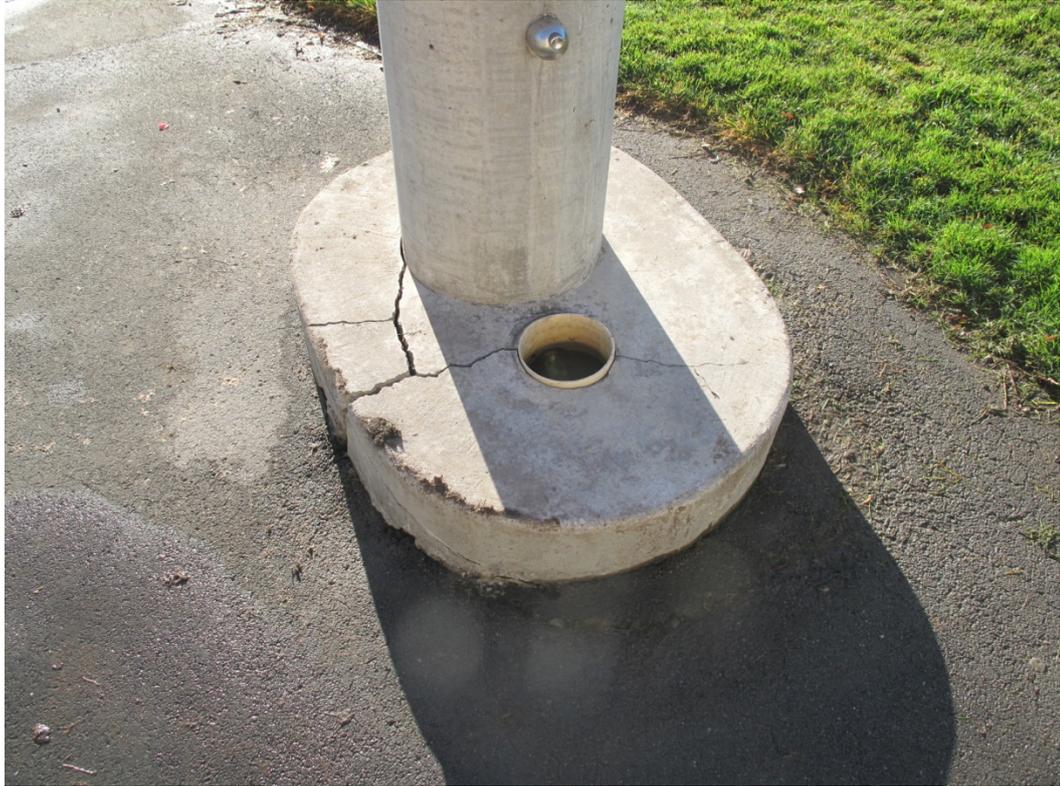
With regards the adjacent drinking foundation concrete foundation significant damage was observed. Shear failure has occurred both along and across the foundations with the largest crack width 30 mm. The cracks are evident in Photographs 5 and 6 in Appendix A. In addition pieces of concrete have been displaced and are now missing.

Photograph 5 Cracking in base of adjacent drinking fountain.

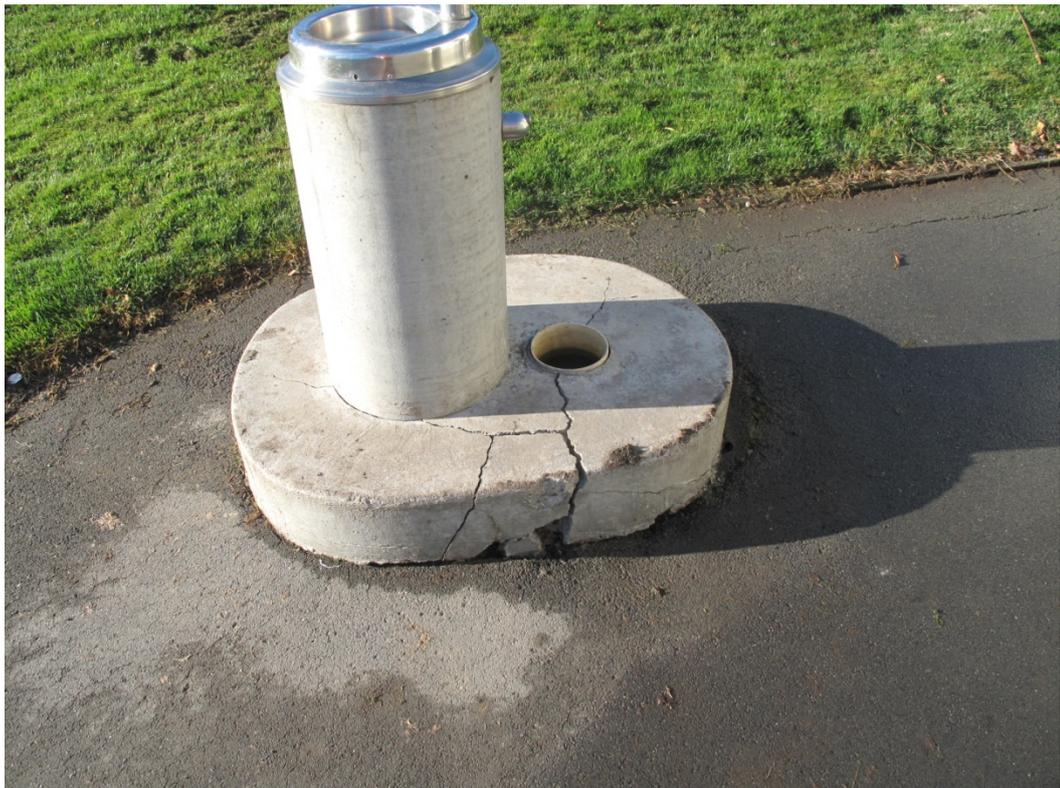
Photograph 6 Cracking and loss of concrete in base of drinking fountain.

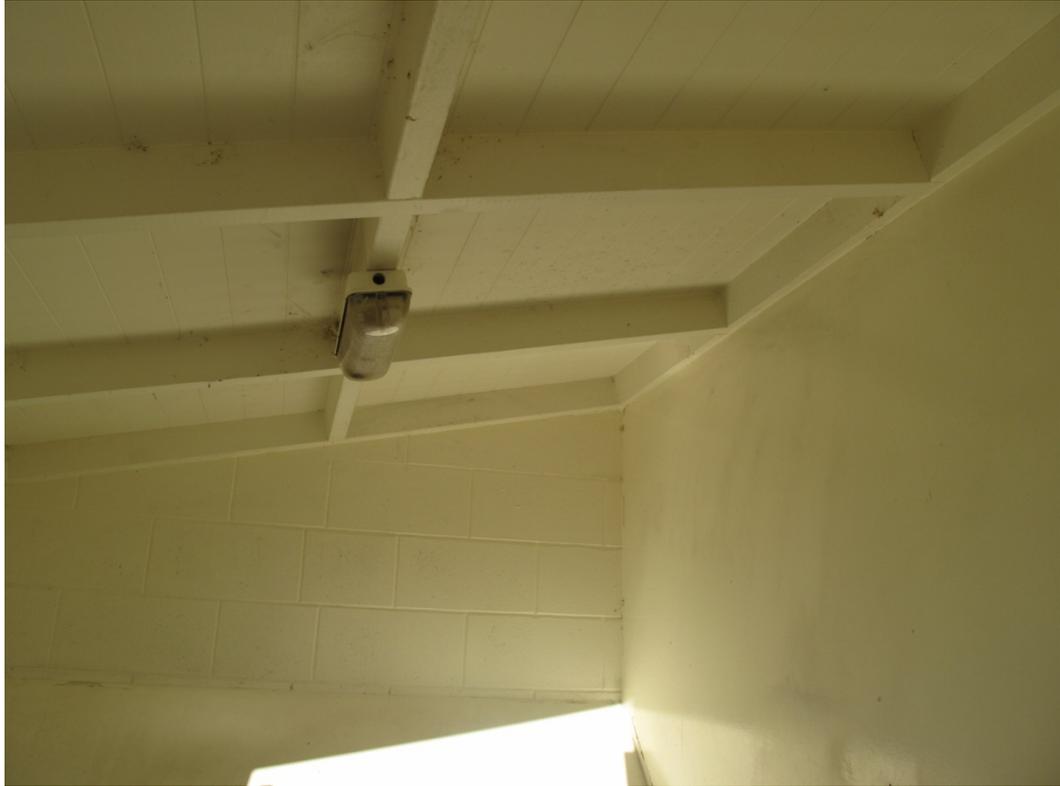
No damage was evident to the timber beam roof structure.

Photograph 7 Timber beams and purlins.

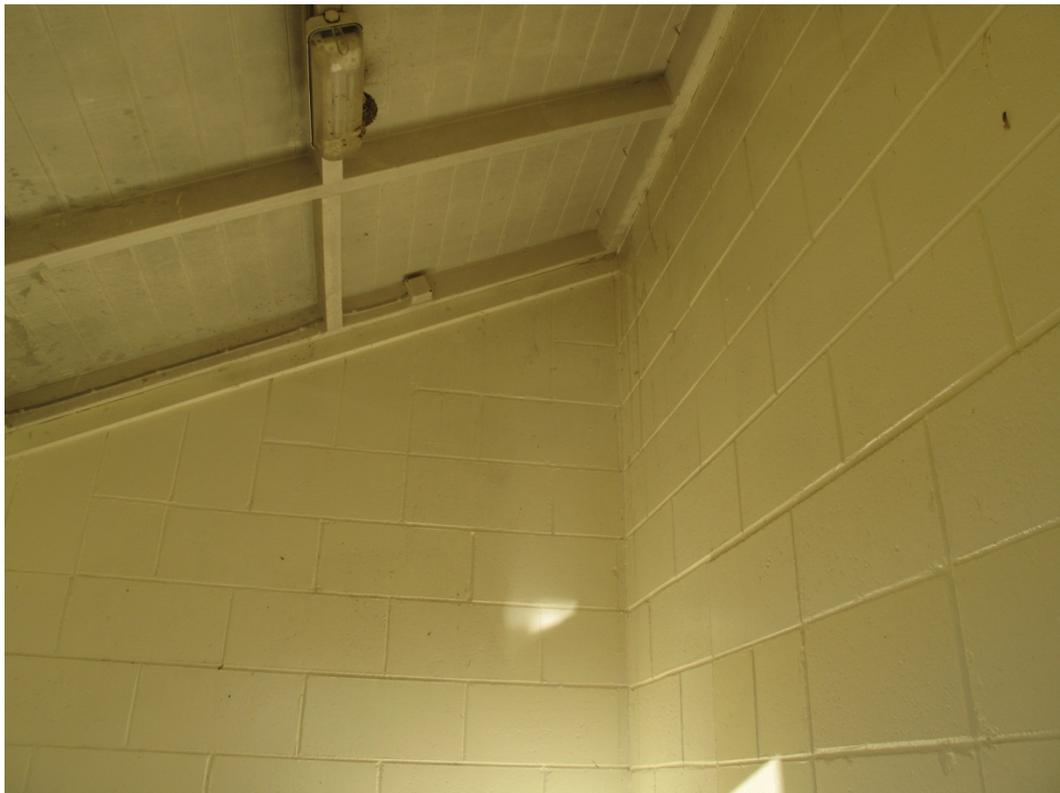
Photograph 8 Timber beam on the back wall connecting the roof to the block walls.

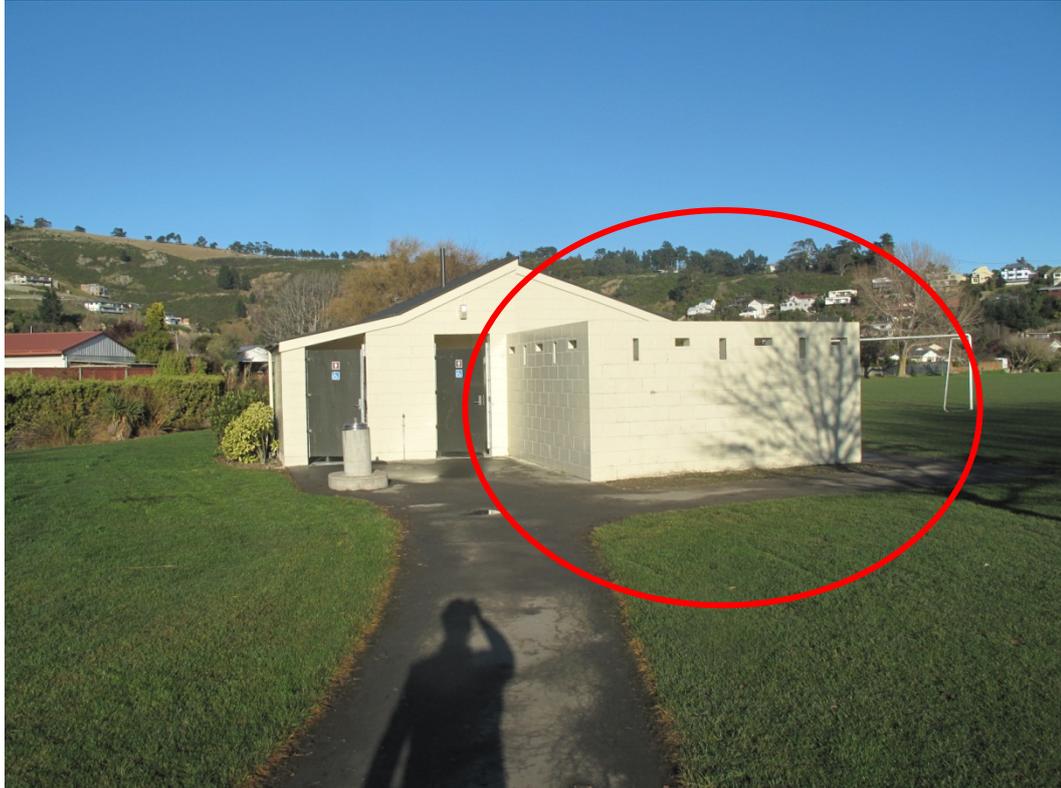
Photograph 9 Wall surrounding pavilion area connected to northwest corner

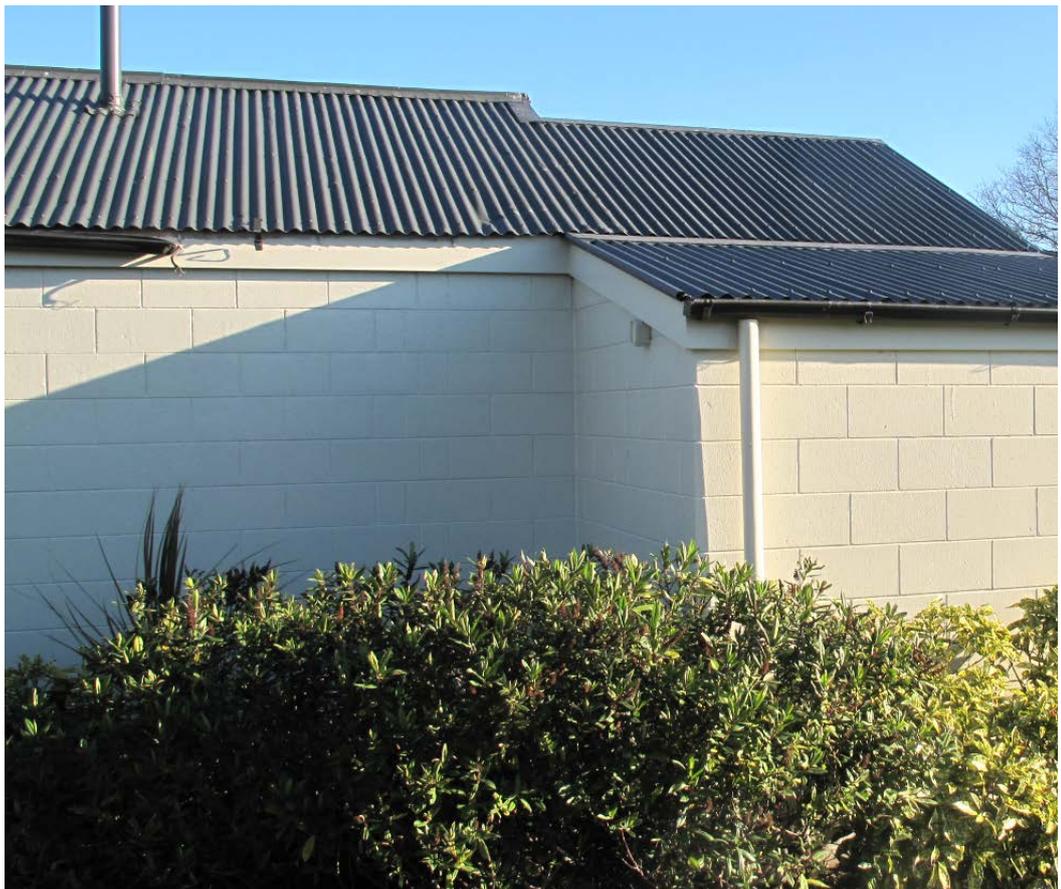
Connected to the toilet block on the south western side is a single leaf reinforced masonry pavilion 16m in length 7m in width and 3.6m in height. Also connected to the toilet block is a single row reinforced masonry wall surrounding a seating area 11m long and 2m high. These structures are integrated and in effect part of the same structure.

Photograph 10 Rear of toilet block shares wall with pavilion.
