Toilets – Hollis Reserve
PRK_1769_BLDG_001
Detailed Engineering Evaluation
Qualitative Report
Version Final

Christchurch City Council

Prepared By
Cormac Joy

Date
24-05-13

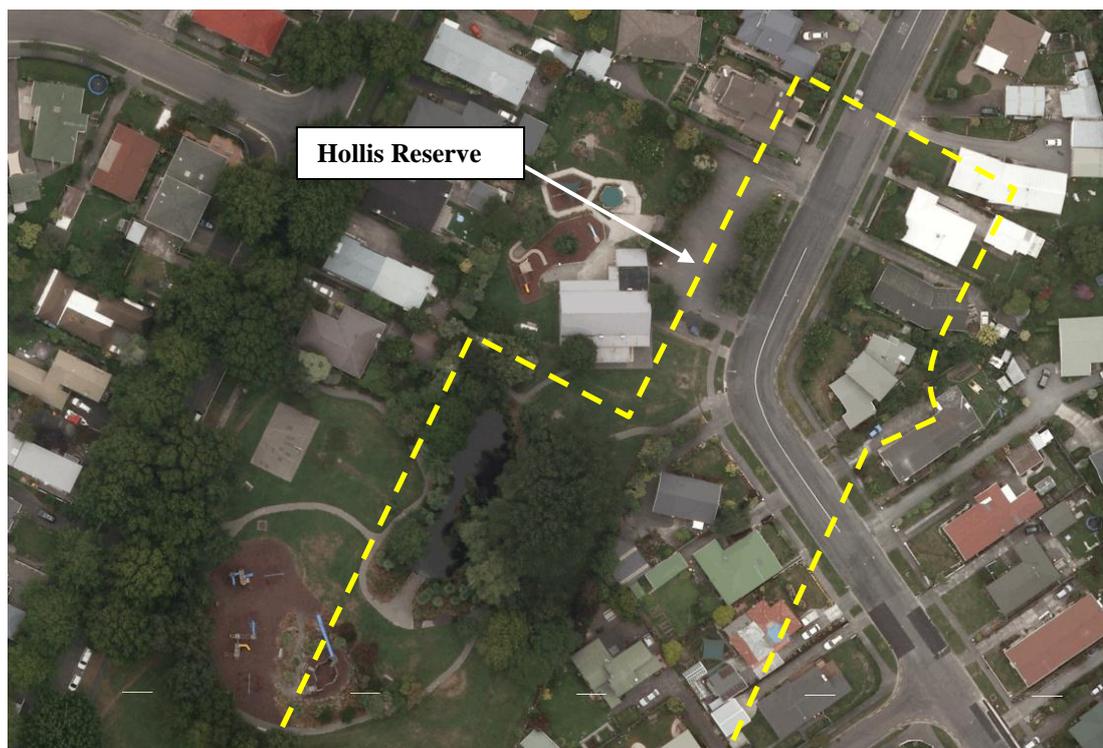
Figure 3 Post February 2011 Earthquake Aerial Photography³

Aerial photography taken following the 22 February 2011 earthquake shows no signs of liquefaction outside the building footprint or adjacent to the site, as shown in Figure 3.

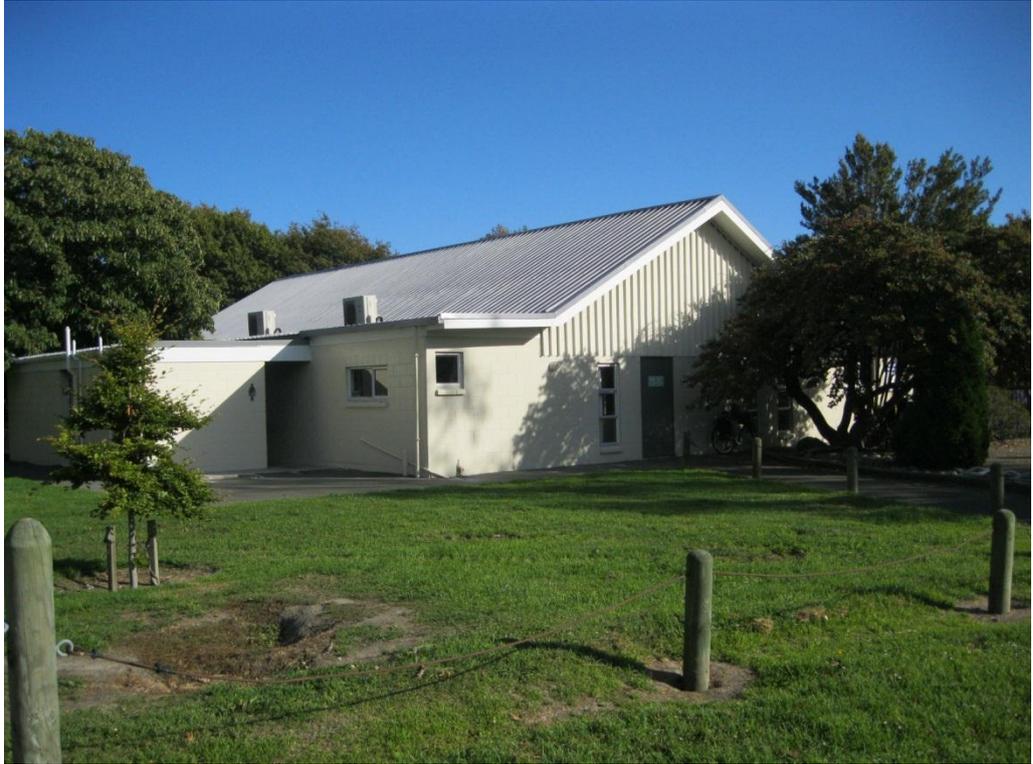
Photograph 1: Western and southern facing elevations showing hall and toilet block

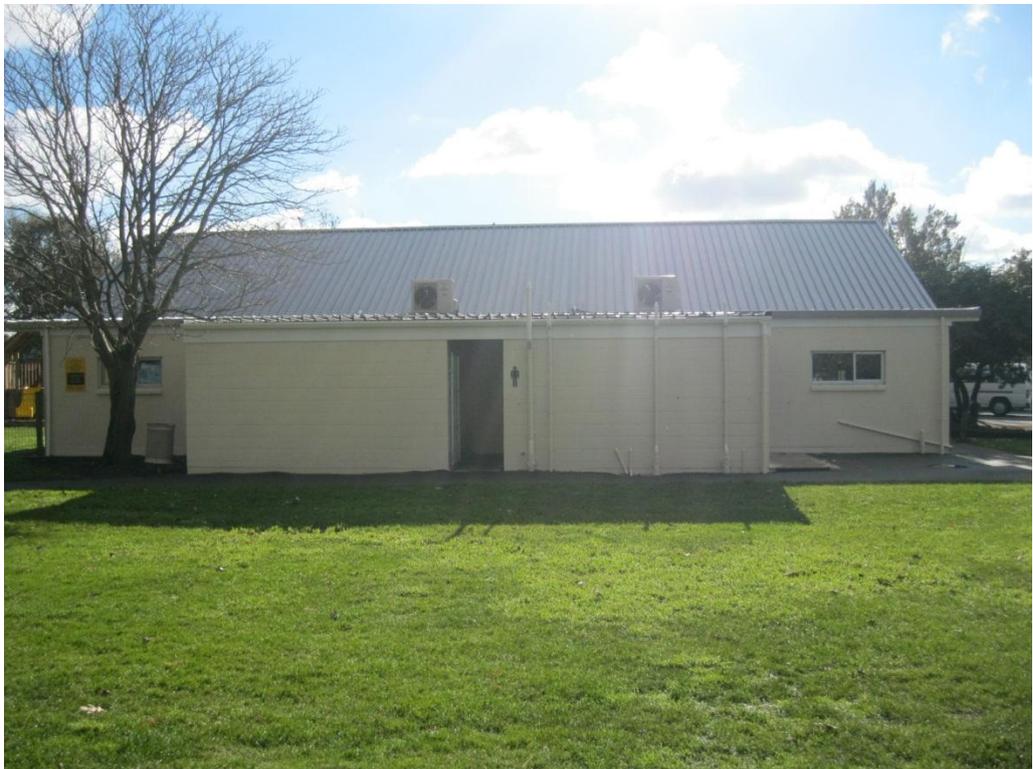
Photograph 2: Toilet block to west of the structure

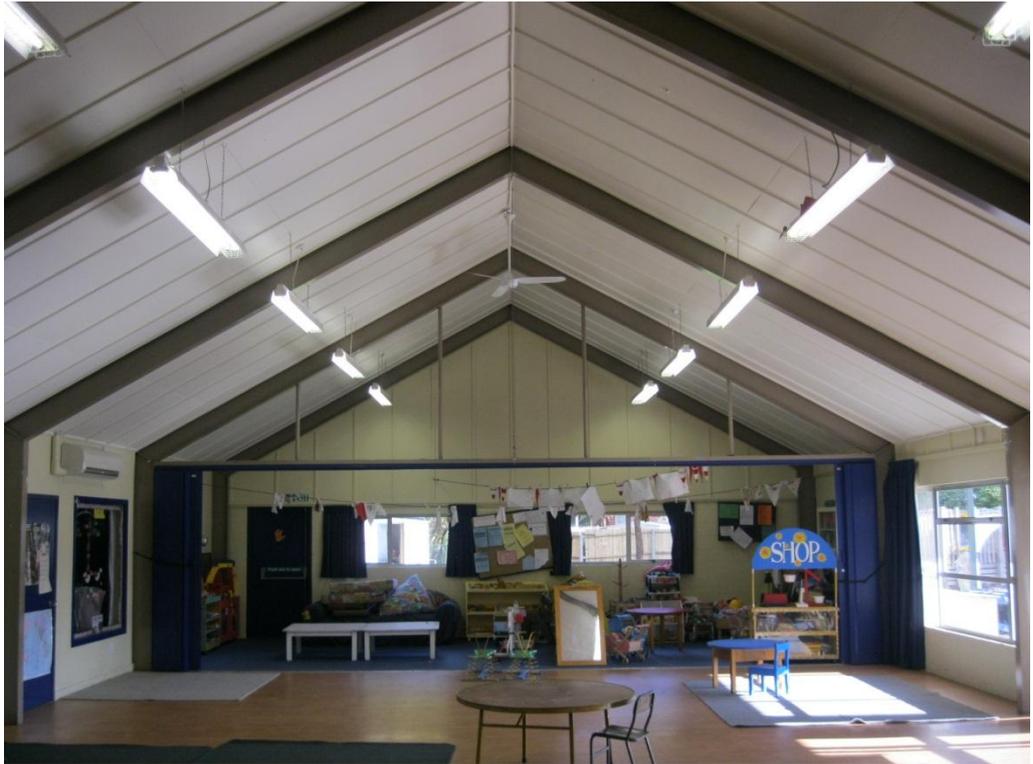
No damage was evident to the portal frames or the concrete beams and columns to the hall structure.

Photograph 3: Steel portal frame to hall structure

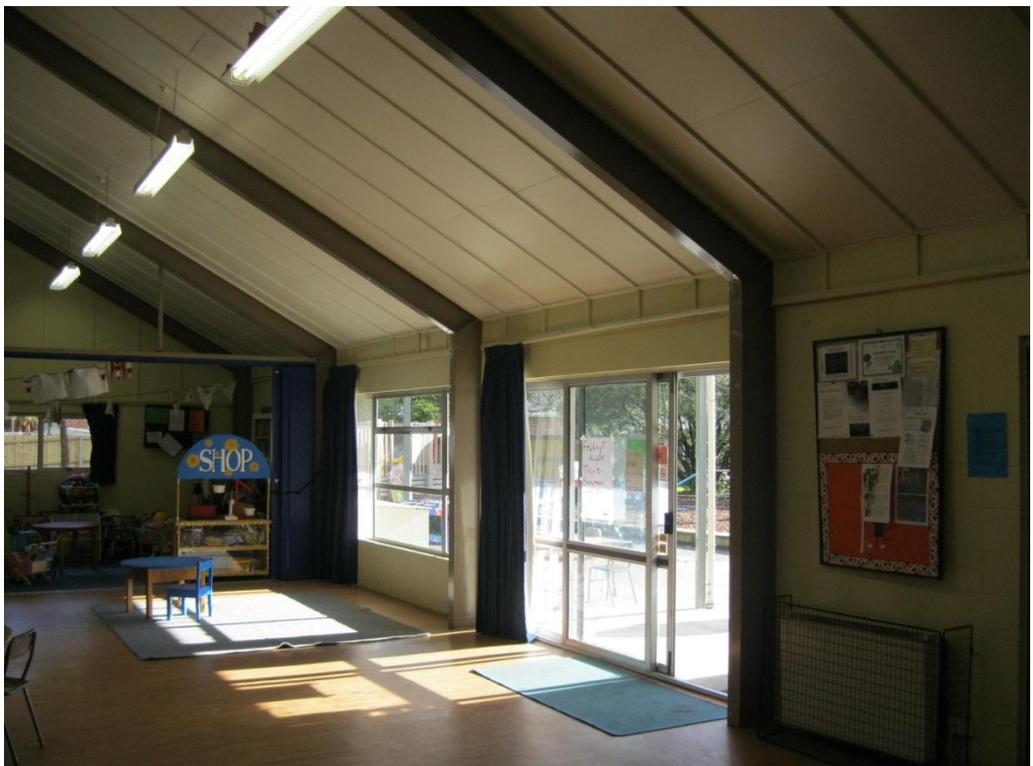
Photograph 4: Concrete columns and beams to right of portal frame to offer support for openings

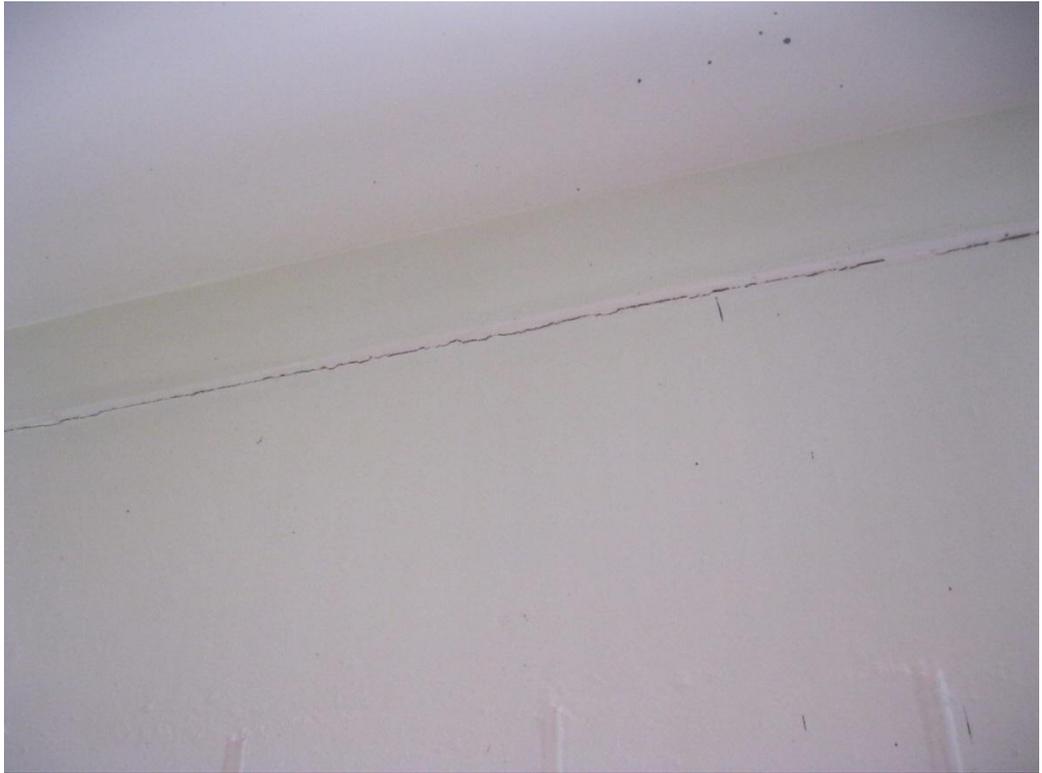
Minor separation was noted between the plasterboard walls and blockwork masonry to structure.

The damage to the building during recent seismic activity in Christchurch has only caused minor damage to the building, with minor separation between the blockwork masonry walls and plasterboard ceiling linings the only damage noted.

Photograph 5: Minor separation between plasterboard ceiling and blockwork masonry

As the building suffered insignificant damage that would not compromise the load resisting capacity of the existing structural systems, has no collapse hazards or significant critical structural weakness and has achieved over 33% NBS following an initial IEP assessment of the building, no further assessment is required. In addition occupancy of the structure is permitted. However, as the building has achieved less than 67% NBS we recommend a quantitative assessment of the building is undertaken to determine the seismic capacity and to develop potential strengthening concepts if required.

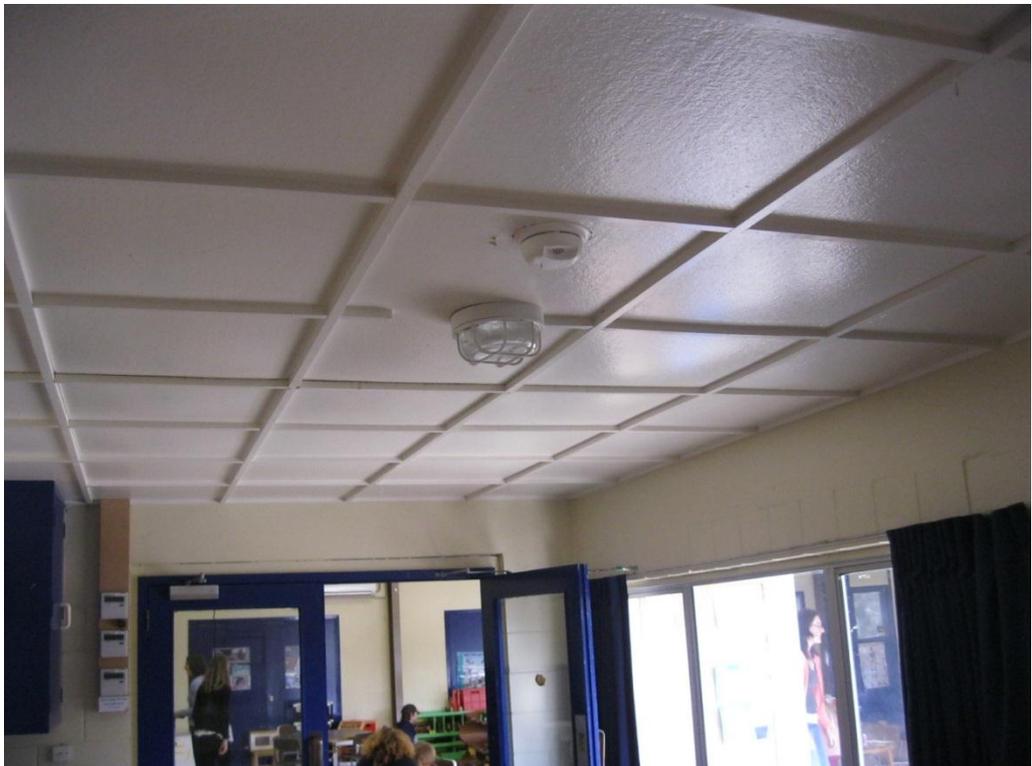
Photograph 6: Fibreboard ceiling to kitchen/toilet block to eastern side of the structure
