Knightsbridge Lane Complex  
PRO 1265  
Detailed Engineering Evaluation  
Quantitative Report  
Version 2.0 - Final

Knightsbridge Lane, Aranui

Christchurch City Council

**Date**  
15<sup>th</sup> October 2013

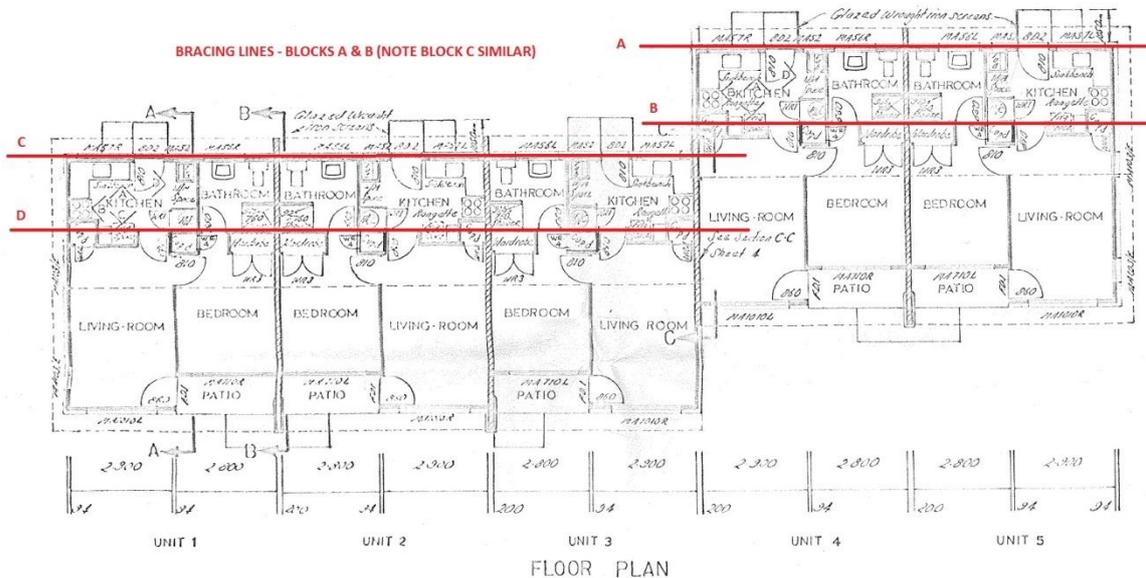
**Figure 8.1 Longitudinal bracing lines for Blocks A, B and D**

The total bracing capacity of the building in the longitudinal direction was evaluated by determining the lengths of plasterboard lined timber framed walls available that satisfy the aspect ratio limit of 3.5:1 suggested in the NZSEE guidelines. Only a small number of sections of walls in each unit satisfy this requirement. There is a significant lack of walls capable of bracing the structure in the perimeter walls due to large penetrations. As a result, the building effectively has two lines of bracing through each unit. The layout of bracing elements and bracing lines is extremely asymmetric and contributes significantly to the assessed score of 22% NBS.

Bracing Line	Bracing Capacity (BU)
A	57
B	318
C	85
D	477
Total Bracing Capacity = 937 BUs

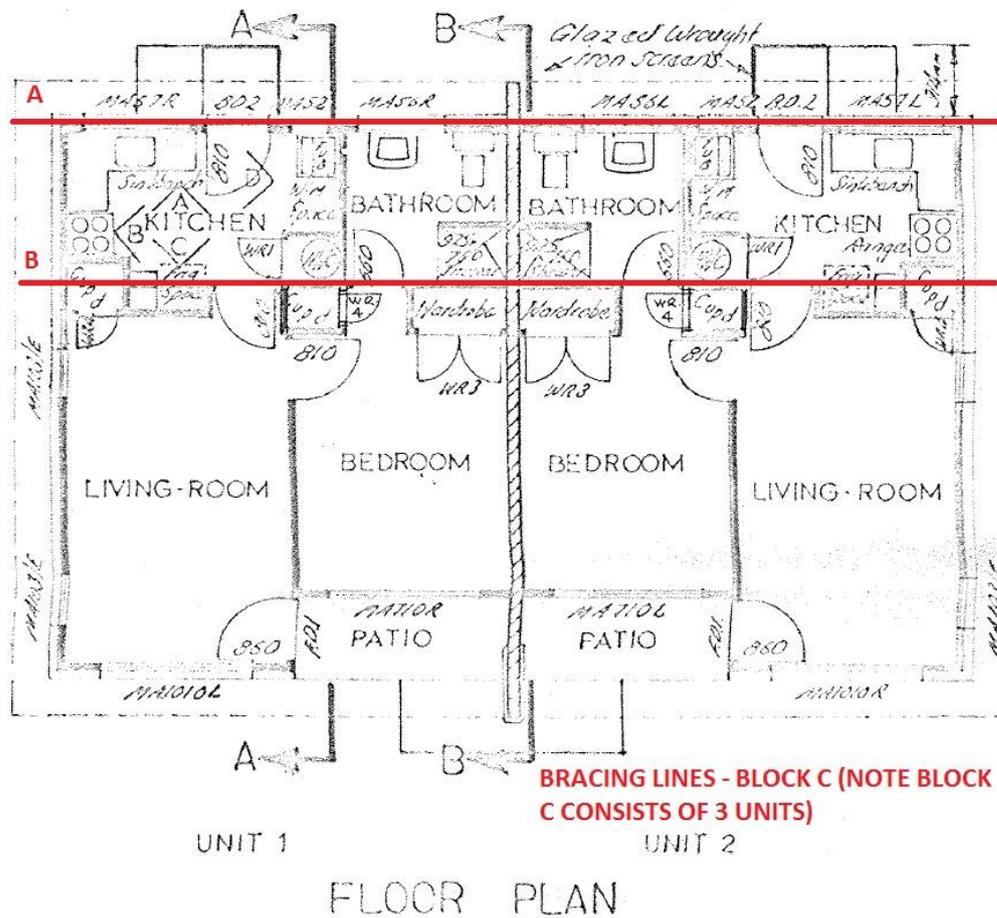
**Figure 8.2 Longitudinal bracing lines for Block C**

The total bracing capacity of the building in the longitudinal direction was evaluated by determining the lengths of plasterboard lined timber framed walls available that satisfy the aspect ratio limit of 3.5:1 suggested in the NZSEE guidelines. Only a small number of sections of walls in each unit satisfy this requirement. There is a significant lack of walls capable of bracing the structure in the perimeter walls due to large penetrations. As a result, the building effectively has two lines of bracing through each unit. The layout of bracing elements and bracing lines is extremely asymmetric and contributes significantly to the assessed score of 22% NBS.

Bracing Line	Bracing Capacity (BU)
A	85
B	477
Total Bracing Capacity =	562 BUs

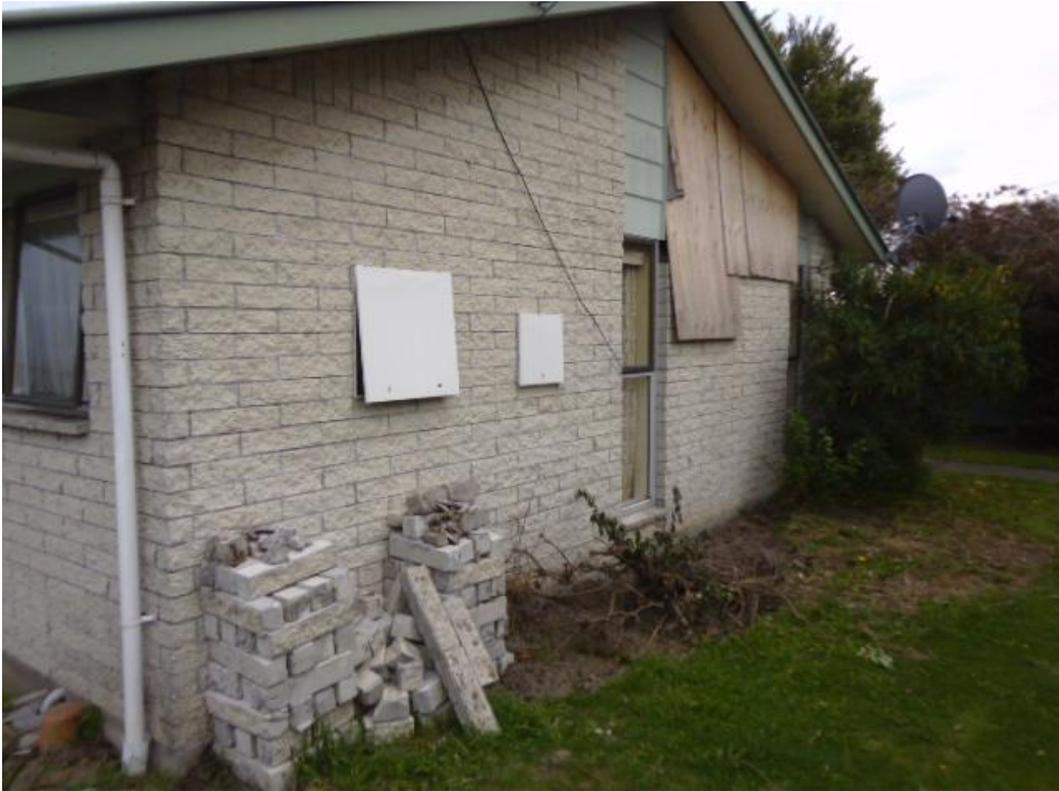
The external brick masonry veneer on the timber framed gable walls at the transverse ends of Block C have collapsed during the recent seismic activity as shown in Photographs 5 and 6. Repairs have been carried out to board up the exposed timber framed walls. Props have been erected to hold the plywood boards in place.

**Photograph 5** View of collapsed brick gable veneer at north-eastern end of Block C

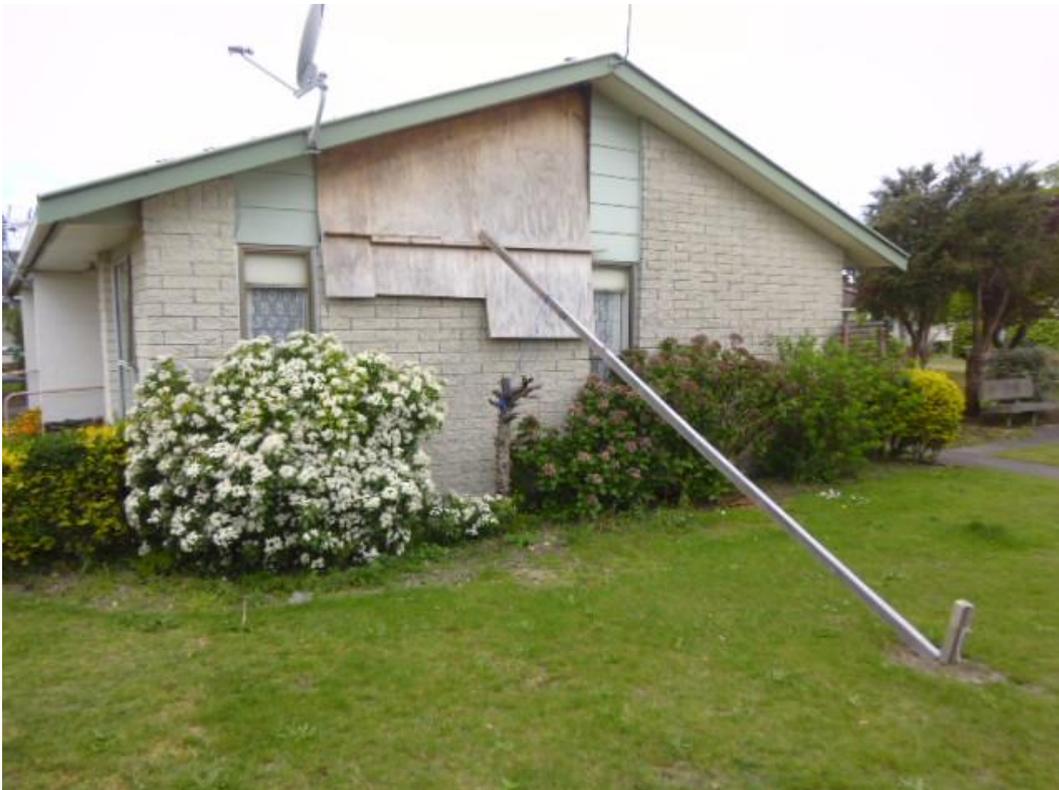
**Photograph 6** View of collapsed brick gable veneer at south-western end of Block C

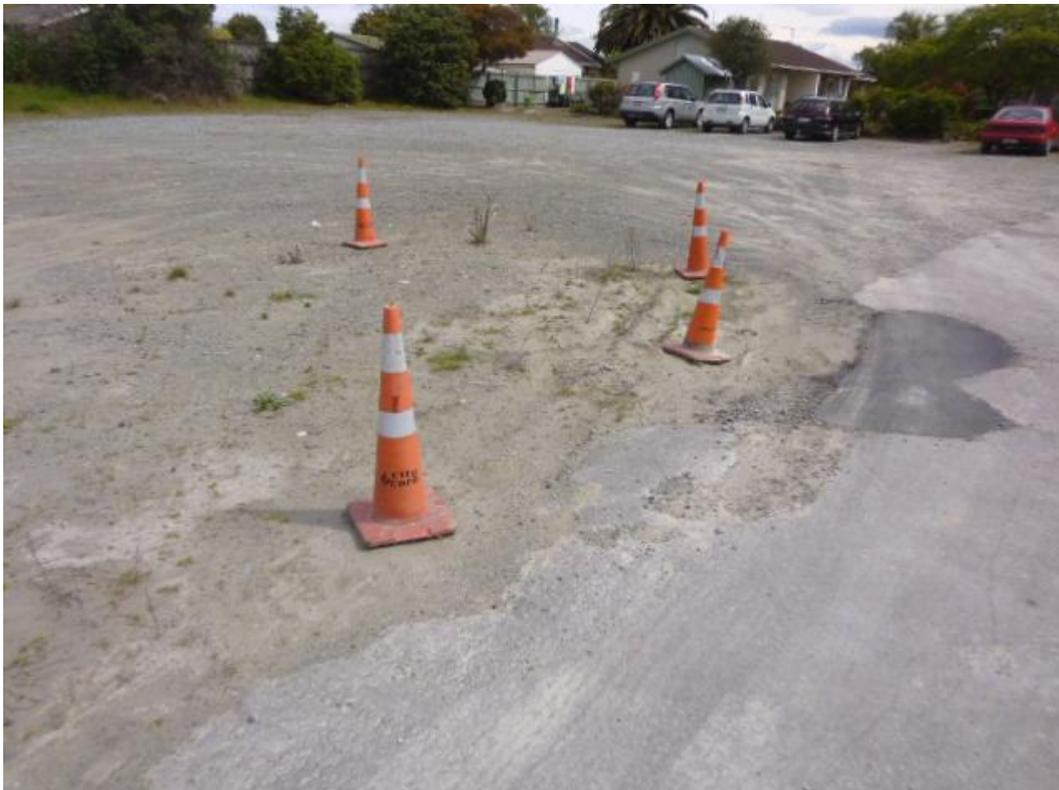
Evidence of liquefaction was observed in the Knightsbridge Lane Complex car park. This is shown in Photograph 10. No damage to the buildings caused by liquefaction induced settlement was observed.

**Photograph 10** Evidence of liquefaction occurring in the car park

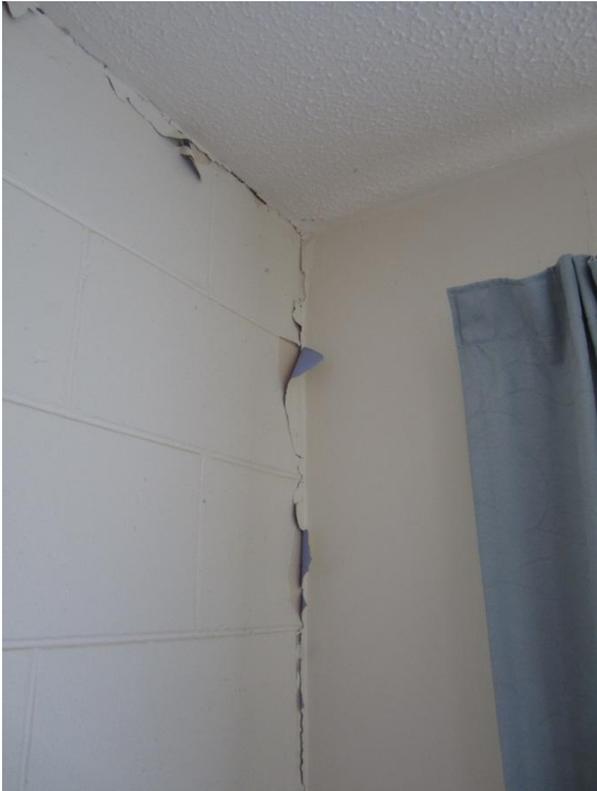
Cracking in the plaster lining between the timber framed walls and the concrete masonry walls (see Photograph 11) was observed in all units in Block A, B, C and D. Cracking in the plaster lining between the ceiling and the concrete masonry walls was also observed. The cracking to the linings is likely due the difference in stiffness between the concrete masonry walls and timber framed walls causing the walls to deflect differentially during an earthquake.

**Photograph 11** Typical damage observed in residential units
