**Lancewood Courts
Housing Complex
PRO 2506**

**Detailed Engineering Evaluation
Quantitative Assessment Report**

Lancewood Courts Housing Complex Quantitative Assessment Report

7-11 Percival Street, Sydenham,

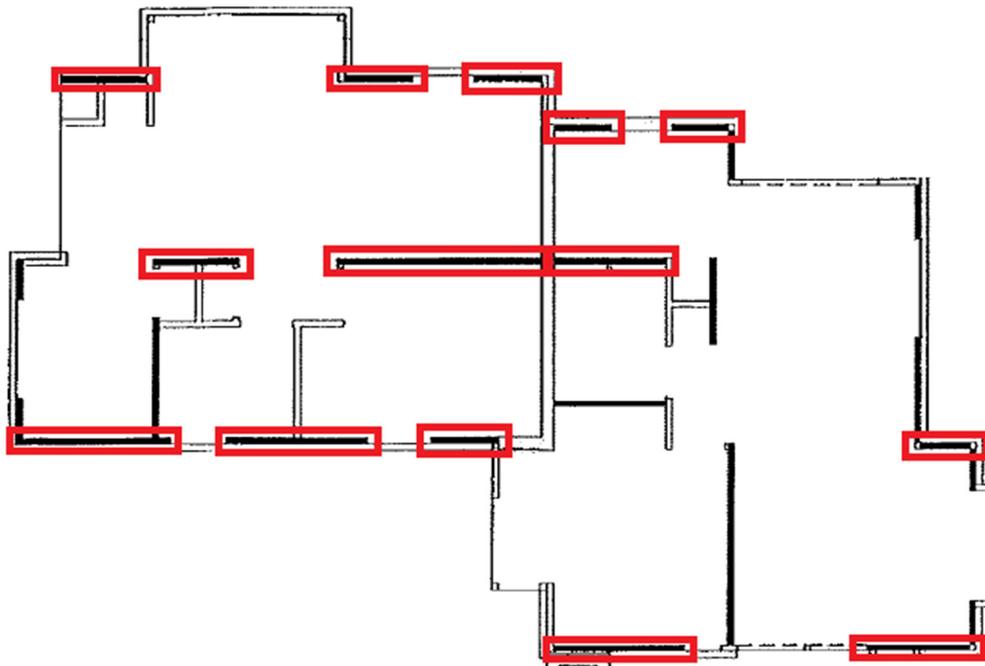
Figure 7: Walls used for bracing in Block A the longitudinal direction.

Block A has a capacity of 67% NBS as limited by the overturning stability of the concrete block fire wall. Block B has a capacity of 75% NBS as limited by the in-plane capacity of the ground-floor timber-framed shear walls in the longitudinal direction. The blocks are deemed to be 'low risk' in a design seismic event according to NZSEE guidelines.

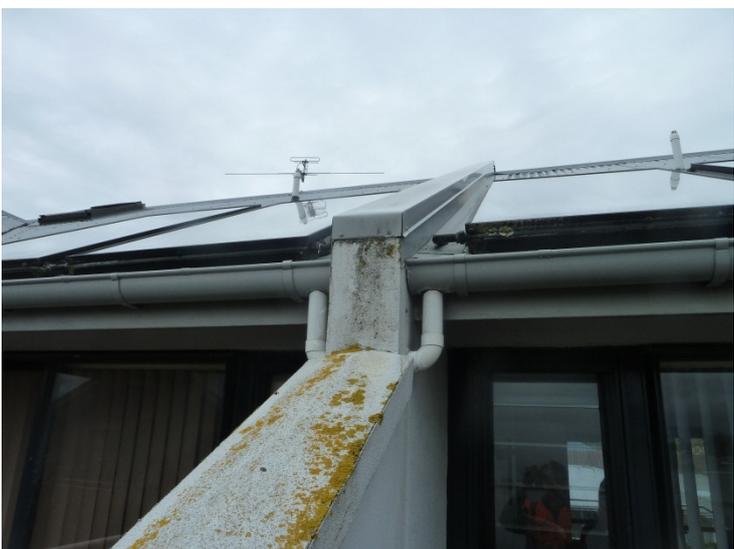
<p>5.</p>	<p>Typical fire wall between units</p>

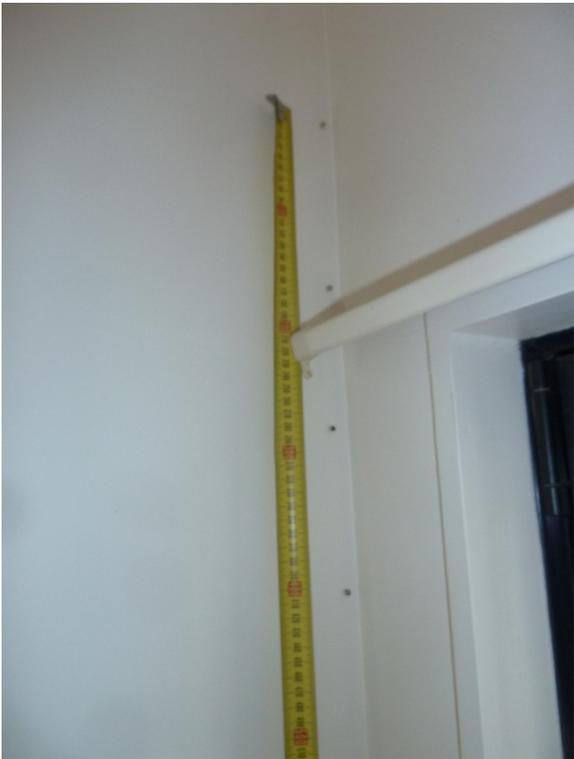
The internal lining nail spacings were measured on site to vary between 150-300mm.

<p>10.</p>	<p>Typical wall fixing spacings – approx. 150mm</p>

Increasing the number of nails in the plasterboard will not significantly improve the strength of the buildings.

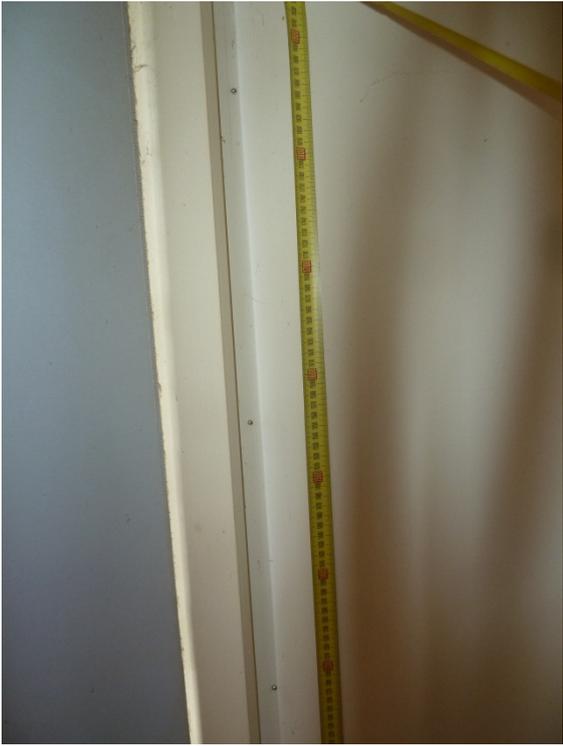
<p>11.</p>	<p>Typical wall fixing spacings – approx. 300mm</p>

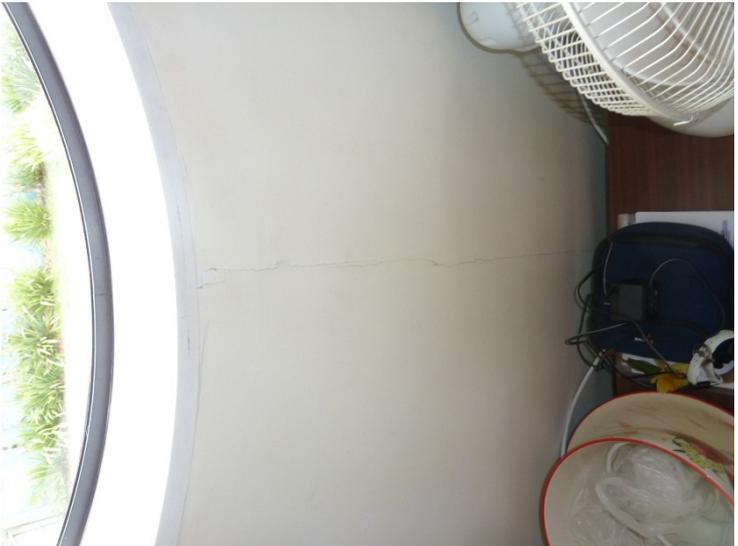
Minimal cracking of plasterboard ceiling diaphragms and wall linings was observed in the units (photo 12). This form of damage is common throughout the units.

<p>12.</p>	<p>Typical minor cracking of wall linings</p>

- Cosmetic repairs be undertaken as required.
