CHRISTCHURCH CITY COUNCIL
PRK_0227_BLDG_003 EQ2
Linwood Nursery – Lunch Room
320 Linwood Ave, Linwood

QUALITATIVE ASSESSMENT REPORT
FINAL

- Rev E
- 26 July 2013

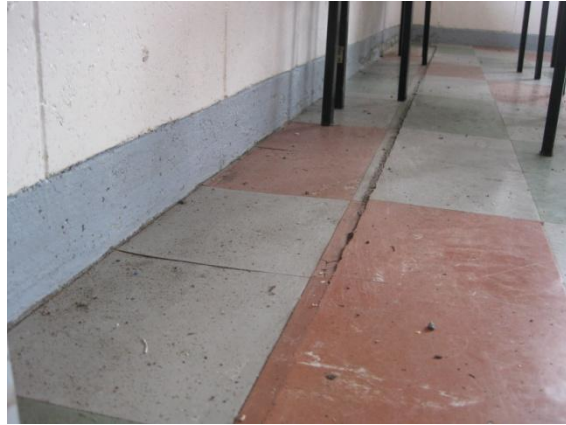
- 1) Differential settlement between the masonry wall footing and internal floor slab, in addition to differential settlement between internal floor slab sections was noted in the lunchroom at the west end of the building. A fall of up to 16% was noted in the floor. The floor lining was damaged at the junction between these elements (see Photo 1 and Photo 2).

Photo 1: Differential settlement between the masonry wall footing and internal concrete slab in the lunchroom on the west side of the building

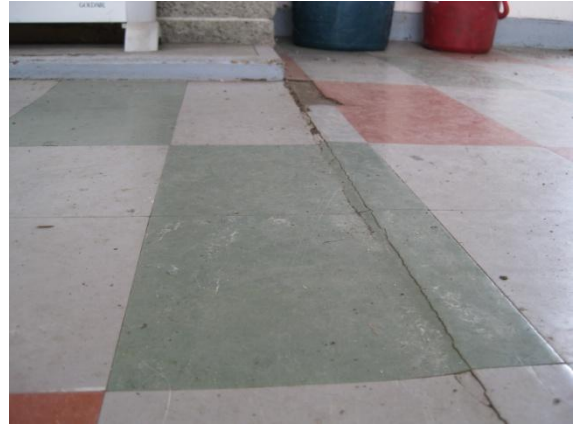
Photo 2: Differential settlement between sections of the internal floor slab in the lunchroom

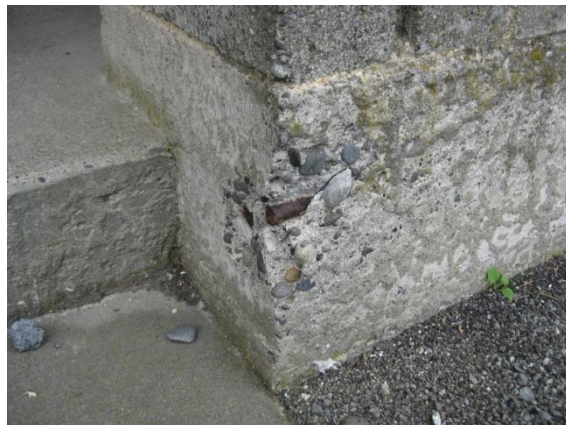
- 2) Exposed reinforcement and some concrete spalling was found on the masonry wall footing, adjacent to the door openings in the southern wall and at the corners of the building. The reinforcement has begun to corrode (see Photo 3 and Photo 4). This is not thought to be earthquake damage.

Photo 3: Typical spalled concrete and exposed reinforcement adjacent to door openings on the south side of the building

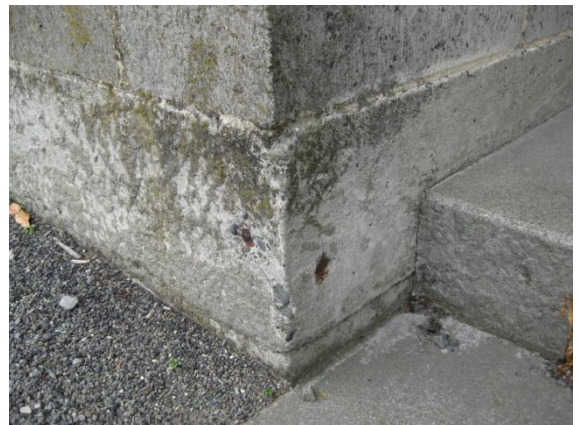
Photo 4: Typical exposed reinforcement in the corners of the building. Note corrosion of the reinforcement

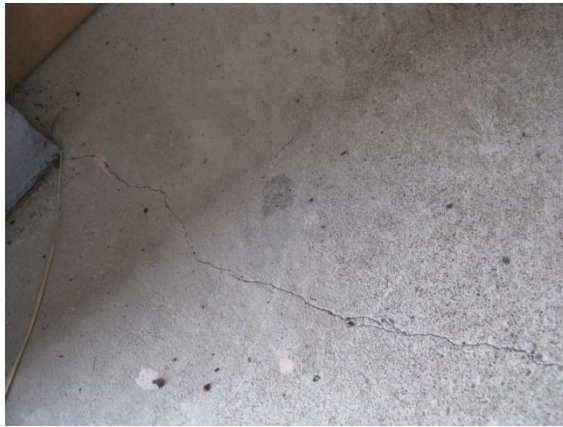
- 3) Cracking less than 0.5mm in width was found in the internal floor slab in the women's toilet at a re-entrant corner. Cracking was also found at the doorway between the changing rooms and cubicles. No cracks were found in the floor slab of the men's toilet and floor lining in the lunchroom prevented an inspection of the condition of the slab there (see Photo 5 and Photo 6). This damage is unlikely to have been caused by the earthquake, though it has likely been exacerbated by it.

Photo 5: 0.5mm cracking in the internal slab in the women's toilet adjacent to an re-entrant corner

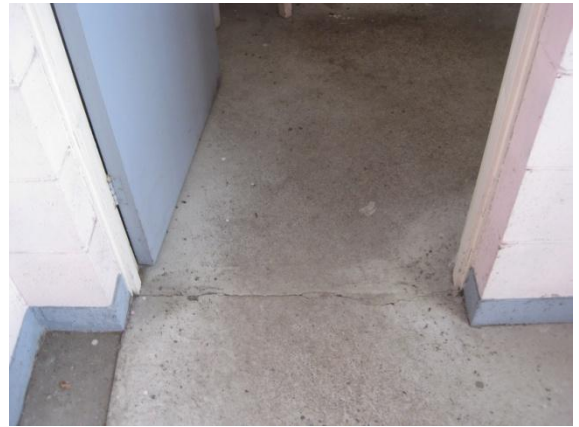
Photo 6: Cracking in the internal floor slab in the women's toilet at the doorway between the changing rooms and cubicles

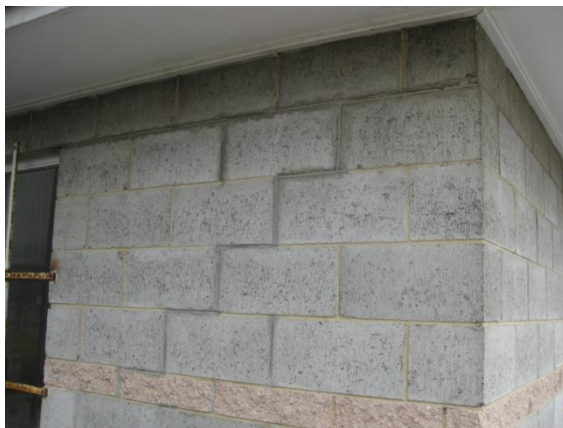
- 4) Settlement of the footing has caused cracking in the perimeter walls on the west side of the building. Evidence of repairs was observed on the northern wall in the north west corner, and earthquake cracking is now evident across those repairs. Cracking in the north west corner was measured at up to 10mm in width. Cracking found adjacent to the entrance to the lunchroom in the southern wall was found to be up to 3mm in width. No damage was noted to the foundation adjacent to the damage in the west side of the building (see Photo 7, Photo 8 and Photo 9).

Photo 7: Repairs to the northern wall of the building completed prior to the earthquake. No damage to the repairs detected

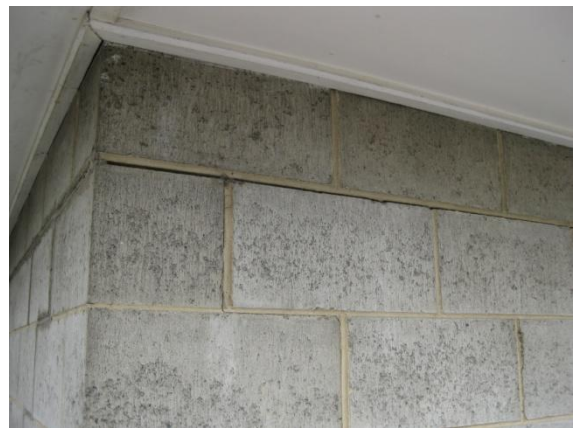
Photo 8: Cracking at the north end of the west wall

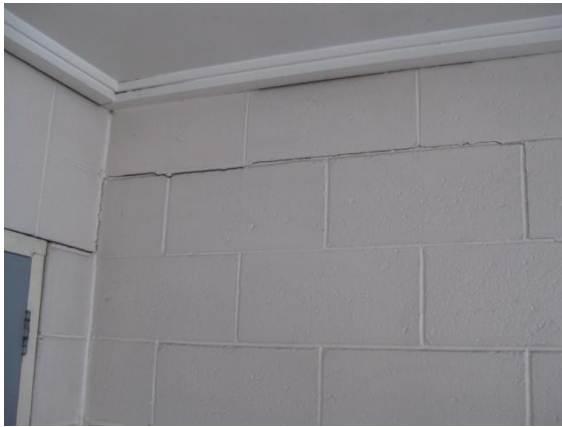
Photo 9: Cracking in the southern wall adjacent to the entrance to the lunchroom

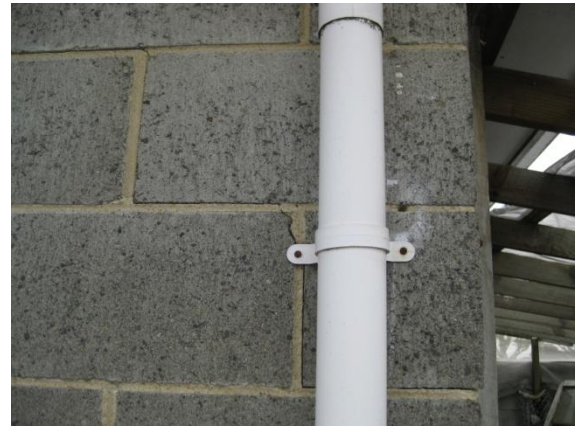
- 5) 2.0mm stepped cracking was found in the south east corner of the building (see Photo 10).
- 6) Stepped cracking was found in all perimeter and internal walls of the building, particularly adjacent to windows and doors. Cracking was found to be up to 0.5mm in width and observed from the interior and exterior of the building. Hairline cracking was also found at the junction between internal and perimeter masonry walls (see Photo 11 and Photo 12).

Photo 10: Cracking in the south east corner of the building

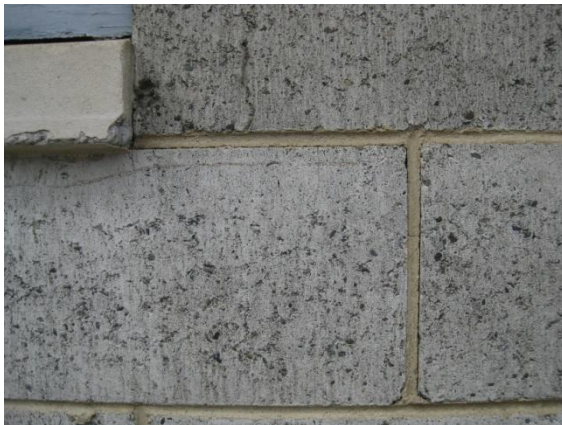
Photo 11: Typical stepped cracking found at the corners of doors and windows

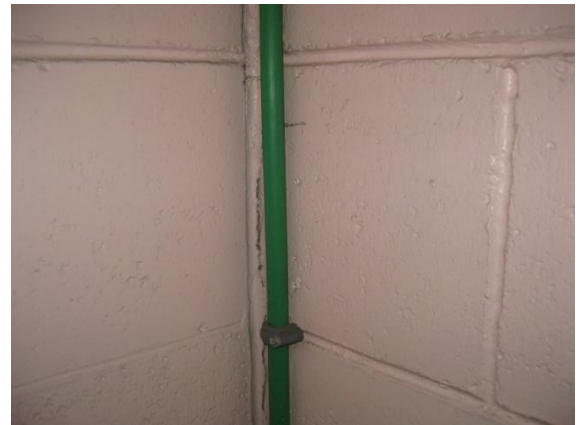
Photo 12: Typical cracking at the junction between internal and external masonry walls

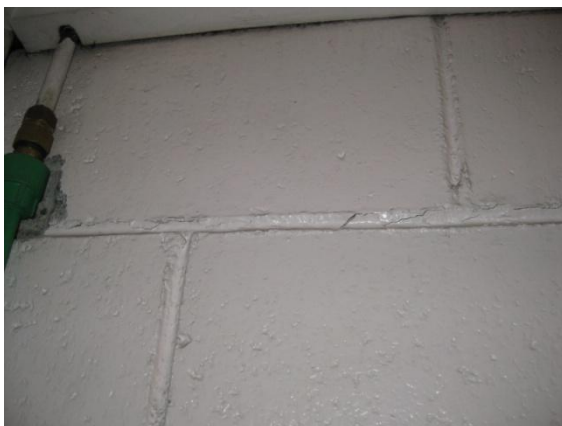
- 7) Hairline cracking was noted below the top course of blocks in the north east corner of the men's toilet (see Photo 13).
- 8) Significant cracking was found in the masonry render on the fireplace in the lunchroom. The upper section of the render has separated from the chimney stack and looks to be at risk of falling off in future seismic activity (see Photo 14, Photo 15 and Photo 16).

Photo 13: Hairline cracking below the top course of blocks in the north east corner of the men's toilet

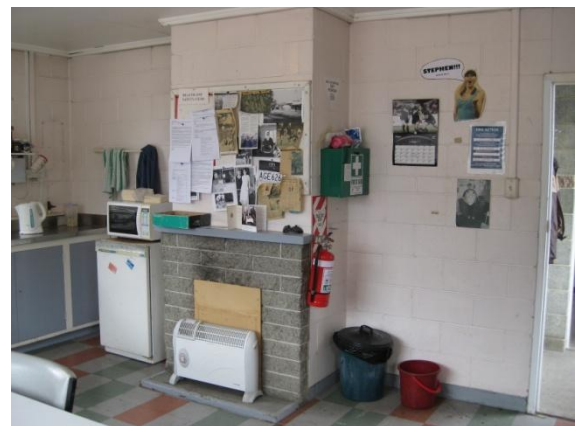
Photo 14: The fireplace in the lunchroom

As an immediate safety precaution, it is recommended that the masonry cladding on the fireplace be removed.

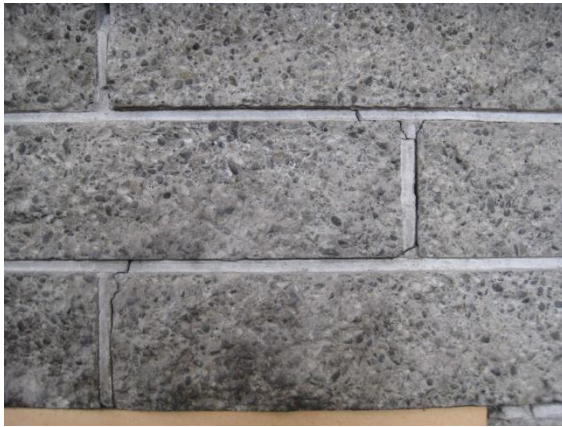
Photo 15: Cracking to the masonry render on the fireplace

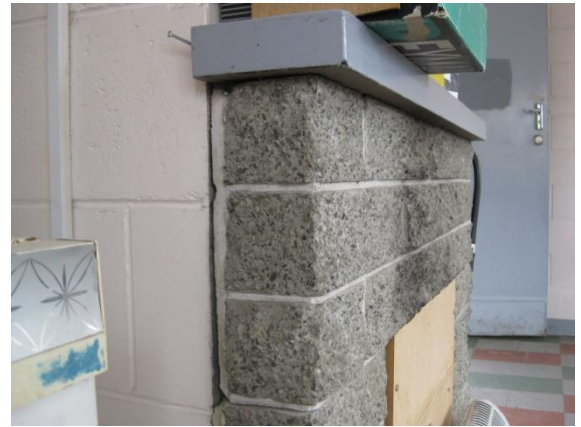
Photo 16: Separation between the masonry render and chimney in the lunchroom

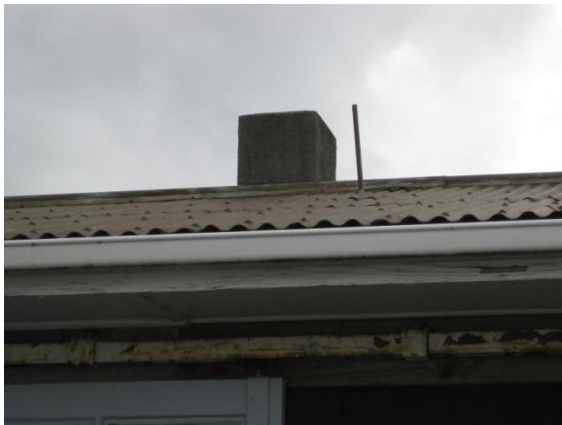
- 9) Hairline cracking was observed in the render on the section of chimney above the roof sheeting (see Photo 17).
- 10) Render on the masonry wall footing has spalled off adjacent to a downpipe on the northern wall. Damage is localised and it is not clear why this has occurred (see Photo 18).

Photo 17: Cracking to the render on the chimney above roof level

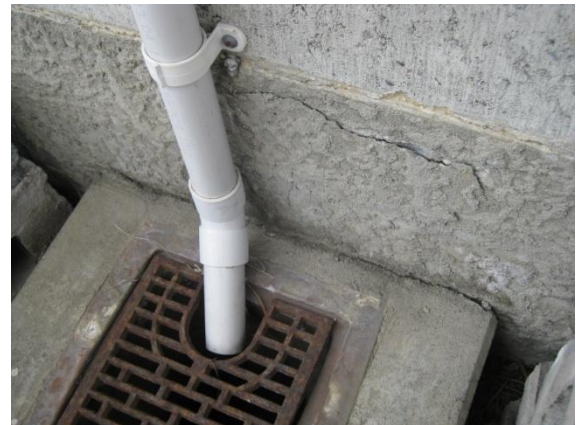
Photo 18: Render spalling off the northern masonry wall footing, adjacent to a drain

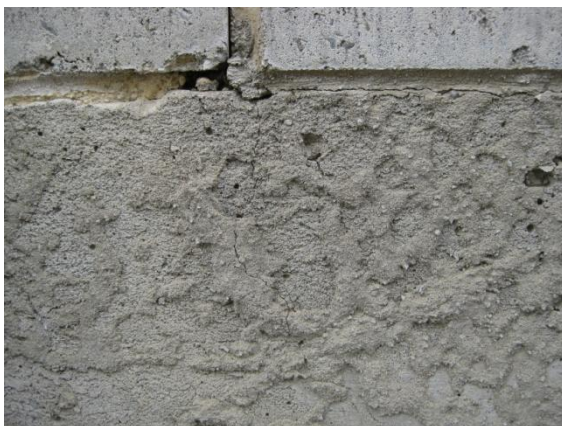
11) Regular vertical hairline cracking was found in the masonry wall footing render (see Photo 19).

Photo 19: Typical vertical hairline cracking in the footing render
