Little Akaloa Clubrooms
BU 3590-003 EQ2
Detailed Engineering Evaluation
Quantitative Report

Detailed Engineering Evaluation Quantitative Report

Date: 10 October 2012
Reference: 6-QUCCC.72
Status: Final V2

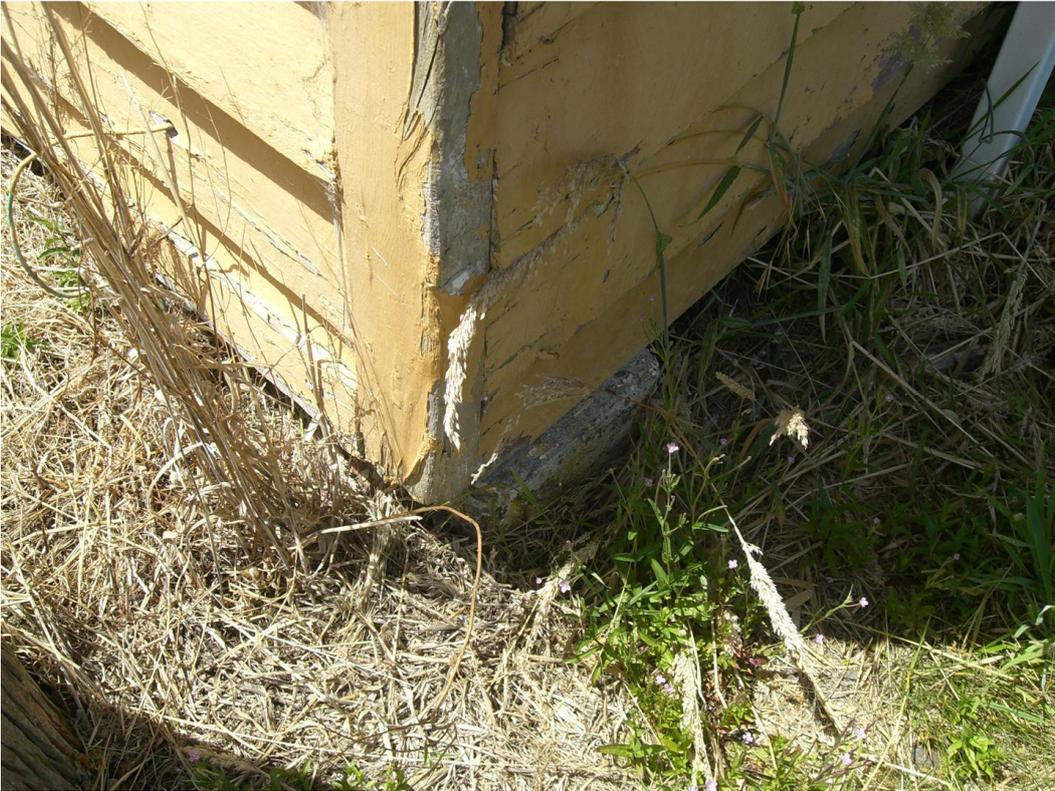
Photo 5: View of the concrete pile at the north west corner of the building

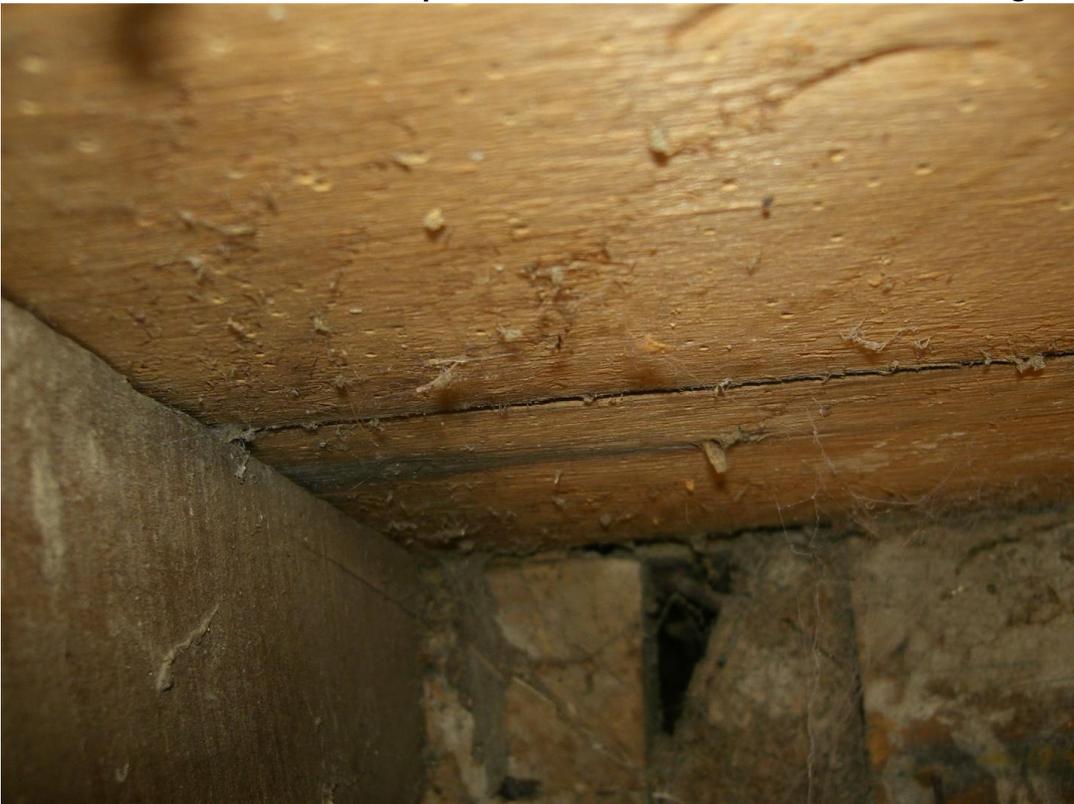
No subfloor bracing appears to have been installed.

- a) There does not appear to be any form of subfloor bracing provided.

The building has a calculated capacity of less than 34% NBS as limited by the subfloor bracing capacity of the concrete piles.

Photo 6: View of the subfloor

- (a) Strengthening options be developed for increasing the seismic capacity of the building to at least 67% NBS.
- (b) Options be developed for existing chimney repair, demolition or replacement.

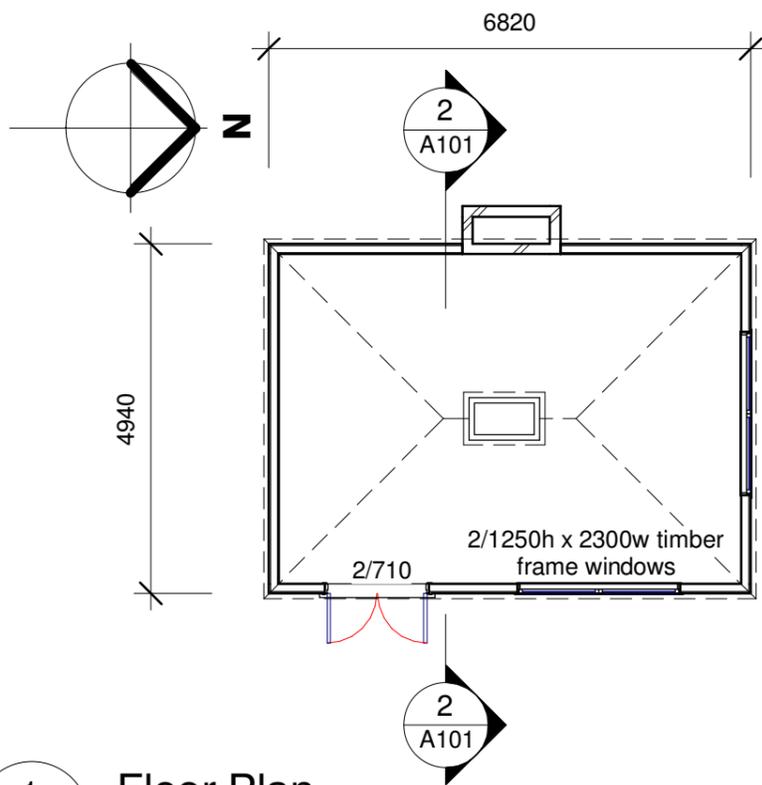
1 Floor Plan
A101 1 : 100

Masonry fire place and chimney , In poor condition
