Little River Education House
PRK 3667 BLDG 001 EQ2
Detailed Engineering Evaluation
Qualitative Report
Version FINAL

4421 Akaroa Road, Little River

Christchurch City Council

Date
14th November 2013

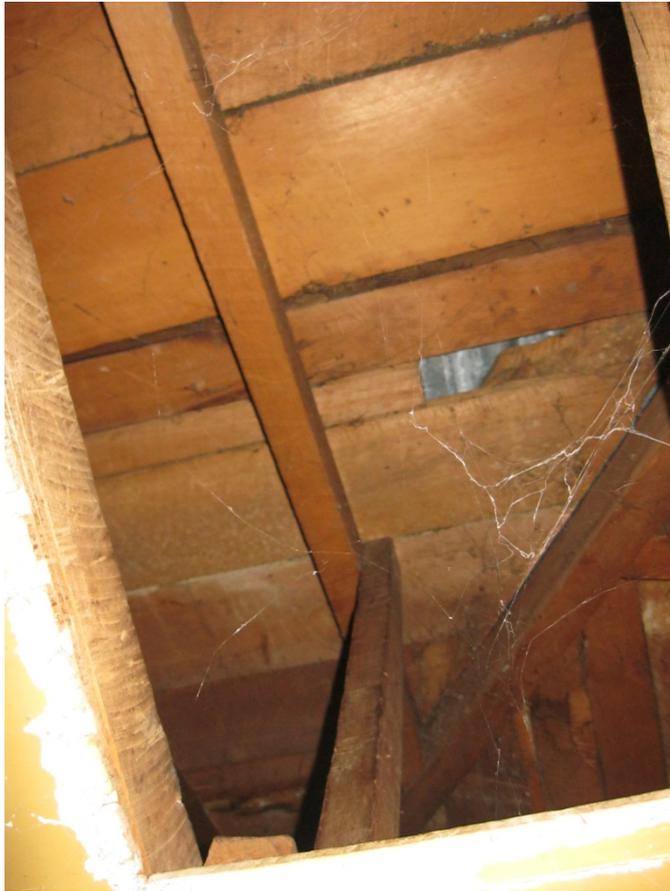
No critical structural weaknesses were observed in the roof structure. Roof in plane bracing will be provided by timber boarding fixed to rafters. A ceiling diaphragm was also present in the form of plastered sarking.

Photograph 3 Timber boards at roof level.

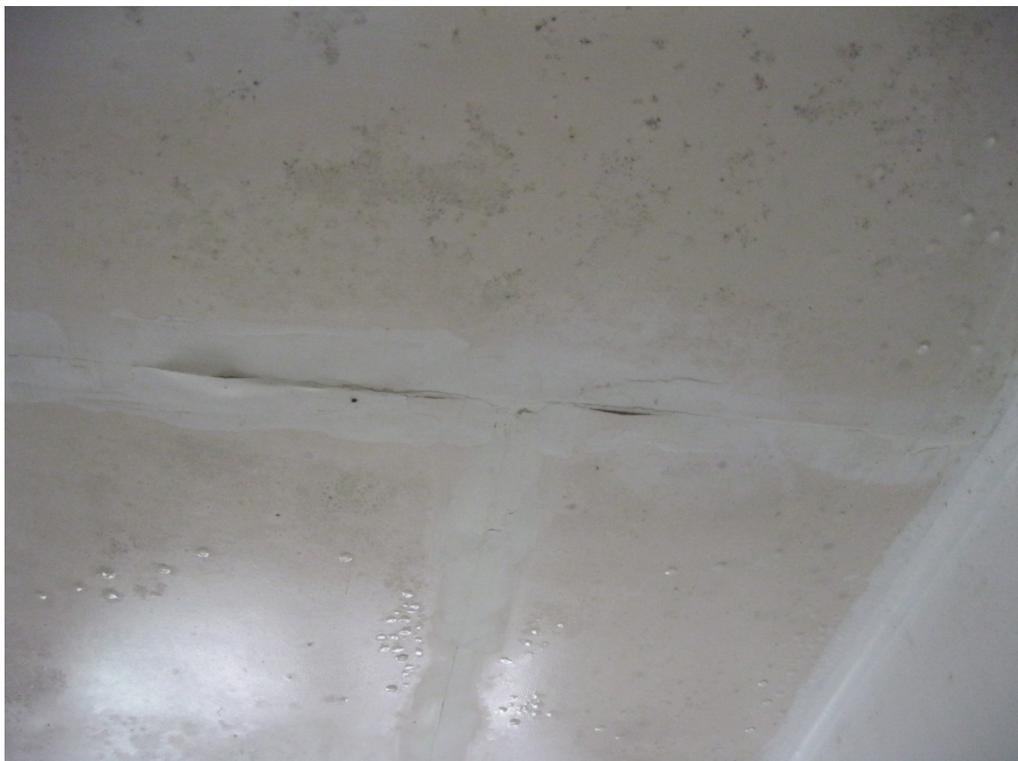
No residual displacements of the structure were noticed during our inspection of the building. However it should be noted that some differential settlement has occurred, most likely caused by piles settling with consolidating founding soils under loading for more than 100 years. Similarly the structure has not been well maintained, leading to water damage and cracking to plaster. There appears to be no earthquake damage.

Photograph 4 Water damage in ceiling

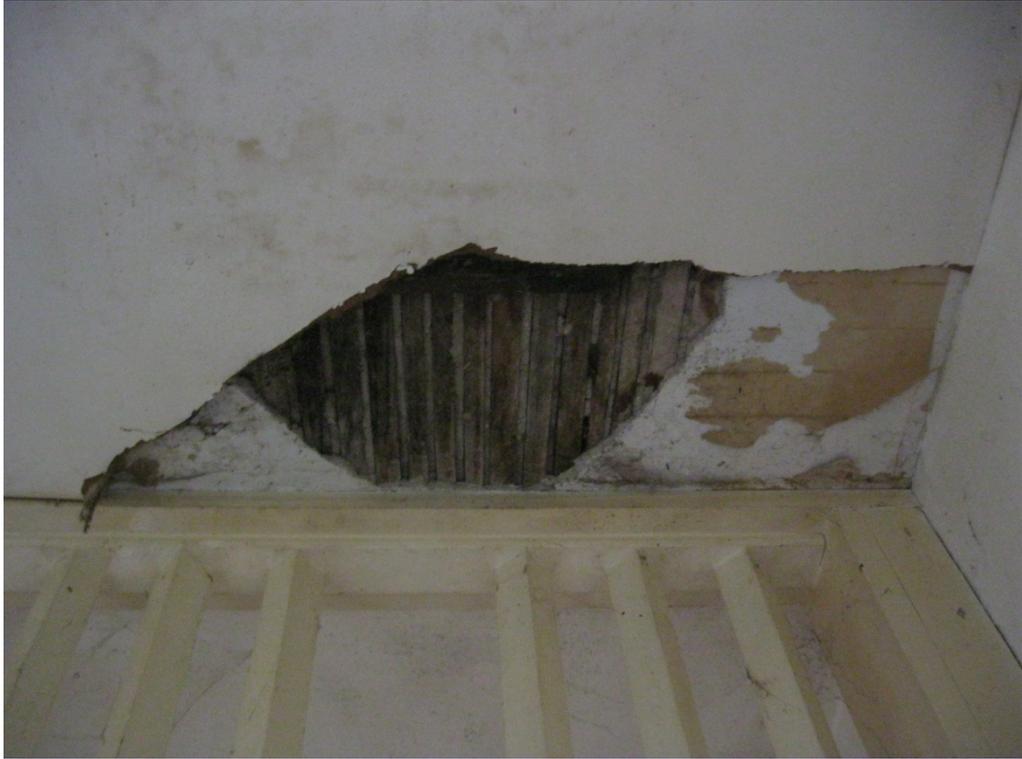
Photograph 5 Dilapidation in ceiling plaster and sarking .

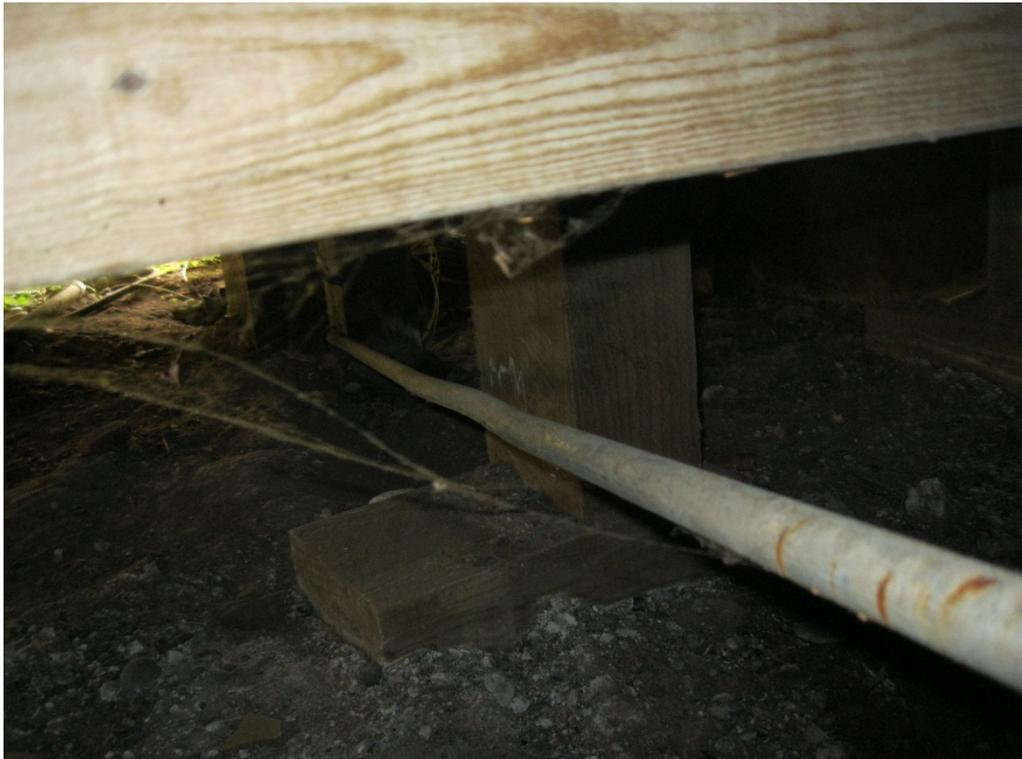
Inspection of the lean-to sub-floor showed pile construction in this area to be sub-standard. Piles did not appear to be founded properly in the sub-strata but instead were supported on timber packers which rested on the soil surface.

Photograph 6 Piles supported on timber packers

As part of the detailed assessment, a full pile survey is recommended as internal laundry piles appeared to be supported on timber packers.
