**Barn - Barclays Road Heritage Park Little River**  
**PRK 3659 BLDG 004 EQ2**  
Detailed Engineering Evaluation  
Qualitative Report  
Version FINAL

Christchurch City Council

**Date**  
10 April 2013

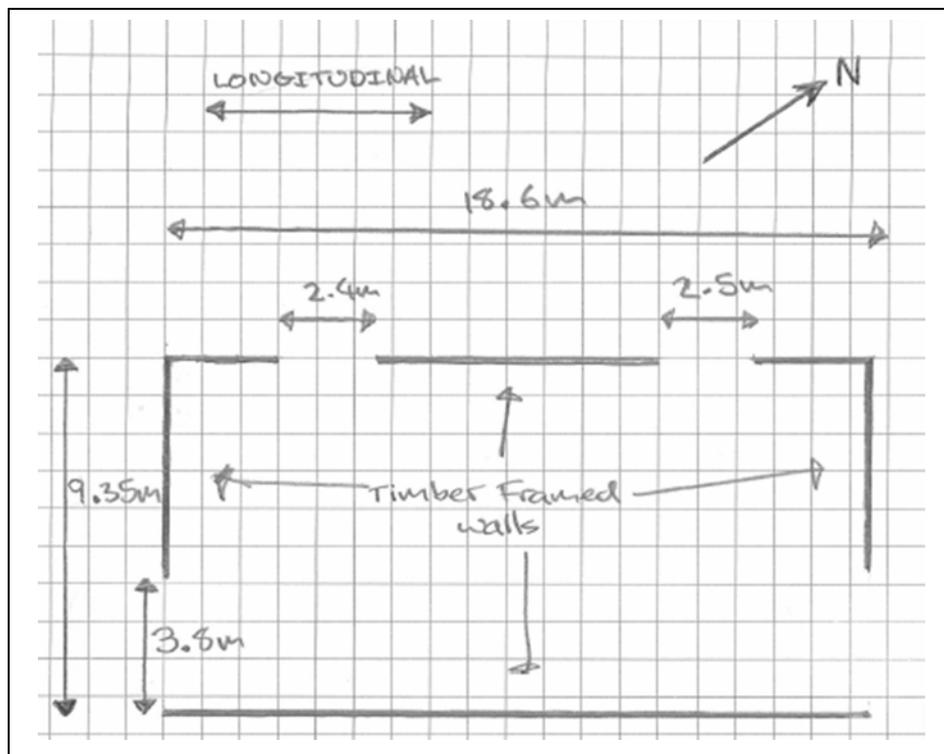
**Figure 2 Plan Sketch Showing Key Structural Elements**

The lateral load resisting systems in the longitudinal and transverse directions is similar.

The braced timber framed roof structure redistributes lateral roof loads to the in-plane timber walls. The diagonal braces and timber framing in the walls combine to brace the lateral roof loads to the timber piles. The weather boards and timber studs may also provide some nominal panel actions to resist lateral loads. Lateral loads will then be transferred to the ground through the timber piles.

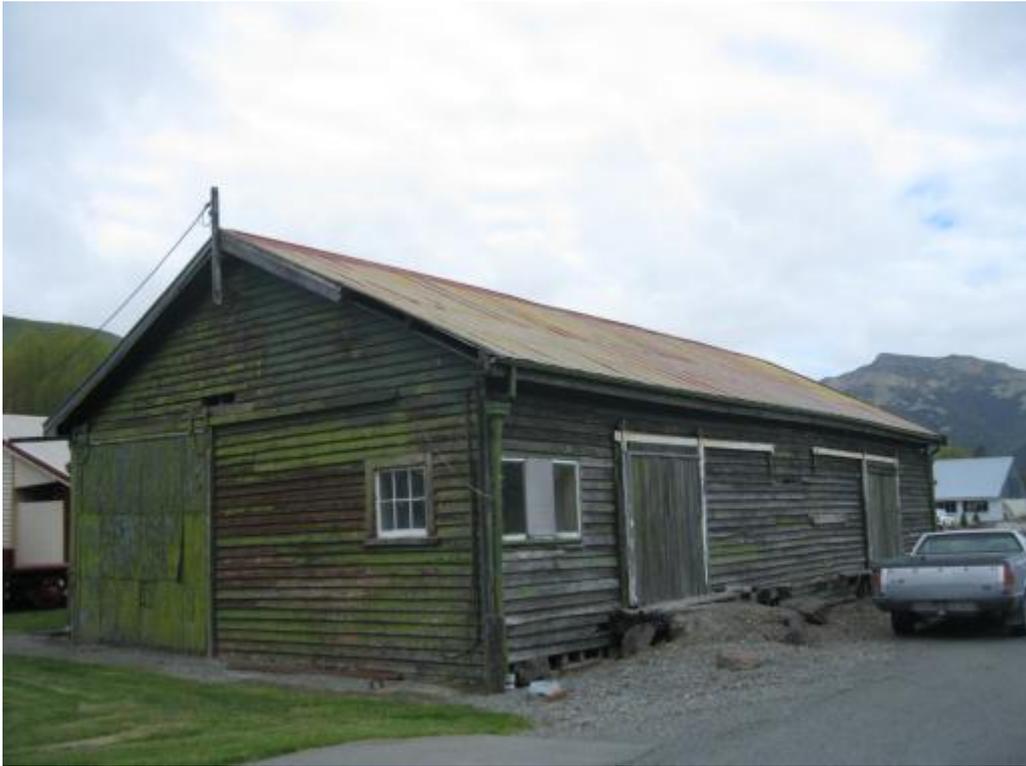
**Photograph 1 View of Barn from the north.**

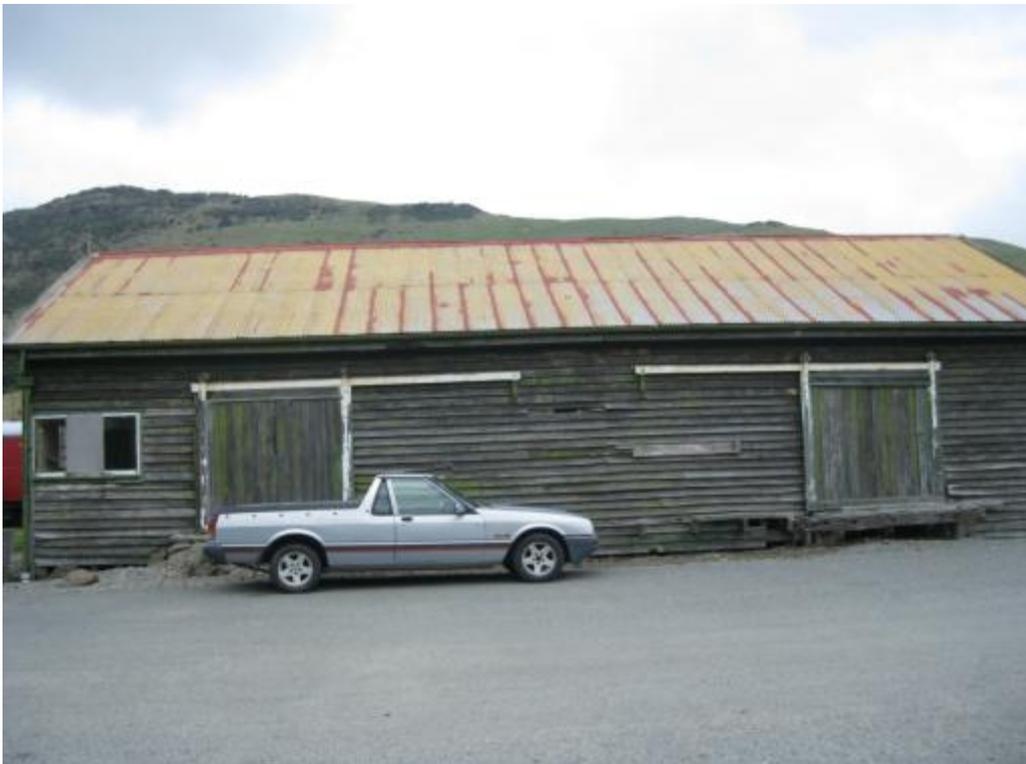
**Photograph 2 Northwest elevation.**

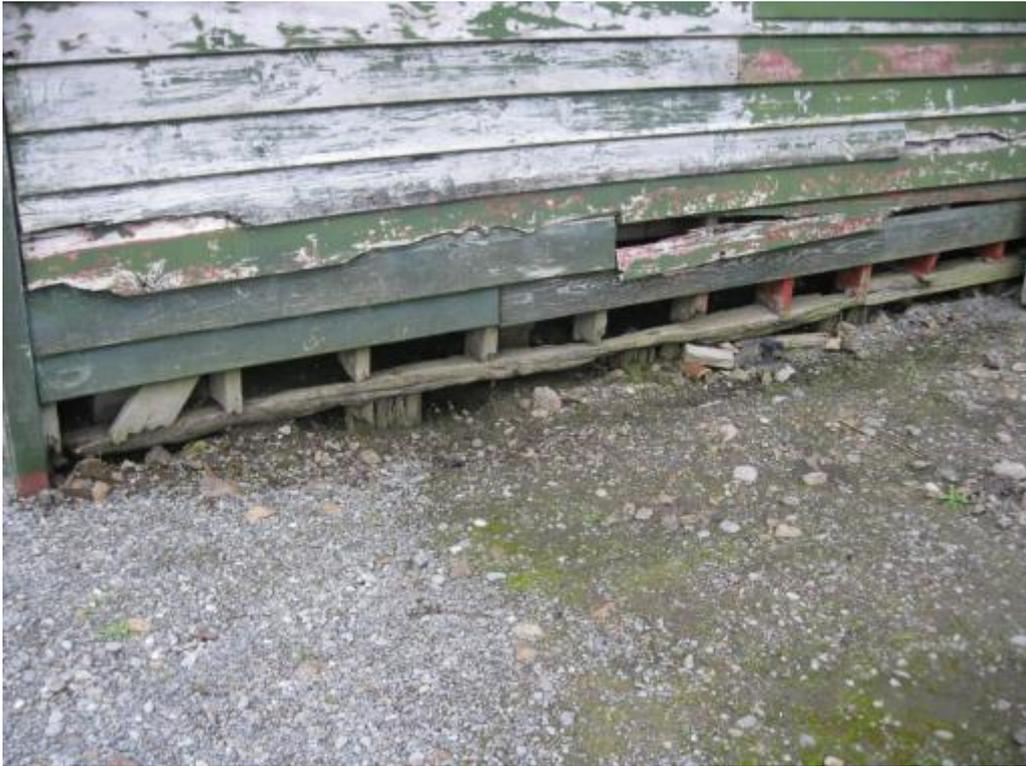
This building is in particularly poor condition as a result of decay and poor maintenance. The corrugated iron sheeting in the roof is rusting and the weather boards are broken or cracked in many locations. At ground level, where weather boards are absent, high levels of rot can be seen. This results in no direct connection between some piles, bearers, studs and braces. Because this is not classed as a CSW, an F factor of 0.7 has been taken to reduce the %NBS by 30%.

**Photograph 3 Rotten timber piles and timber bearer, and broken weatherboards.**

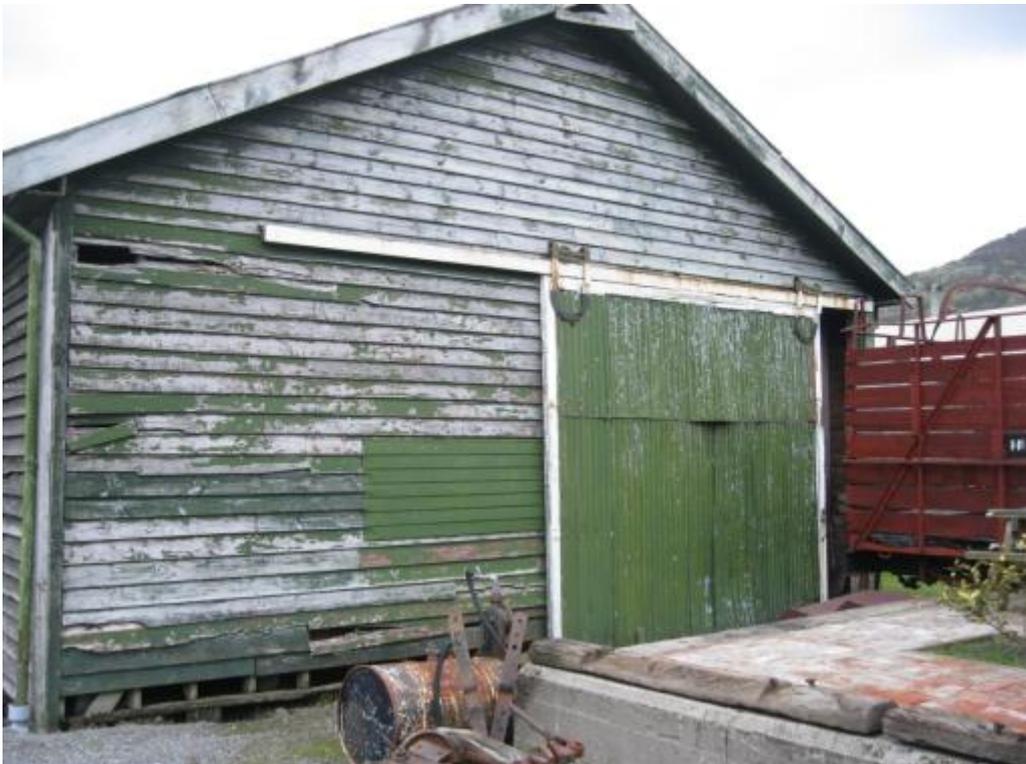
**Photograph 4 Southwest elevation of the barn.**

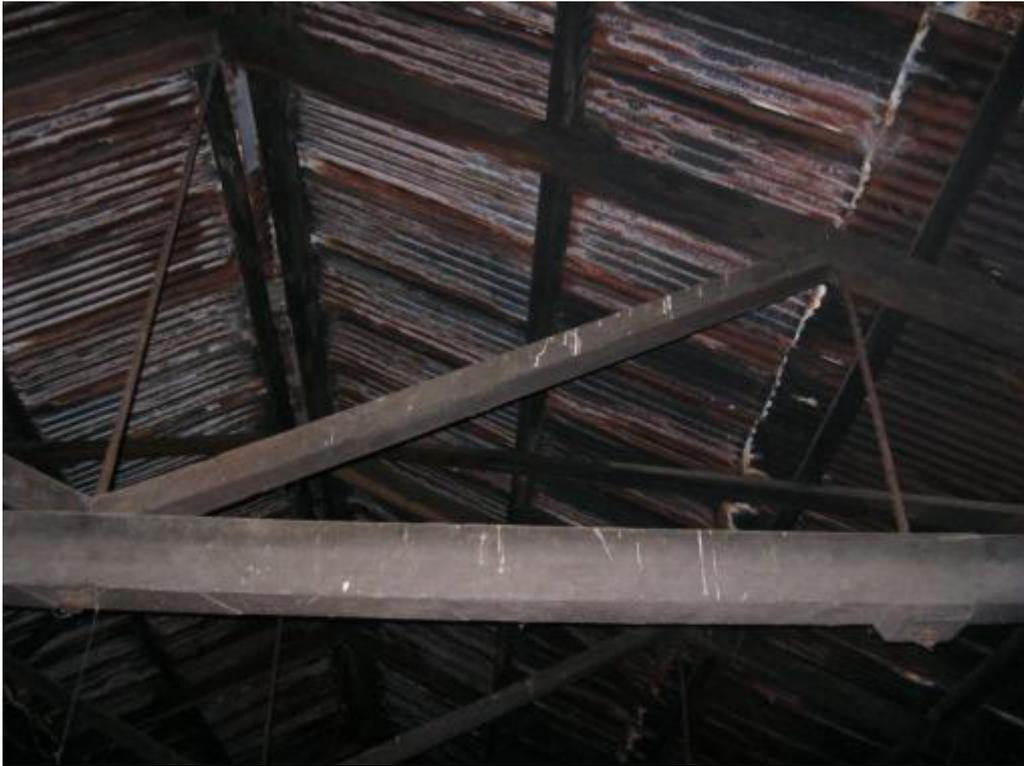
**Photograph 5 Timber truss roof structure with rusted corrugated iron cladding above.**

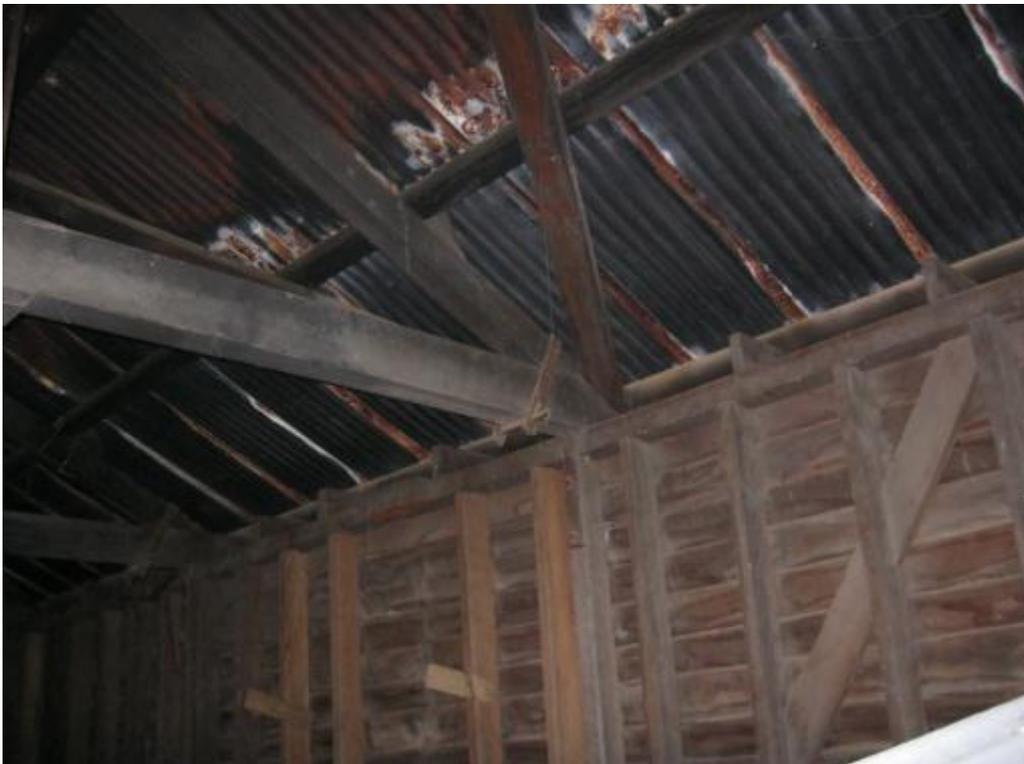
**Photograph 6 Connection between timber roof and wall. Diagonal bracing in roof.**

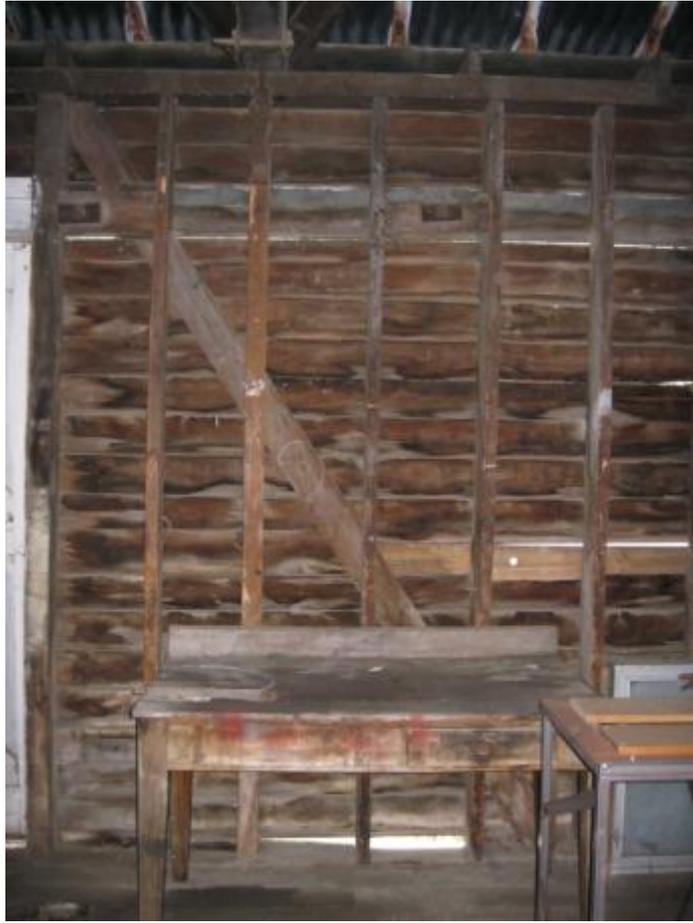
**Photograph 7 Diagonal let-in timber brace in timber framed wall.**

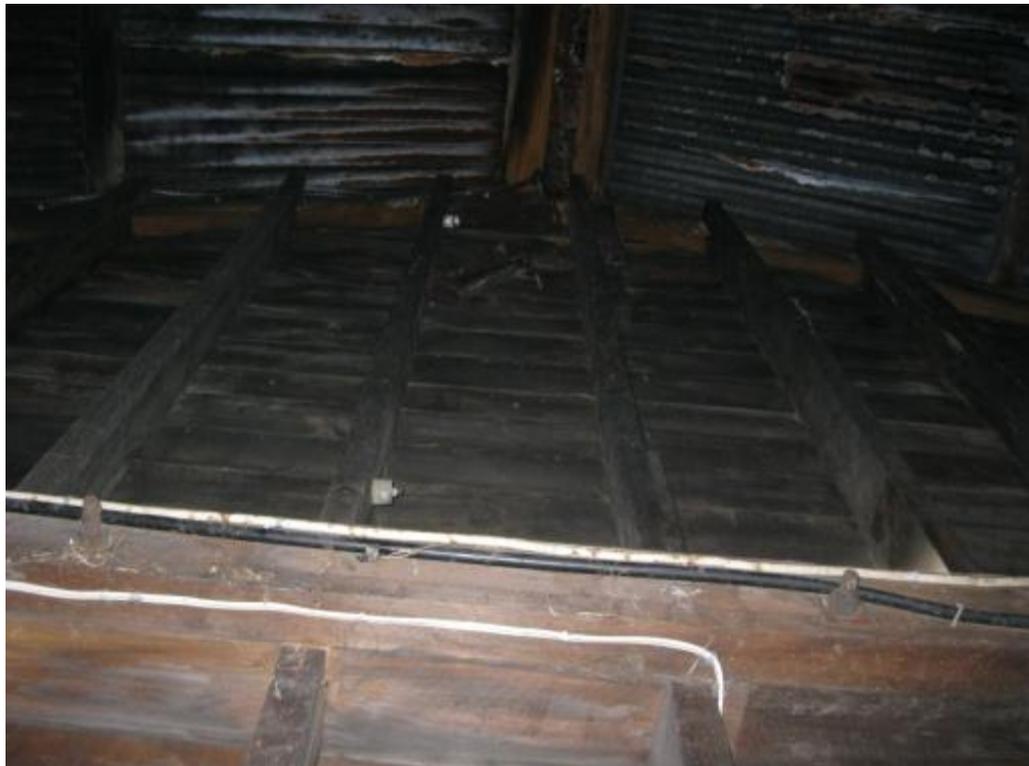
**Photograph 8 Gable end of timber framed wall.**
