Heritage Park Little River - Old Railway Station & Toilets

Detailed Engineering Evaluation

Quantitative Assessment Report

Date: February 2013
Reference: 6-QUCC1.27/28
Status: Final

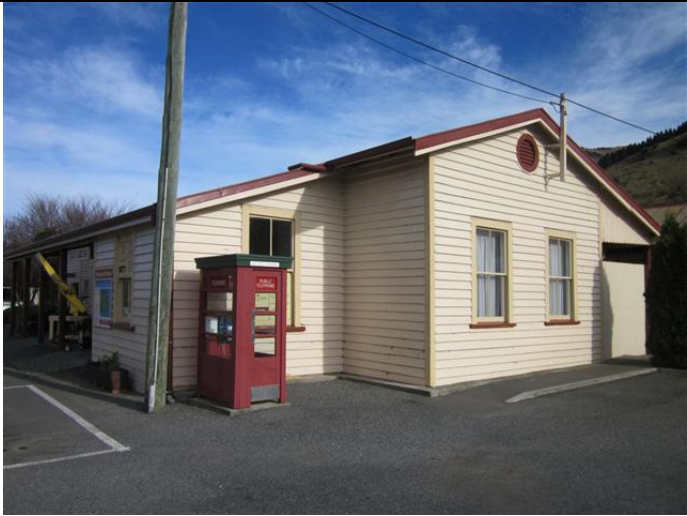
General Photos		
1.	North end of building

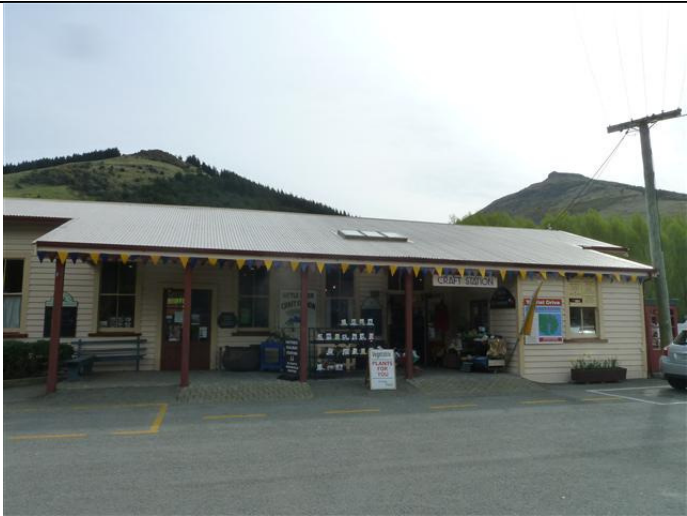
2.	East side of building, Northern end

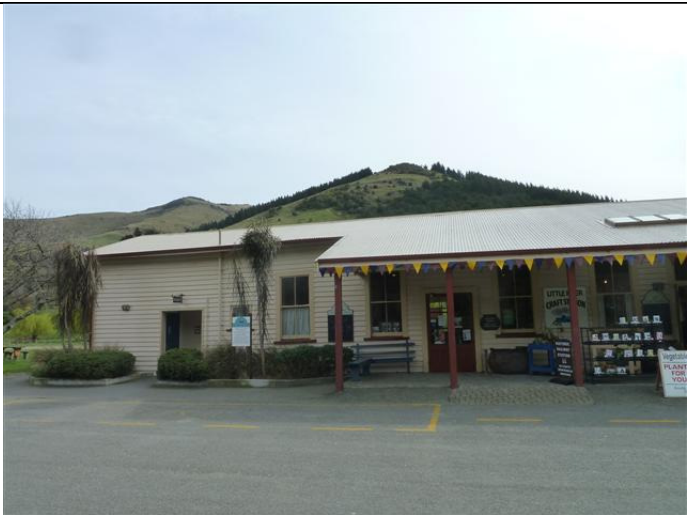
3.	East side of building, Southern end

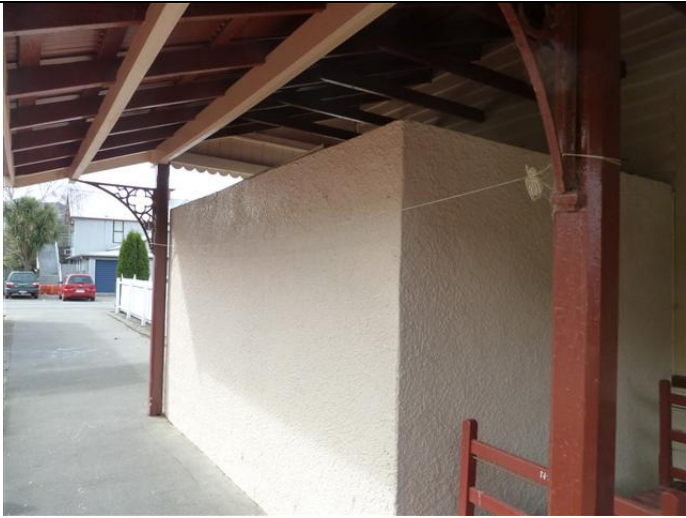
There is a self-supporting concrete room at one end of the building which appears to have no significant integration with the rest of the structure. It is expected that this room will not affect the seismic response of the main timber structure, and thus it has not been evaluated as contributing to the seismic capacity of the building.

7.	Free-standing concrete room, west side
