Mackenzie Courts Housing Complex PRO 0921

**Detailed Engineering Evaluation
Quantitative Assessment Report**

Mackenzie Courts Housing Complex Quantitative Assessment Report

Date: March 2014
Reference: 6-QC374.00
Status: Final

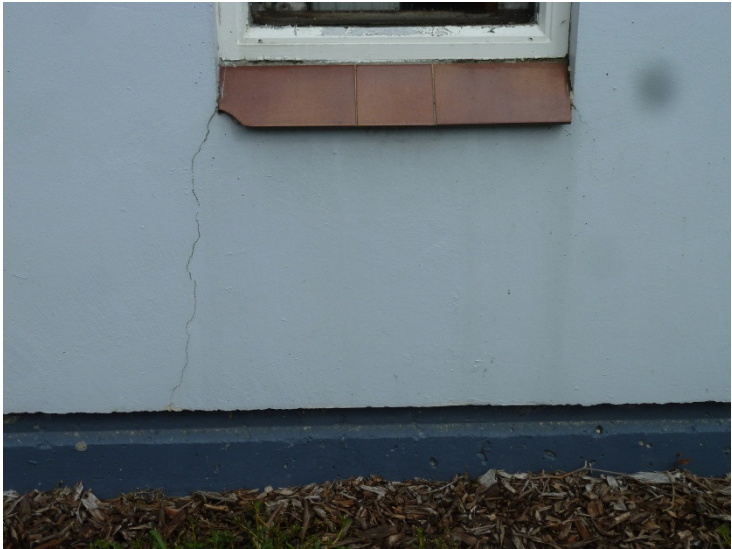
The residential units suffered minor damage to non-structural elements. This included cracking of interior wall and ceiling linings. Structural damage to the residential units was generally minor and was limited to some minor hairline cracking of some exterior concrete wall panels. This damage is deemed not to affect the seismic capacity of the structure. The cracking requires repair to avoid corrosion of the steel reinforcing bars.

Minor cracking on the exterior concrete wall panels was observed on some units (photo 9). No damage was evident in the roof structure. This damage is deemed minor and not to affect the seismic capacity of the gravity structure.

9.	Cracking on exterior concrete wall panel

- Exterior cracking to the concrete panels be repaired to prevent corrosion of the reinforcement.
- Cosmetic repairs be undertaken as required.
- Header tanks in the ceiling be secured.

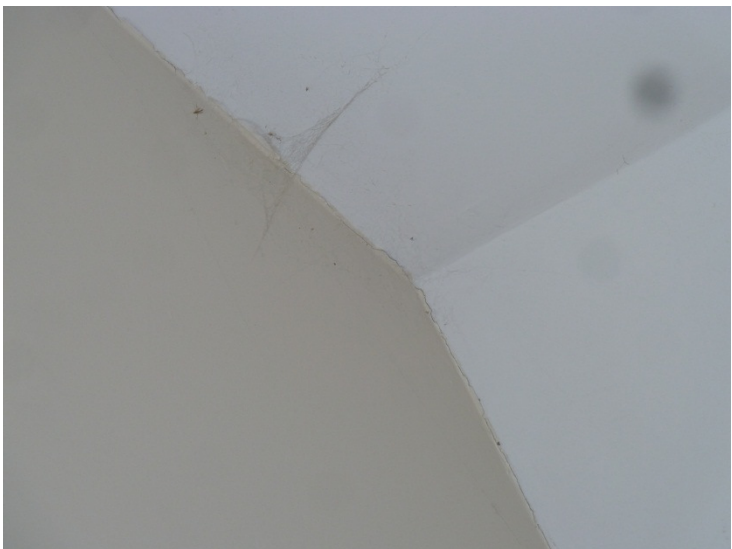
Minimal cracking of plasterboard ceiling diaphragms and wall linings was observed in the units (photo 11). This form of damage is common throughout the units. This damage is deemed minor and not to affect the seismic capacity of the lateral resistance structure.

11.	Typical cracking of wall lining
