**Margaret Murray
Courts
BE 0208 EQ2**

**Detailed Engineering Evaluation
Quantitative Assessment Report**

Margaret Murray Courts

Detailed Engineering Evaluation
Quantitative Report - Summary
Final

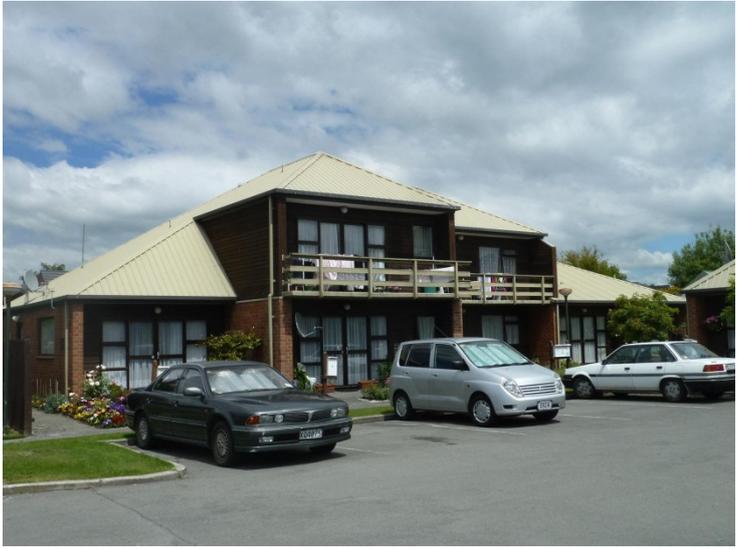
Margaret Murray Courts		
No.	Item description	Photo
1	View on North elevation, Block A

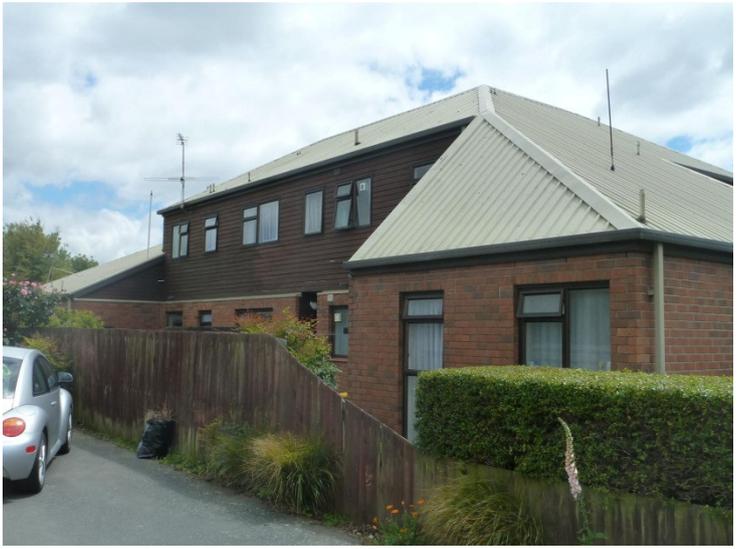
2	View on South elevation, Block A

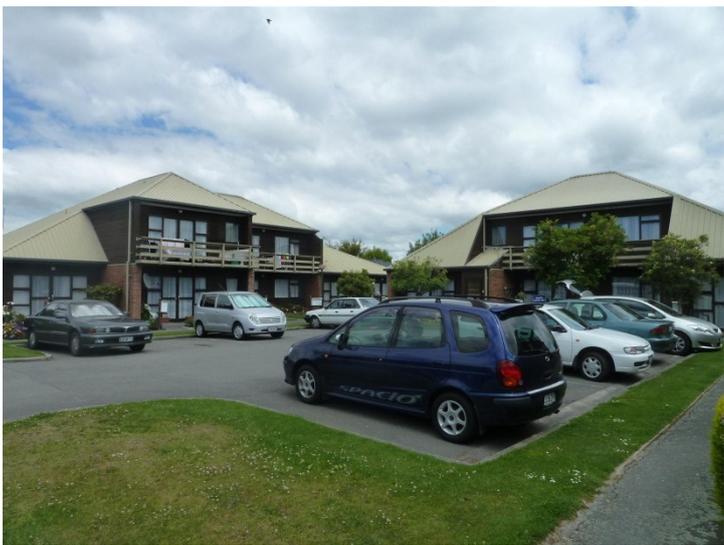
3	View on North East elevation, Blocks A & B

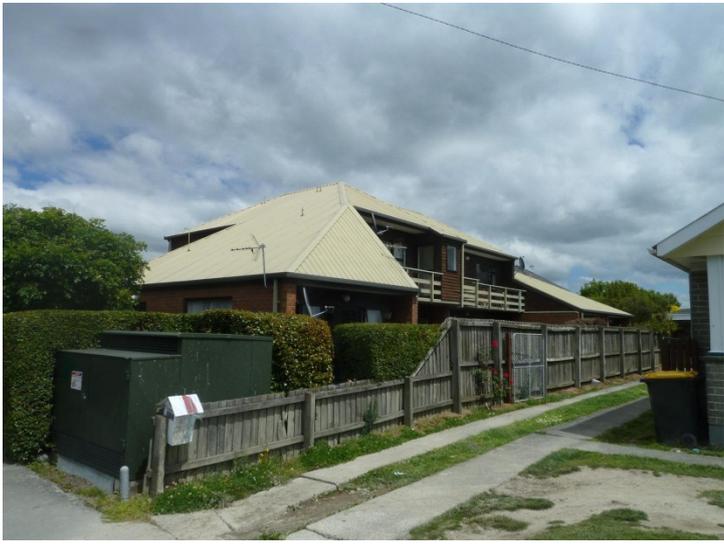
4	View on North elevation, Block C

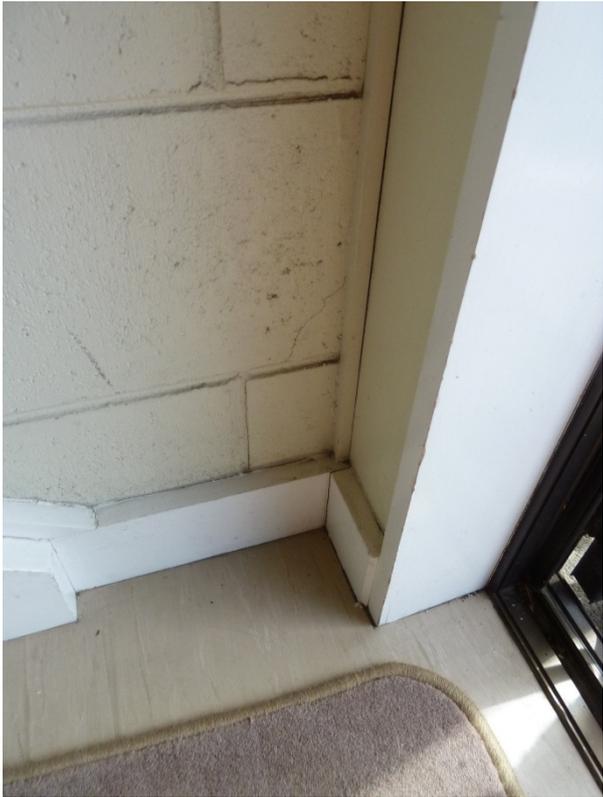
Some minor damage was noted such as cracking in brick veneer grout and cracking to block work at the base of the Unit 3/4 interior staircase and 1st floor level.

5	Cracking of inter-tenancy blockwork wall. Block A stairwell, unit 3/4
