CHRISTCHURCH CITY COUNCIL  
PRO\_0862  
Maurice Carter Court Owner/Occupier  
16 Dundee Place, Spreydon

QUANTITATIVE ASSESSMENT REPORT

- Rev D
- February 2014

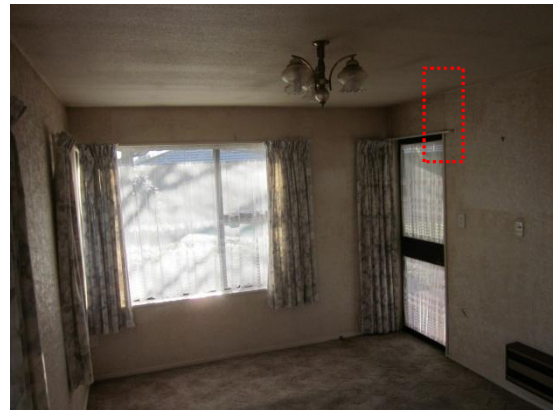
Structural damage	
-	None observed
Non-structural damage	
E-1	Superficial cracking to plasterboard lining in the living room in the Unit 35 (PHOTO 8)

PHOTO 8: Maurice Carter Court Owner/Occupier Units – Interior view of the Unit 35. Hairline cracking in the gip lining above the rear entrance door.

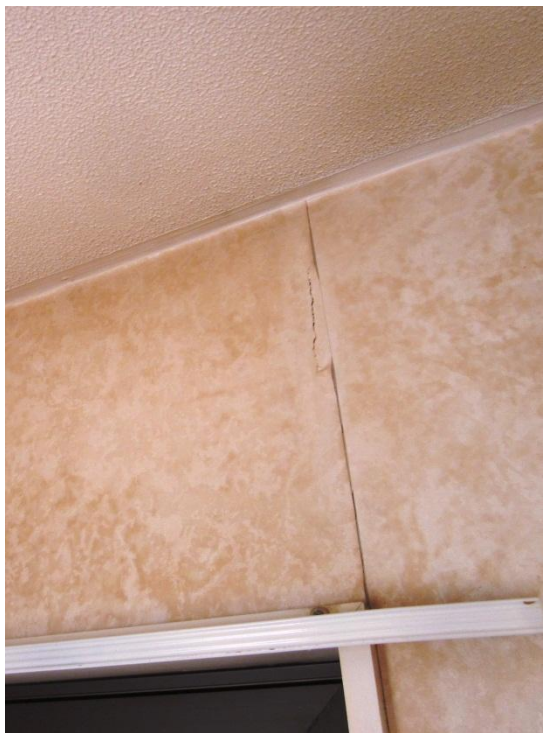
PHOTO 9: Detail of previous photo (probably earthquake damage)

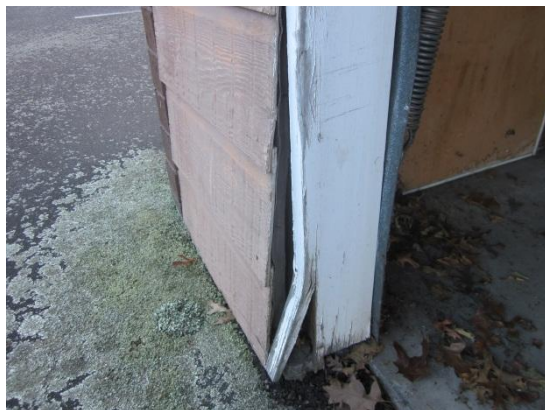
Structural damage	
-	None observed
Non-structural damage	
E-2	Door frame to the Garage 1 has broken – doesn't appear to be earthquake damage (PHOTO 23)

PHOTO 23: Garage 1 – Damage to door frame (not earthquake related)

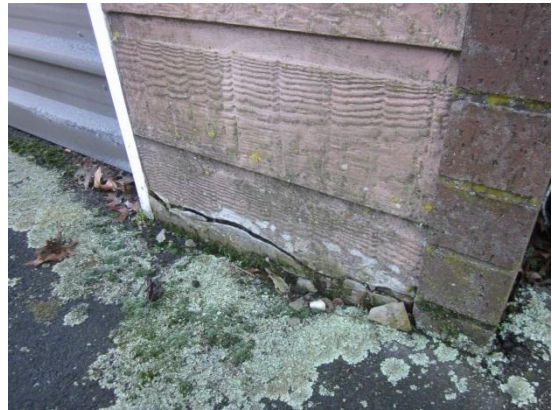
Structural damage	
-	None observed
Non-structural damage	
E-3	Weatherboard to the bottom of the front elevation of Garage 4 has been damaged (PHOTO 28)

PHOTO 28: Garage 4 – Cracked hardies  
to the bottom of the front elevation  
(possibly earthquake damage)
