**Memorial Park – Cemetery - Toilets/Shelter**  
**PRK 0880 BLDG 001 EQ2**  
Detailed Engineering Evaluation  
Quantitative Report  
Version FINAL

31 Ruru Road, Bromley

Christchurch City Council

**Date**  
09 June 2014

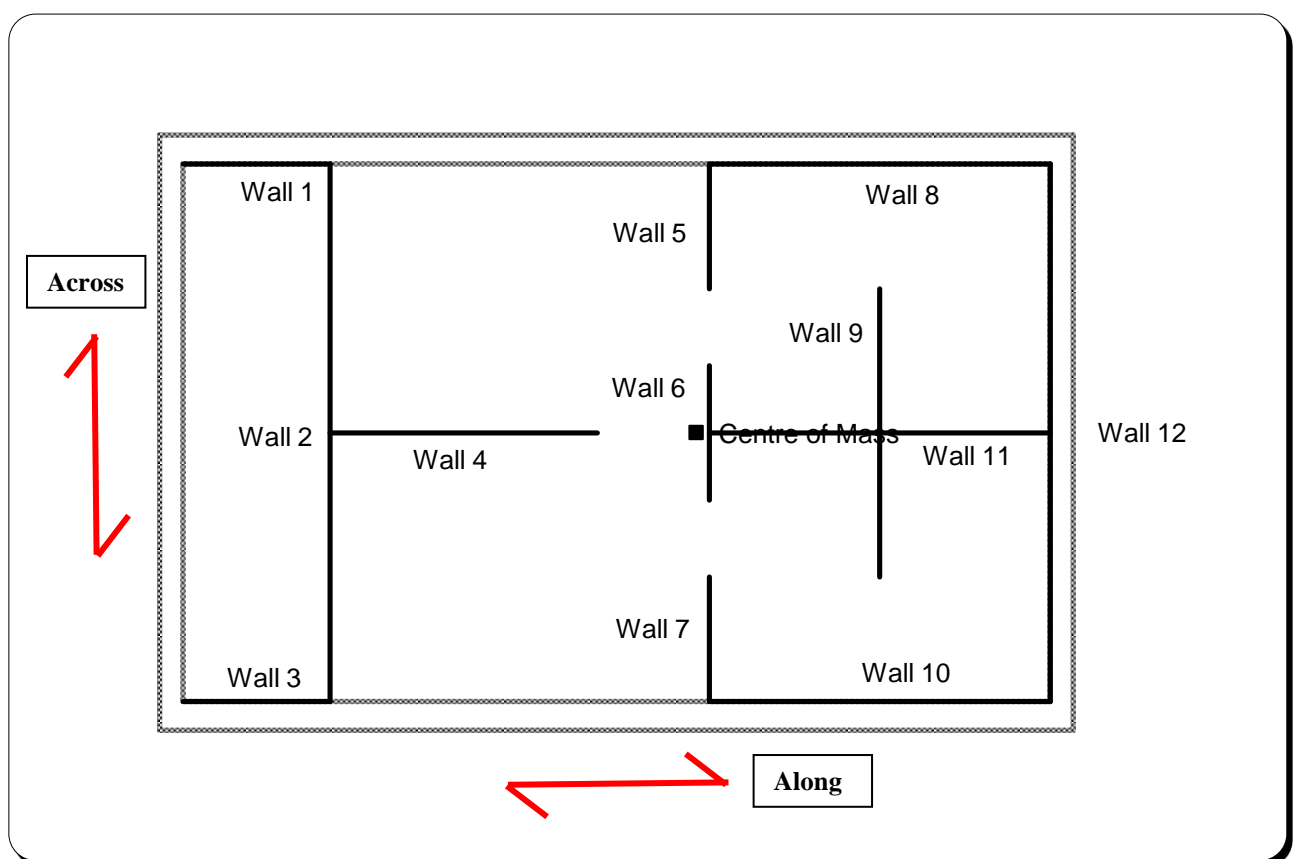
Figure 4 Plan Centres of Mass and Wall Numbering

Following a detailed assessment, the toilet/shelter block has been assessed as achieving 16 %NBS for the unreinforced brick masonry walls. Under the New Zealand Society for Earthquake Engineering (NZSEE) guidelines Memorial Park Cemetery Toilet is considered to be Earthquake Prone. The buildings brick masonry walls are unreinforced, but there are no other critical structural weaknesses or potential collapse hazards identified in the building.

The recent seismic activity in Christchurch has caused loss or damage to the mortar in multiple areas on the building, as apparent from the repairs. There is also evidence of ground settlement and the uneven floor slabs should be re-levelled or replaced. The park building has achieved approximately 16% NBS following a Quantitative Detailed Engineering Evaluation. Further assessment is not required. GHD recommends that continuing occupancy may be permitted. However, significant wall strengthening or wall replacement options be explored and implemented to bring the %NBS of the building up to a minimum of 67% NBS in accordance the NZSEE guidelines.

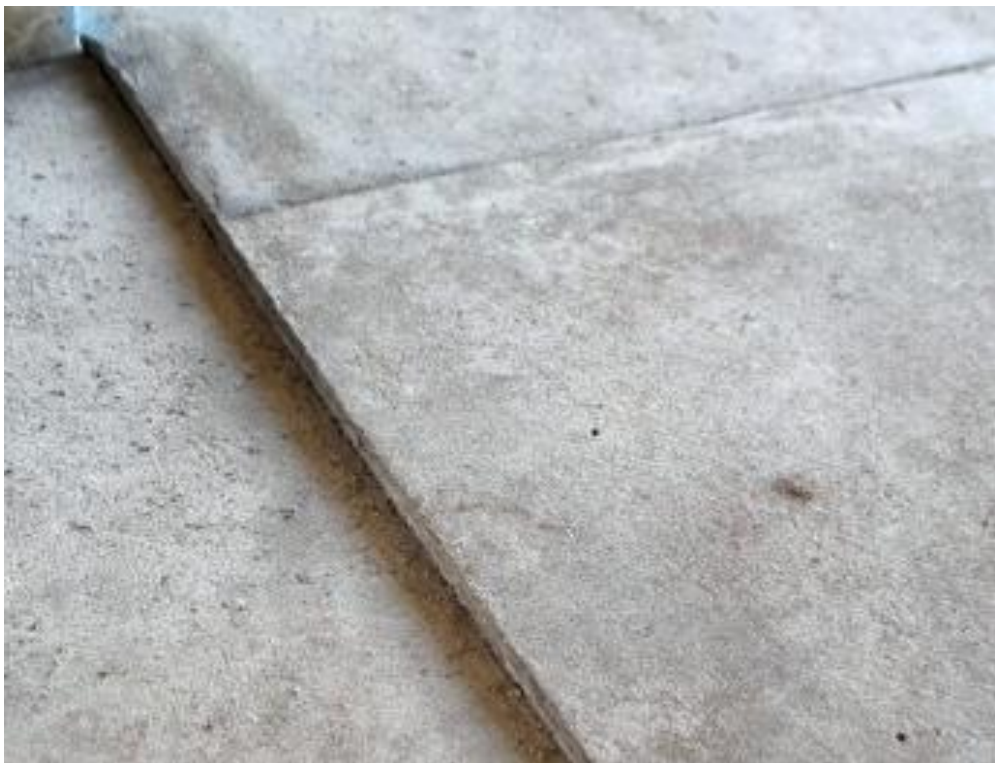
Geotechnical assessment of soil conditions indicate minor to moderate vertical land settlements however no liquefaction or land cracking has been observed on the site. However there is evidence of ground settlement with uneven and displaced floor slabs.

**Photograph 4 Differential settlement of the concrete foundation slab.**

The recent seismic activity in Christchurch has not caused any significant damage to the building. The uneven, settled floor slabs should be re-levelled or replaced. The building has achieved approximately 16% NBS following a Quantitative Detailed Engineering Evaluation. Further assessment is not required. GHD recommends significant wall strengthening or full replacement options be explored and implemented to bring the %NBS of the building up to a minimum of 67% NBS in accordance the NZSEE guidelines.

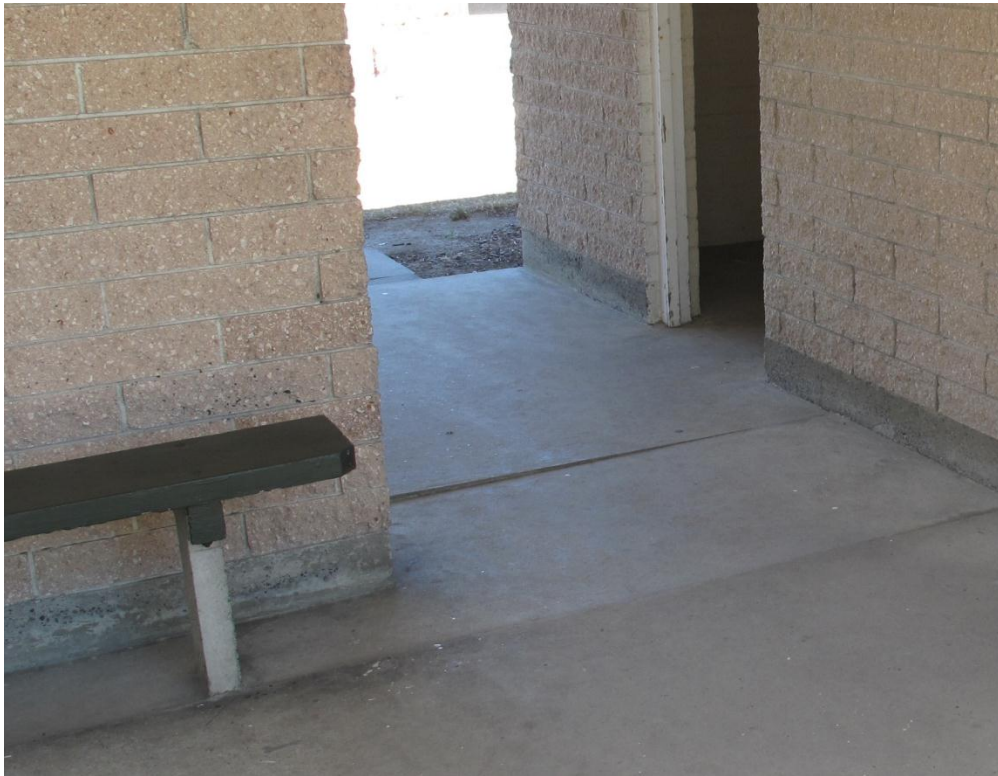
**Photograph 5 Differential settlement of the concrete foundation slab.**

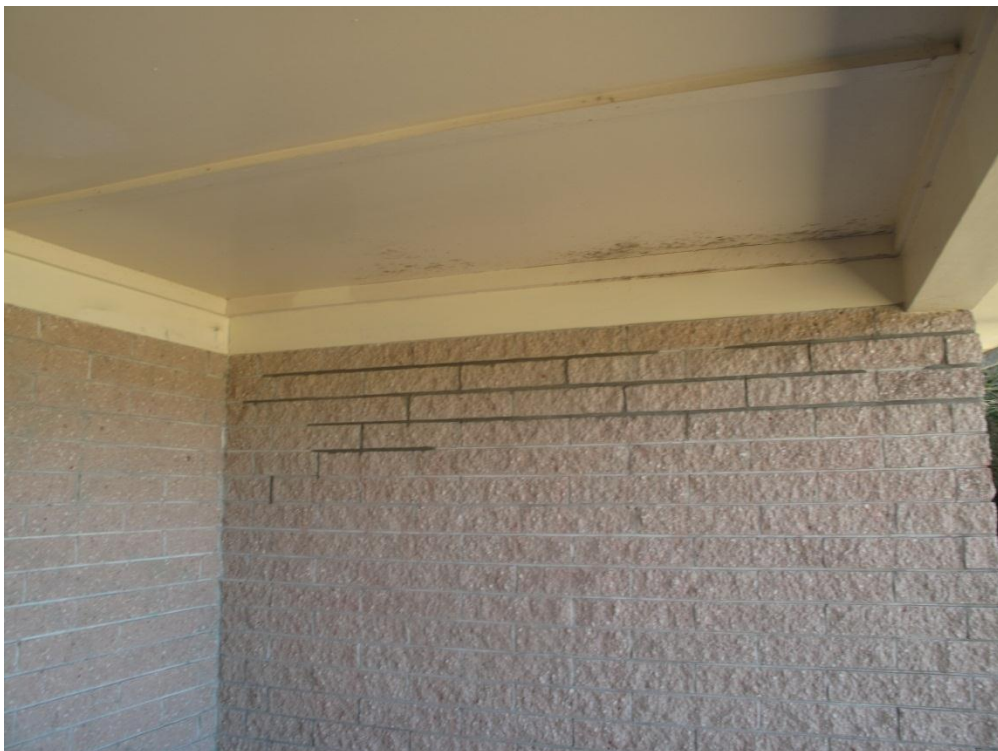
Damage was evident in the mortar of the concrete brick masonry walls. Repairs to the mortar were evident in a number of areas throughout the structure (See photograph 6, 7, and 8)

**Photograph 6 Repairs to damaged mortar in the brick masonry walls.**

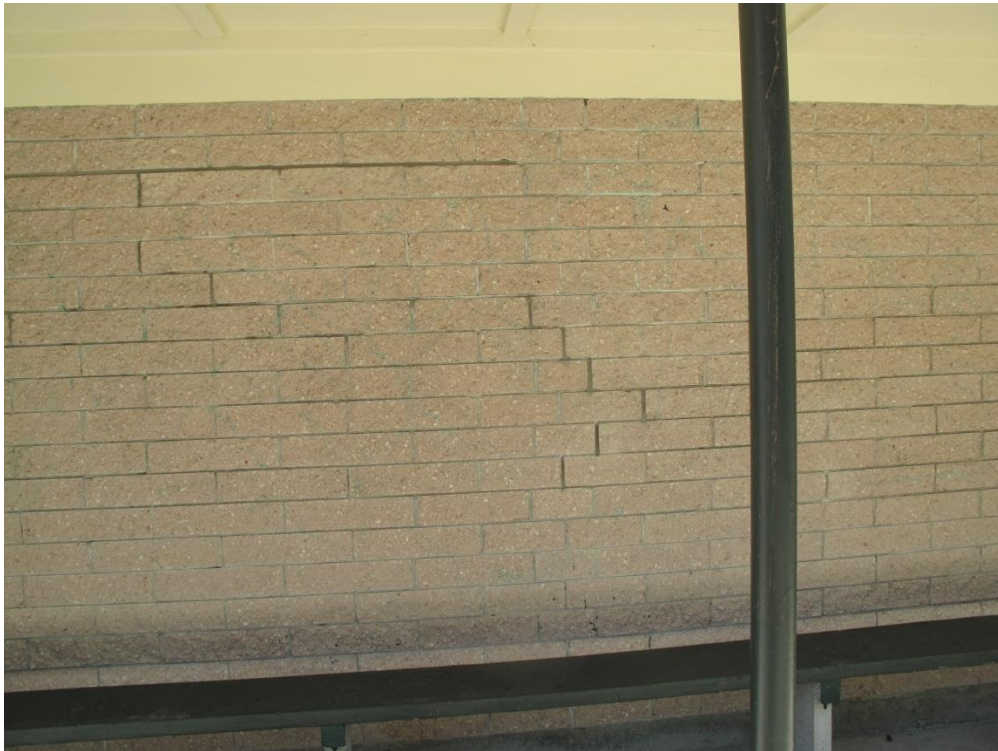
**Photograph 7 Repairs to damaged mortar in the brick masonry walls.**

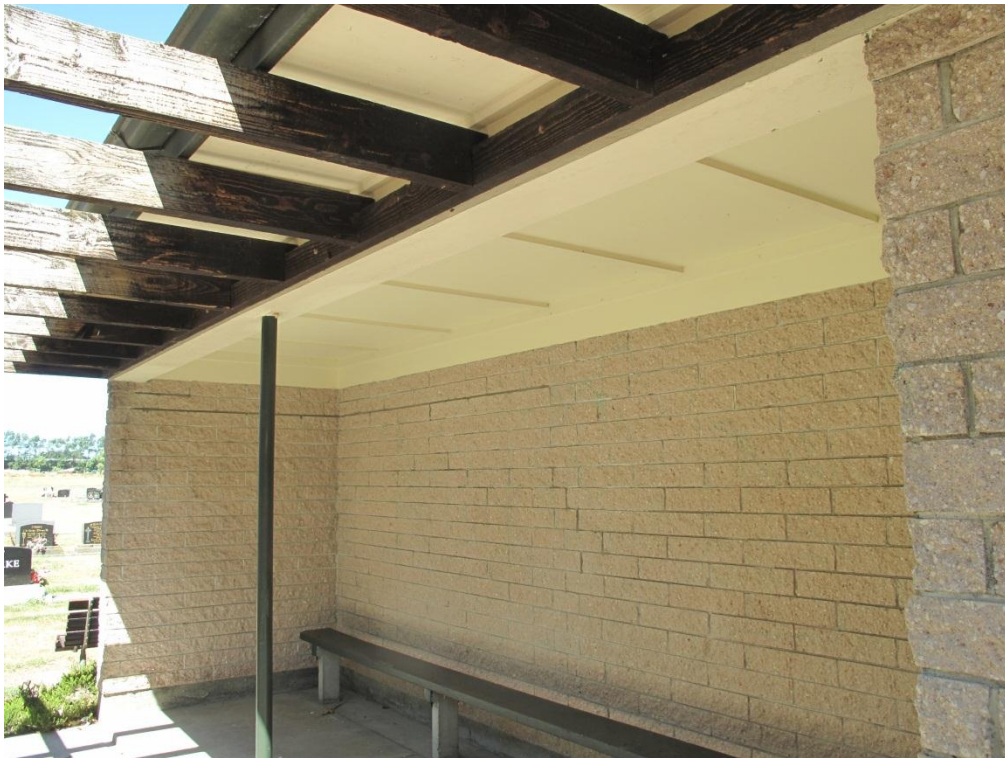
**Photograph 8 Repairs to damaged mortar in the brick masonry walls.**

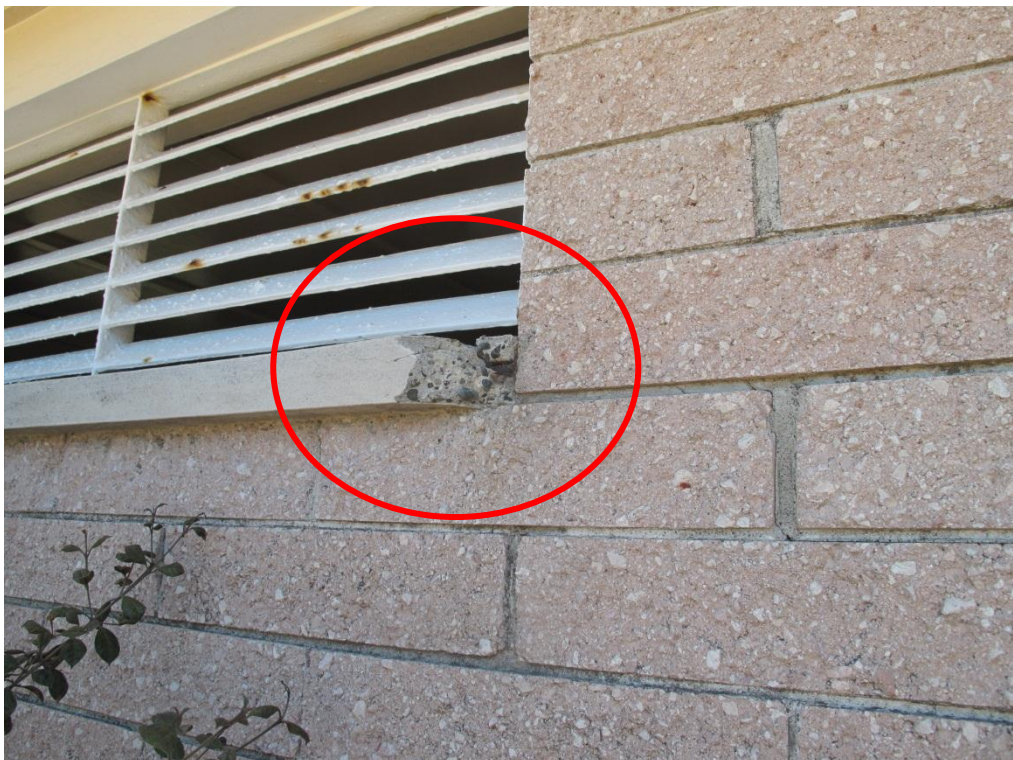
**Photograph 10 Minor spalling damage to concrete window sill.**
