# City Care Milton Street Depot – Truck Shelter Detailed Engineering Evaluation BU 1141-004 EQ2 Qualitative Report

**Prepared for Christchurch City Council (CCC)**

**By Beca Carter Hollings & Ferner Ltd (Beca)**

17 December 2013

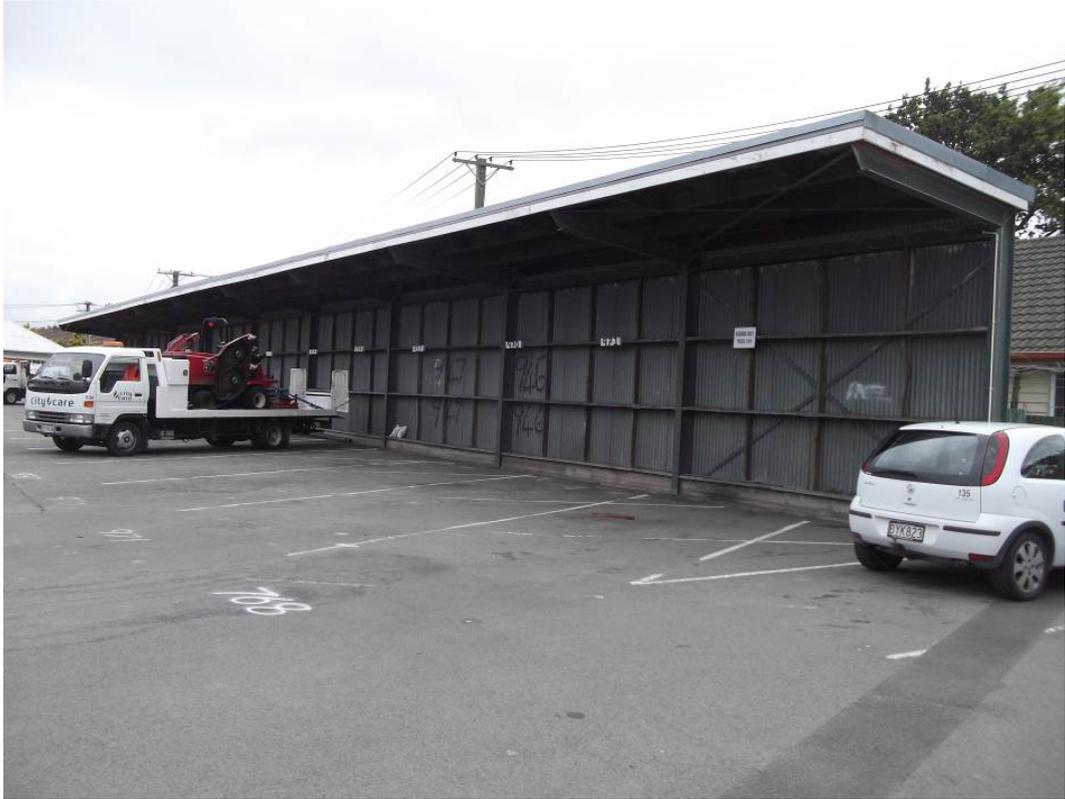
**Photo 1: Northern Shelter**

Visual inspection on 1 February 2012 indicates no damage was observed as a result of the recent earthquakes.
